The Crooked House, 21 Queen Street, Emsworth

Design & Access and Heritage Statement

Helyer Davies Architects have been appointed by a private client to extend and renovate the existing dwelling at 21 Queen Street, The Crooked House, Queen Street, Emsworth. This document outlines the proposed works to include:

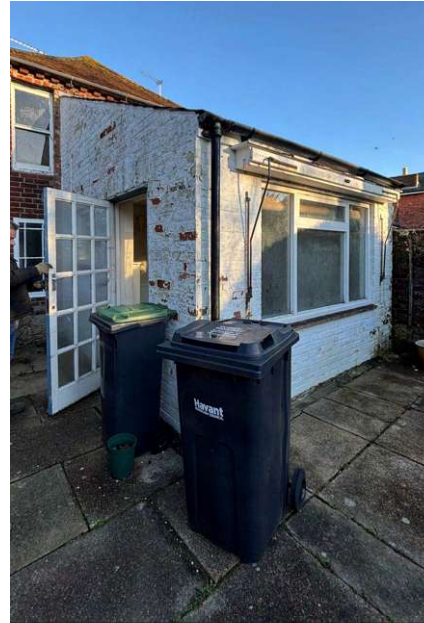
Figure 24: Existing Extension

The proposal is to demolish the existing, 1960's rear extension and replace it with a more functional and usable space.

**Justification** - The 1960s extension is in a deteriorated condition and has no historical merit, making it unsuitable for continued use. Rebuilding it will create a safer, more functional, and energy-efficient living space.

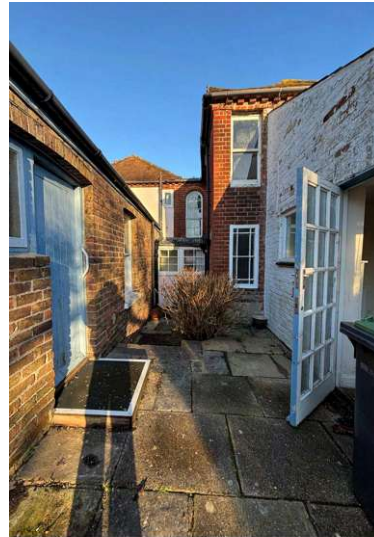
Figure 27: Existing Courtyard Area

The proposal is to remove the existing substandard link, build a small link that connects the 2 sides of the house and provides a kitchen and space for a small table. With windows out onto the courtyard space.

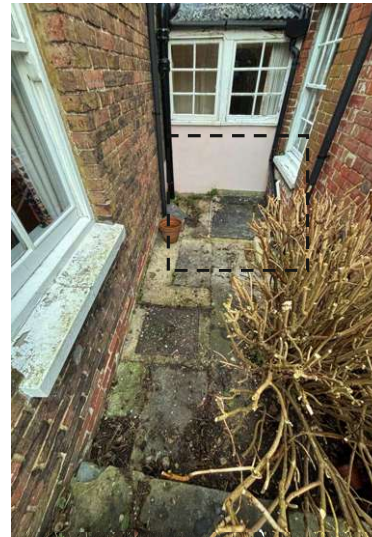
Figure 28: Coal Chute Area

**Coal Chute:** The coal chute is causing ongoing damp issues, which are negatively affecting the historic fabric of the building, covering it is necessary to prevent further deterioration and preserve the structure's integrity.

**Coal Chute:** The covering of the coal chute will be carried out using materials that are sympathetic to the original structure to maintain visual continuity from the basement.

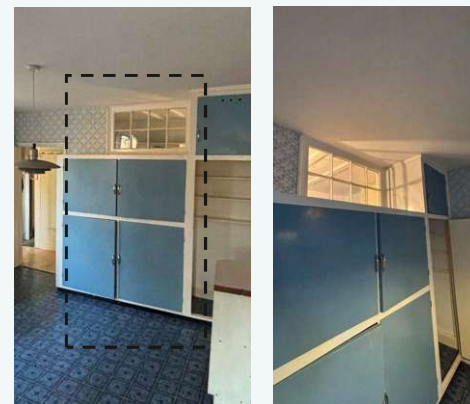
Figures 31 & 32: Existing Window between Kitchen & Larder.

**Proposal:** Removal of internal window and relocation of larder access.

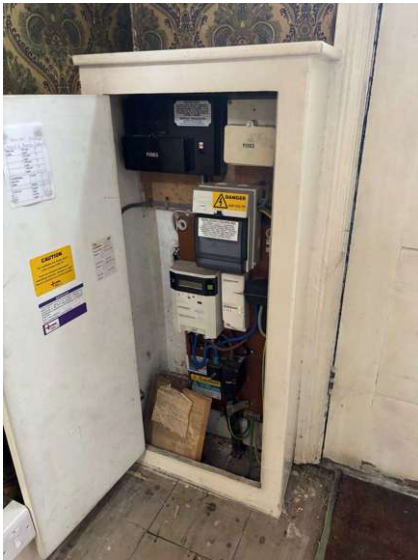
Figure 35: Existing Location of Electric Meter

**Proposals:** To relocate the existing electric meter from the entrance hall to the external western elevation, and to lift and replace the existing floorboards due to their poor condition, with salvaged boards reused elsewhere in the property.

**Mitigation:** The new electric meter location is discreet and not visible from Queen Street, and replacement floorboards will match the original in appearance, with reuse of existing material elsewhere to minimise loss.

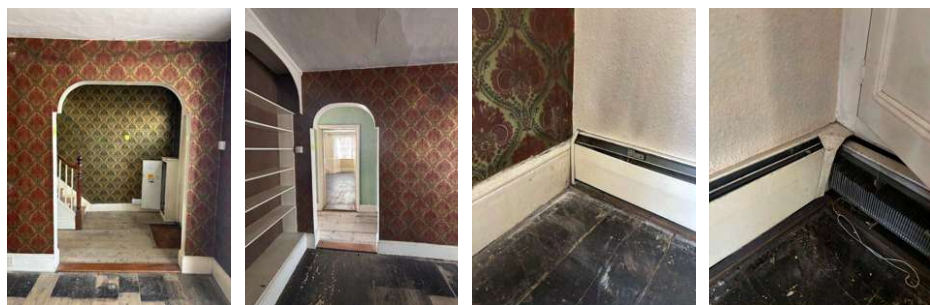
**Proposals:** To remove heated skirting boards and replace them with traditional-style skirting to match existing, while refurbishing the remaining skirting; to enclose the two existing archways and install traditional doors; and to carry out additional works including refurbishing windowsills, constructing a new window seat, repairing plaster to the internal face of the external wall, replacing damaged ceilings, and removing bookshelves.

Figure 40 & 41: Archways to be turned into doors.

Figure 42 & 43: Heated skirting removed.

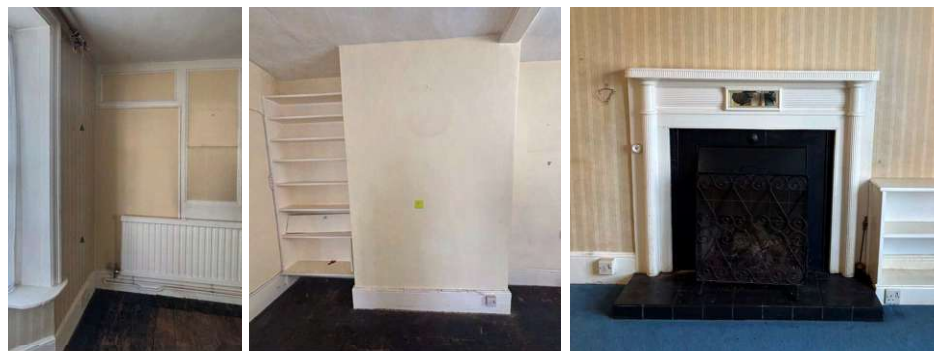
**Proposals:** To retain the existing fireplace while replacing its surround with a more period-appropriate design; reopen a previously closed original fireplace; and reinstate an original doorway to restore access to the main hallway. Additional proposals include refurbishing the skirting boards, windowsills, and ceiling; repairing the internal face of the external wall; and replacing the existing shelving units.

Figure 44: Door to be reinstated

Figure 45: Fireplace to be opened.

Figure 46: Surround to be replaced.

**Justification:** Relocating the meter enhances the historic character of the entrance hall, which allows for the reopening of an original door [see fig 44]. New flooring is necessary due to the deterioration of the original boards in this high-traffic area.

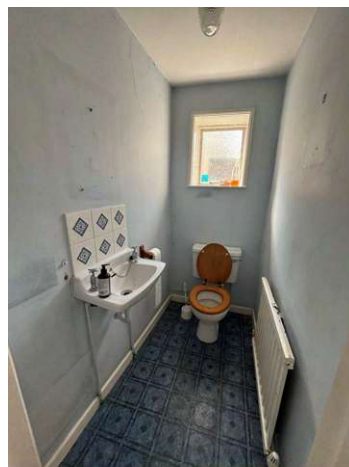
The proposals include are to replace the existing metal window and remove all current fixtures and fittings in the downstairs WC, which will be updated with new, modern appliances.

**Mitigation:** The new window will reflect traditional styling, and all new fixtures will be installed with care to avoid damage to historic fabric, ensuring a respectful upgrade.

Figure 47: New window & fixtures.

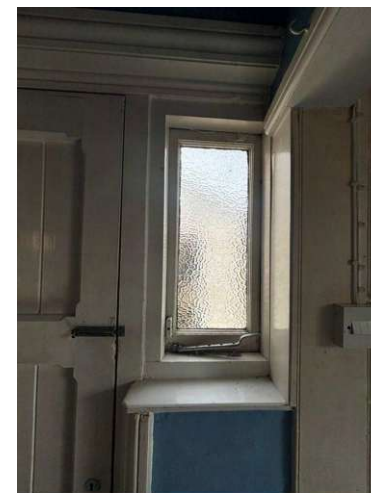
In the back lobby the proposal is to refurbish the existing window, replace the glazing, and change obscure glass to standard clear glazing.

**Mitigation:** Refurbishment will retain the original window frame, with new glazing installed to match traditional profiles and detailing.

Figure 48: Replacement glazing.

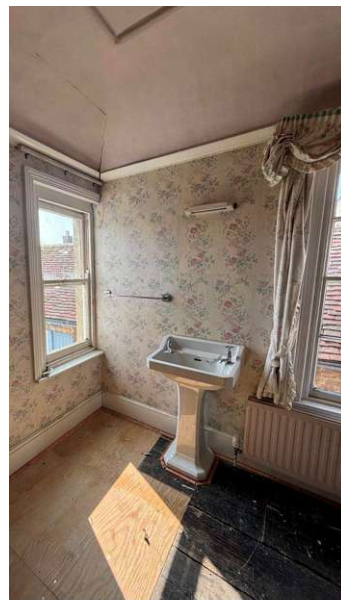
Figures 51: Existing Window & Sink to be removed.

**Proposals:** To remove the existing south-facing window, infill the wall, and install a new pair of centrally positioned windows; additionally, to remove the existing sink and replace the ceiling.

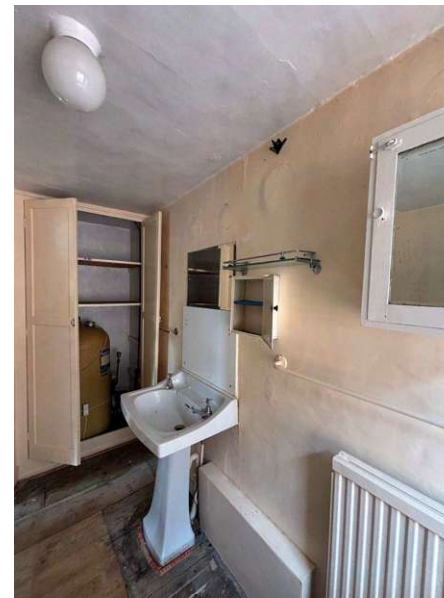
Figures 52 & 53: Existing fixtures & fittings to be removed.

The proposal is to remove all existing bathroom fixtures and fittings and replace them with new ones.

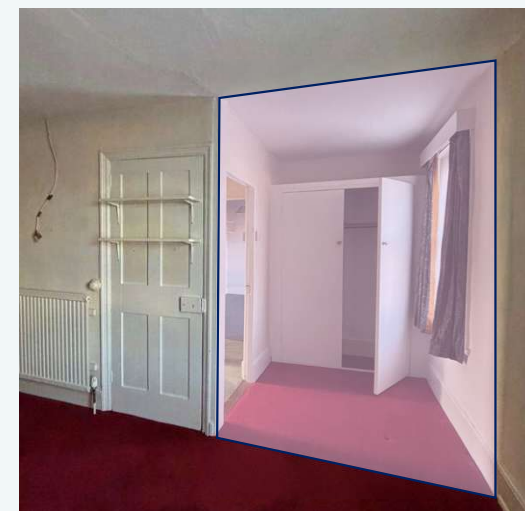
Figures 55: Wall is to be reinstated, and existing door used to enter the bedroom.

**Proposal:** To install new partition walls to create an ensuite and reinstate the front portion of the landing, remove the existing sink and cupboards to accommodate the new layout, and refurbish the ceiling and wall surfaces to improve their condition.

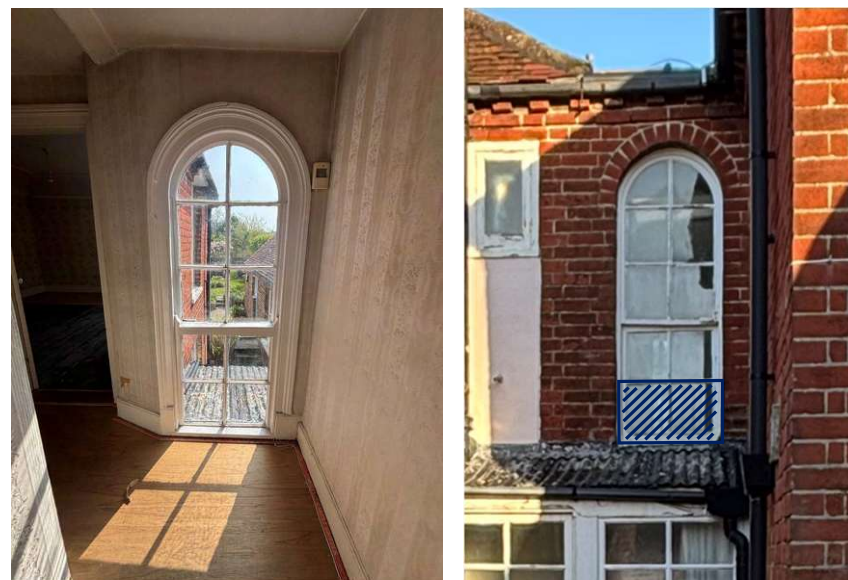
Figure 62: Existing Arched window to lose bottom 2 panes.

**Justification:** The modification is essential to facilitate the link extension and addresses a safety concern by reducing the risk of low-level glazing.

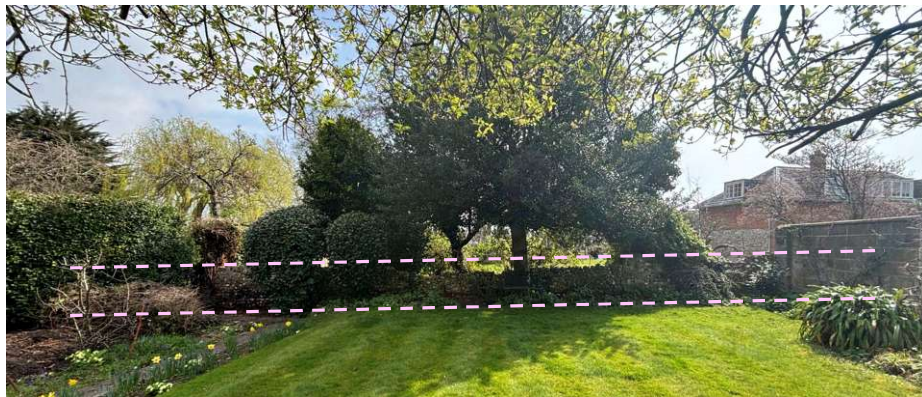
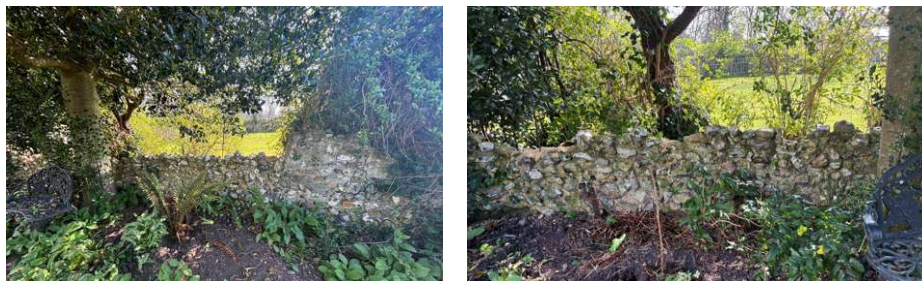
Figure 63 – 65: Existing rear garden wall.

**Proposal:** To repair the rear boundary wall up to its original height to restore its historic form and improve privacy.

**Justification:** The current reduced height offers limited privacy and does not reflect the original design; rebuilding will restore function and historical accuracy.

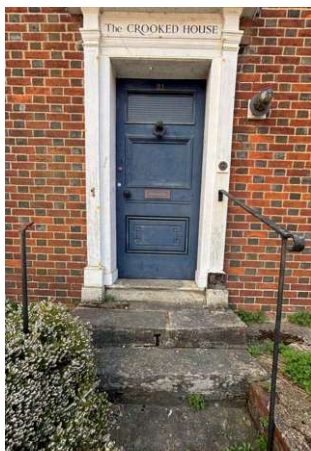
Figure 69: Front doorstep & surround to be repaired.

**Proposal:** To repair the front doorstep, surround, railings, and to remove the concrete surfacing in the front garden.

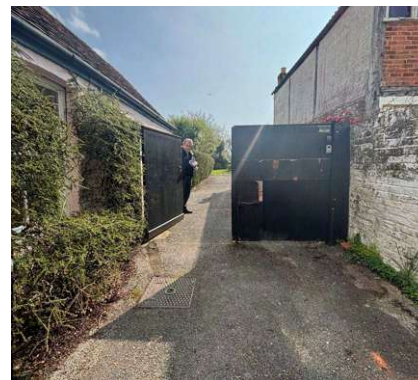
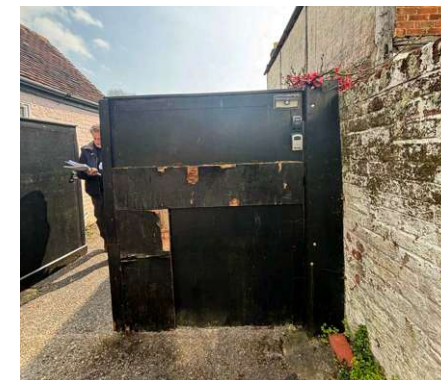
Figure 72 & 73: Existing gate to be replaced.

**Proposal:** To replace the existing damaged gates with new ones that are more in keeping with the architectural style of the property.

**Justification:** The existing gates are in poor condition; new gates will enhance the appearance and complement the historic setting.

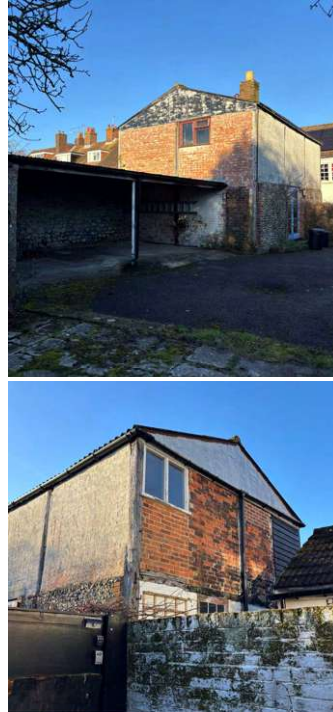
Figures 74 & 75: Existing Barn – External

**External Proposals:** The barn will be externally clad at first floor level, the roof and windows replaced, and three roof lights added. An existing window on the north elevation will be removed and repositioned on the east elevation with double glazing to prevent overlooking.

**Justification** - By cladding some of the external walls it creates a more cohesive aesthetic, addressing the current mix of materials while respecting the historic Georgian character. Replacing the roof prevents ongoing water damage and damp issues, whilst also prolonging the building's lifespan, and improving weatherproofing. The roof is also asbestos so the client keen for it to be safely removed.

The barn is constructed of a timber frame and masonry infill, showing widespread decay, missing lintels, and inadequate support, particularly at low-level timber posts and floor joists.

- Water ingress and timber rot have significantly compromised several load-bearing elements.
- The roof (currently asbestos) is no longer fit for purpose and must be replaced.
- The first floor is unstable, with unsupported openings and a distorted ceiling structure.

- Replace the roof using traditional materials.
- Replace or repair decayed structural timbers.
- Introduce breathable insulation, conservation-style roof lights, and appropriate structural bracing.
- Retain and repair existing framing where feasible, with new elements tied sympathetically into the existing structure.

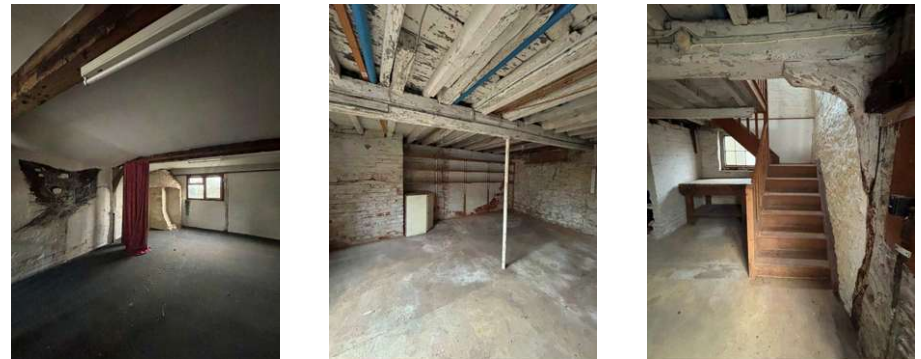
Figures 79 - 81: Existing Barn – Internal

**Internal Proposals:** The internal works involve lining the walls for better insulation, restoring a bathroom, repairing damaged structures, and removing the existing chipboard ceiling to the first floor, replacing the staircase, opening the ceiling to create a vaulted space, enhancing functionality while preserving the building's historic character.

**Impact:** The works may slightly impact the building's historic fabric, including alterations to surfaces and possible loss of original finishes. Structural repairs could require removal or replacement of deteriorated fabric.
