Our ref: GE17736/GR02/181102

**RE: Manor Farm, Lower Road, Bedhampton**

Further to your instruction, we write to present the results of the supplementary ground investigation and in-situ testing undertaken to assess the potential for use of borehole soakaways as part of a drainage solution for storm water discharge from the proposed development.

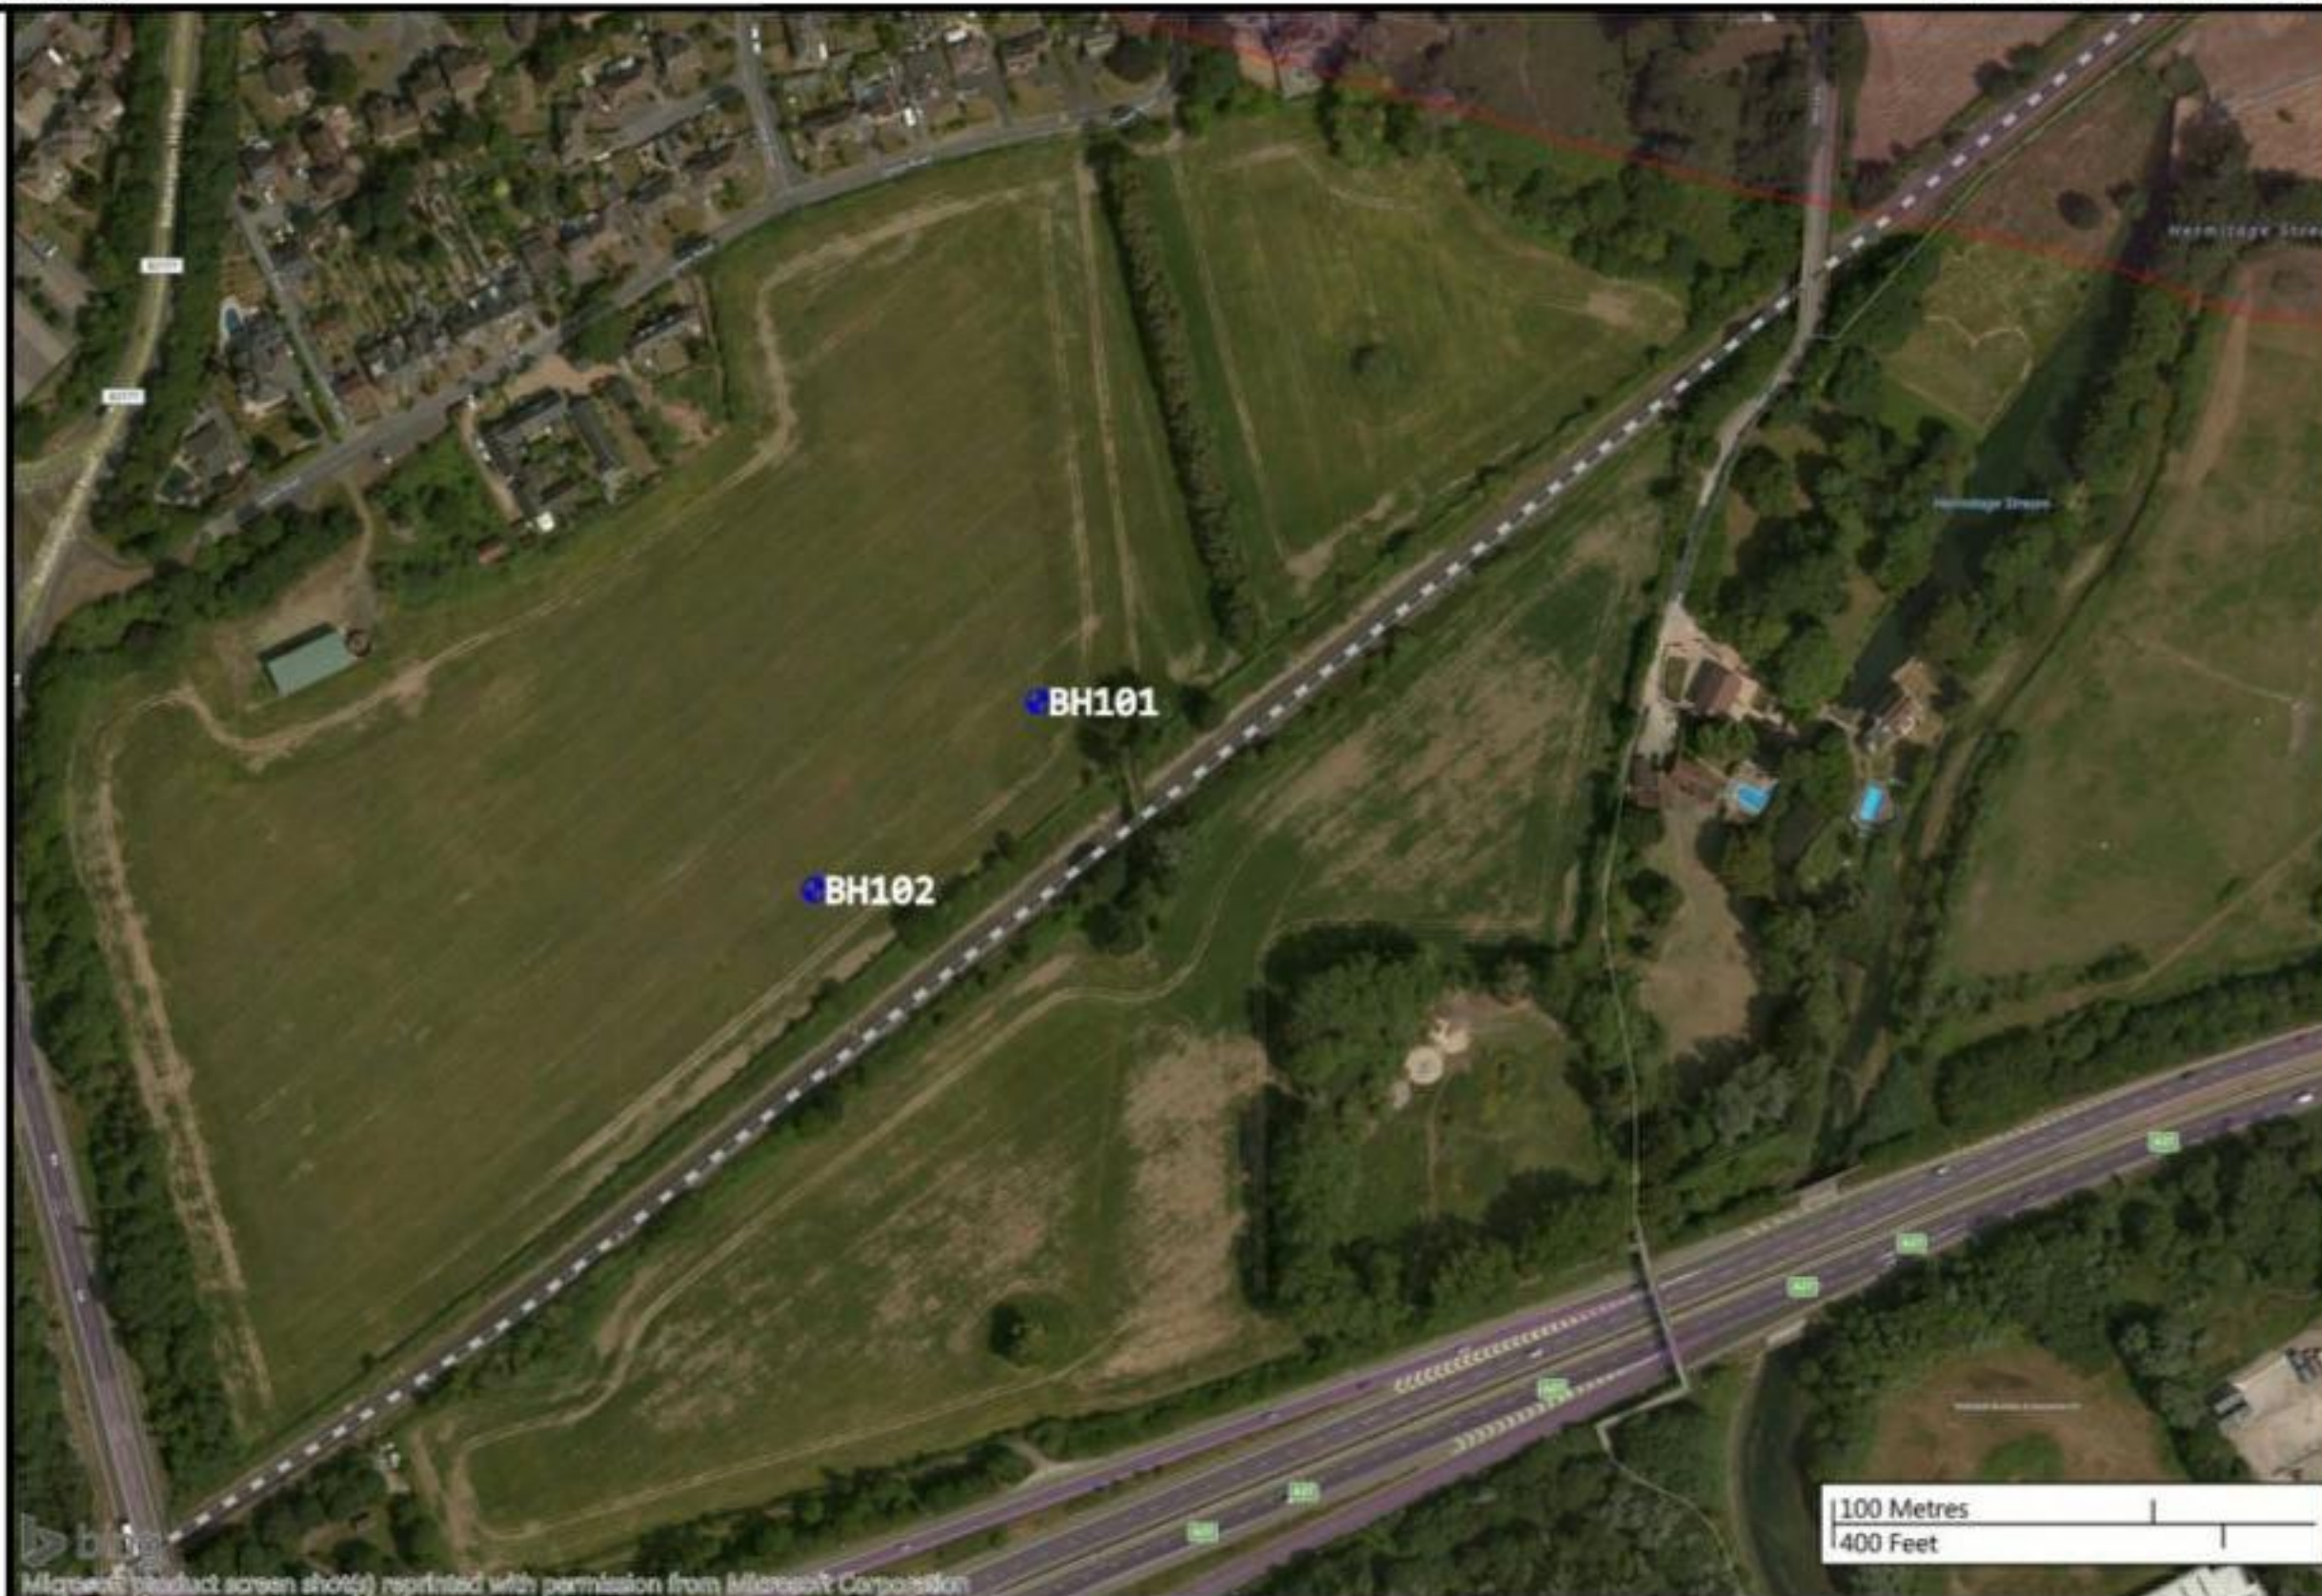
| Unit 7, Danworth Farm<br>Hurstpierpoint<br>BN6 9GL<br>www.gesl.net | | <h1 style="text-align: center;">Borehole Log</h1> | | | Borehole No.<br><b>BH101</b><br>Sheet 1 of 2 | |

| Project Name: Manor Farm, Bedhampton | | Project No. GE17736 | | Co-ords: 470062E - 106081N | | Hole Type<br>CP |

| Well | Water Strikes | Sample and In Situ Testing | | | Depth (m) | Level (m) | Legend | Stratum Description | |
|---|---|---|---|---|---|---|---|---|---|
| | | 10.50 | D | N=13 (3/2,3,3,5) | 12.50 | | Recovered as white and off-white weak gravel sized clasts of CHALK with some silt and sand size chalk. Gravel sized clasts occasionally iron stained.<br>CHALK | 11 | |

The ground conditions encountered within the two cable percussion boreholes were consistent with those encountered during previous phases of investigation, i.e. Topsoil overlying a succession of gravelly clay (River Terrace Deposits) and highly weathered structureless Chalk, with less weathered Chalk at depth. A summary of the ground conditions encountered is presented in Table 1 below. For further details, reference should be made to the borehole logs enclosed herein.
