# Arboricultural Impact Assessment

Havant footbridge replacement

HCC Arb Reference: P-HBC-HvntStnFtbrdg-SS24762-AIA-1.5

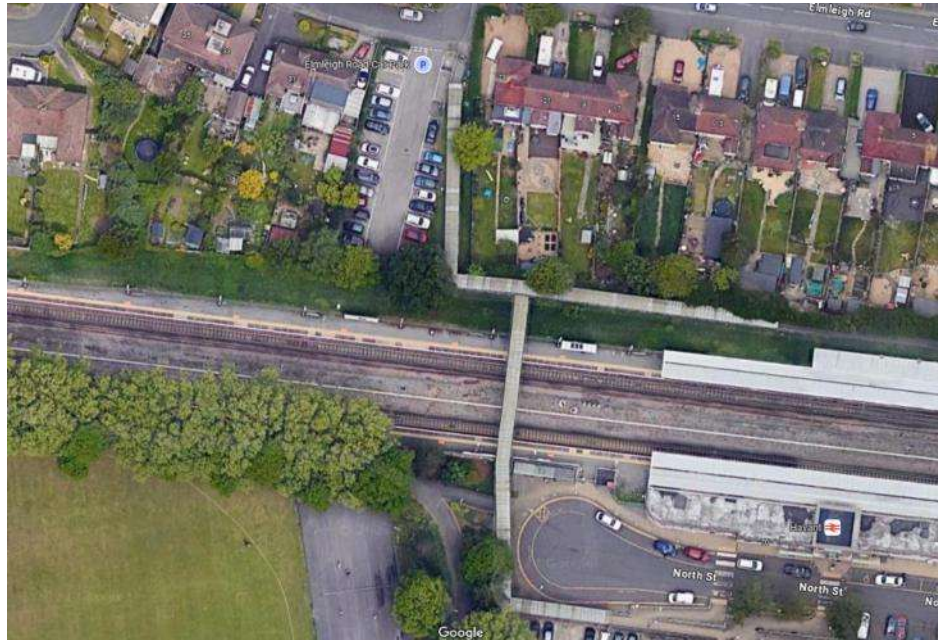
2.12 The site is a suburban location, originating in the Elmleigh Road car park to the north of the railway line: the existing covered bridge turns to the east, then a footbridge runs south to cross the railway line, and a ramp continues east to access the station on the north side. Location is shown in the clip below:

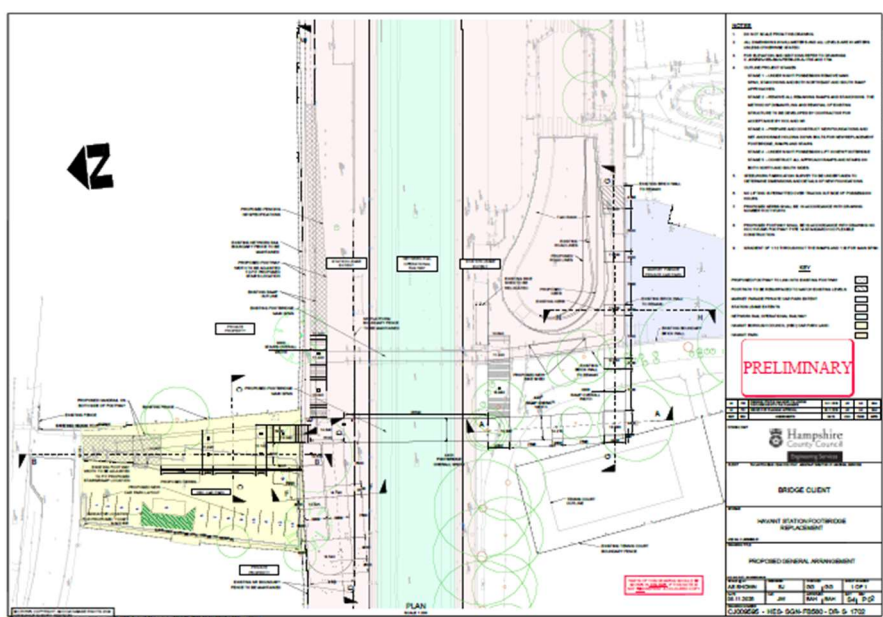
4.4 The proposed layout is as follows: note north is to the left in this drawing.

4.5 There is no scope to relocate the support positions even though this would be a way to reduce the impact on trees. They have been designed to be lower impact where they must be within the RPA's but it impossible to deliver the scheme within the site constraints with less arboricultural impact.

- 4.6 The new structure supports will use Continuous Flight Auger (CFA) pile foundations for the main span. The piles will be around 5 meters deep with concrete pile cap supporting the steel trestles of the structure. The piling rigs will only work from protected ground or existing hard standing. See paragraph 2.12 of the Arboricultural Method Statement for detail of ground protection.

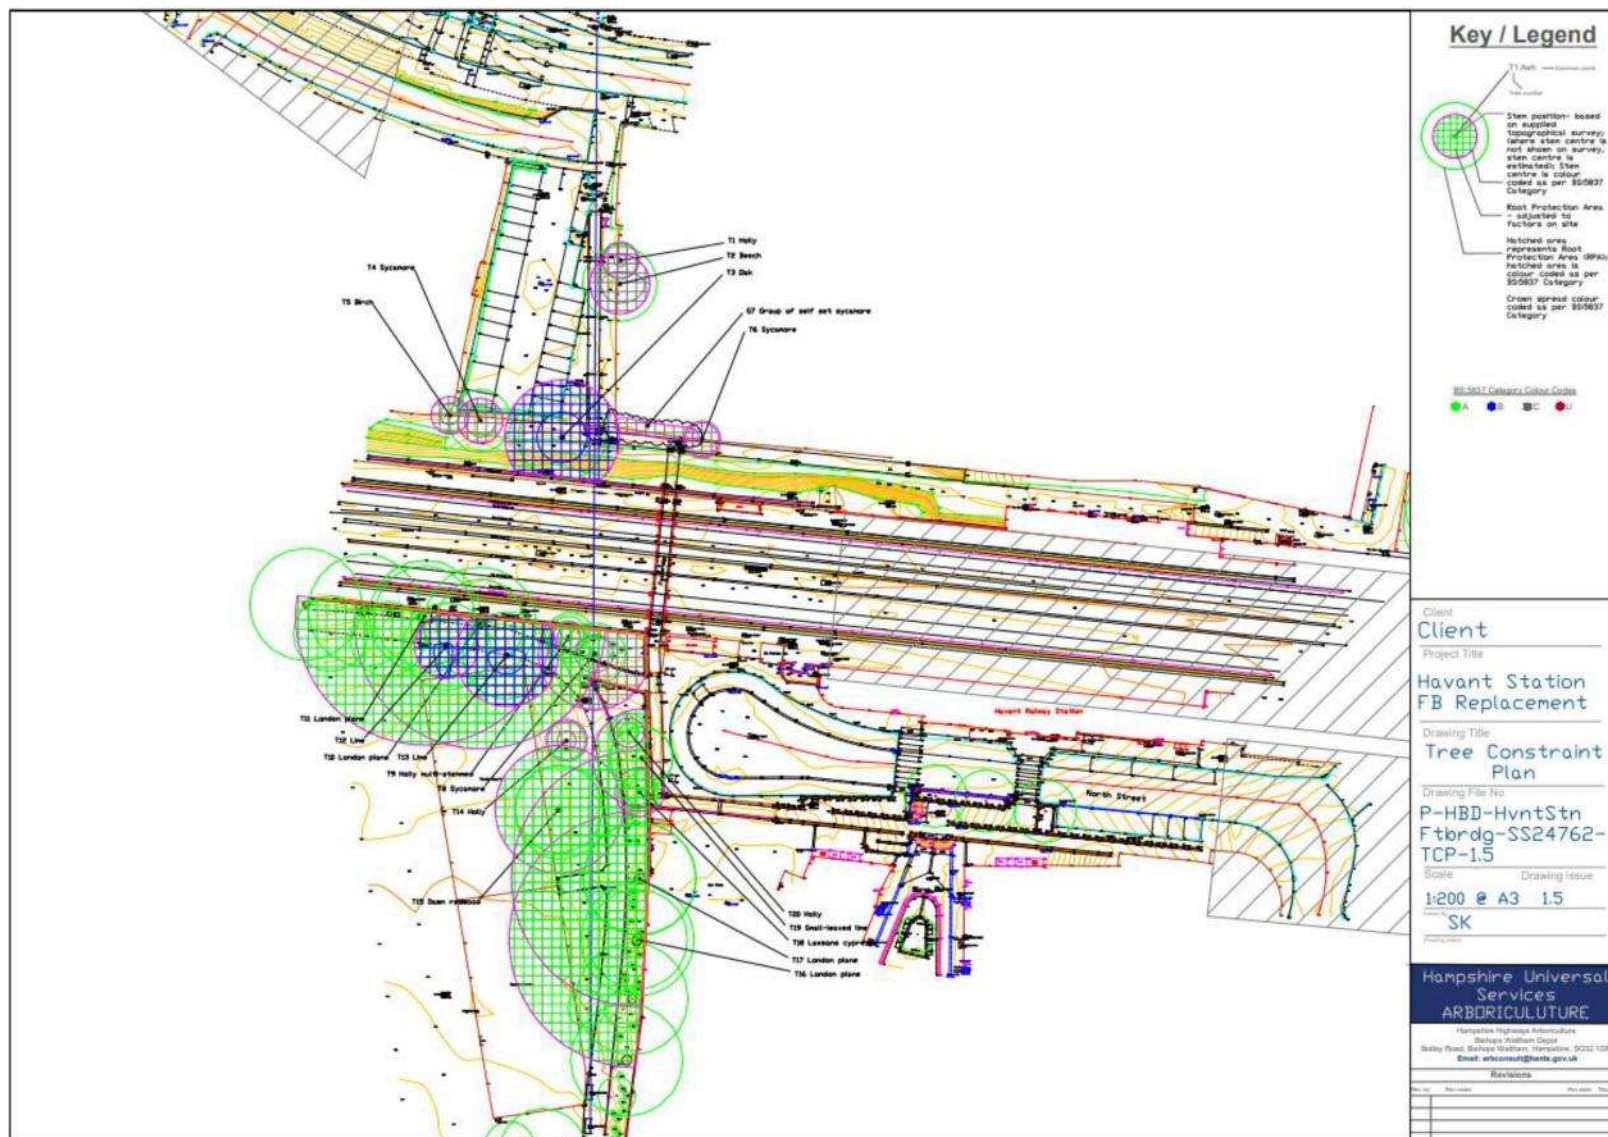
## Appendix B Tree constraints plan *clipped below and attached separately (ref P-HBC-HvntStnFtbrdge-SS24762-TCP-1.5)*

- 2.4 Tree data is found in the tree survey data table appendix B to this report.

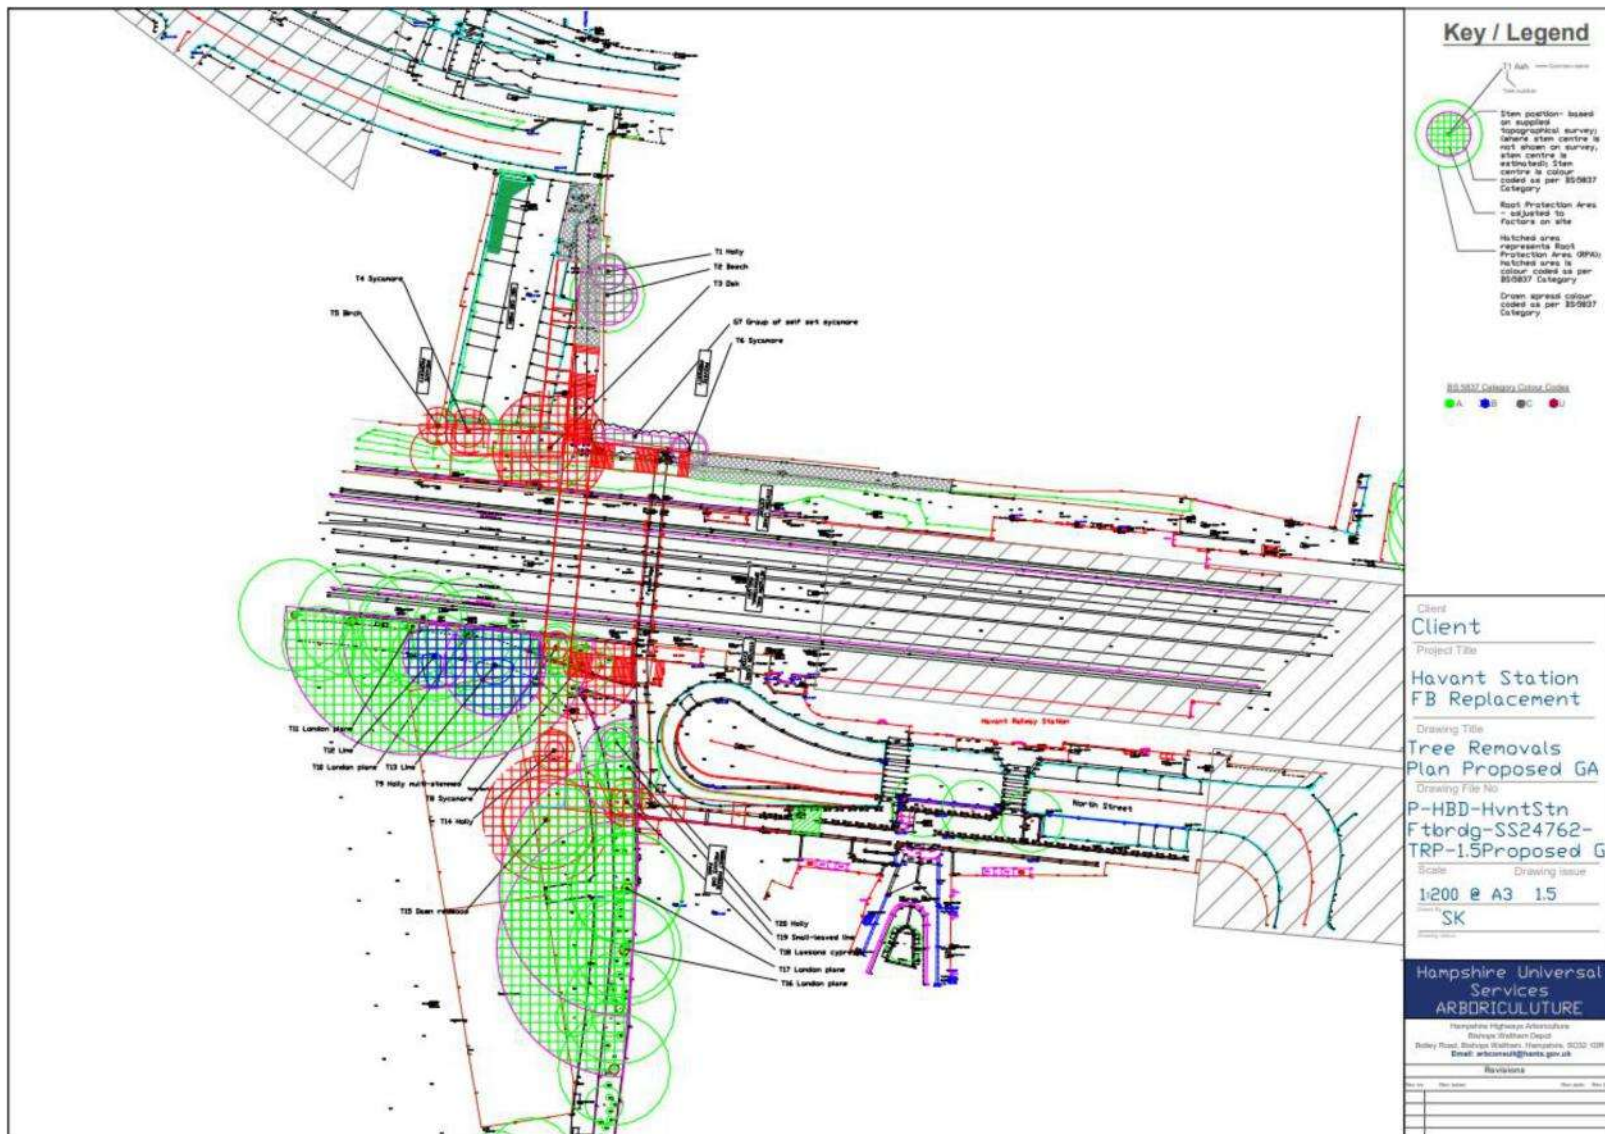
**Appendix C Tree removal plan** *clipped below and attached separately (ref P-HBD-HvntStnFtbrdg-SS24762 -TPR-1.5Proposed GA)*

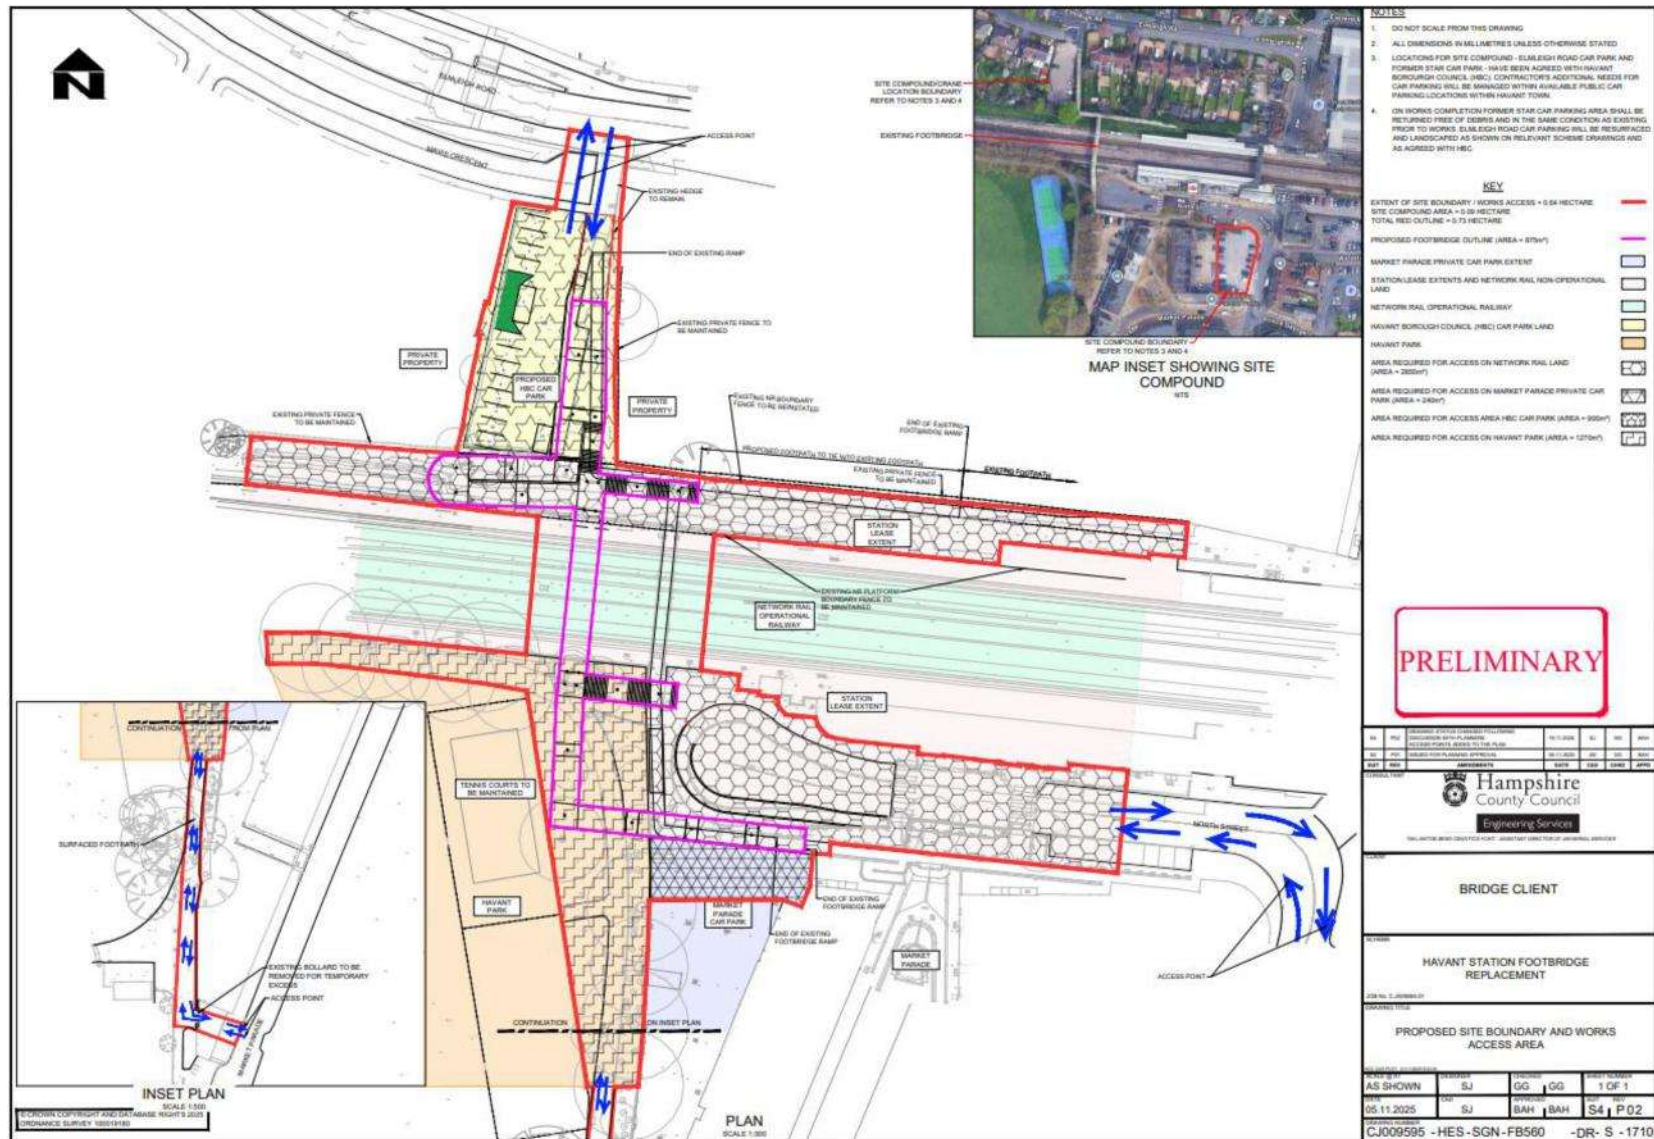
## Appendix G Proposed works and access areas – drawing reference C.J009595-HES-SGN-FB560-DR-S-1710 Proposed Site Boundary and Works Access Area, 19.11.2025
