**Land east of St. Patrick's RC Church,  
Hayling Island PO11 0QU**

**Flood Risk Assessment dated August 2026**

### **1.0 Introduction**

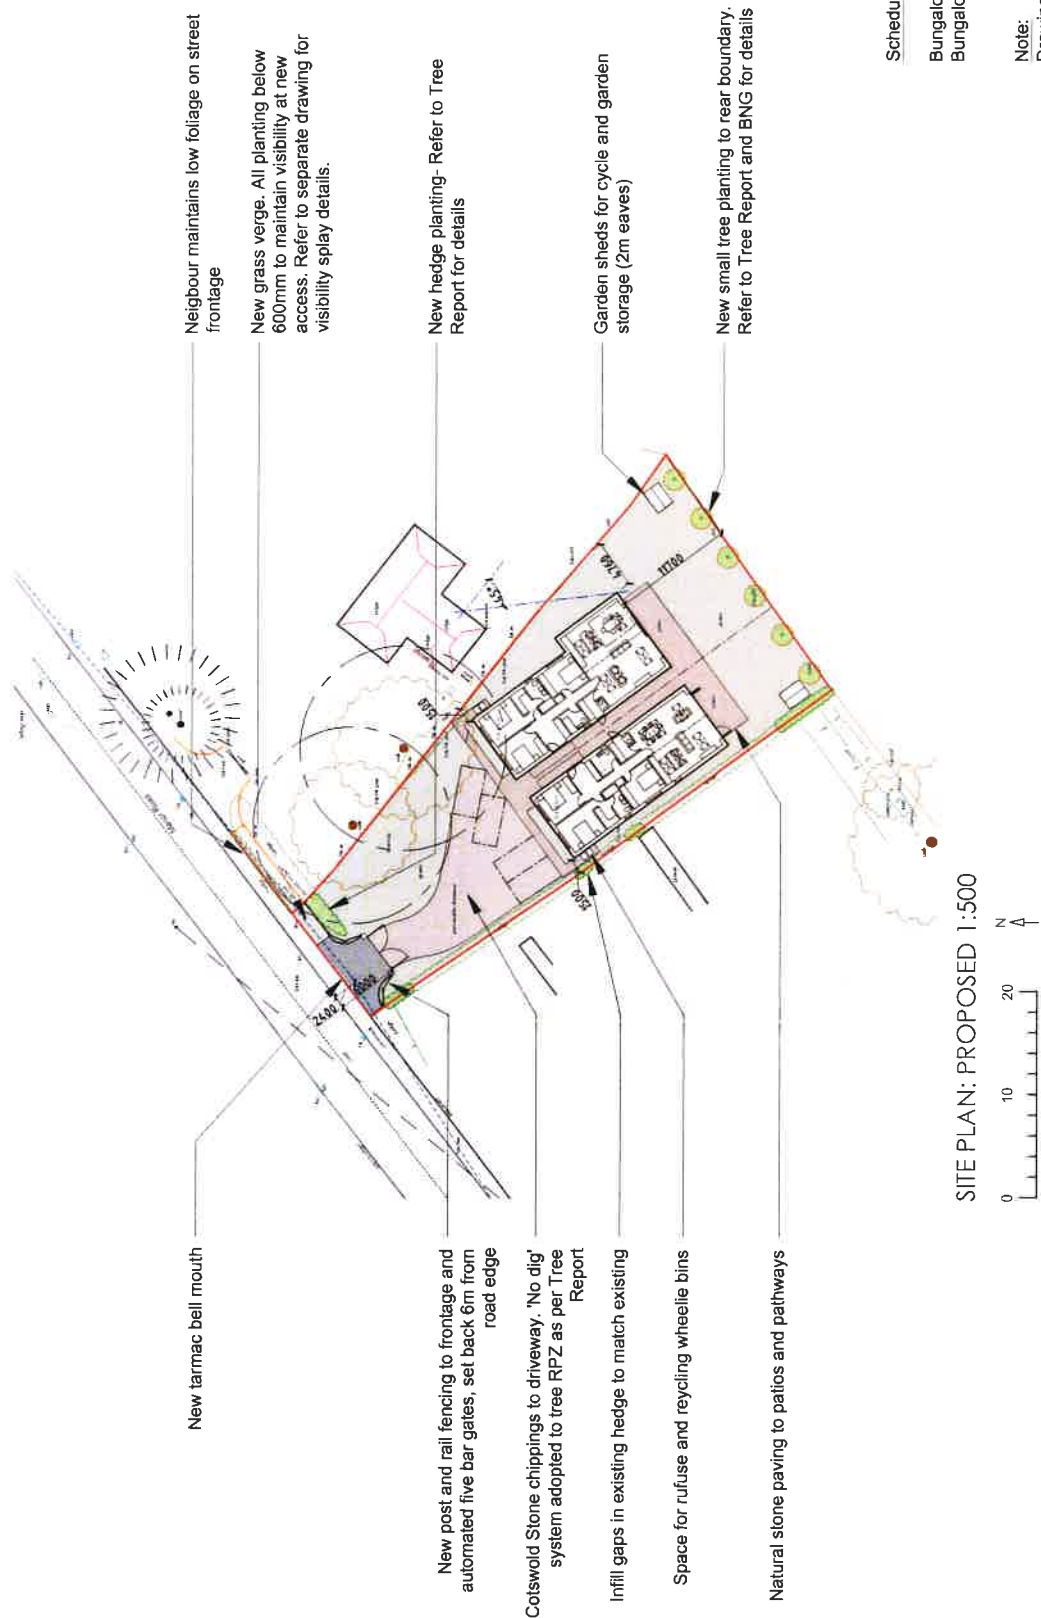
**Proposed Site Layout Plan**

- 1.3 Planning consent is being sought for the construction of 2 no. residential units and associated hardstanding areas; as shown by the architectural drawing included within Appendix D.

- 4.2 An inspection of the proposed site layout included within Appendix D demonstrates that this approach is not possible for this site.
- 4.3 The approach which is to be adopted for this site is to replace the current depression on the site, currently available to alleviate flooding in the future, located below the proposed buildings, with a similar depression in terms of water storage volume at similar levels within the areas of the site designated for gardens.

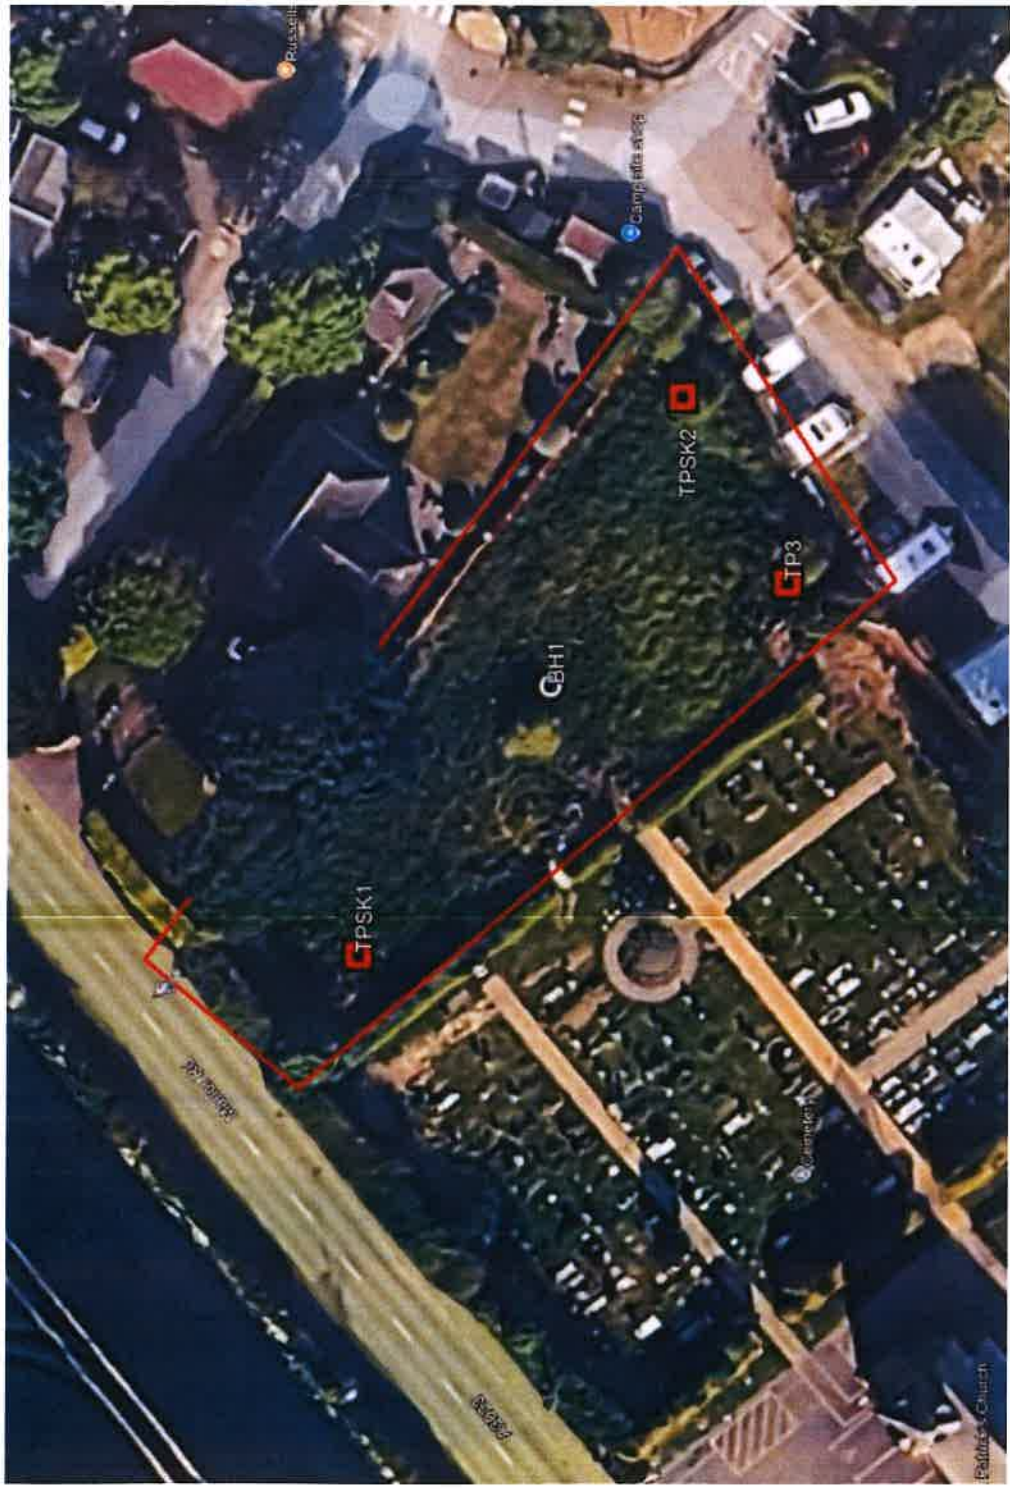
Figure 3 – Exploratory Hole Plan

Figure 2 shows exploratory hole locations.
