## Optera Structural Solutions

### SOW OPT-20500 Agreement to install a root barrier for Brawdla

| <b>OUR REFERENCE:</b> | <b>OPT-20500</b> |

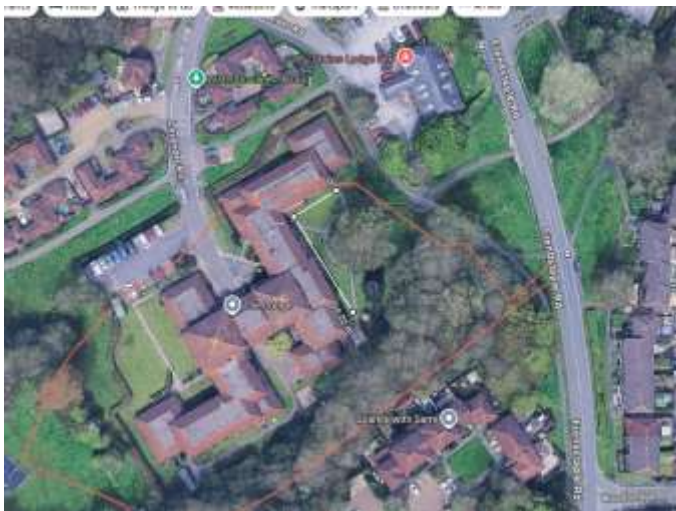
Aerial plan indicating proposed 50m length and alignment of barrier.

| Specifications of Barrier | | | | | |
| Barrier Type | length | Max Root Depth from SI | Minimum depth to be achieved with barrier | Distance between tree / Vegetation and barrier | shortest distance between barrier and foundation |
| <b>Copper</b> | <b>50m</b> | <b>1.7m</b> | <b>3.5m</b> | <b>11m</b> | <b>3m</b> |

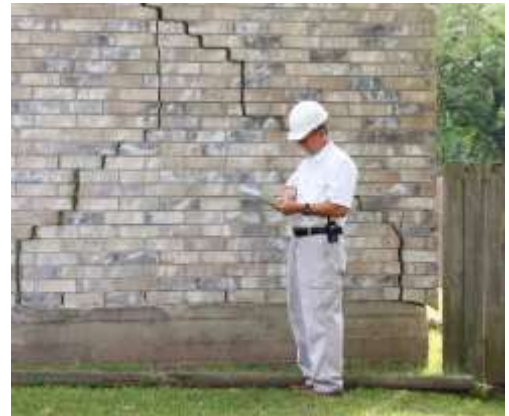
The barrier will be positioned between the offending tree(s) and the affected part of the building, and will be installed to a depth designed to cut the tree(s) roots between the tree and the foundations; the act of excavation severs the roots, causing any roots beneath the foundations to wither and die. This prevents the tree(s) from extracting moisture from the clay supporting the foundations, allowing the clay to rehydrate and recover their natural moisture levels. Naturally, there is a period of time required for the recovery process to take place, but repairs can typically be undertaken shortly after the installation is complete.

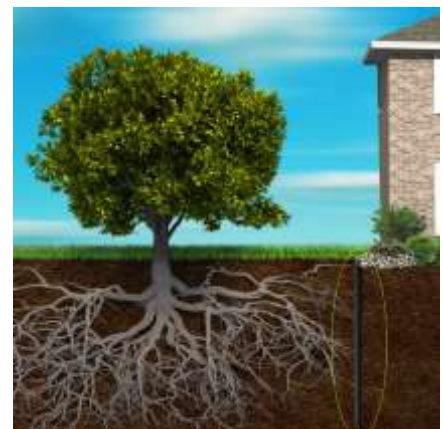
Trees are known to cause clay soils to shrink by drawing water through their roots, predominantly during the Spring and Summer months. The shrinkage results in both vertical and horizontal ground movement that, when transmitted to a building's foundations, cause damage to the building's structure. The amount of shrinkage depends on the type of clay soil, the type and size of vegetation, and on weather patterns.

The moisture content of a clay soil tends to vary with depth. Closer to the surface there can be relatively large changes in soil moisture content between summer and winter as a result of evaporation from the ground surface, the drying effect of the Sun and general vegetation, including grasses. Such variations are normally confined to the upper 1m of the ground. However, where trees are growing within influencing distance of a building, then the soil moisture profiles will fluctuate much more widely through the seasons and to a much greater depth; in response, soil volume changes are amplified, and consequential building movements will be far greater.

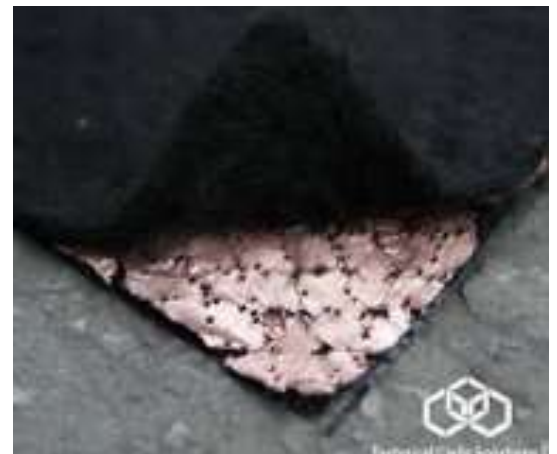
The bio-root barrier is strong and flexible, with very high tear resistance, as well as being water-permeable, thus allowing the natural movement of water through the ground without impediment. The Copper contained within the core of the membrane also acts as a chemical repellent to the roots without constituting a hazard to plants or animals. The Copper foil securely bonded within the porous geotextile membrane, releases Copper ions into the adjacent soil by forming Copper Carbonate (verdigris); these signal adverse conditions to any roots growing towards the barrier, preventing a proliferation of roots close to the barrier. The levels of Copper generated do not constitute a burden on the eco-system or impact groundwater quality.

Outdated, impervious barriers divert rather than stop roots and may prevent the movement of groundwater causing unintended consequences. The use of Optera's permeable barrier stops roots both by forming a physical impenetrable obstacle and by acting as a chemical inhibitor to the reestablishment of roots.

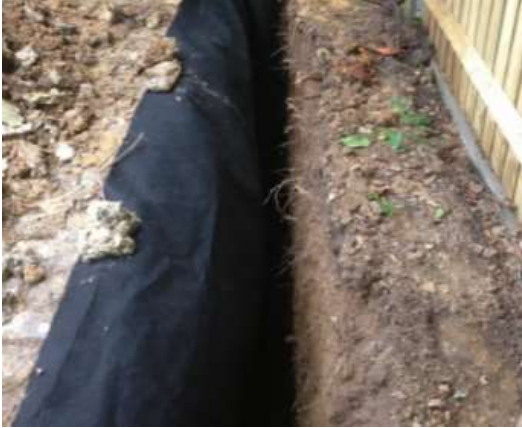
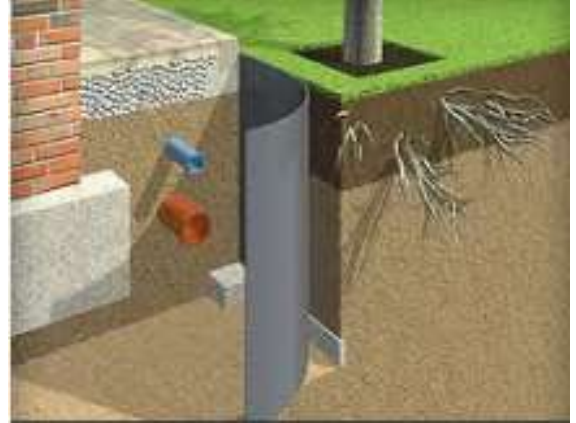
Following installation of the root barrier, the trench may be backfilled with 20mm single sized stone, alternatively, and dependent upon site conditions, backfilling could be done with as-dug material, which would be placed and compacted with a plate-compactor mounted on the excavator arm. In specific circumstances, we may also use no-fines concrete on the structure side of the shield.

Some degree of surface settlement can be experienced following completion, where this happens, Optera will return to top-up the trench; typically this occurs within the first six months of installation.
