# **FLOOD RISK ASSESSMENT AND DRAINAGE STATEMENT**

**Helmsley House, Bartons Road, Havant, Hants, PO9 5NB.**

Document reference: **2709-HELM-ICS-XX-RP-C-07.001**

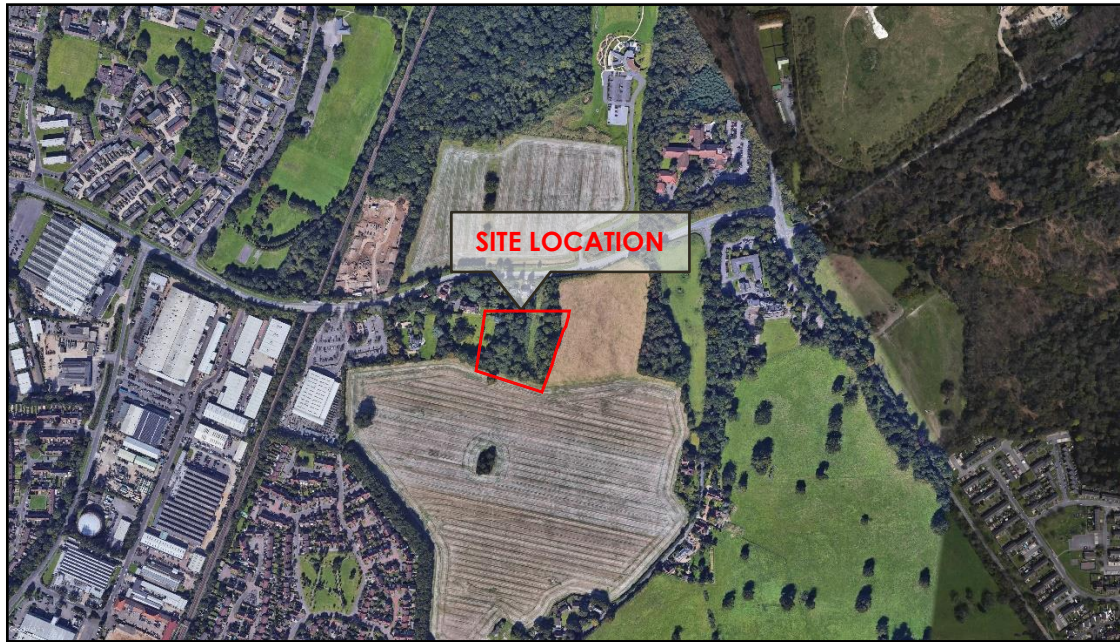
Figure 3.1.1 - Site Context

The site is in Helmsley House, Bartons Road, Havant, Hants, PO9 5NB, bound by Bartons Road to the North, with Helmsley House to the west, with open/agricultural land to the east and a Bellway residential construction site to the south of site.

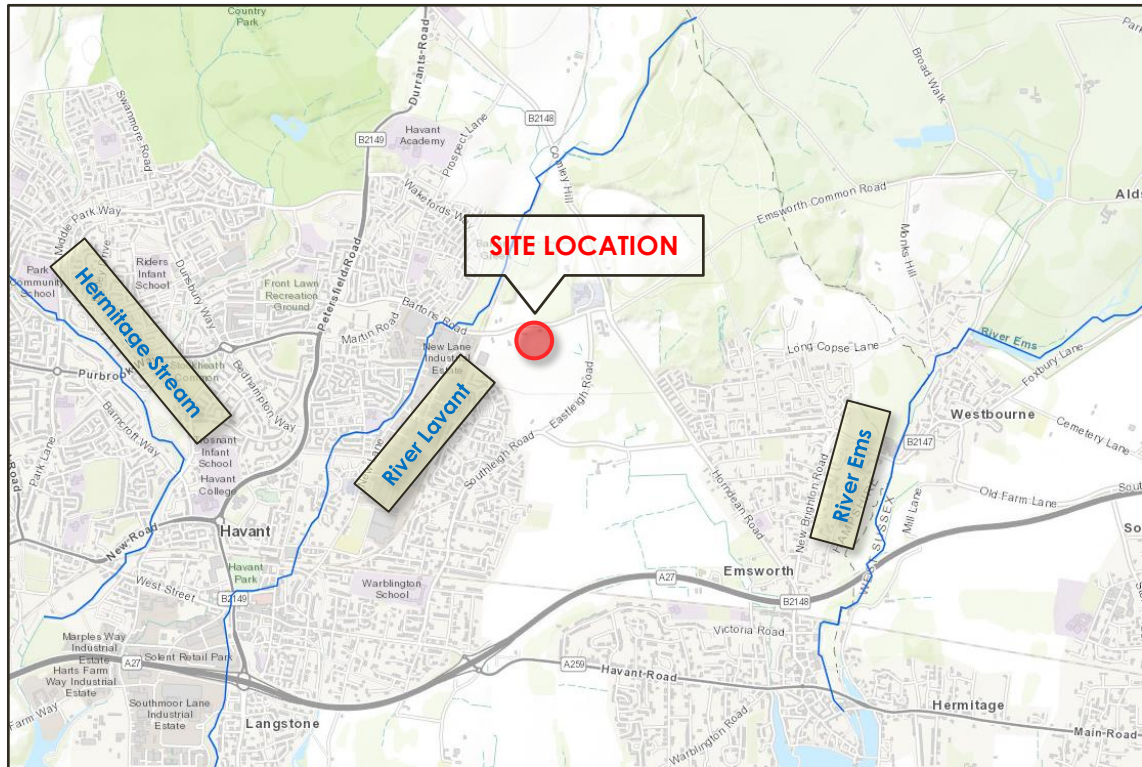
Figure 3.7.1 – Local Rivers

The nearest main river watercourse to the site is the River Lavant, which is located 435m to the West of the site.

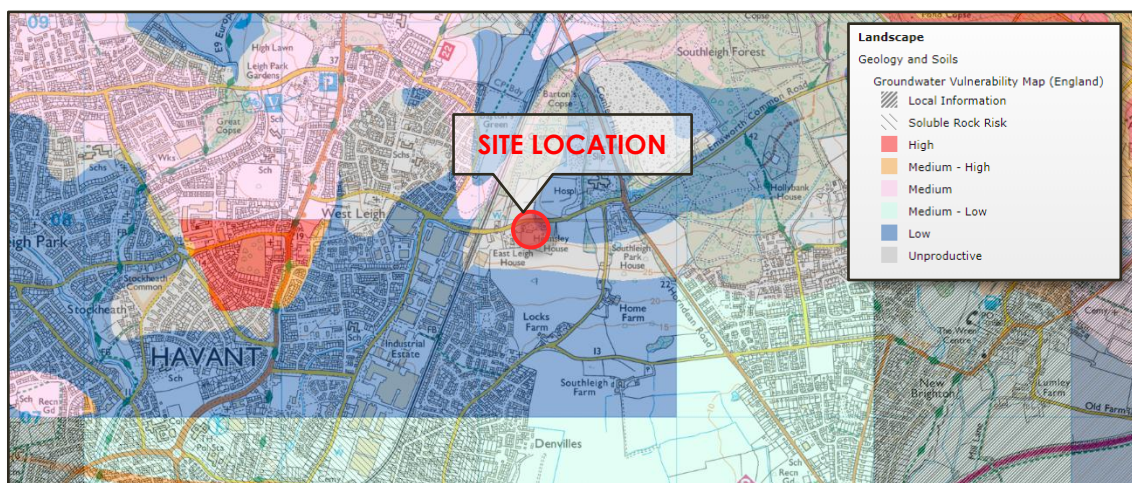
Figure 3.8.1 – Groundwater Protection Zones

Reference to the Environment Agency Groundwater protection zone map shows the area is sited within a Low to Unproductive groundwater protection zone(s). The Environment Agency have defined Source Protection Zones (SPZs) for groundwater sources such as wells, boreholes, and springs used for public drinking water supply. These zones show the risk of contamination from any activities that might cause pollution in the area. The closer the activity, the greater the risk.

The Environment Agency use the zones to set up pollution prevention measures in areas which are at a higher risk, and to monitor the activities of potential polluters nearby.

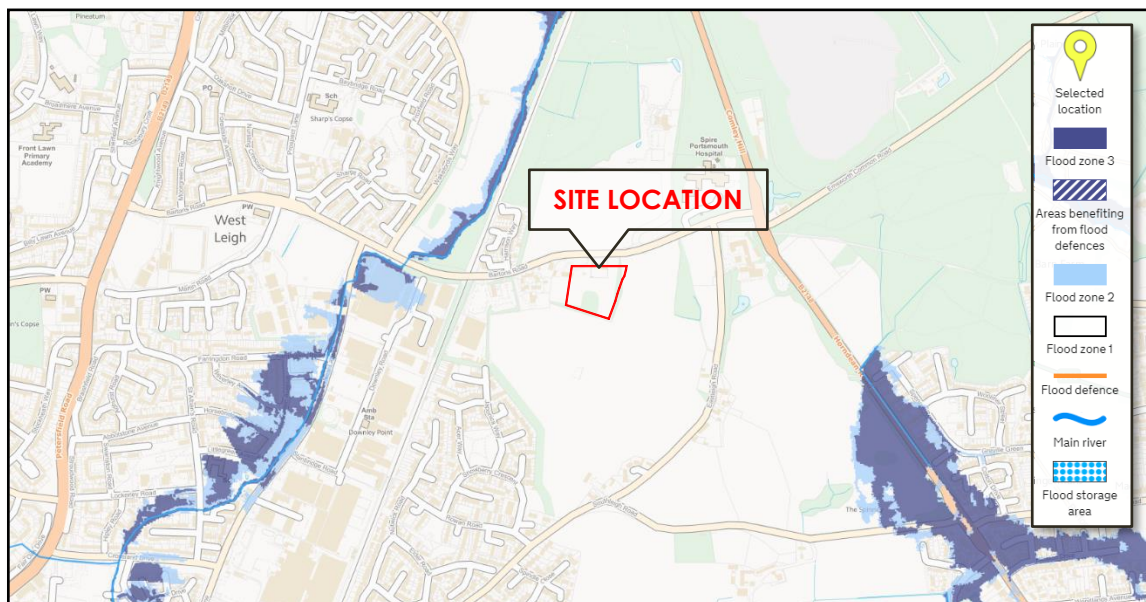
Figure 5.1 - Environment Agency Flood Zone map

The flood map for the development site shown below suggests that the site wholly falls within flood zone 1, which is defined as land assessed as having a less than 1 in 1000 annual probability of river flooding in any one year.

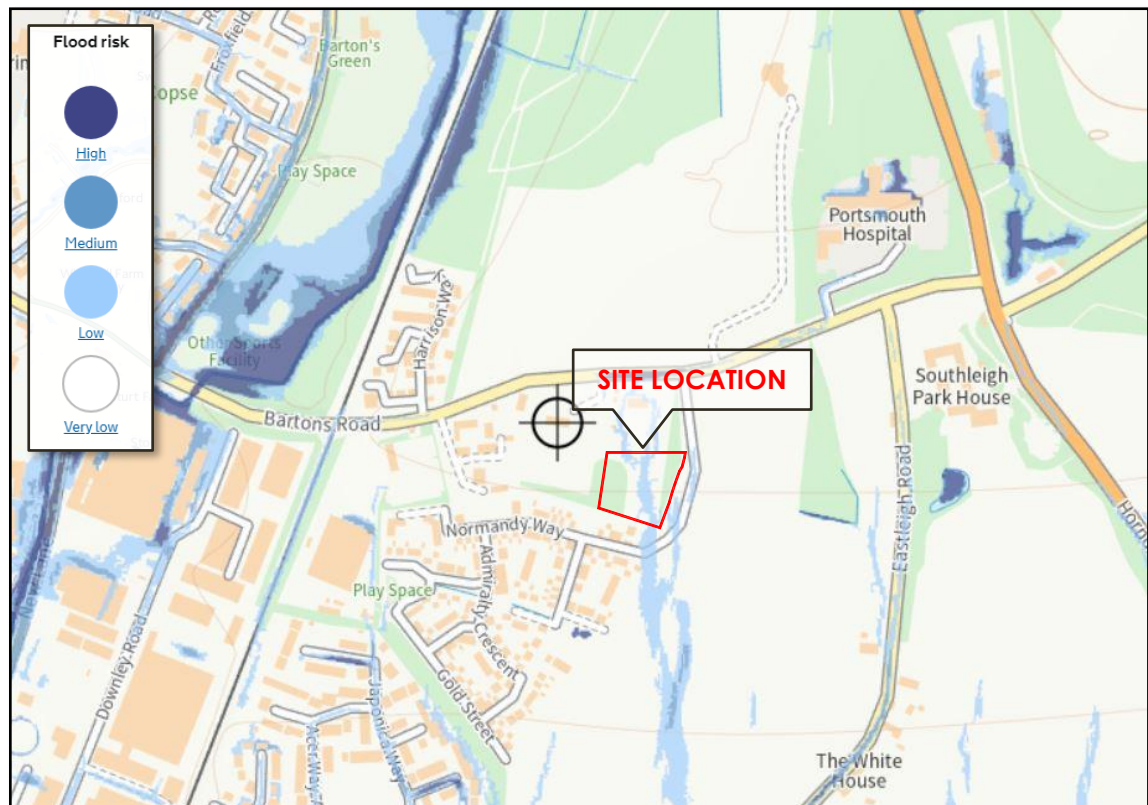
Fig 6.2 – Environment Agency Flood Risk from Surface Water map

The risk of flooding due to overland flood flows is considered low by the Environment Agency. The surface water flood data for the site, shown below, indicates that there is a low risk through the development site, however this has been mitigated as the proposed flow route replicates the access road serving the building, and as such, any flows will bypass the building and run through the site following the existing route.

***It is, therefore, the consideration of this FRA that the site has a low risk of flooding from overland flow.***

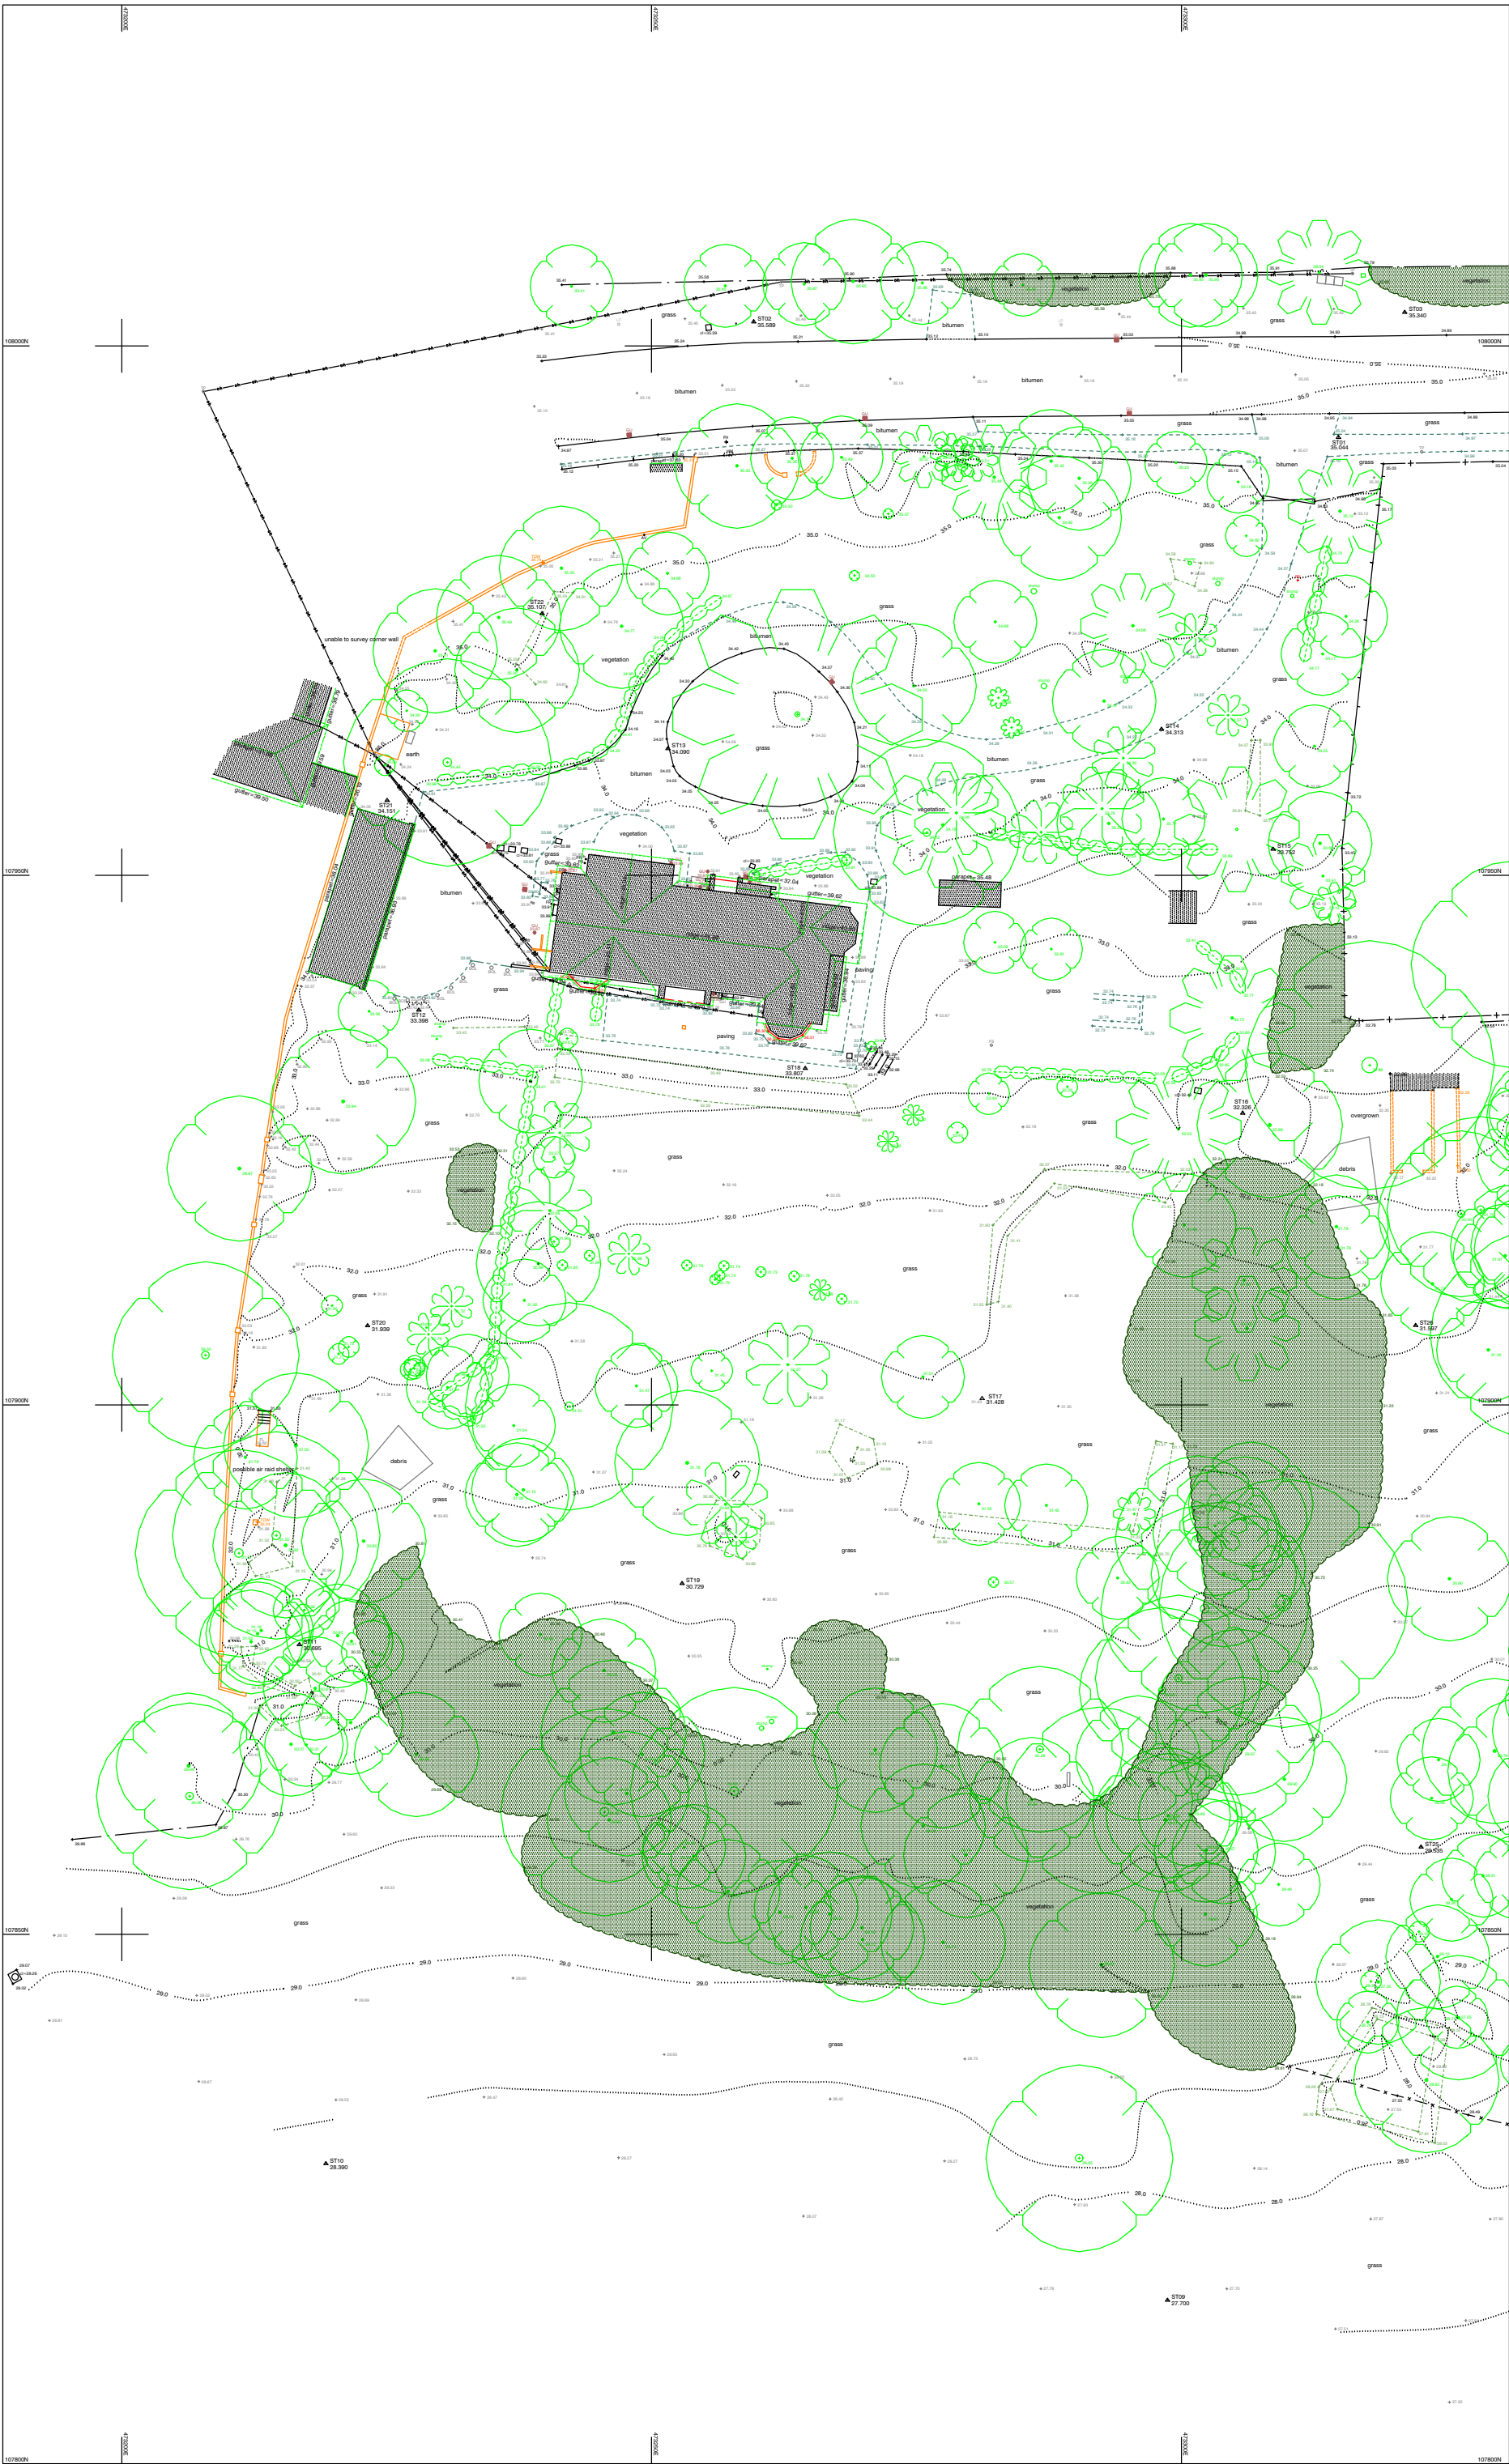
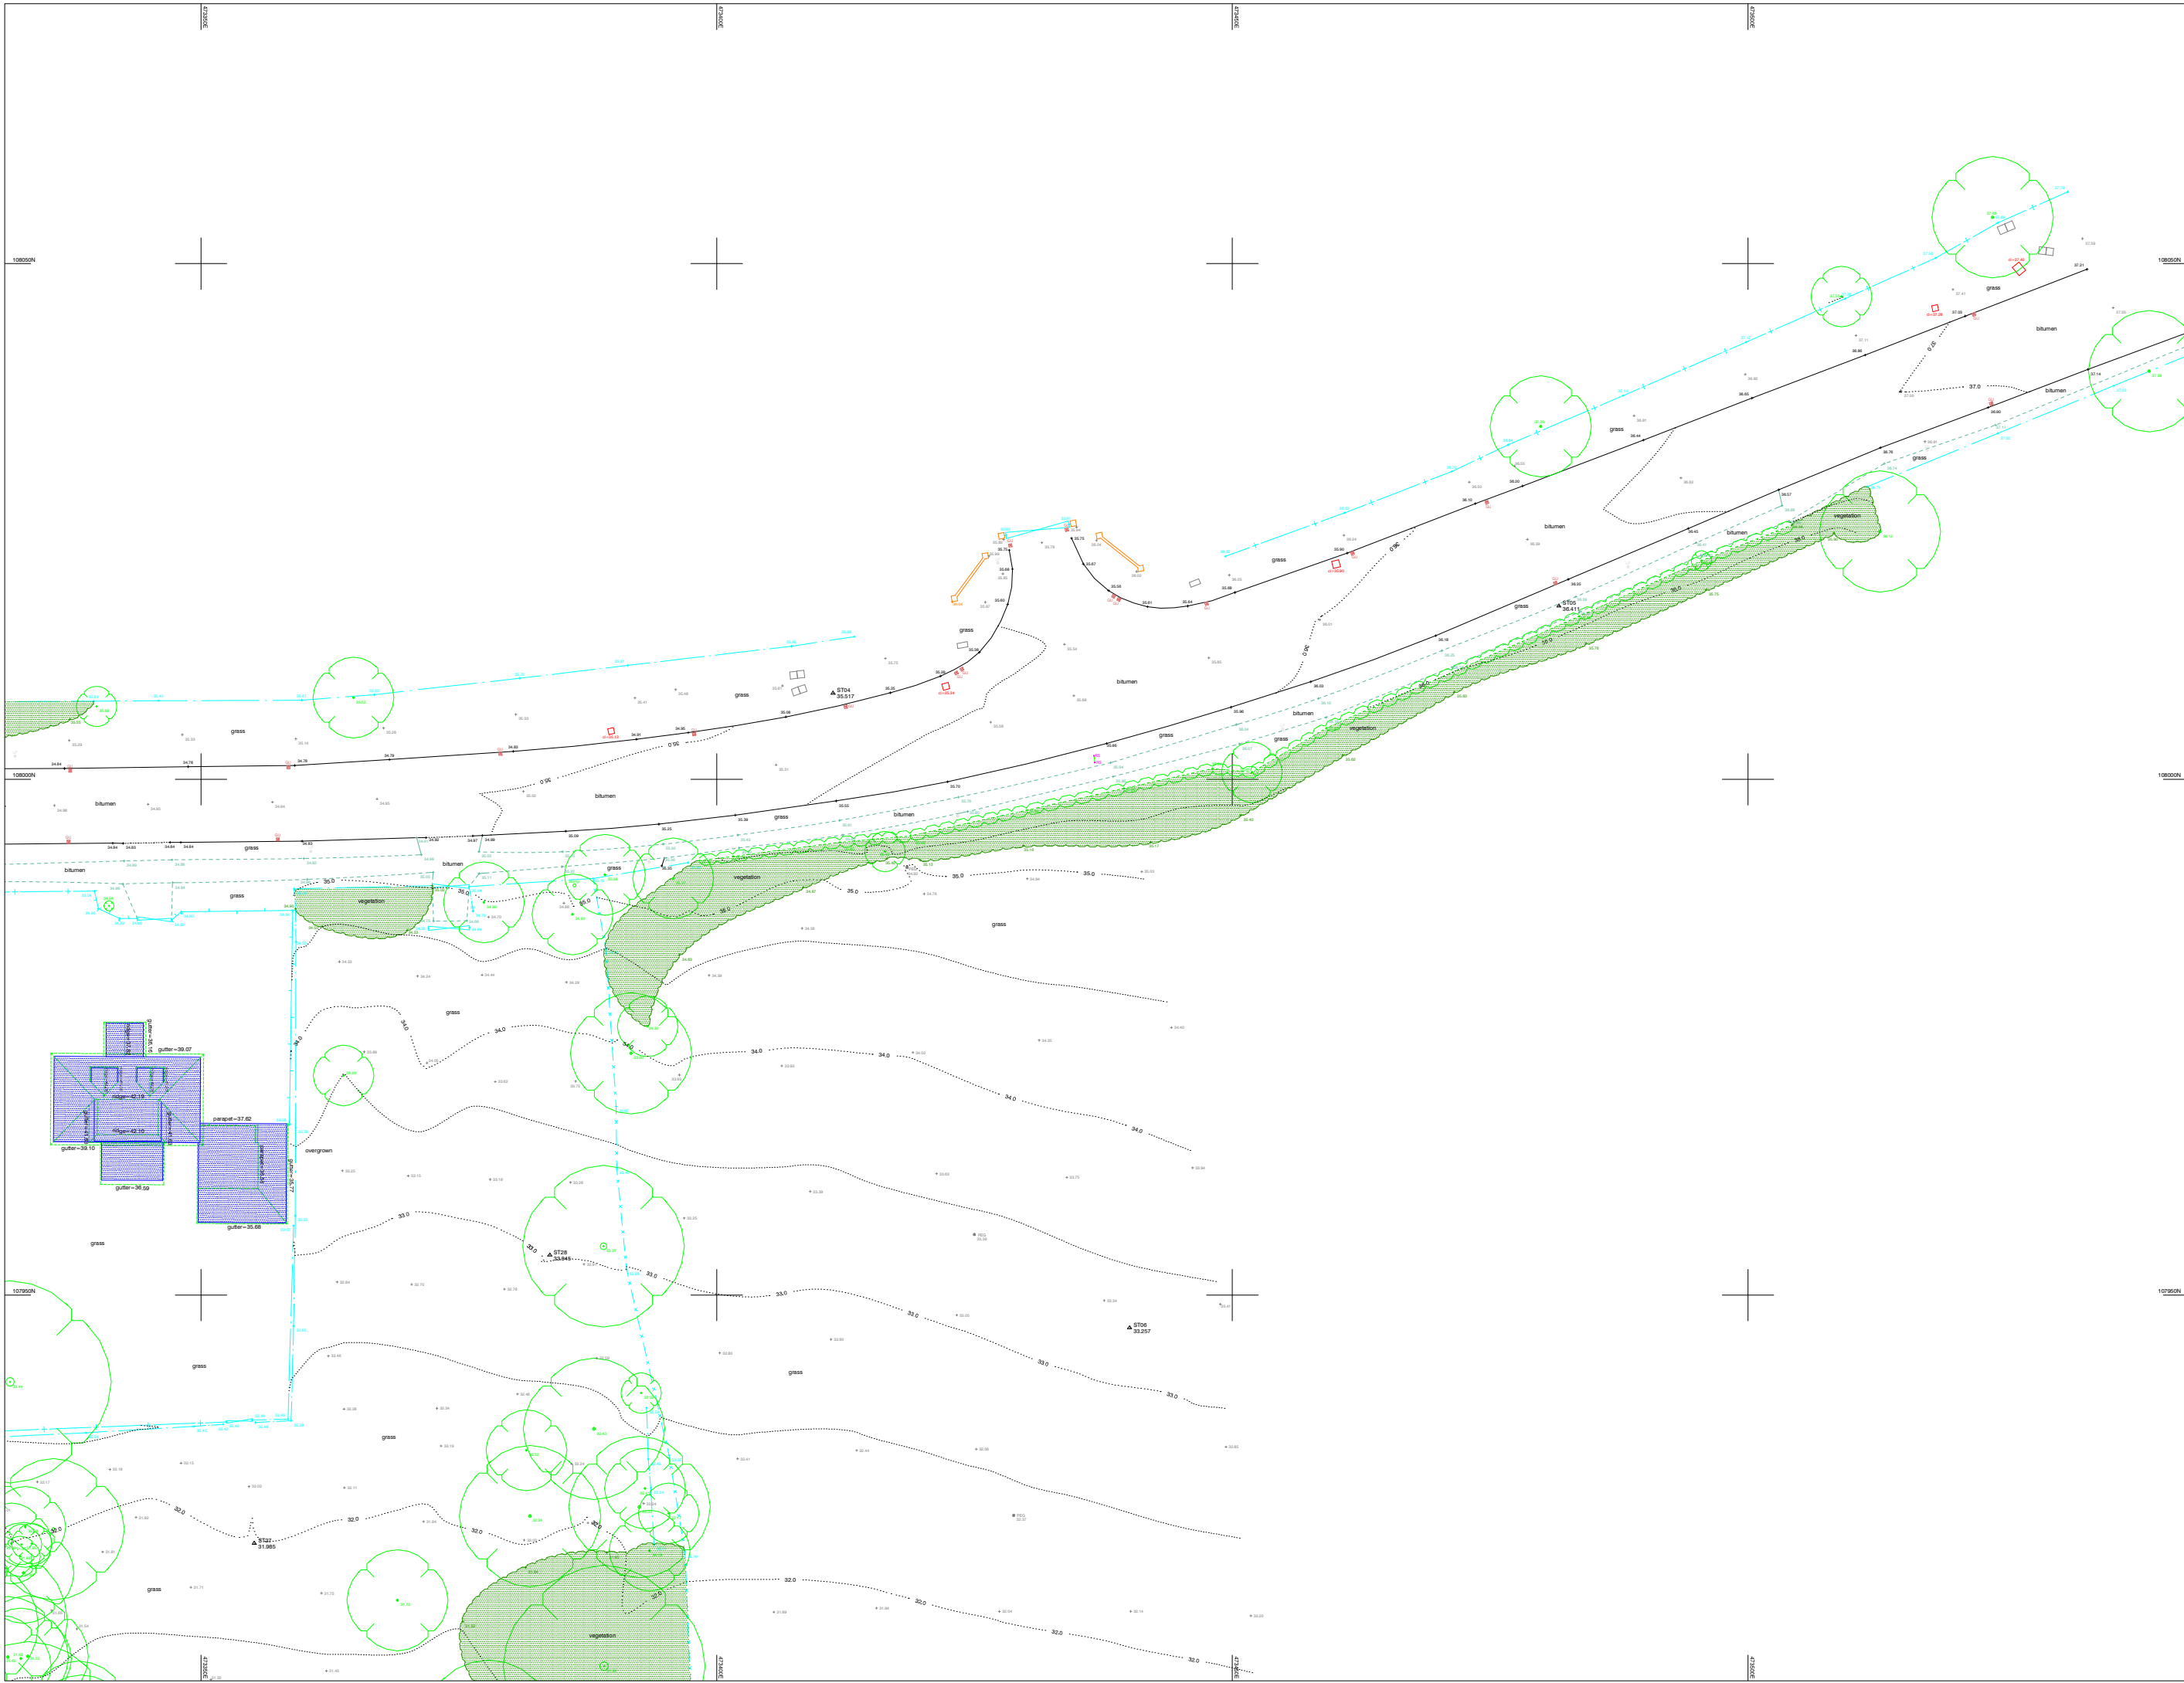
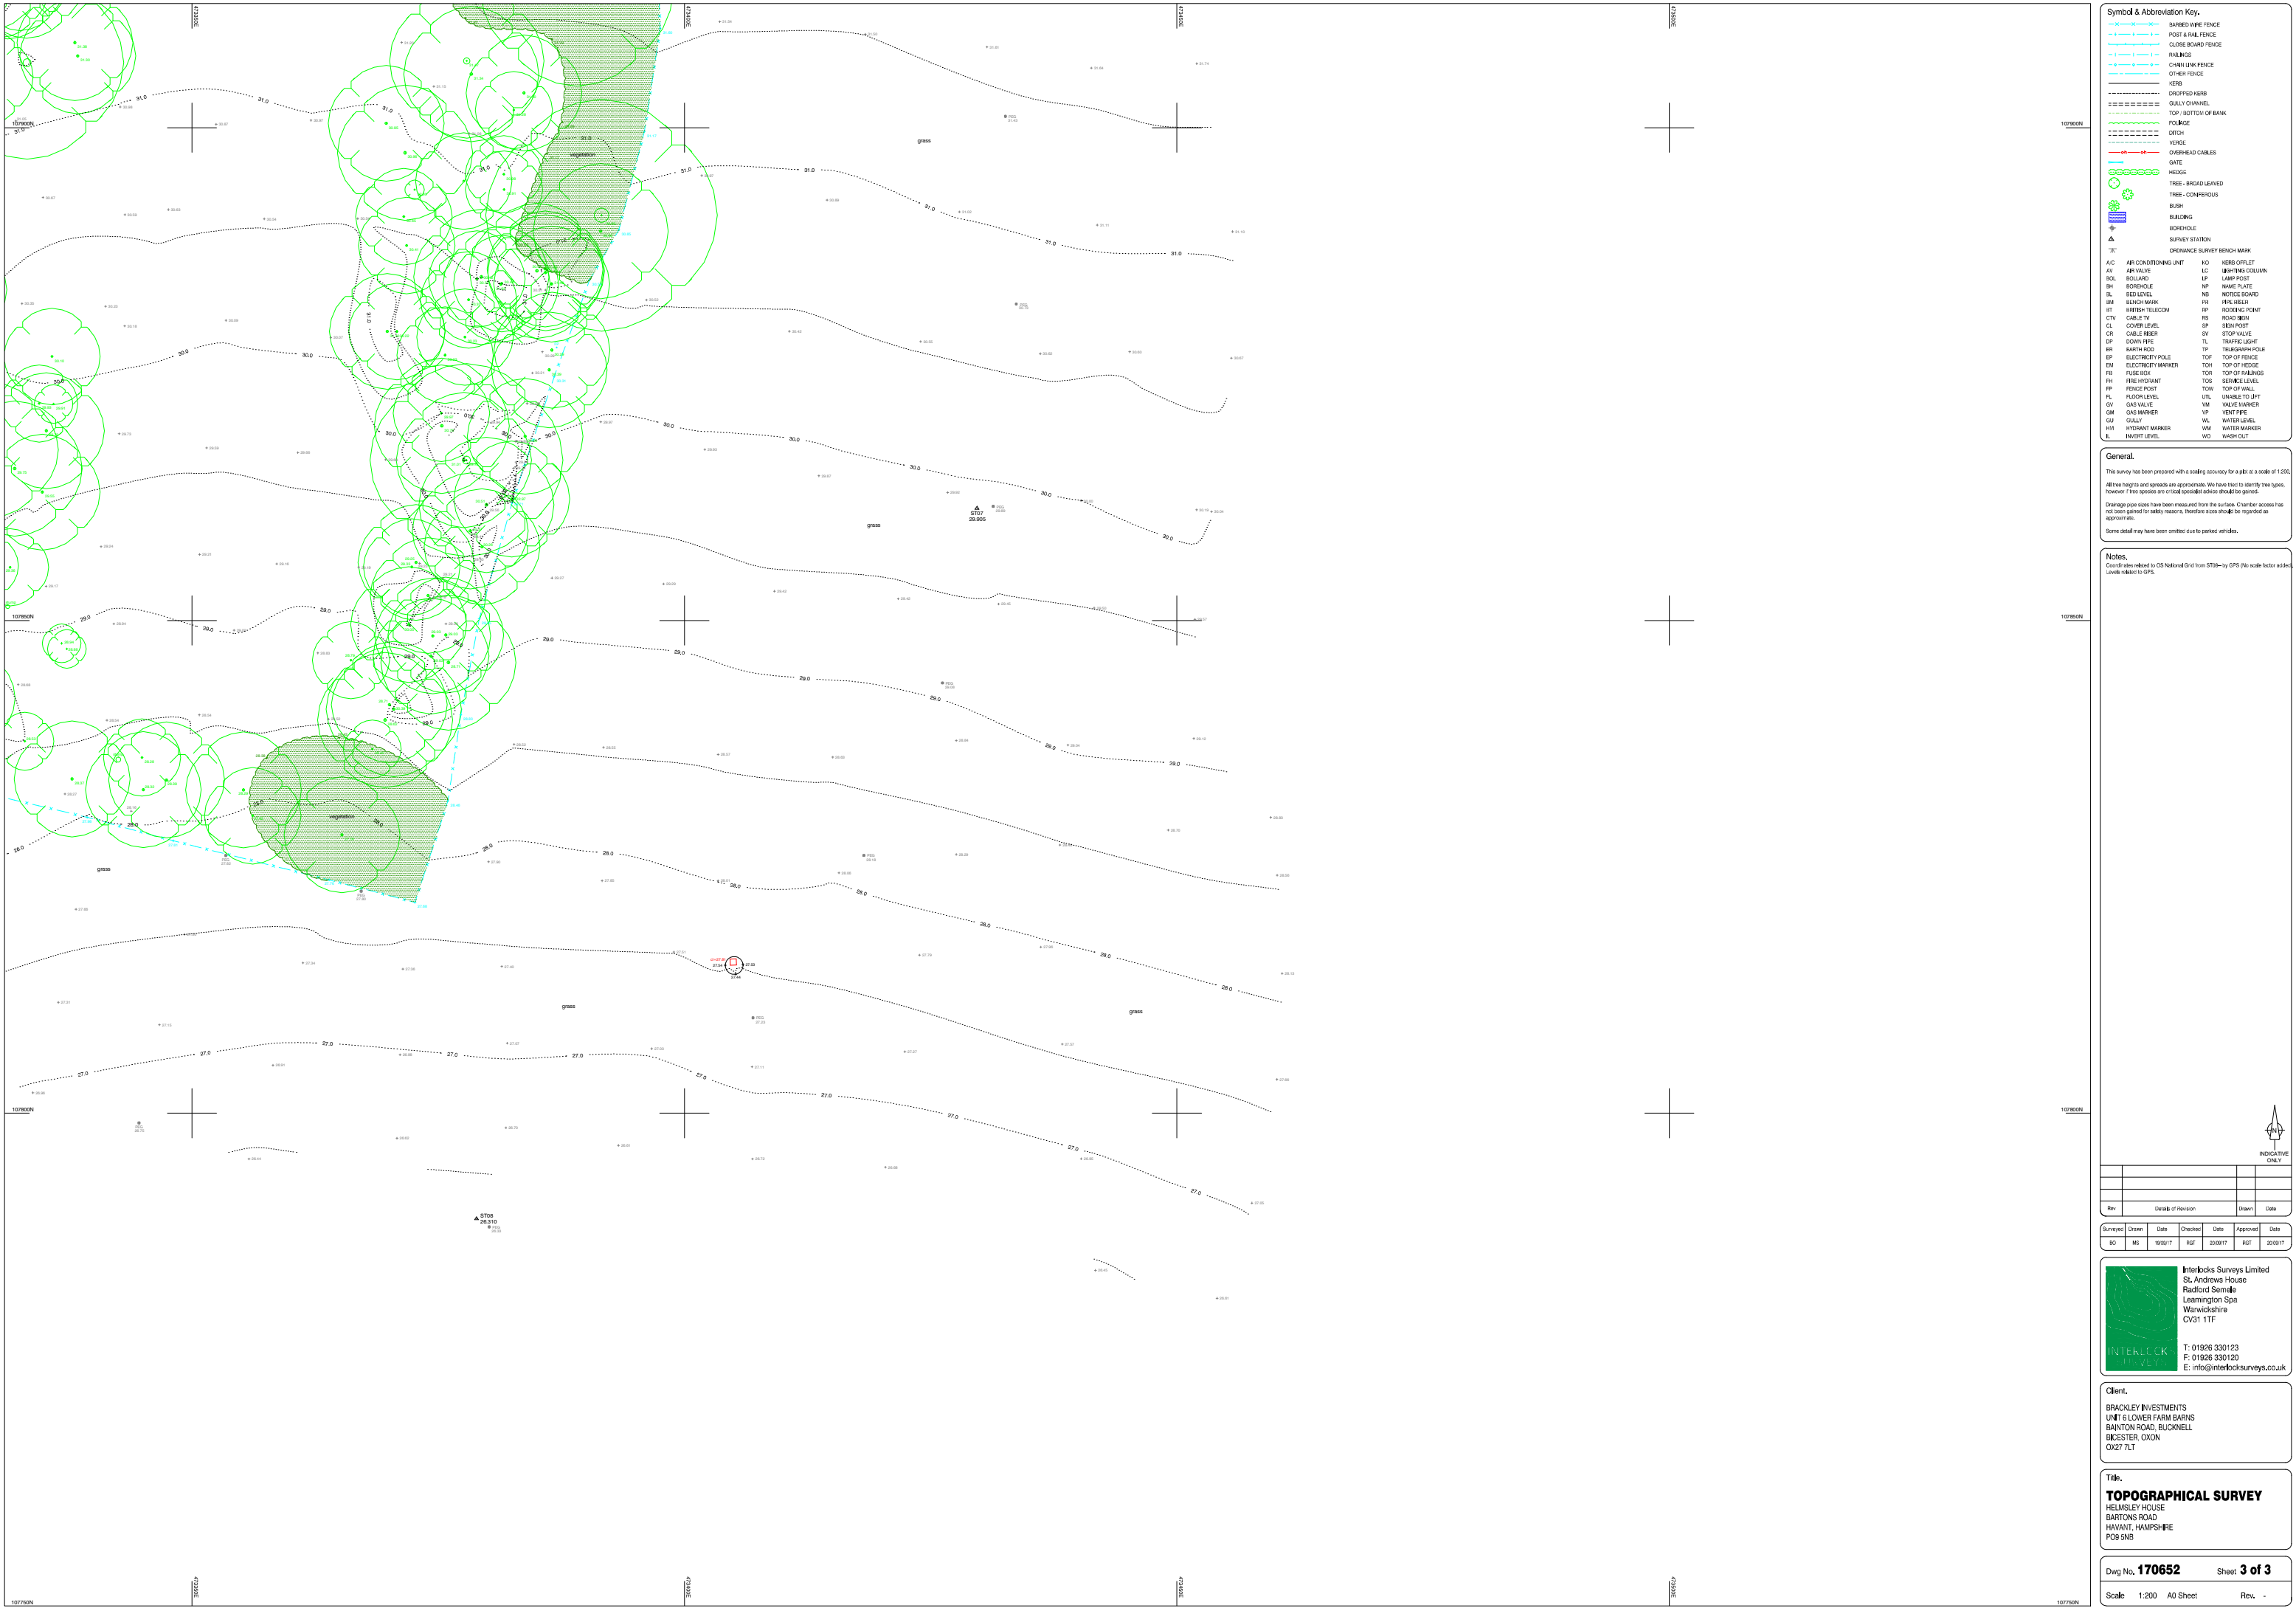
Dwg No **170652** Sheet **1 of 3**

**Title.**  
**TOPOGRAPHICAL SURVEY**  
HELMASLEY HOUSE  
BARTONS ROAD  
HAVANT, HAMPSHIRE  
PO9 5NB

Levels vary within the site between 35.04mAOD to the northern boundary (at the access road location) and 26.44mAOD to the southern boundary. The maximum fall across the site is 8.6m over 195m, giving a gradient of 1 in 23.

Refer to Appendix A for a copy of the topographic survey.

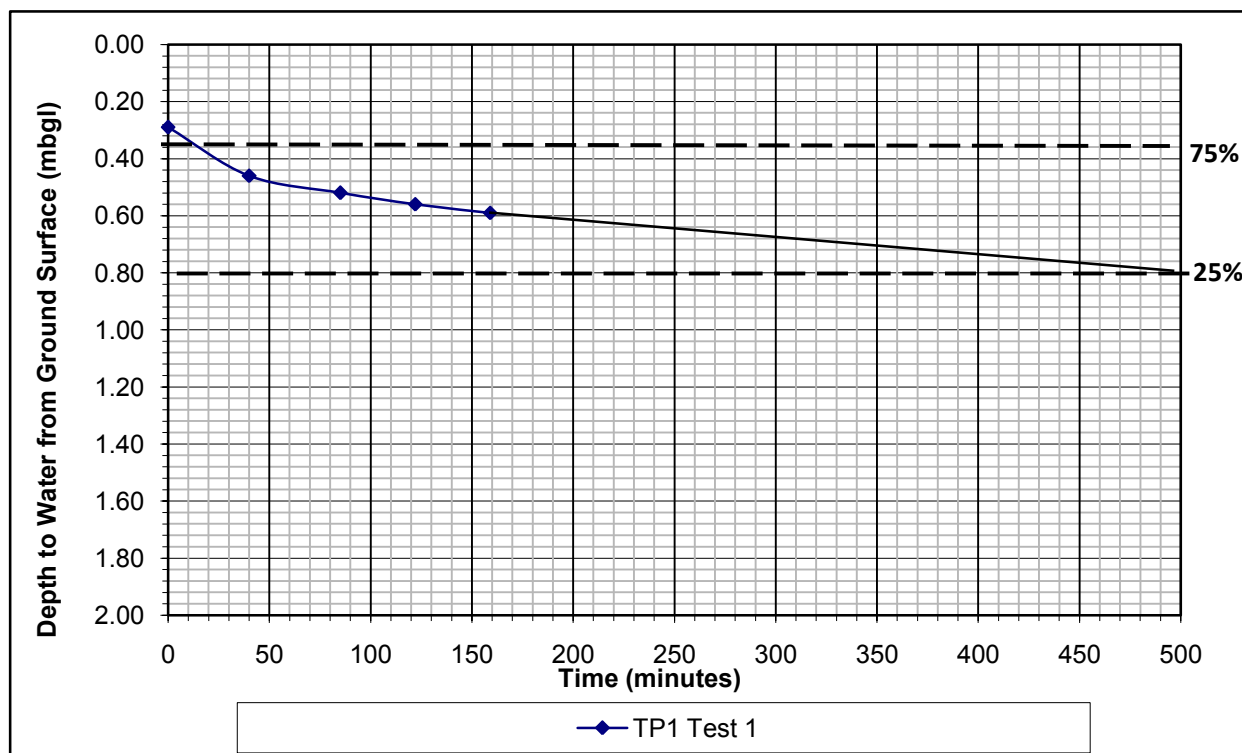
Soil Infiltration Rate =  $3.25 \times 10^{-6}$  m/s

Comments : CAUTION - RESULTS EXTRAPOLATED

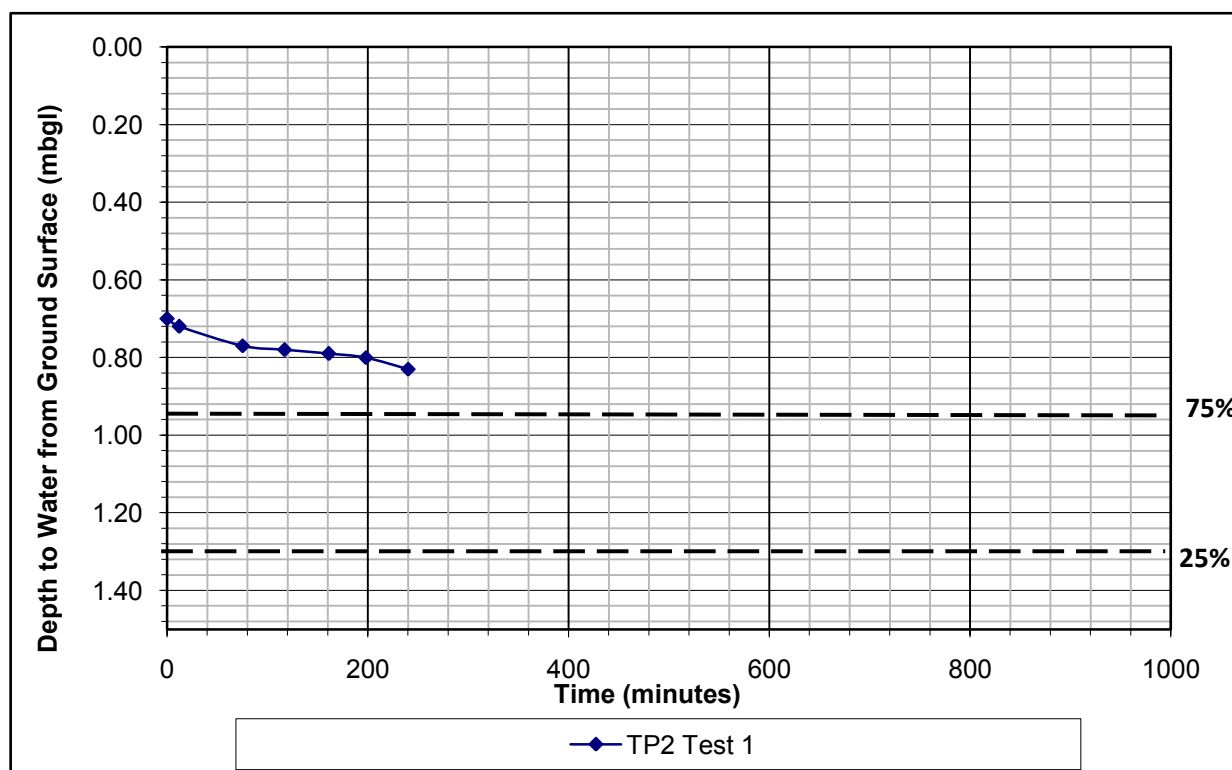
### Trial Pit Infiltration Testing to BRE Digest 365

**Client:** Brackley Investments  
**Site:** Havant, Barton Road  
**Dimensions:** 0.30m x 1.20m x 1.52m  
 (width x length x depth)

**Unable to Calculate Average Soil Infiltration Rate**

**Infiltration:** TP2 – Unable to Calculate Average Soil Infiltration Rate

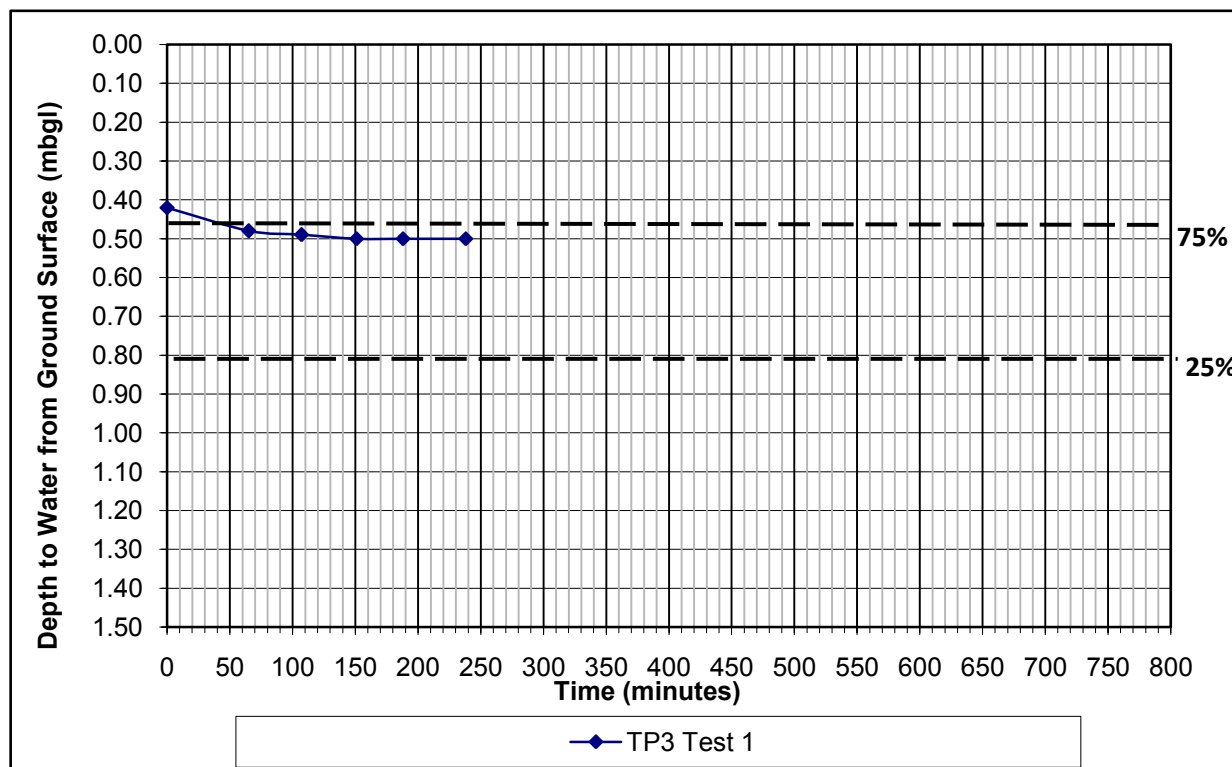
### Trial Pit Infiltration Testing to BRE Digest 365

**Client:** Brackley Investments  
**Site:** Havant, Barton Road  
**Dimensions:** 0.30m x 1.20m X 0.95m  
 (width x length x depth)

**Unable to Calculate Average Soil Infiltration Rate**

TP3 – Unable to Calculate Average Soil Infiltration Rate

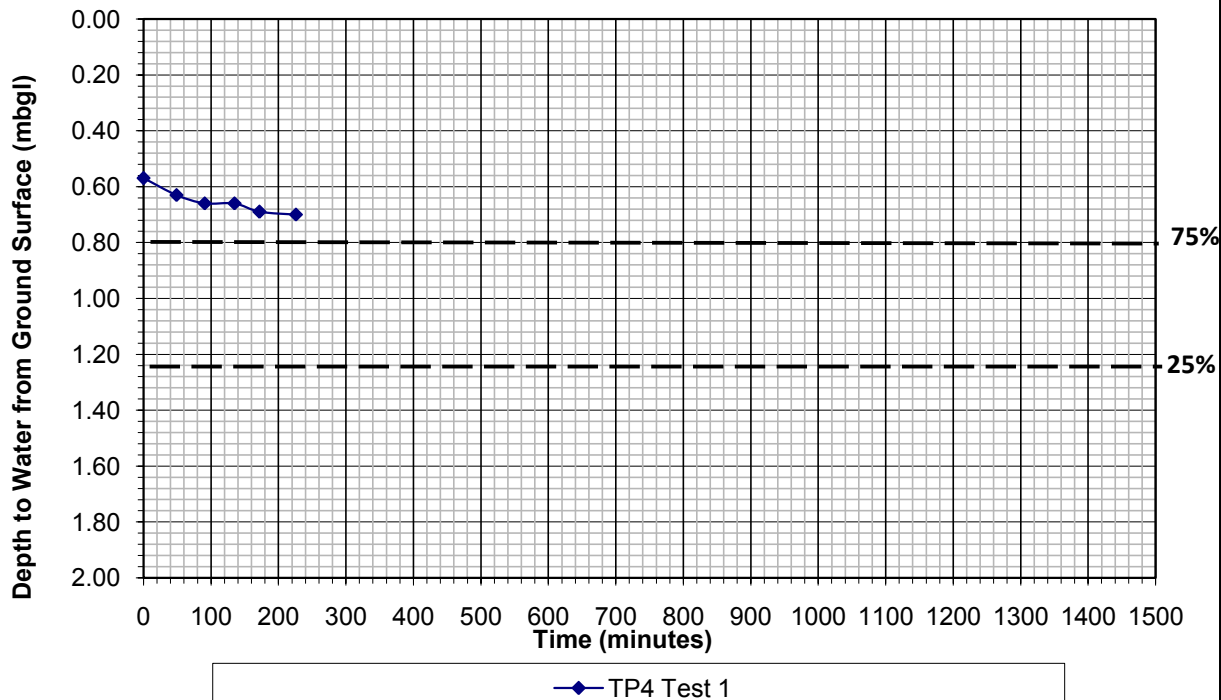
### Trial Pit Infiltration Testing to BRE Digest 365

**Client:** Brackley Investments  
**Site:** Havant, Barton Road  
**Dimensions:** 0.30m x 1.10m x 1.48m  
 (width x length x depth)

**Unable to Calculate Average Soil Infiltration Rate**

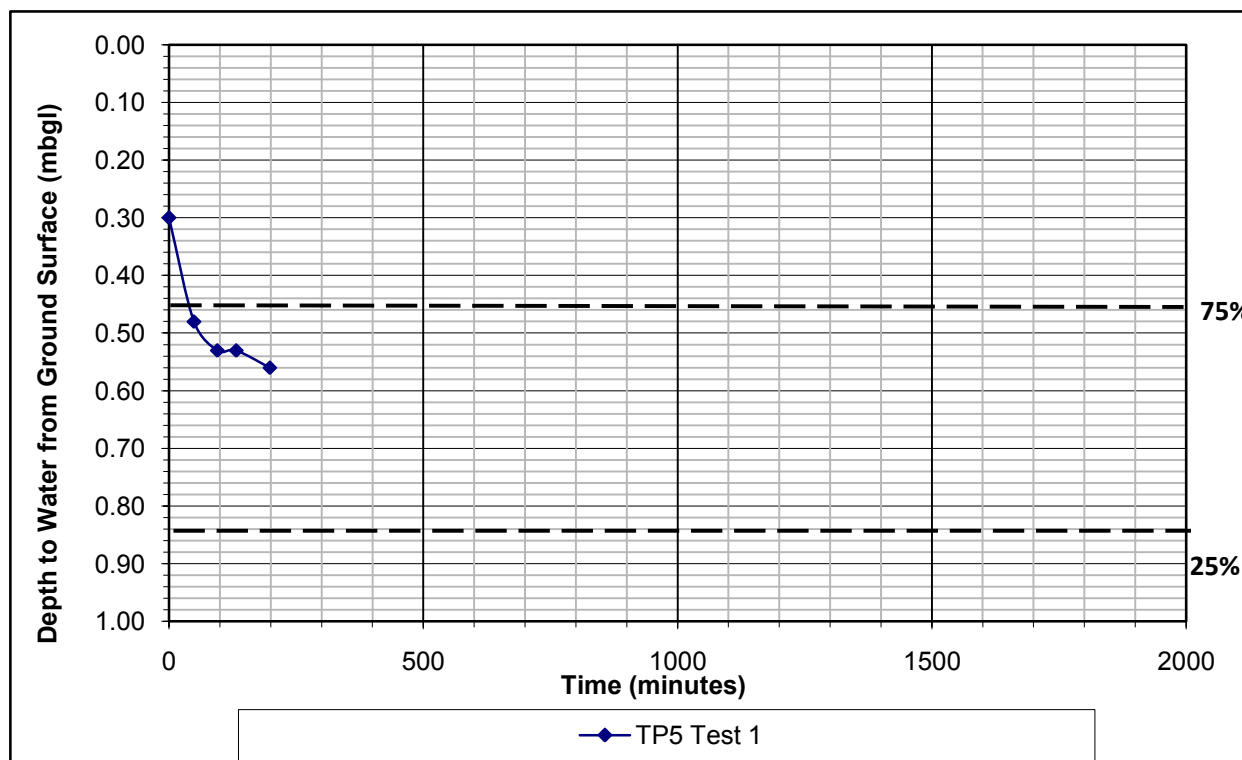
## **Trial Pit Infiltration Testing to BRE Digest 365**

**Client:** Brackley Investments  
**Site:** Havant, Barton Road  
**Dimensions:** 0.30m x 1.10m x 1.00m  
(width x length x depth)

**Soil Infiltration Rate =  $1 \times 10^{-6}$  m/s**

**Comments:- CAUTION - Extrapolated assuming Tp25 =1500mins**
