# **Stage 1 Road Safety Audit Report (Feasibility)**

**Helmsley House, Bartons Road,  
Havant**

**Proposed new residential care home  
development.  
( Internal access road )**

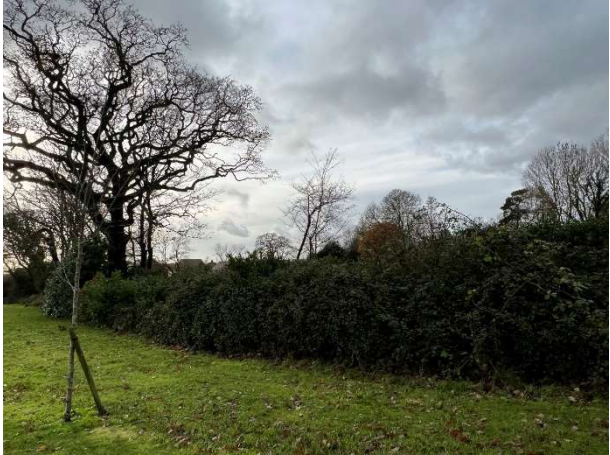
| 8.1 *Problem* (Item A1.5) | |
|---|---|
| <b>Location:</b> | Pedestrian crossing across junction with Normandy Way |
| <b>Summary:</b> | Vegetation located within pedestrian visibility splays obstructing visibility |
| <p>There currently is vegetation located along the western side of Normandy Way where the proposed access junction for the residential car development will be located. This vegetation will obstruct pedestrian visibility for pedestrians crossing the access road, reducing their visibility of oncoming vehicles. Remove vegetation from within visibility splays.</p> | |
| Risk of pedestrian injury due to obstructed visibility caused by vegetation. | |

| 8.1 *Problem* (Item A1.5) | |
|---|---|
| Remove vegetation from within required visibility splays. | |

| Stage 1 (Feasibility) Road Safety Audit<br>DESIGNER'S ROAD SAFETY AUDIT RESPONSE<br><b>Scheme Name:</b> Helmsley House P6 & CC5 S38 Highway Works | | | |
|---|---|---|---|
| 8.1 | Vegetation located within pedestrian visibility splays obstructing visibility | Vegetation will be cleared prior to commencing works so not an issue | |

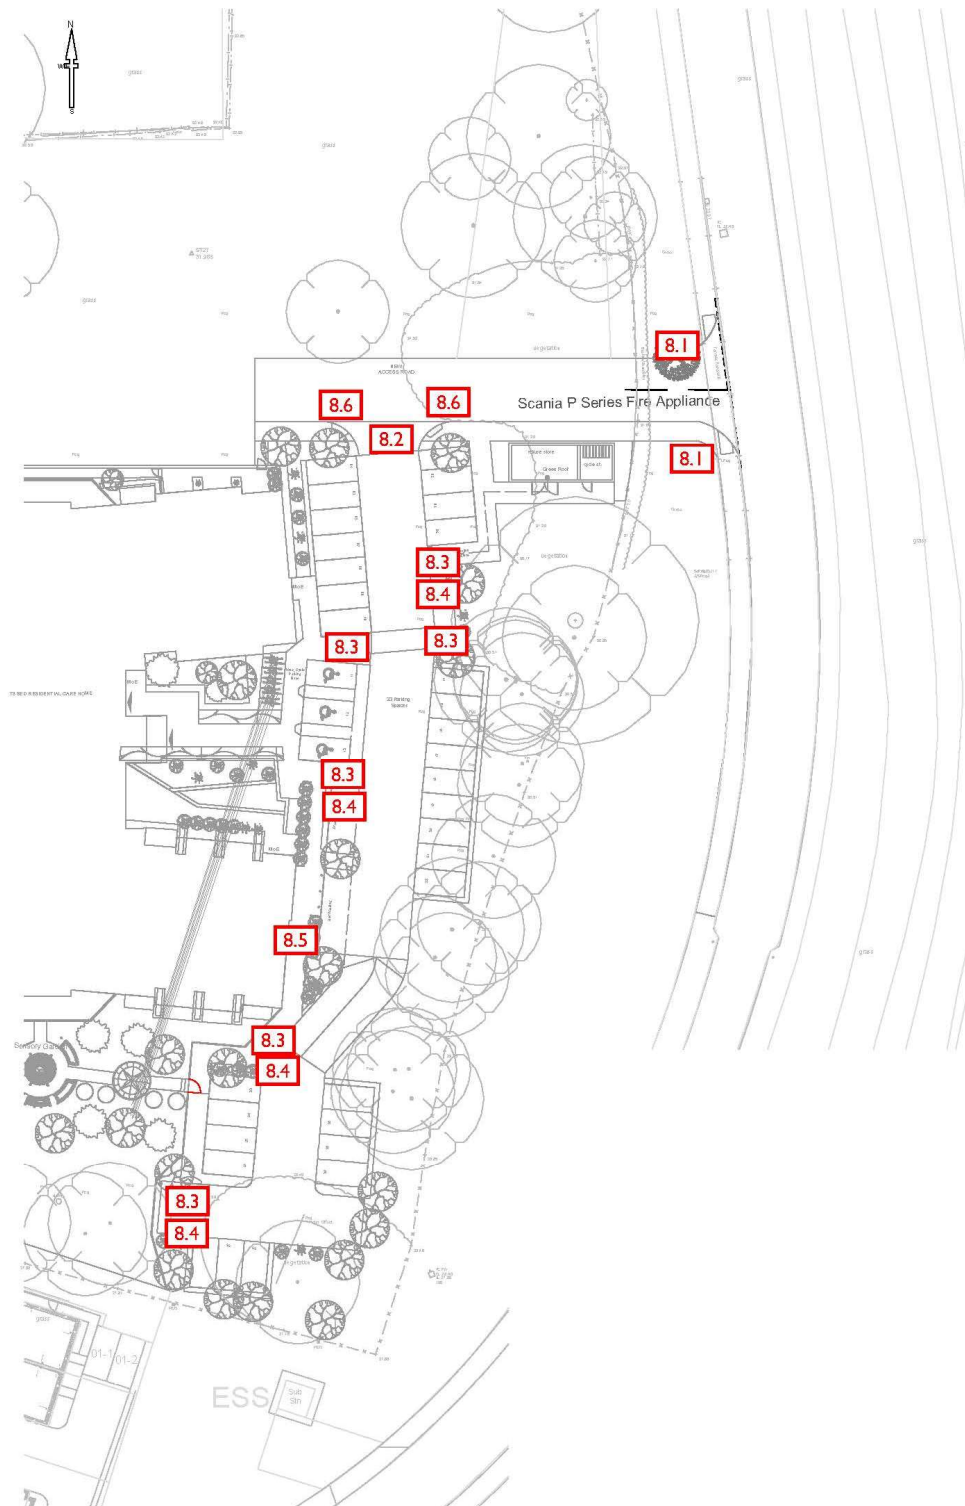
### 13. Identified Road Safety Audit Matters location plan

Identified locations of Road Safety Audit Matters are indicated on drawings within **Appendix A** to the rear of this report.
