# **Stage 1 Road Safety Audit Report (Feasibility)**

**Helmsley House, Bartons Road,  
Havant**

**Proposed new residential care home  
development.  
( Internal access road )**

**Date: 14<sup>th</sup> December 2023**

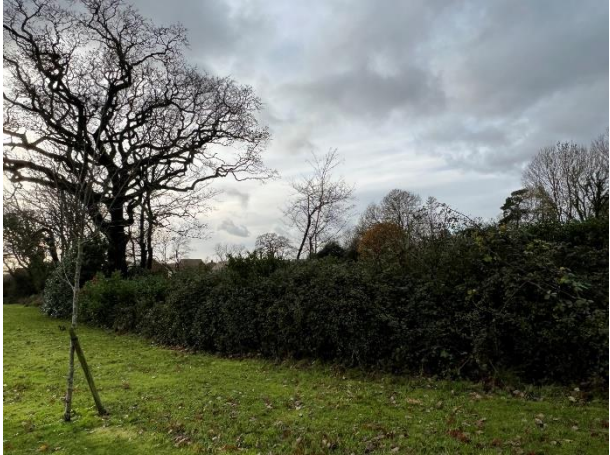
| 8.1 *Problem* (Item A1.5) | |
|---|---|
| <b>Location:</b> | Pedestrian crossing across junction with Normandy Way |
| <b>Summary:</b> | Vegetation located within pedestrian visibility splays obstructing visibility |
| <p>There currently is vegetation located along the western side of Normandy Way where the proposed access junction for the residential car development will be located. This vegetation will obstruct pedestrian visibility for pedestrians crossing the access road, reducing their visibility of oncoming vehicles. Remove vegetation from within visibility splays.</p> | |
| Risk of pedestrian injury due to obstructed visibility caused by vegetation. | |

| 8.1 *Problem* (Item A1.5) | |
|---|---|
| Remove vegetation from within required visibility splays. | |

| Stage 1 (Feasibility) Road Safety Audit | | | |
|---|---|---|---|
| 8.1 | Vegetation located within pedestrian visibility splays obstructing visibility | Vegetation will be cleared prior to commencing works so not an issue | |

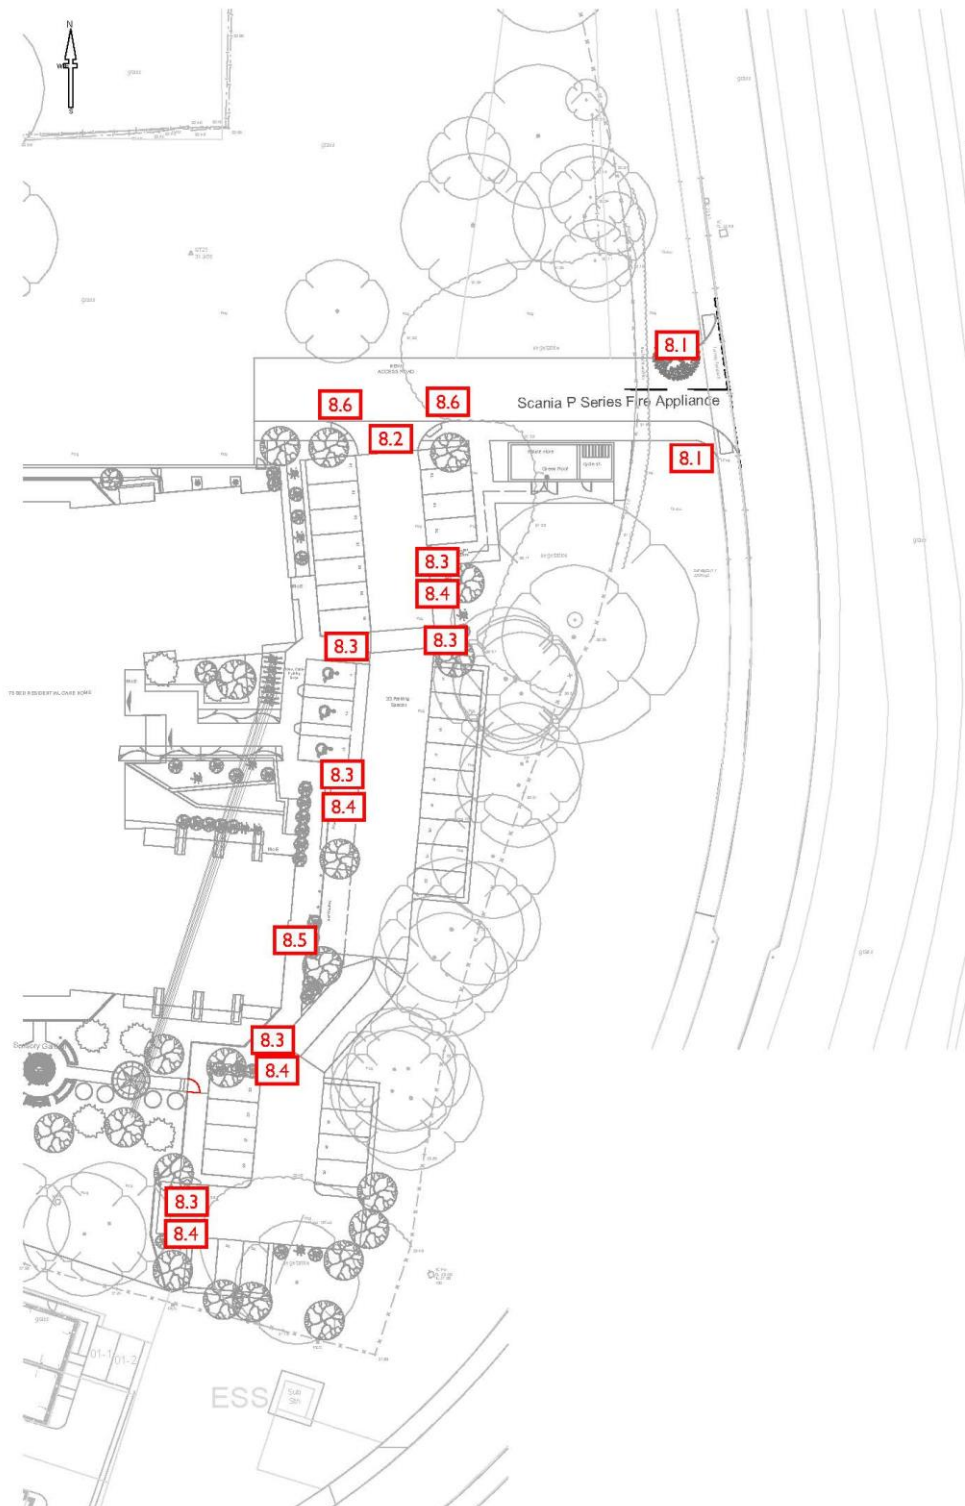
### 13. Identified Road Safety Audit Matters location plan

Identified locations of Road Safety Audit Matters are indicated on drawings within **Appendix A** to the rear of this report.
