# Flood Risk Assessment .

1133 -17 Billet Avenue Waterlooville PO7 7SZ -  
Rev 01

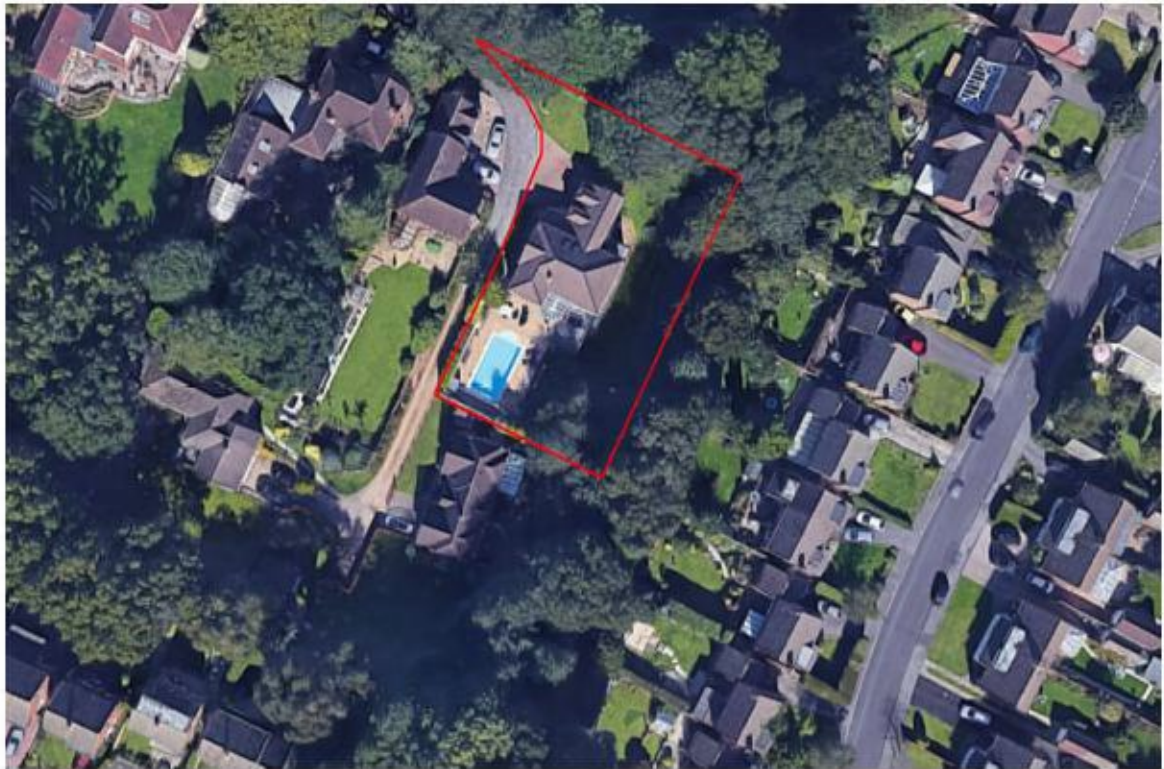
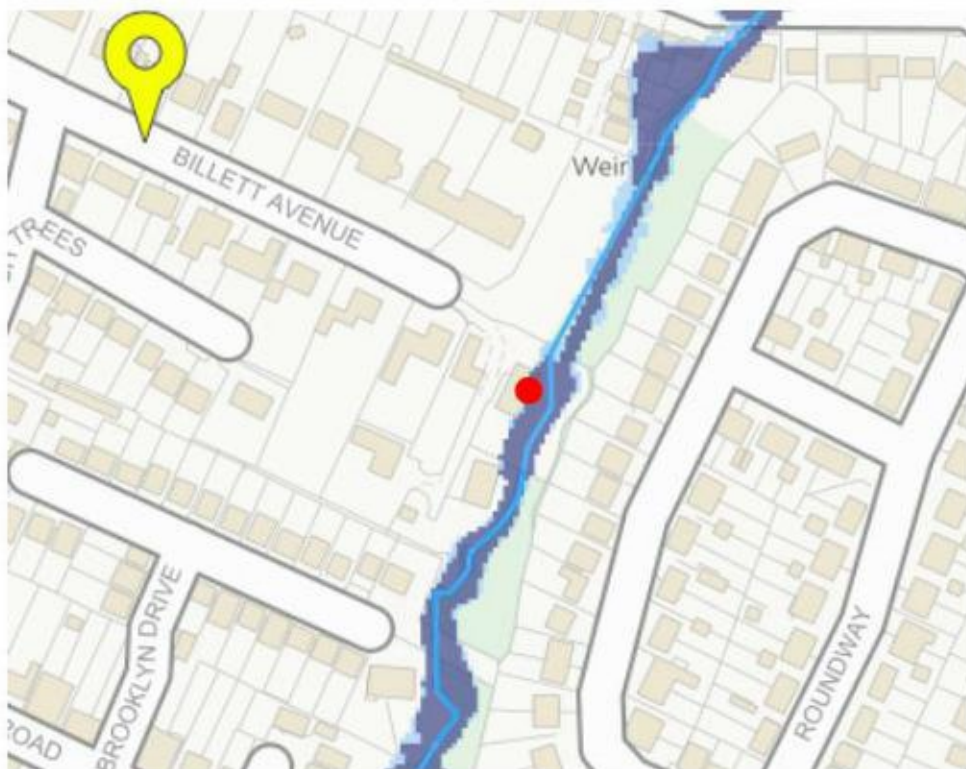
The site is within a well-established residential area and forms part of a private road at the end of Billet Avenue. As seen in the aerial image is the shape of the previous driveway. The driveway lies at a higher level with a flat rear garden with sloped banks. The site is bound by a number of mature trees and hedgerows.

The property surrounding the house and within the red line boundary has a number of different levels. The western side of the property is the highest. The house echoes a change of level from north to south where the house and a retaining wall creates a distinct high and low point between

the West (High) and East (Low) side. The Flood 3 zone is contained to this lower level edge and is seen in the flood risk map. Continuing through the site to the South East corner the site falls away again dramatically to the Hermitage Stream. All of which creating huge areas within the plot of land to hold any water generated by the increased driveway.

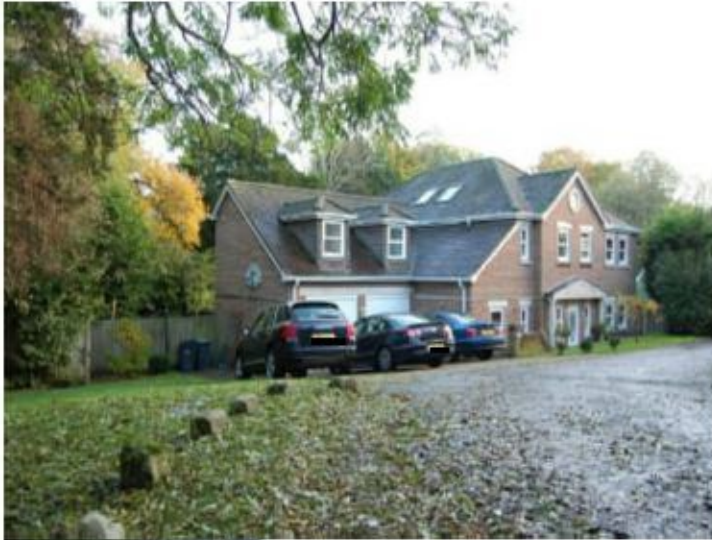
View of the front of the existing property prior to the new driveway.

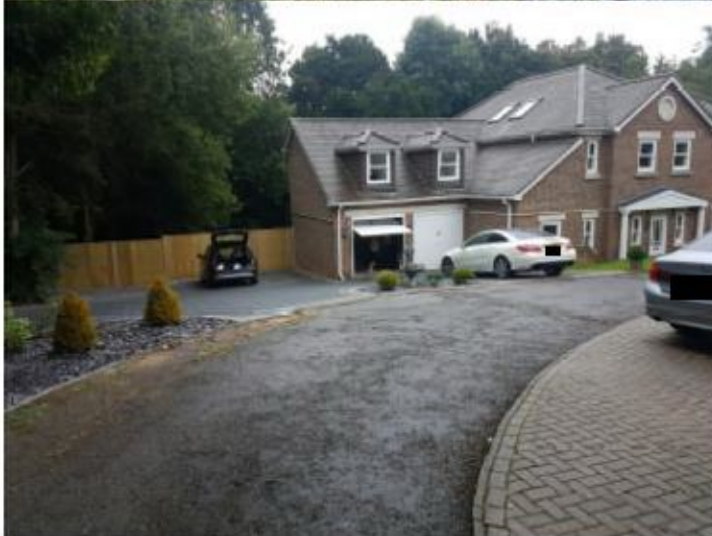
View of the front of the renewed driveway.

The site has multiple levels. As previously mentioned the new driveway area is outside of the flood risk 3 zone. This is due to the fact that the existing property is raised above the rear garden level (flood risk 3 zone). The existing property is approx. 2015mm above the rear garden level. The driveway area sits behind a retaining wall which has a height varying from 1650mm tall to its low point of 900mm tall above this ground level. The site has the Hermitage stream running through it, the previous owners culverted the stream. This at the lowest point of the garden sits lower by as much as 2640mm from this rear garden level. Any water generated by the additional hard landscaping will be easily managed and retained on site with the site levels alone. The following photographs and section have been prepared to assist in allowing an understanding of the various levels of the site and ultimately concluding that there is little to no impact generated by the installed driveway.

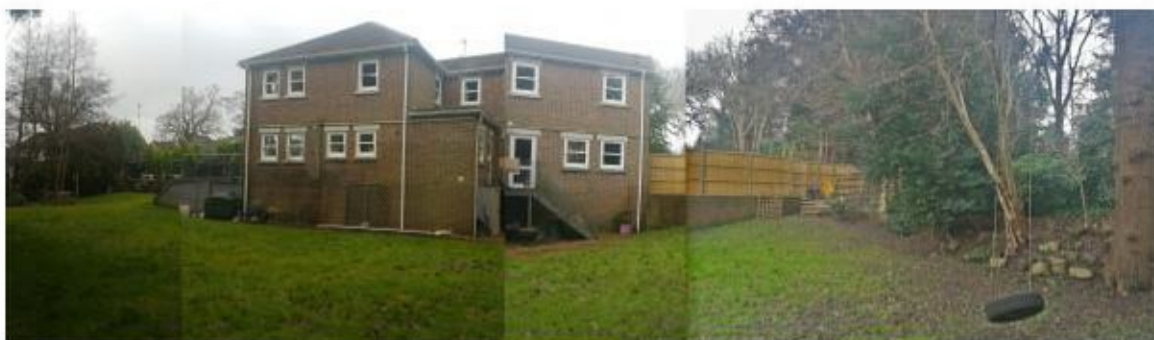
The house as seen in the photograph is at a higher level with the retaining wall and fence to the right hides the driveway at the higher level outside of the flood risk 3 zone.

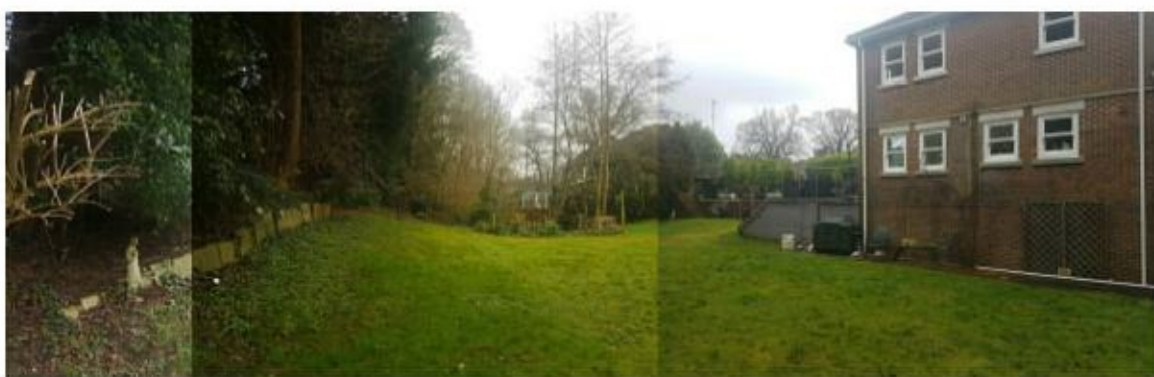
The Hermitage Stream has been previously culverted through the centre of the grass area. Note the steep bank side and mature trees.

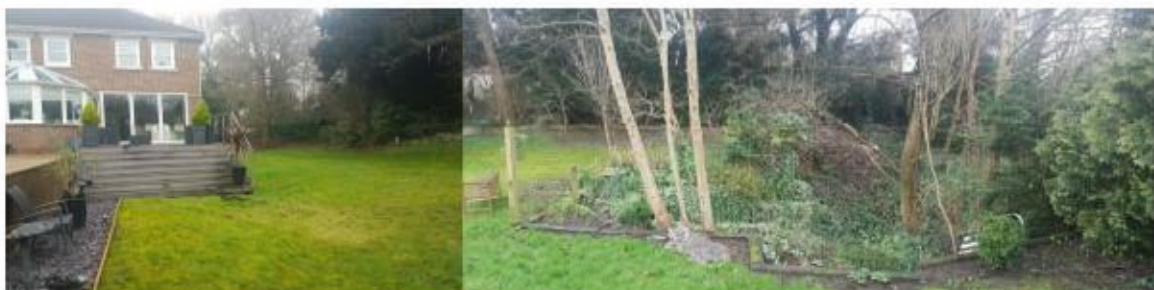
Here we can still see the higher level of the house and to the left is the access/ egress to the culverted area.

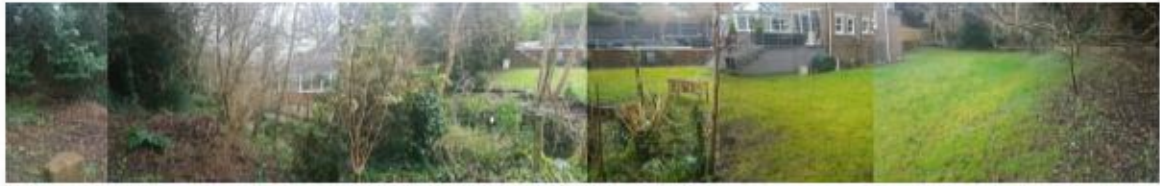
View of the culverted area looking back towards the house.

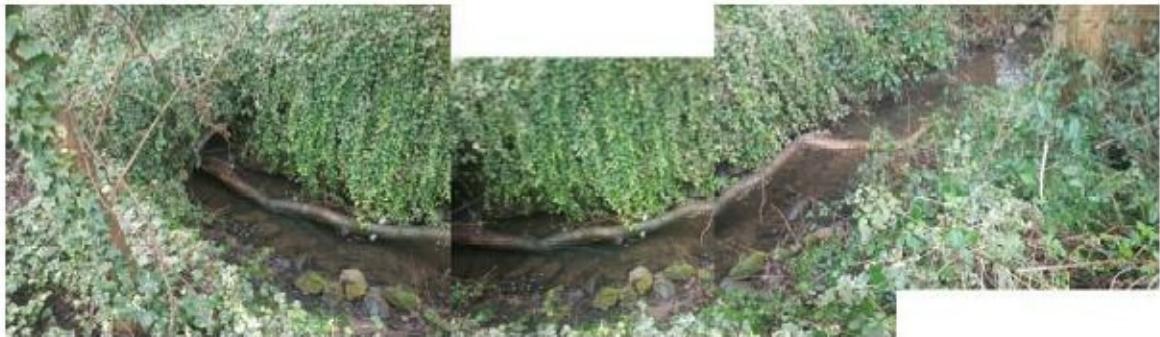
The Hermitage Stream at a much lower level than the garden.
