| Project: | 13 Bursledon Road<br>Purbrook<br>Waterlooville<br>PO7 5NJ | | |
| | Alterations | | |
| Title: | Proposed Plans and Elevations | | |
| Drawing No. | 9000 - P.01.01 | Rev: | . |

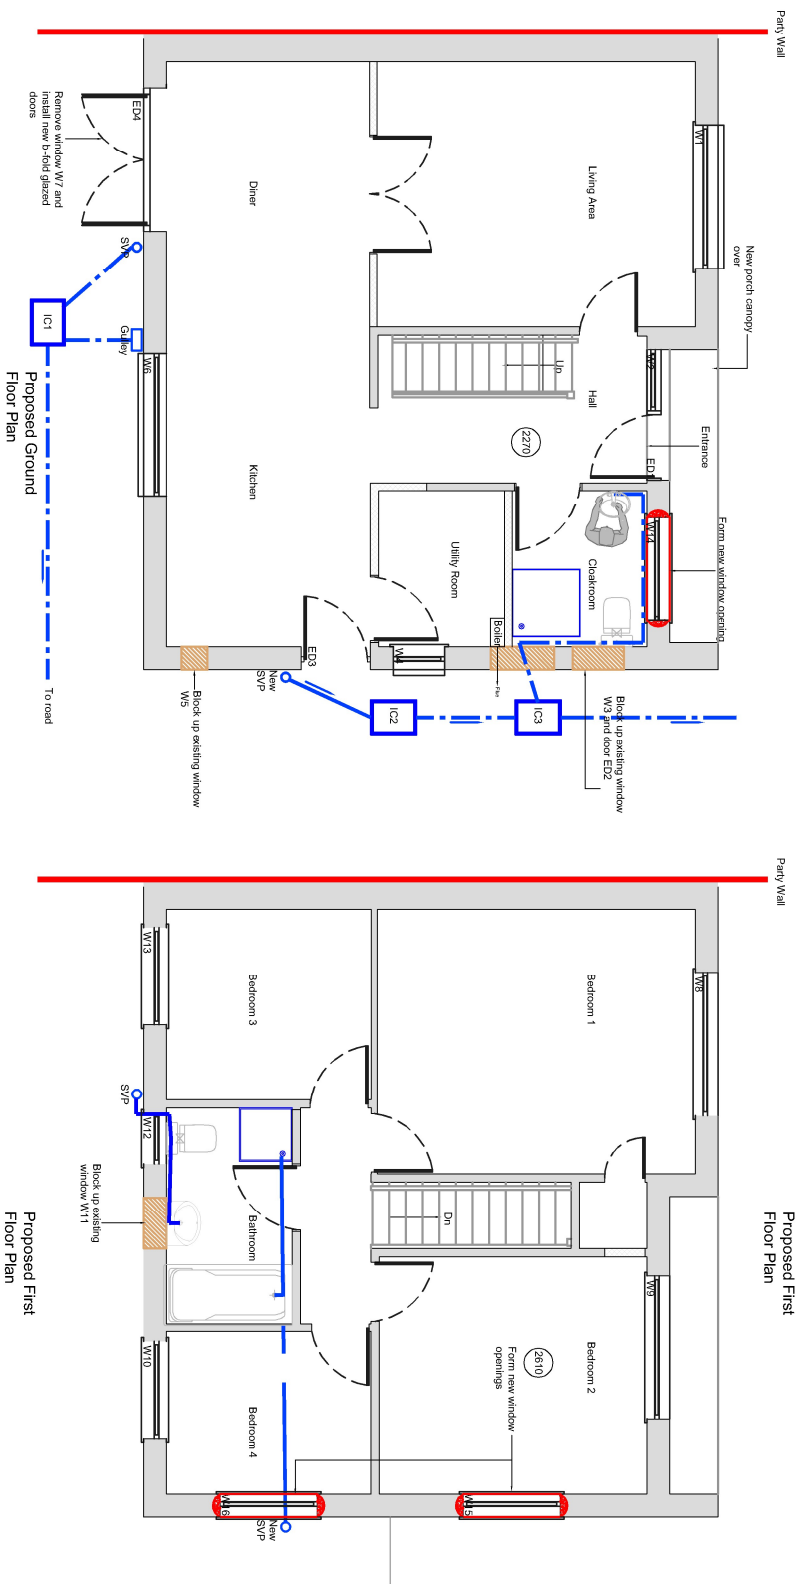
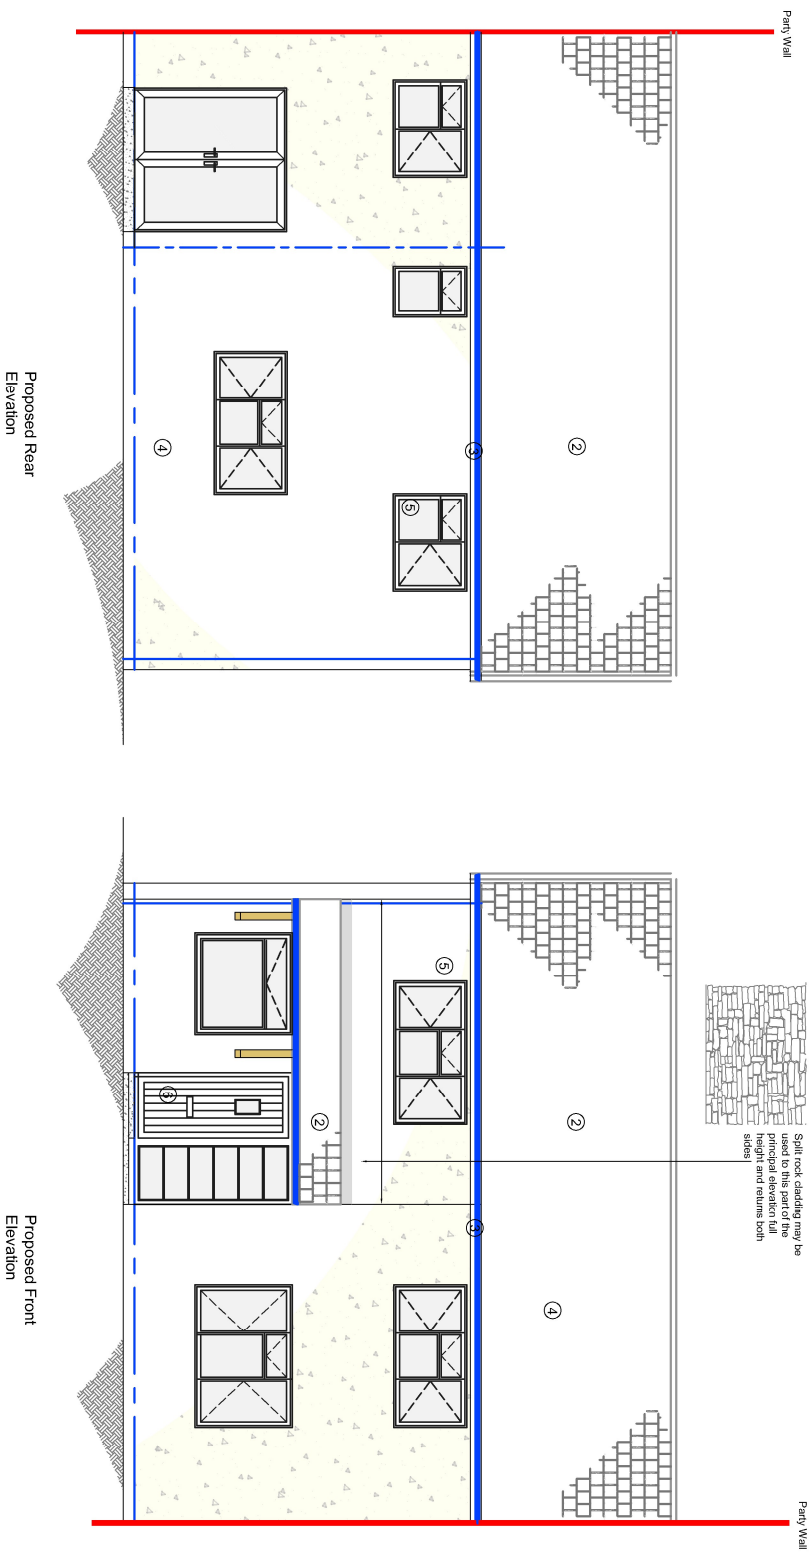
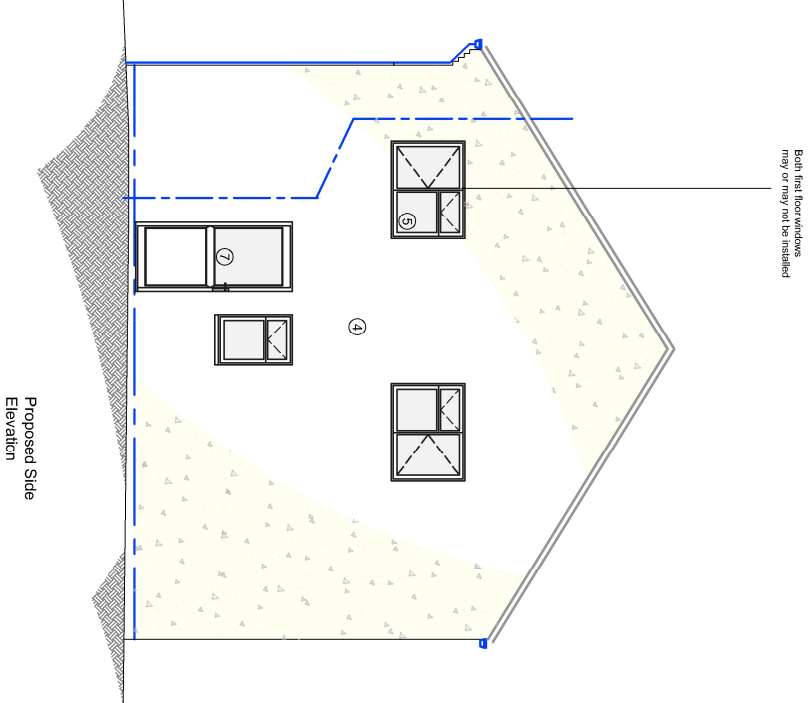
- KEY**
- Chimney removed
  - Pitched roof with gableend - Ludlow tile
  - PVCu soffits and fascia with PVCu gutters / downpipe / SVP
  - White / Light grey K-Render to elevation where noted  
Front elevation to entrance door and return possible Split Rock cladding
  - Anthracite colour PVCu double glazed window units and cill  
W4, W11 & W14 to have obscured / privacy glass
  - Composite insulated door in Anthracite colour with double glazed bank of windows commensurate to the door
  - Anthracite colour PVCu door with obscured glazed upper panel and insulated lower panel
  - Anthracite colour PVCu bi-fold double glazed doors with match cill
  - Front canopy on gallows brackets and fixed to walls, fitting commensurate to mainroof - tile to closely match colour / profile but may be smaller tiles
