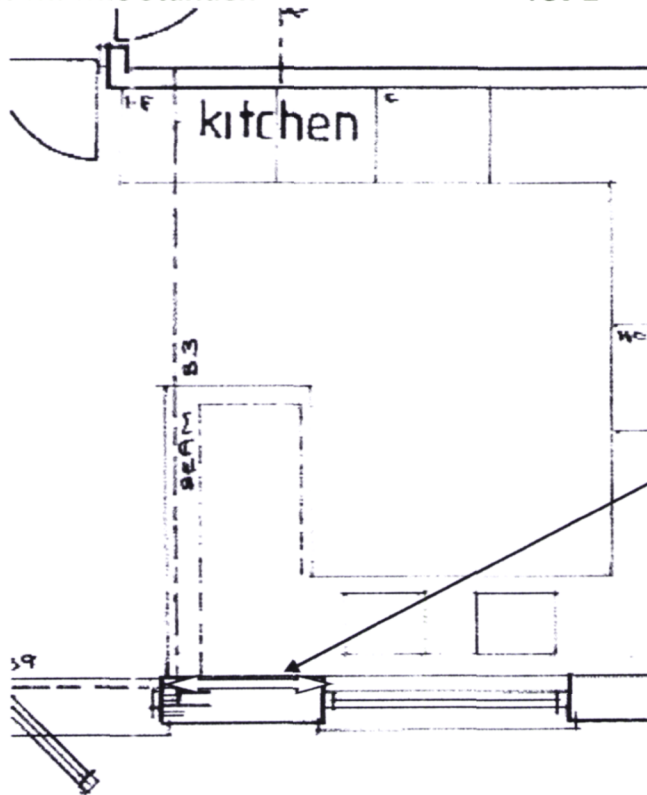
This section of inner skin wall to  
be rebuilt in 7 Nmm strength  
blockwork ie Thermalite Hi  
strength 7 blocks (see **Structural**  
note above, page 2)
