## **ARBORICULTURAL IMPACT ASSESSMENT**

**COCKLE POINT,  
MARINE WALK,  
HAYLING ISLAND, HAMPSHIRE**

**CAAD Ltd on behalf of MR STEWART JOHNSON**

**Report Number: MB221204-01**

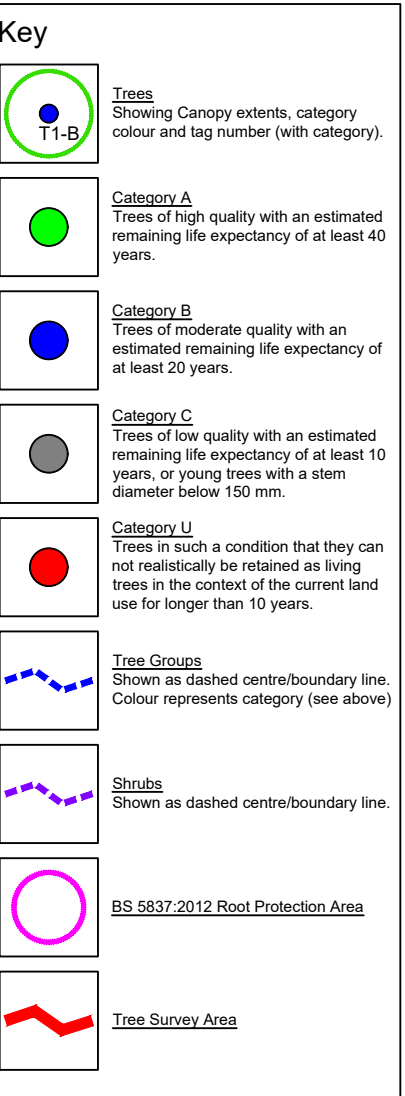
Drawing MB221204-01-01 Tree Constraints Plan

Arbor-Eco Consultancy, Tree Constraints Plan, Drawing Number MB221204-01-01 in Section 5 indicates the location of the trees surveyed.

It is worthy of note that the trees identified and discussed within this report (and shown on Arbor-Eco Consultancy Tree Constraints Plan, Drawing Number MB221204-01-01), are the only trees likely to be impacted or, deemed to be in conflict with, the proposed development. All remaining trees will be protected and retained.

All trees within and closely surrounding the site have been surveyed and each has been identified with a unique number. The location of the trees can be found on Drawing Number MB221204-01-01 in Section 5.

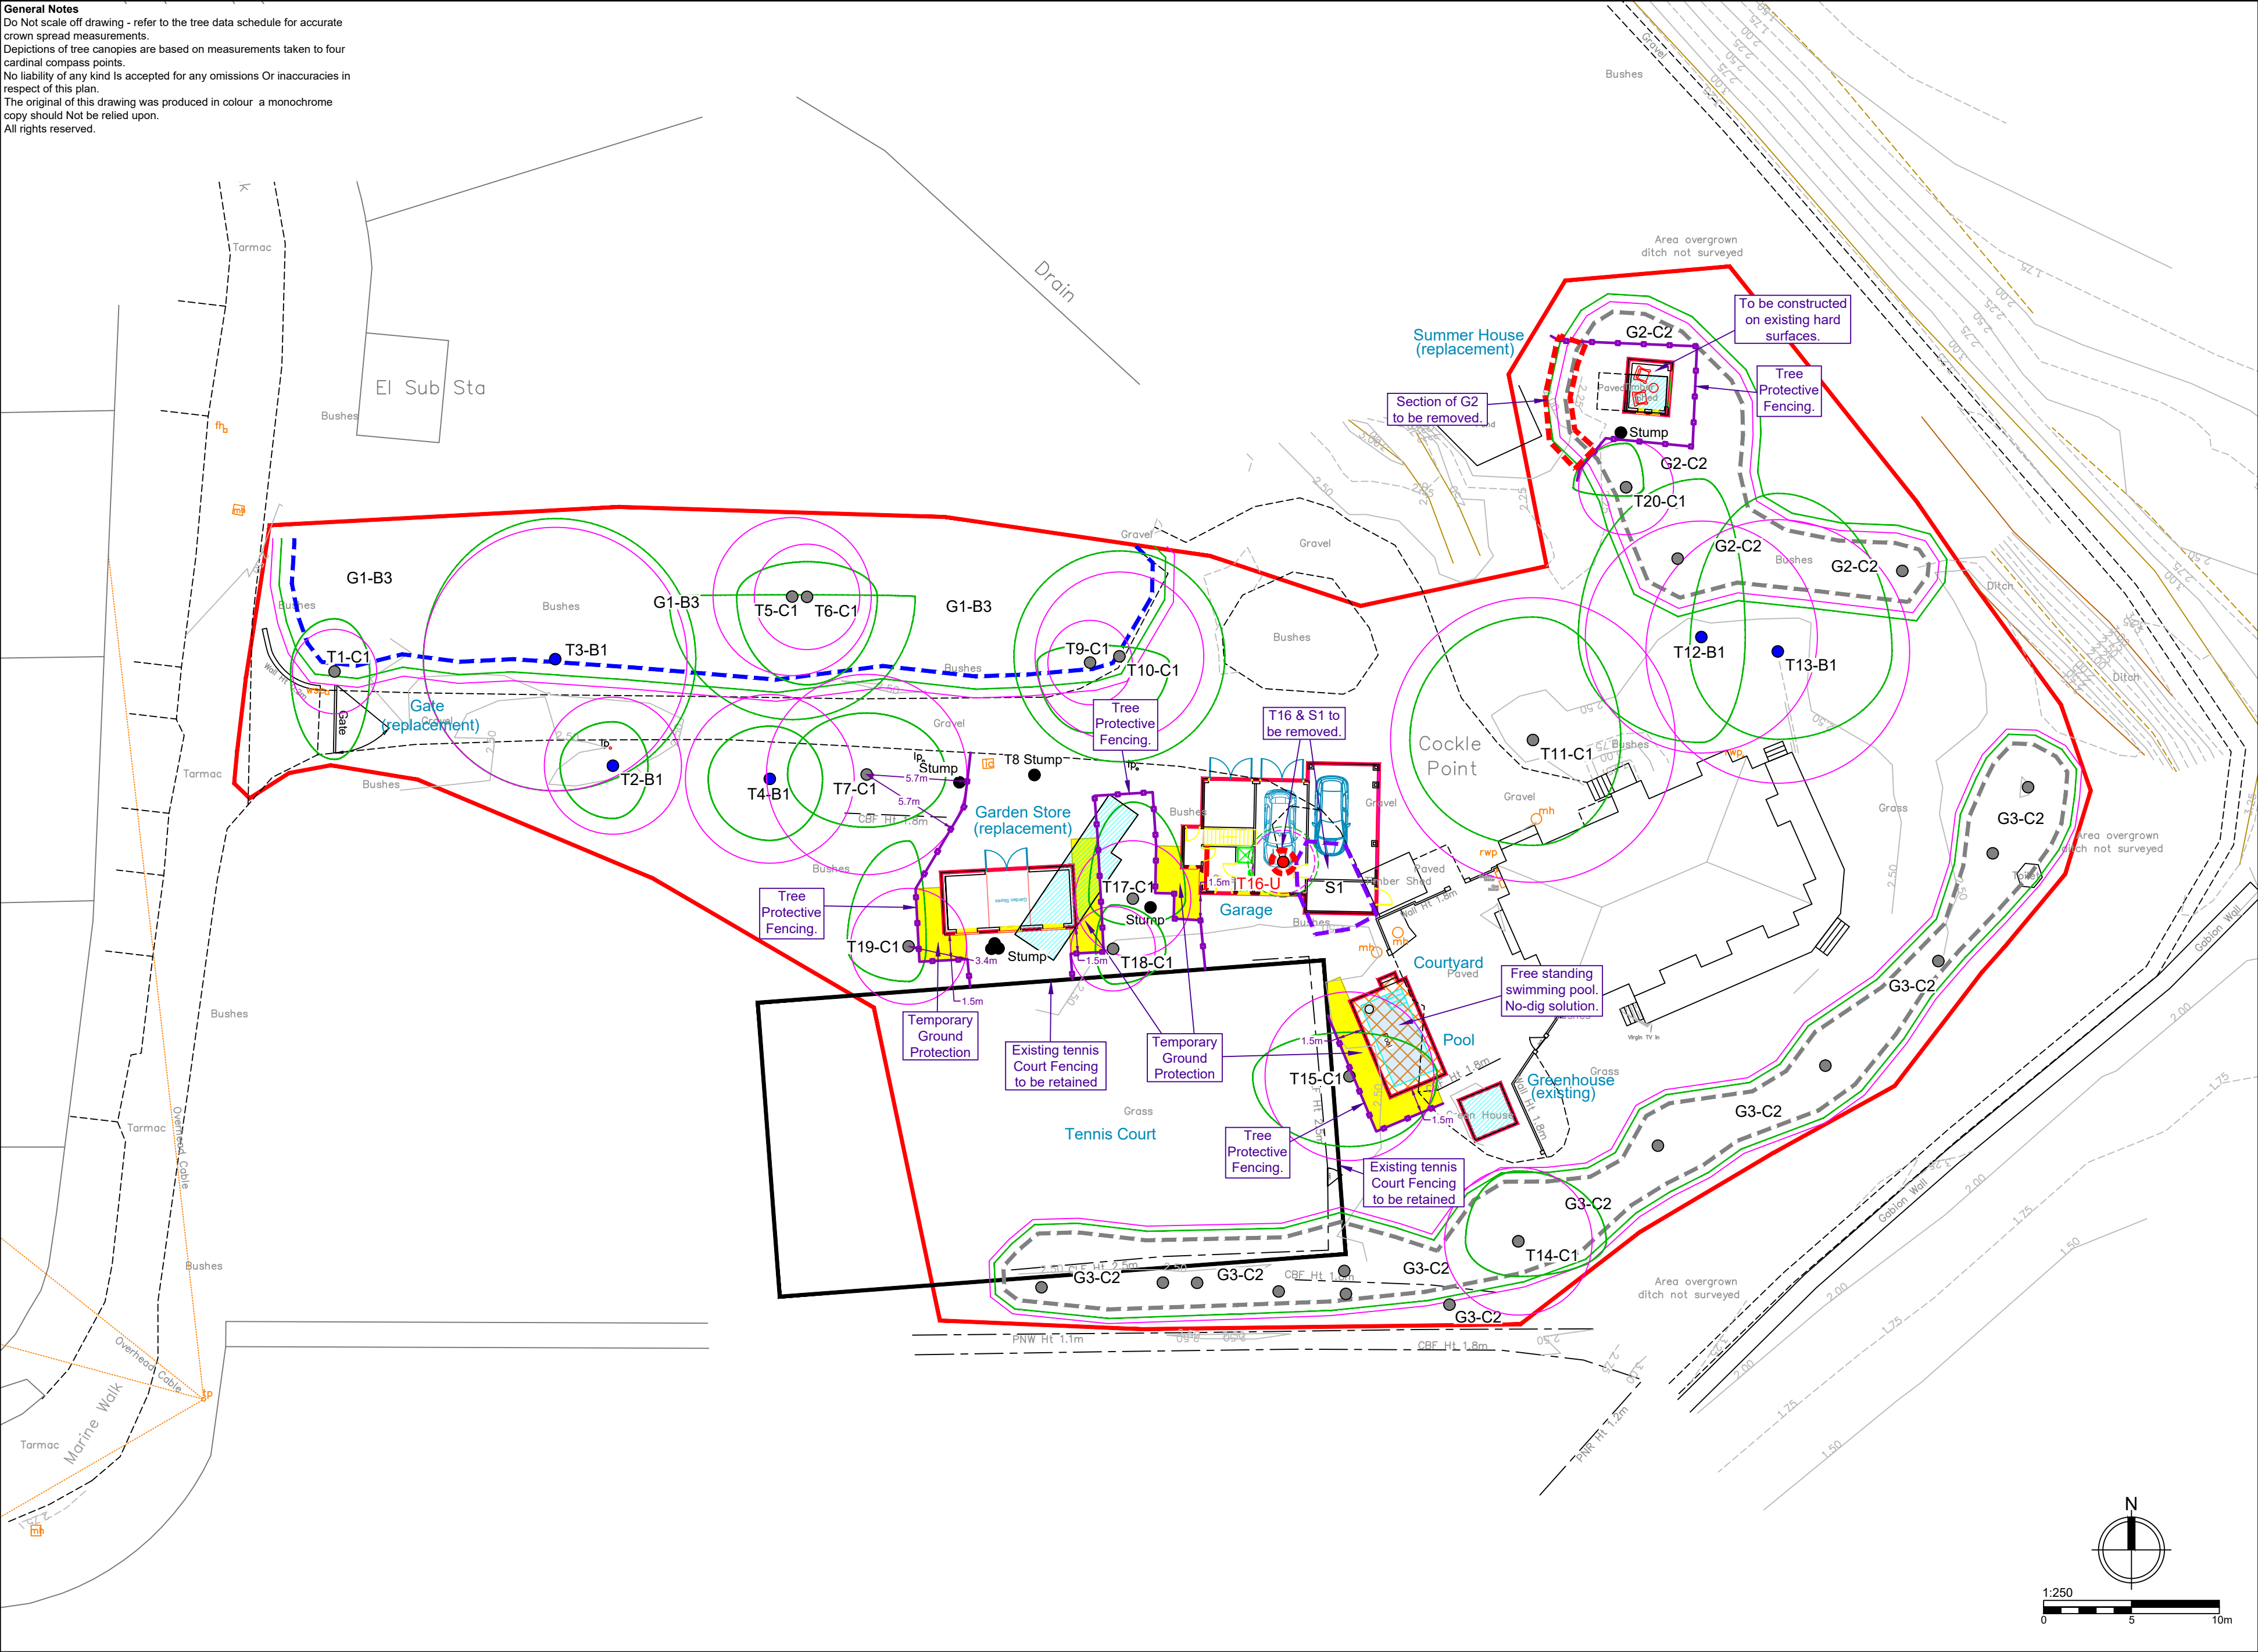
Drawing MB221204-01-02 Tree Protection Plan

The proposed development of the site has been designed so that no major works are required within the RPAs of the retained trees. Whilst the Tree Protection, Drawing Number MB221204-01-02 may indicate otherwise, it should be noted at this early stage that the buildings will be lightweight, partially portable for the swimming pool and be constructed on existing footings or plinth foundation blocks and therefore only minor intrusion into the ground is anticipated.

The construction works to develop the swimming pool and associated pump room has the greatest potential to cause harm to the retained trees. It is considered that the trees identified on Tree Protection Drawing MB221204-01-02, Section 5, will not be so significantly impacted upon with the adoption of tree protection measures, the installation of suitable ground protection and good working practices as described within Sections 3.3.6 and 3.3.8.

The potential for direct damage to the stems of the trees will be controlled by the installation of protective barriers as shown on Tree Protection Plan Drawing Number MB221204-01-02, Section 5.

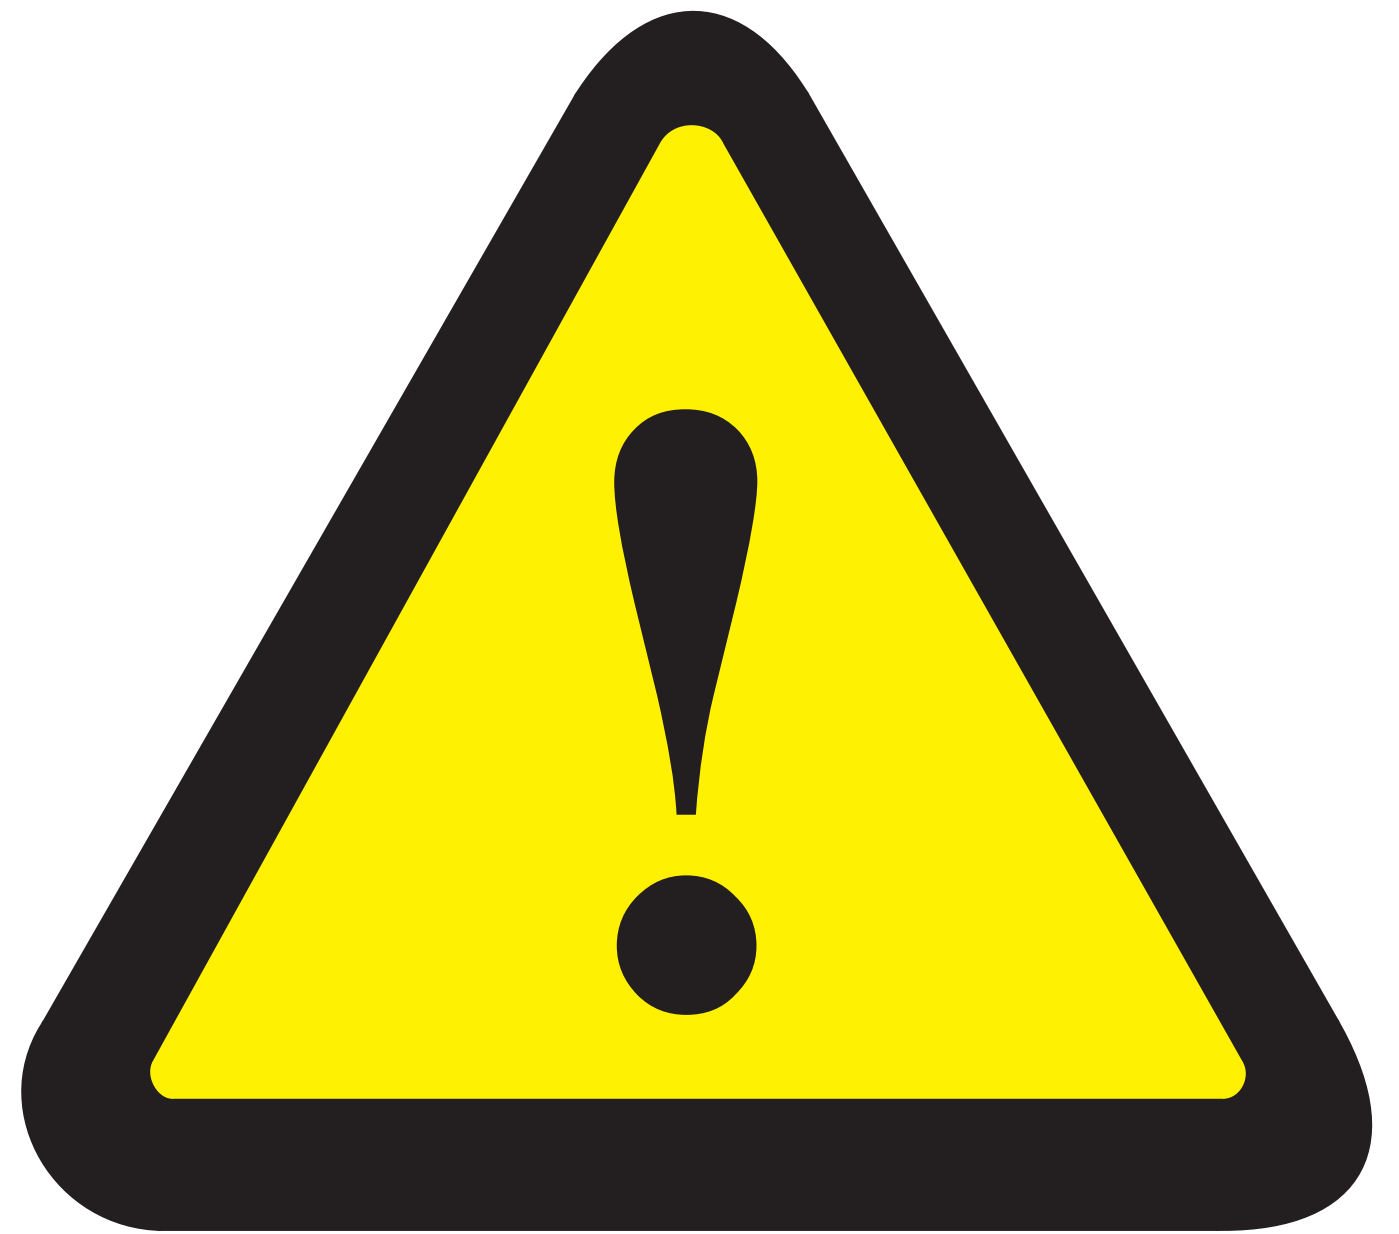
**TREE PROTECTION AREA  
KEEP OUT !**

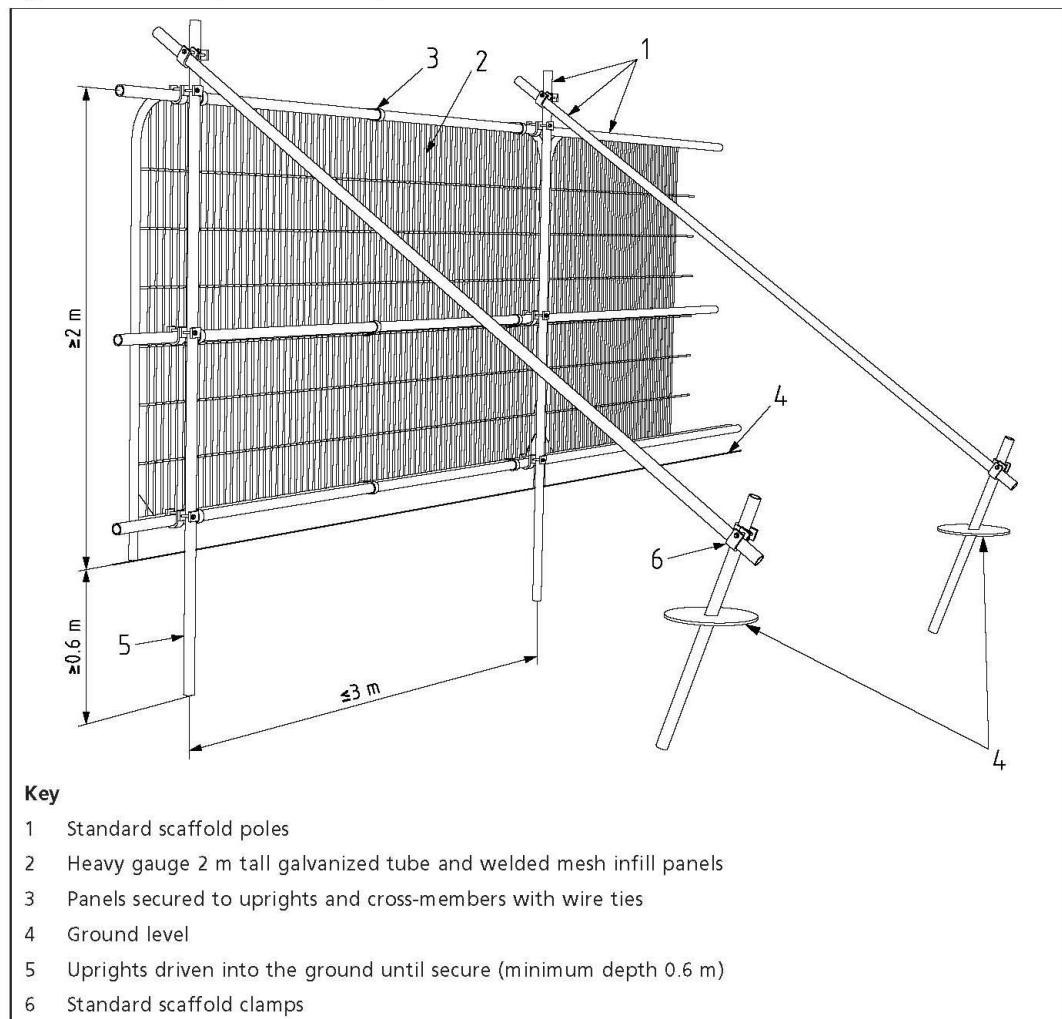
Figure 2 Default specification for protective barrier

### **Details of Protective Barrier (Default and Variant)**
