## Staunton Country Park Works to Northern Wall of Storey Gardens

# Combined Design and Heritage Statement

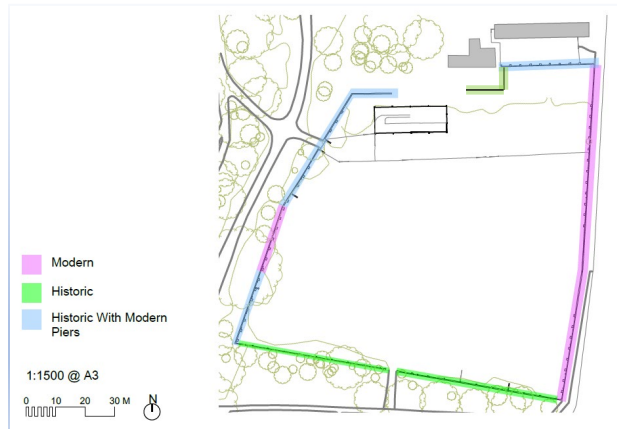
Fig 2: Construction History

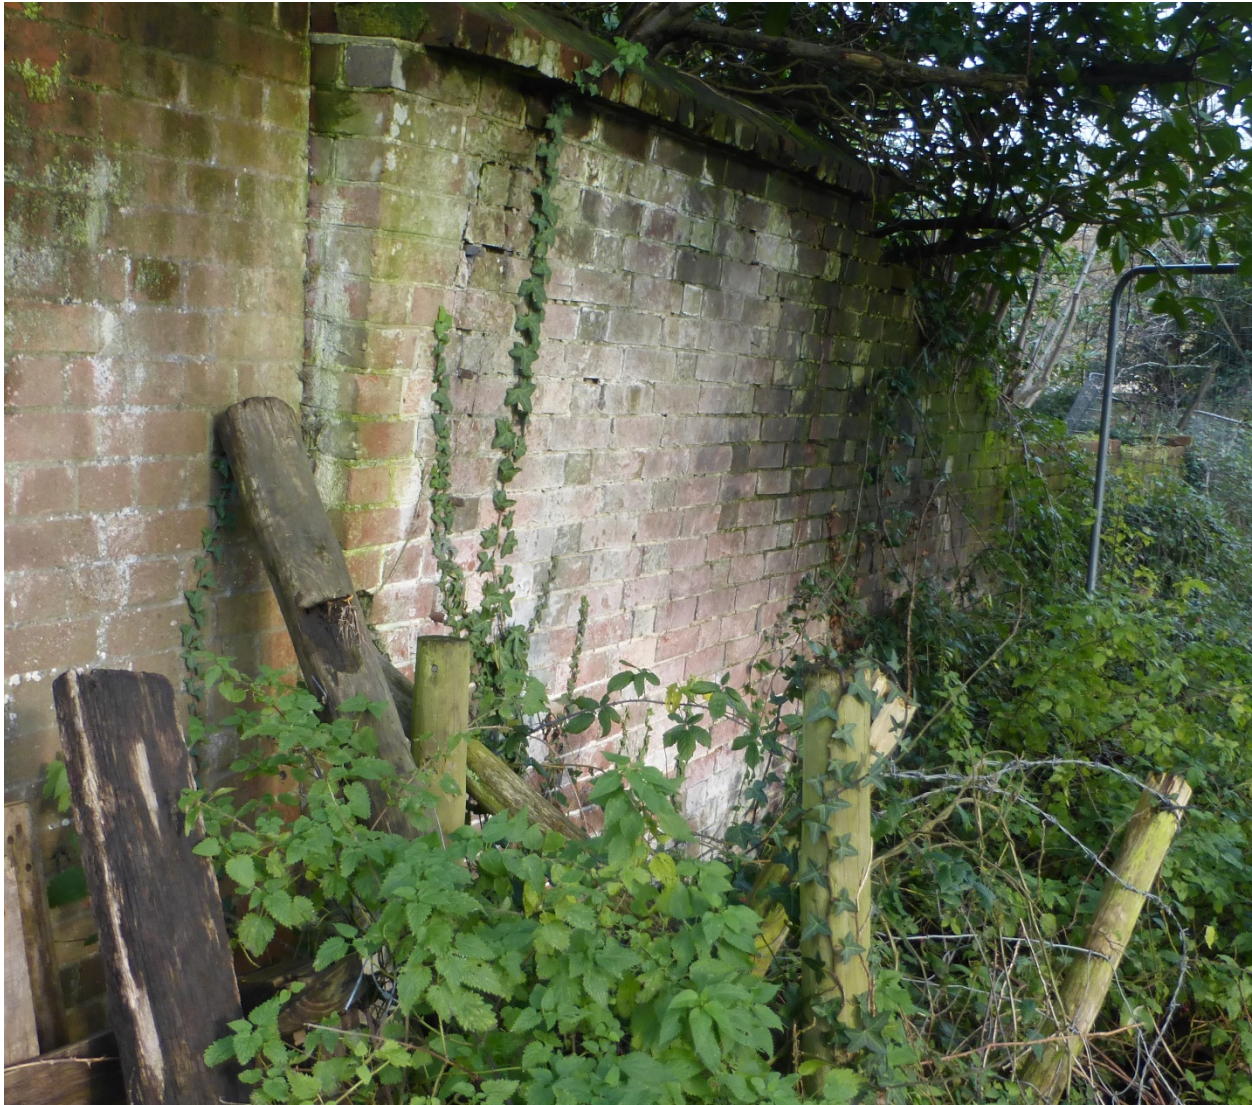
The wall to the Northern boundary is built in 9-inch brickwork with intermediate supporting piers and canted brick coping.

Fig 4: Image to show leaning wall

This application includes works and infill to the Northern wall of the Storey Gardens which also forms the boundary to Stable Cottage. During a recent structural safety inspection, it was identified that a length of wall is leaning, which, in the short term have been fenced off for safety reasons. A 25m length of this wall has historically collapsed and the boundary is protected only by vegetation.

The works comprise an initial short-term addition of timber shoring to prevent collapse. The next stage will be to carefully take down the leaning length of wall and rebuild in 9 inch brickwork with piers and a parapet brick capping, to match the existing walls. To the length of wall which has historic partial collapse, the proposal includes brickwork repairs, and to infill the gap with a timber close boarded fence.
