| <b>Project:</b> | Woodcroft Farm Lovedean PO8 9QA | <b>Title</b> | Development Levels Plan - Phase 3 Farmyard and Chalk Pit |
| <b>Client:</b> | Vistry Homes Southern | <b>Geo-Environmental Services Ltd</b> | |

| <b>Project:</b> | Woodcroft Farm Lovedean PO8 9QA | | | <b>Title</b> | Remediation Strategy Plan - Phase 2B Farmyard Volumes | | |

| <b>Project:</b> | Woodcroft Farm Lovedean PO8 9QA | | | <b>Title</b> | Remediation Strategy Plan - Phase 3 Horse Arena, Chalk Pit & Farmyard Volumes | | |

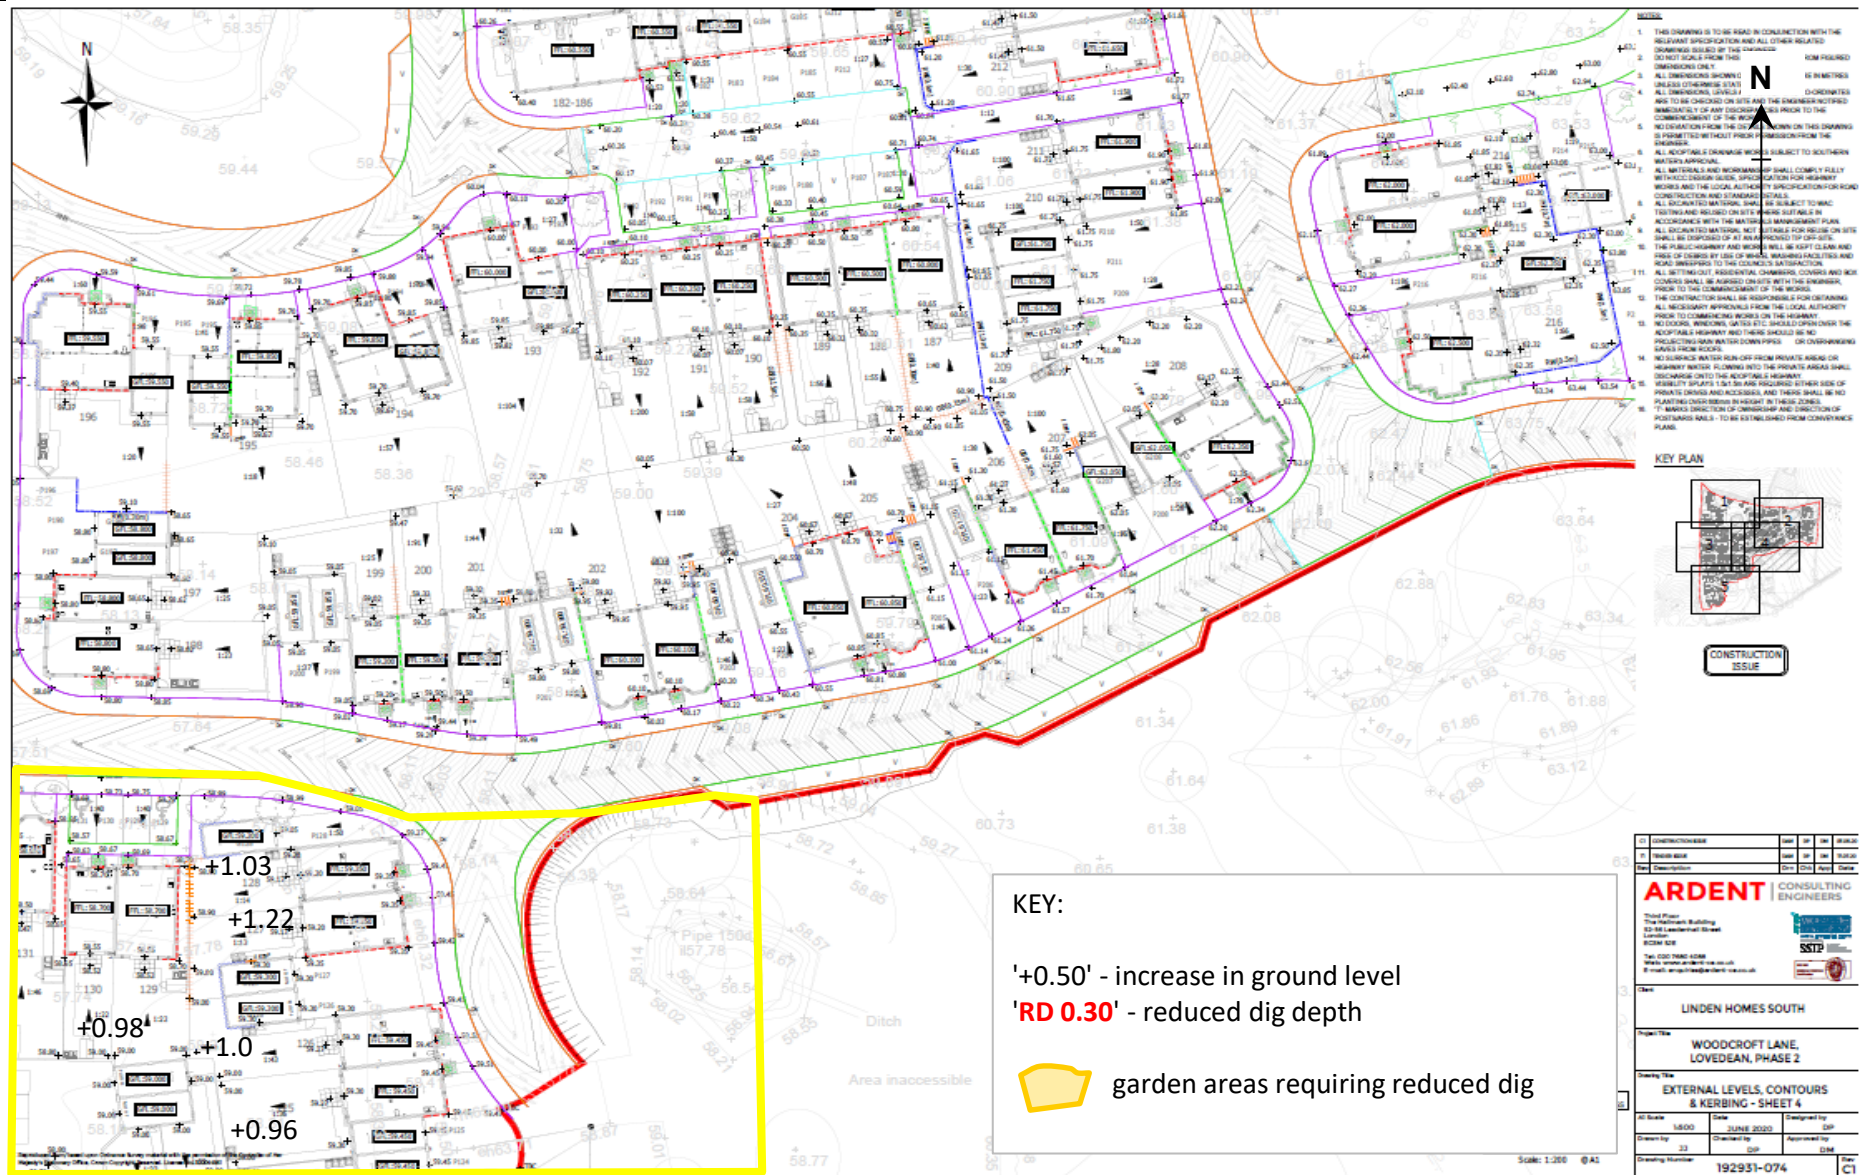
**Figure:** 14

**Title** Development Levels Plan - Phase 3 Farmyard

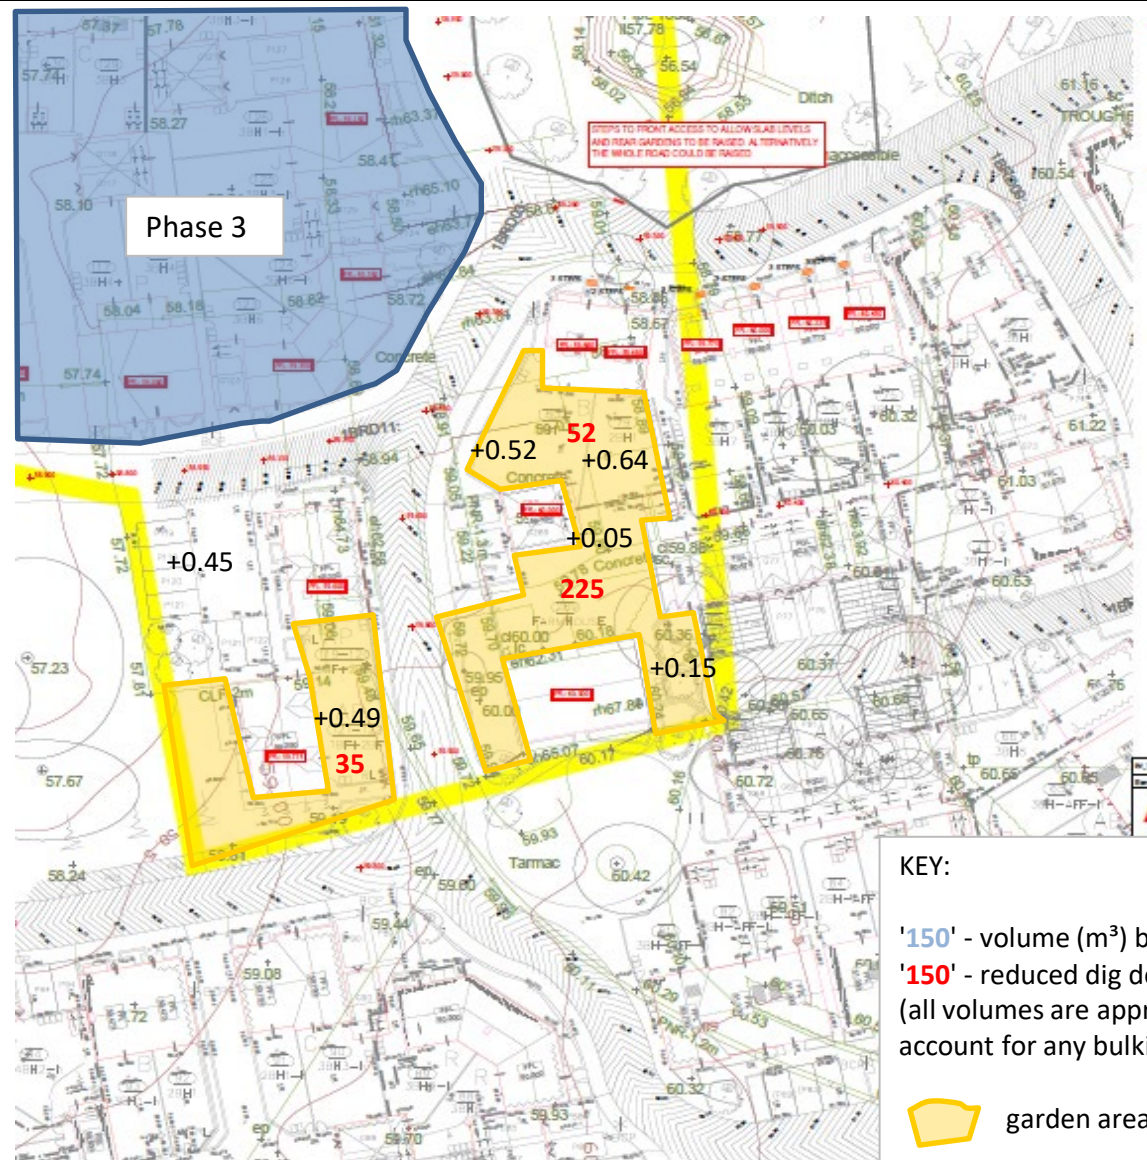
'150' - volume (m<sup>3</sup>) below soil cover system

'150' - reduced dig depth volume (m<sup>3</sup>)

(all volumes are approximate and do not account for any bulking)

garden areas requiring reduced dig

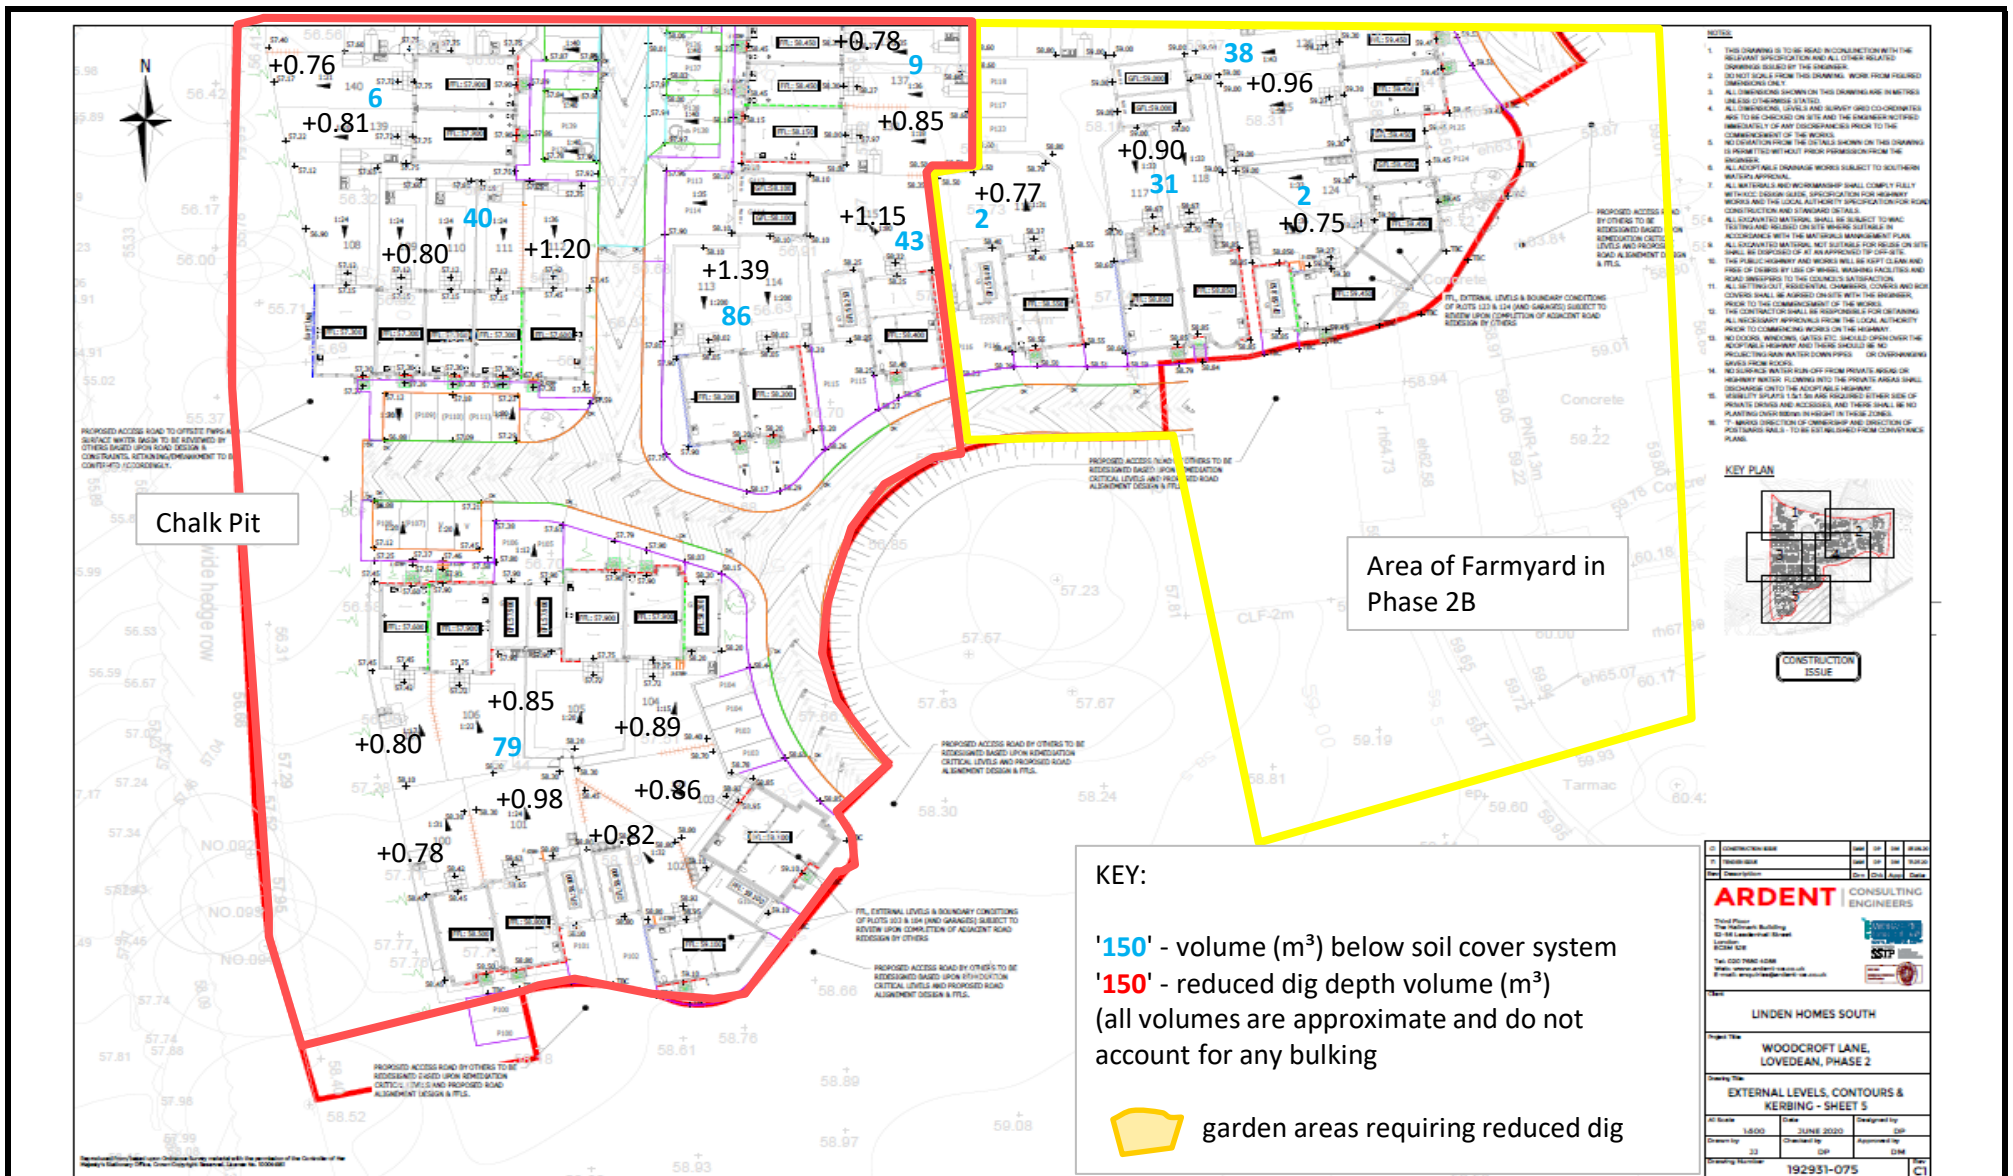
| <b>Project:</b> | Woodcroft Farm Lovedean PO8 9QA | | | <b>Title</b> | Remediation Strategy Plan - Phase 3 Farmyard and Chalk Pit Volumes | | |

'150' - volume (m<sup>3</sup>) below soil cover system  
'150' - reduced dig depth volume (m<sup>3</sup>)  
(all volumes are approximate and do not account for any bulking)

garden areas requiring reduced dig
