Additional Structural note

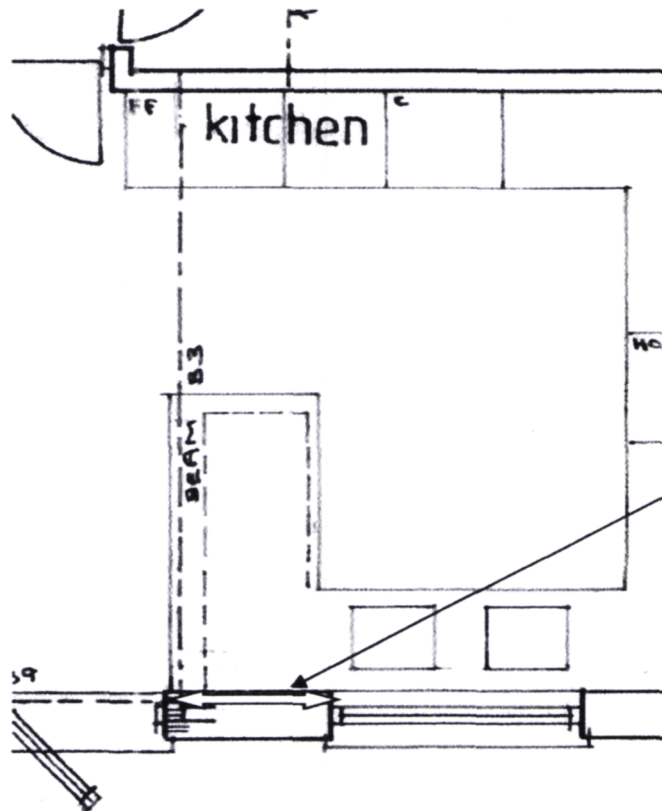
This section of inner skin wall to be rebuilt in 7 Nmm strength blockwork ie Thermalite Hi strength 7 blocks (see **Structural** note above, page 2)
