## Arboricultural Method Statement

46 Warblington Road

Client: Mr Charles Glanville

Date: March 2021

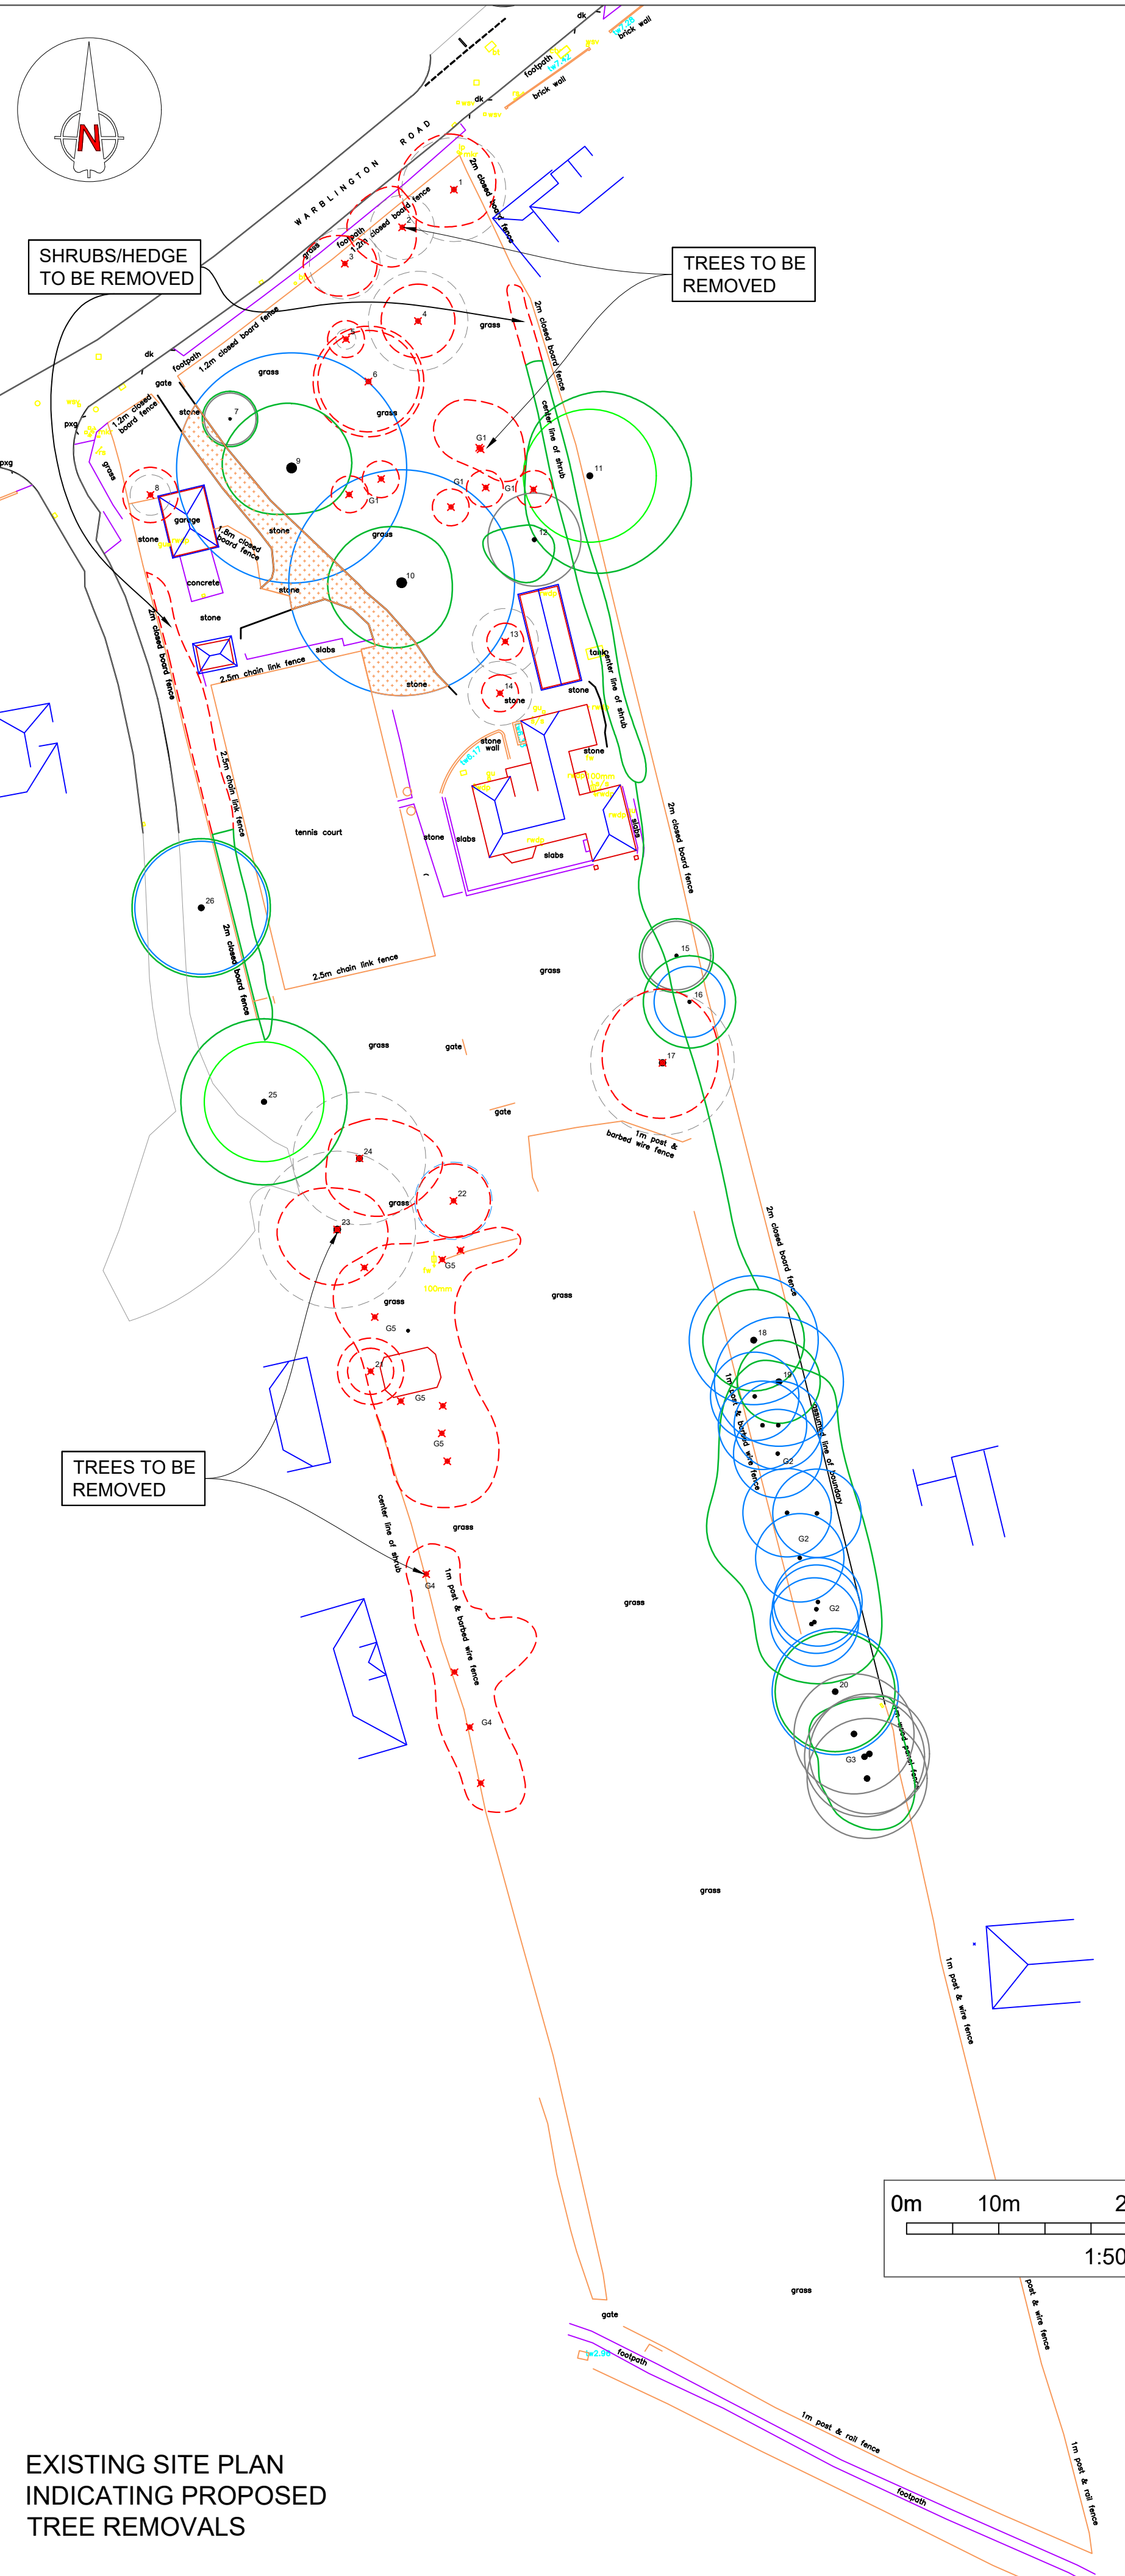
EXISTING SITE PLAN  
INDICATING PROPOSED  
TREE REMOVALS

| Tree no. | Species | Height | BS Category | Work required | Reason for work |
|---|---|---|---|---|---|
| 1-6 & 8 | Various | 5m/6m | C & U | Fell to ground level | Within footprint of proposed building. |
| 13 | Apple | 3.0m | C | Fell to ground level | Within footprint of access drive |
| 14 | Fig | 2.0m | C | Fell to ground level | Within footprint of access drive. |
| 17 | Weeping Willow | 14m | C | Fell to ground level | Becoming hazardous and of only short term value. |
| 21 | Cider Gum | 9m | U | Fell to ground level | Within footprint of proposed building. |
| 22 | Himalayan Birch | 11m | B | Fell to ground level | Within footprint of proposed building. |
| 23 | Cider Gum | 20m | C | Fell to ground level | Within footprint of proposed building. |
| 24 | Snow Gum | 20m | C | Fell to ground level | Within footprint of access drive. |

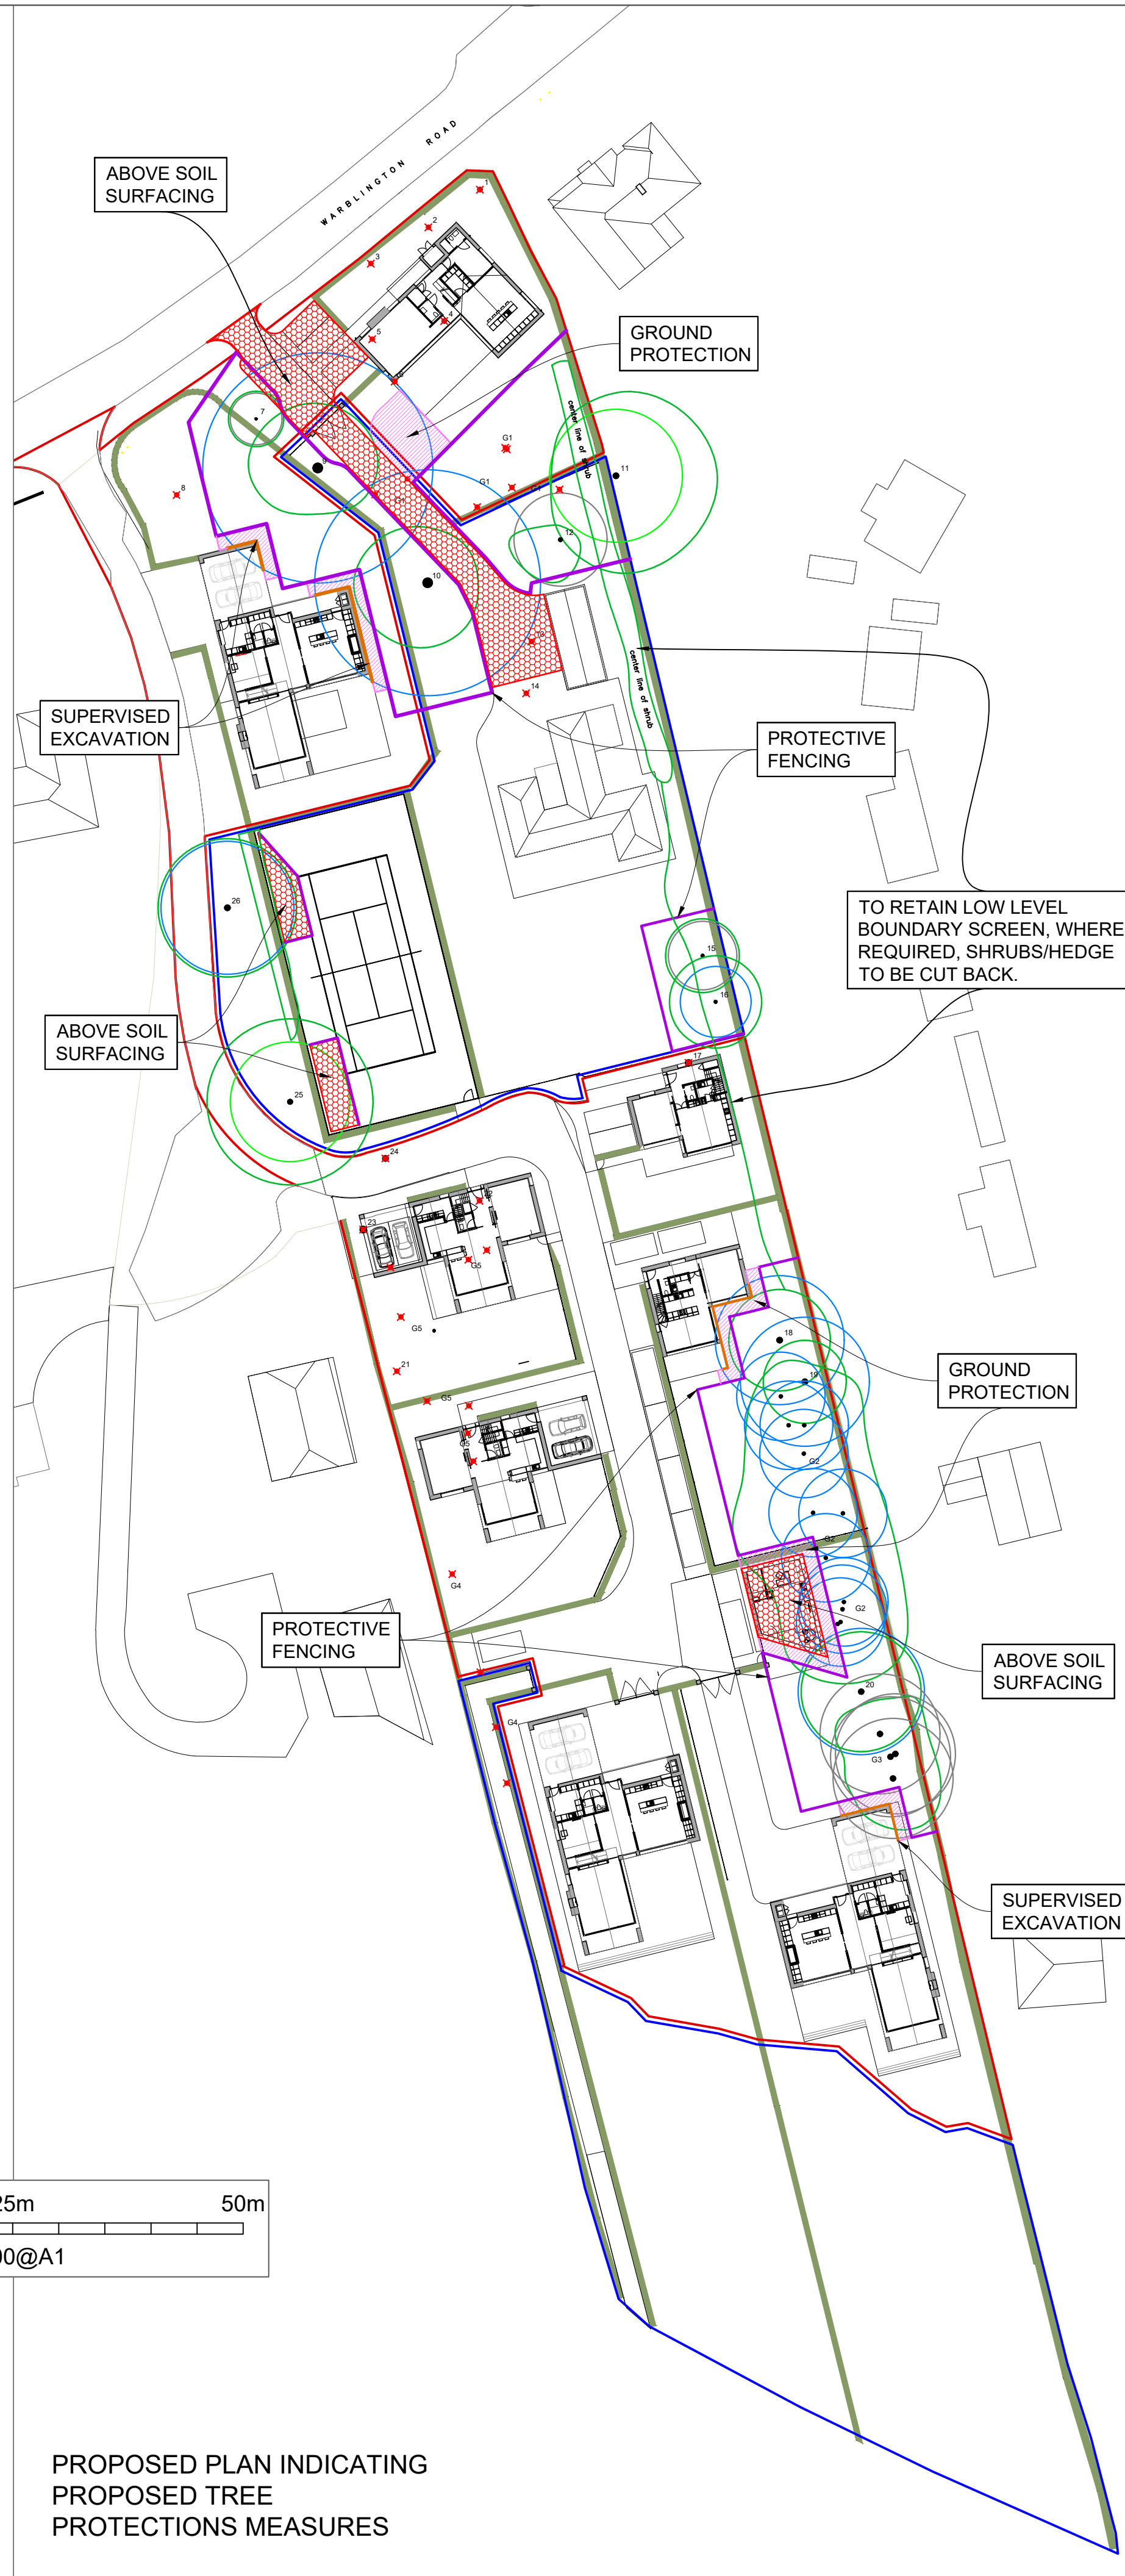
PROPOSED PLAN INDICATING  
PROPOSED TREE  
PROTECTIONS MEASURES

- 4.1 No vehicles of any kind shall enter the site, nor any works commence, until the root protection areas of the retained trees, as shown on the TPP, have been protected by the erection of protective fencing to the specification found in BS 5837, Section 6.2. The location of the fencing is denoted by the continuous, bold purple lines on the TPP.

- 4.2 The fencing shall be at least 2.1m in height and comprise standard 'Heras' welded mesh fence panels mounted on a scaffolding framework. The panels shall be fixed to each other with at least two clamps and secured with anti-lift devices to concrete or rubber bases that are pinned to the ground to a depth of 450mm by short lengths of scaffolding tube.

- 4.3 Scaffold uprights shall be at 3.5m centres and supported on the side closest to the retained trees by struts braced to the ground at an angle of 45 degrees. The Heras panels shall be secured to the two cross members between the uprights with heavy duty cable ties. Notices stating "Tree Protection Zone – Keep Out" will be attached with cable ties to every other panel.

- 5.1 In order to protect the structure of the soil within the RPAs of trees adjacent to areas of construction, temporary ground protection shall be put in place for the duration of the construction period, in the locations shown by pink hatching on the TPP. This ground protection should be capable of supporting any traffic, pedestrian or mechanical, entering or using the site without being distorted or causing compaction of underlying soil.

Proprietary inter-linked ground protection boards will be placed on top of a compression-resistant layer (e.g. 150mm depth of woodchip), laid onto a geotextile membrane.

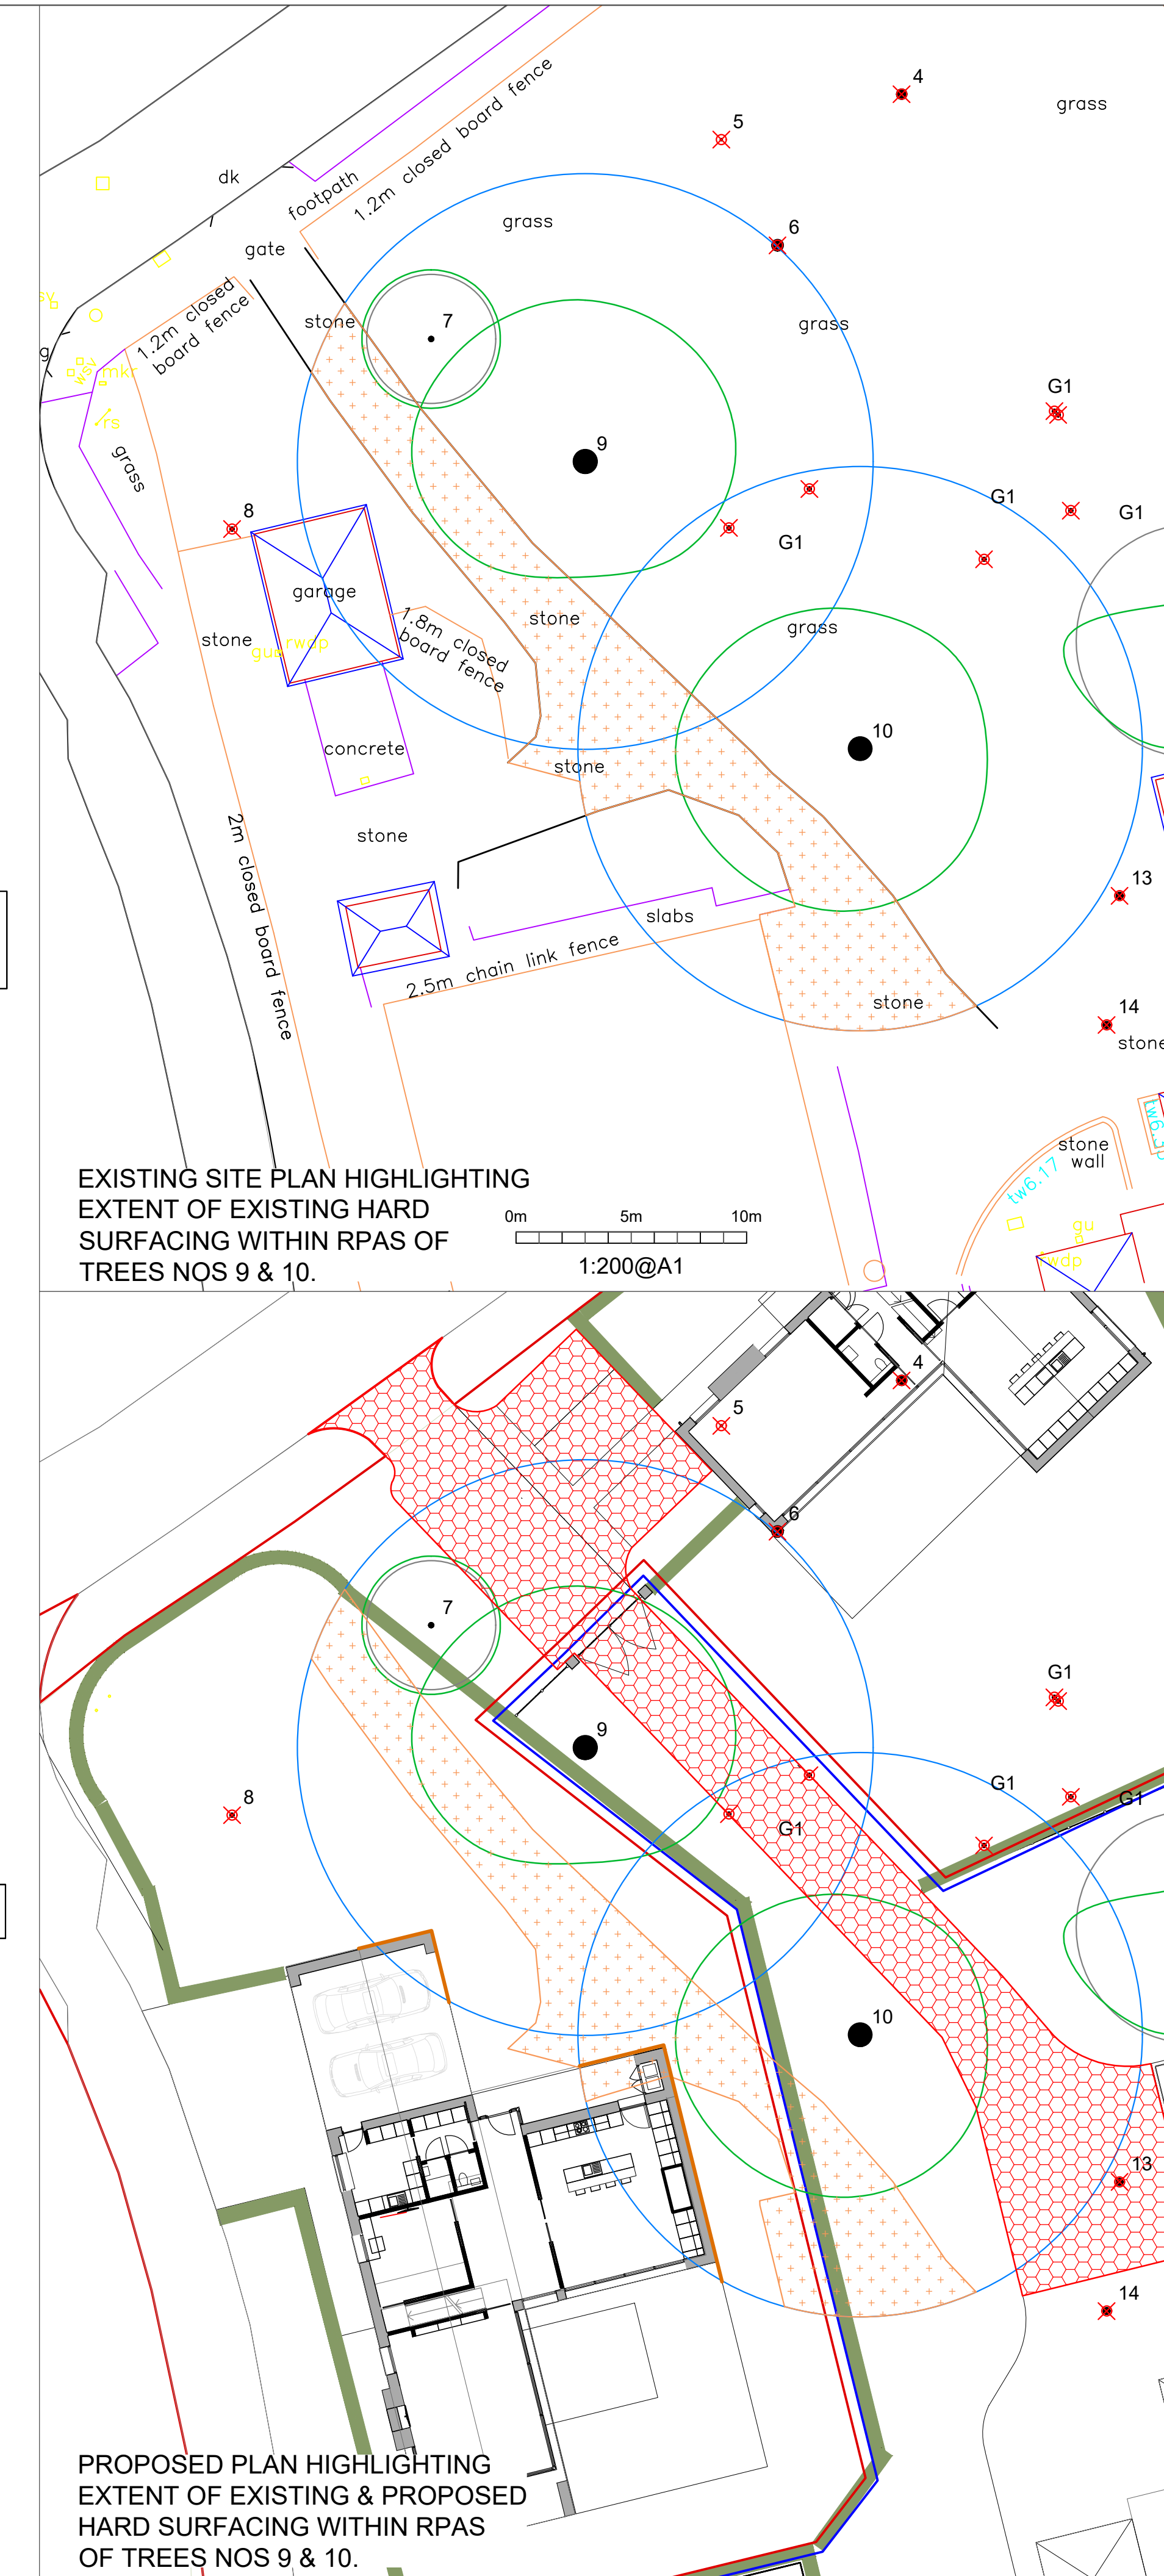
PROPOSED PLAN HIGHLIGHTING  
EXTENT OF EXISTING & PROPOSED  
HARD SURFACING WITHIN RPAS  
OF TREES NOS 9 & 10.

- 6.3 If existing hard surfacing is to be removed within the RPAs of retained trees, particularly in the case of T9 & T10, it shall be undertaken as detailed below, under direct on-site arboricultural supervision.

- 6.4 The wearing course will be broken up using a hand held pneumatic breaker, hand tools and wheelbarrows to break up and remove the surfacing. Where it is necessary to remove the sub-base this is to be undertaken using a fork to loosen the material, which will then be moved using shovels and wheelbarrows.

- 8.1 Prior to the commencement of any construction works (other than the erection of protective fencing), the proposed access drive, tennis court and garden studio (Plot 1) as denoted by red honeycomb hatch on the TPP, shall be constructed to the specification detailed below and in accordance with the recommendations of Section 7.4 in BS 5837.

- 8.2 The new access drive replaces the existing drive which will be removed and re-instated by soft landscaping. Some soil remediation in the form of 'Terralifting' may be required if it is found that the subsoil under the drive is unduly compacted. The new access will be 'above existing soil' thus there will be a net gain in the rooting environment of the two Monterey Pines (T9 & T10).

- 8.5 The ground shall be covered with a perforated cellular confinement system such as 'Geoweb' or 'Cellweb' with a minimum cell depth of 150mm and backfilled with clean, no-fines angular aggregate (20mm-40mm). Edge supports of appropriate size and strength

- 8.6 A permeable geotextile membrane will also be laid on top of the cellular confinement system to prevent fines and other debris filling the air spaces in the aggregate. The wearing course shall be of a permeable and gas porous nature such as porous tarmac or concrete setts with sand jointing.
