Our ref: GE18761/FG02/200304

**RE: WOODCROFT FARM (PHASE 2B), WOODCROFT LANE, LOVEDEAN – LEACHATE TESTING**

# Trial Pit Log

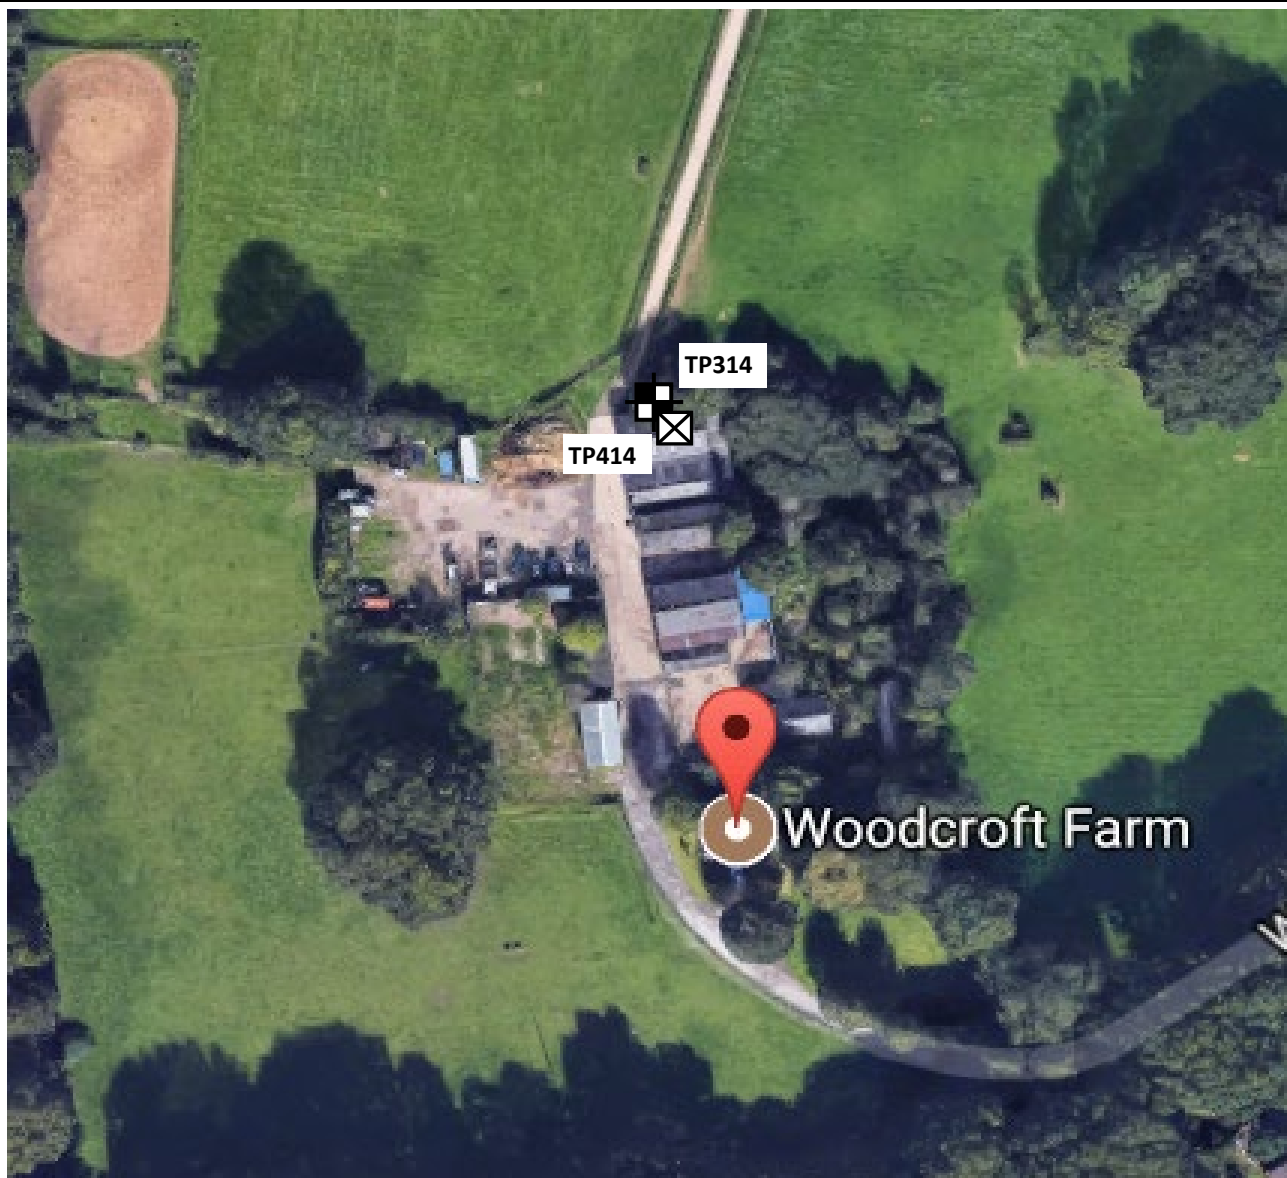
In total, the intrusive investigation comprised the excavation of 1No. trial pit to a depth of 2.00m bgl. Figure 2 presents the exploratory hole location.

Figure 2 presents the investigation locations along with the location of the previously undertaken TP314. For more detailed descriptions of the ground conditions, reference should be made to the exploratory hole logs enclosed in Appendix A.

| <b>Project:</b> | Woodcroft Farm, Lovedean, PO8 9QA | | | <b>Title</b> | Exploratory Hole Location Plan | |
