## Arboricultural Method Statement

46 Warblington Road

Client: Mr Charles Glanville

Date: April 2020

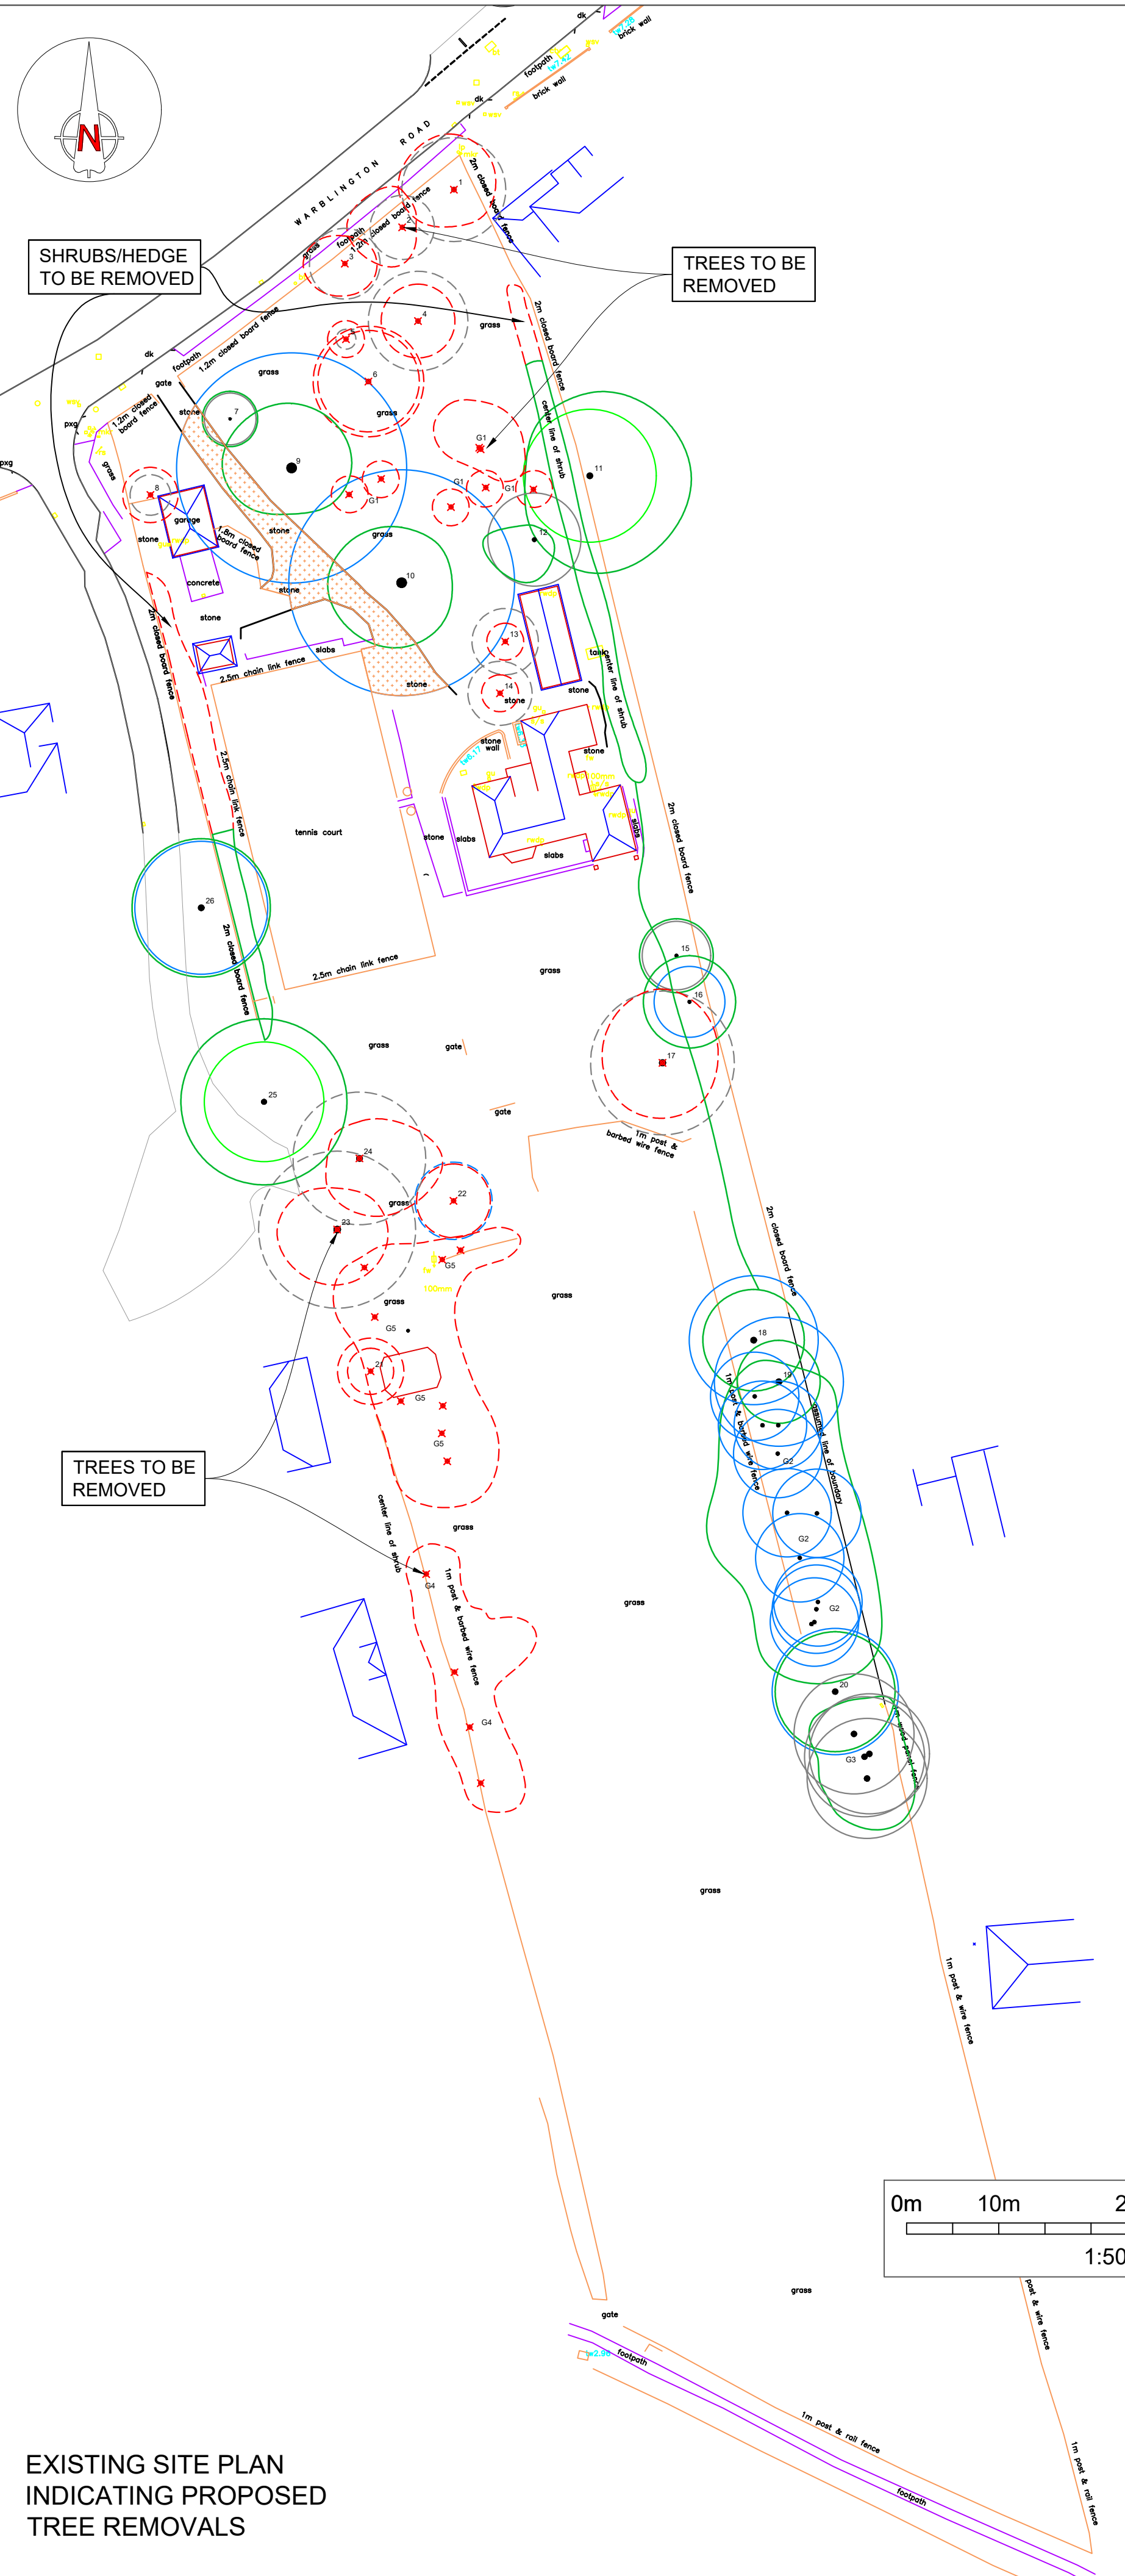
EXISTING SITE PLAN  
INDICATING PROPOSED  
TREE REMOVALS

- 3.1 The trees listed in Table 1 below shall be felled to ground level; stumps shall be ground out to 450mm below ground level.

**Table 1 – Tree Removals and Pruning.**

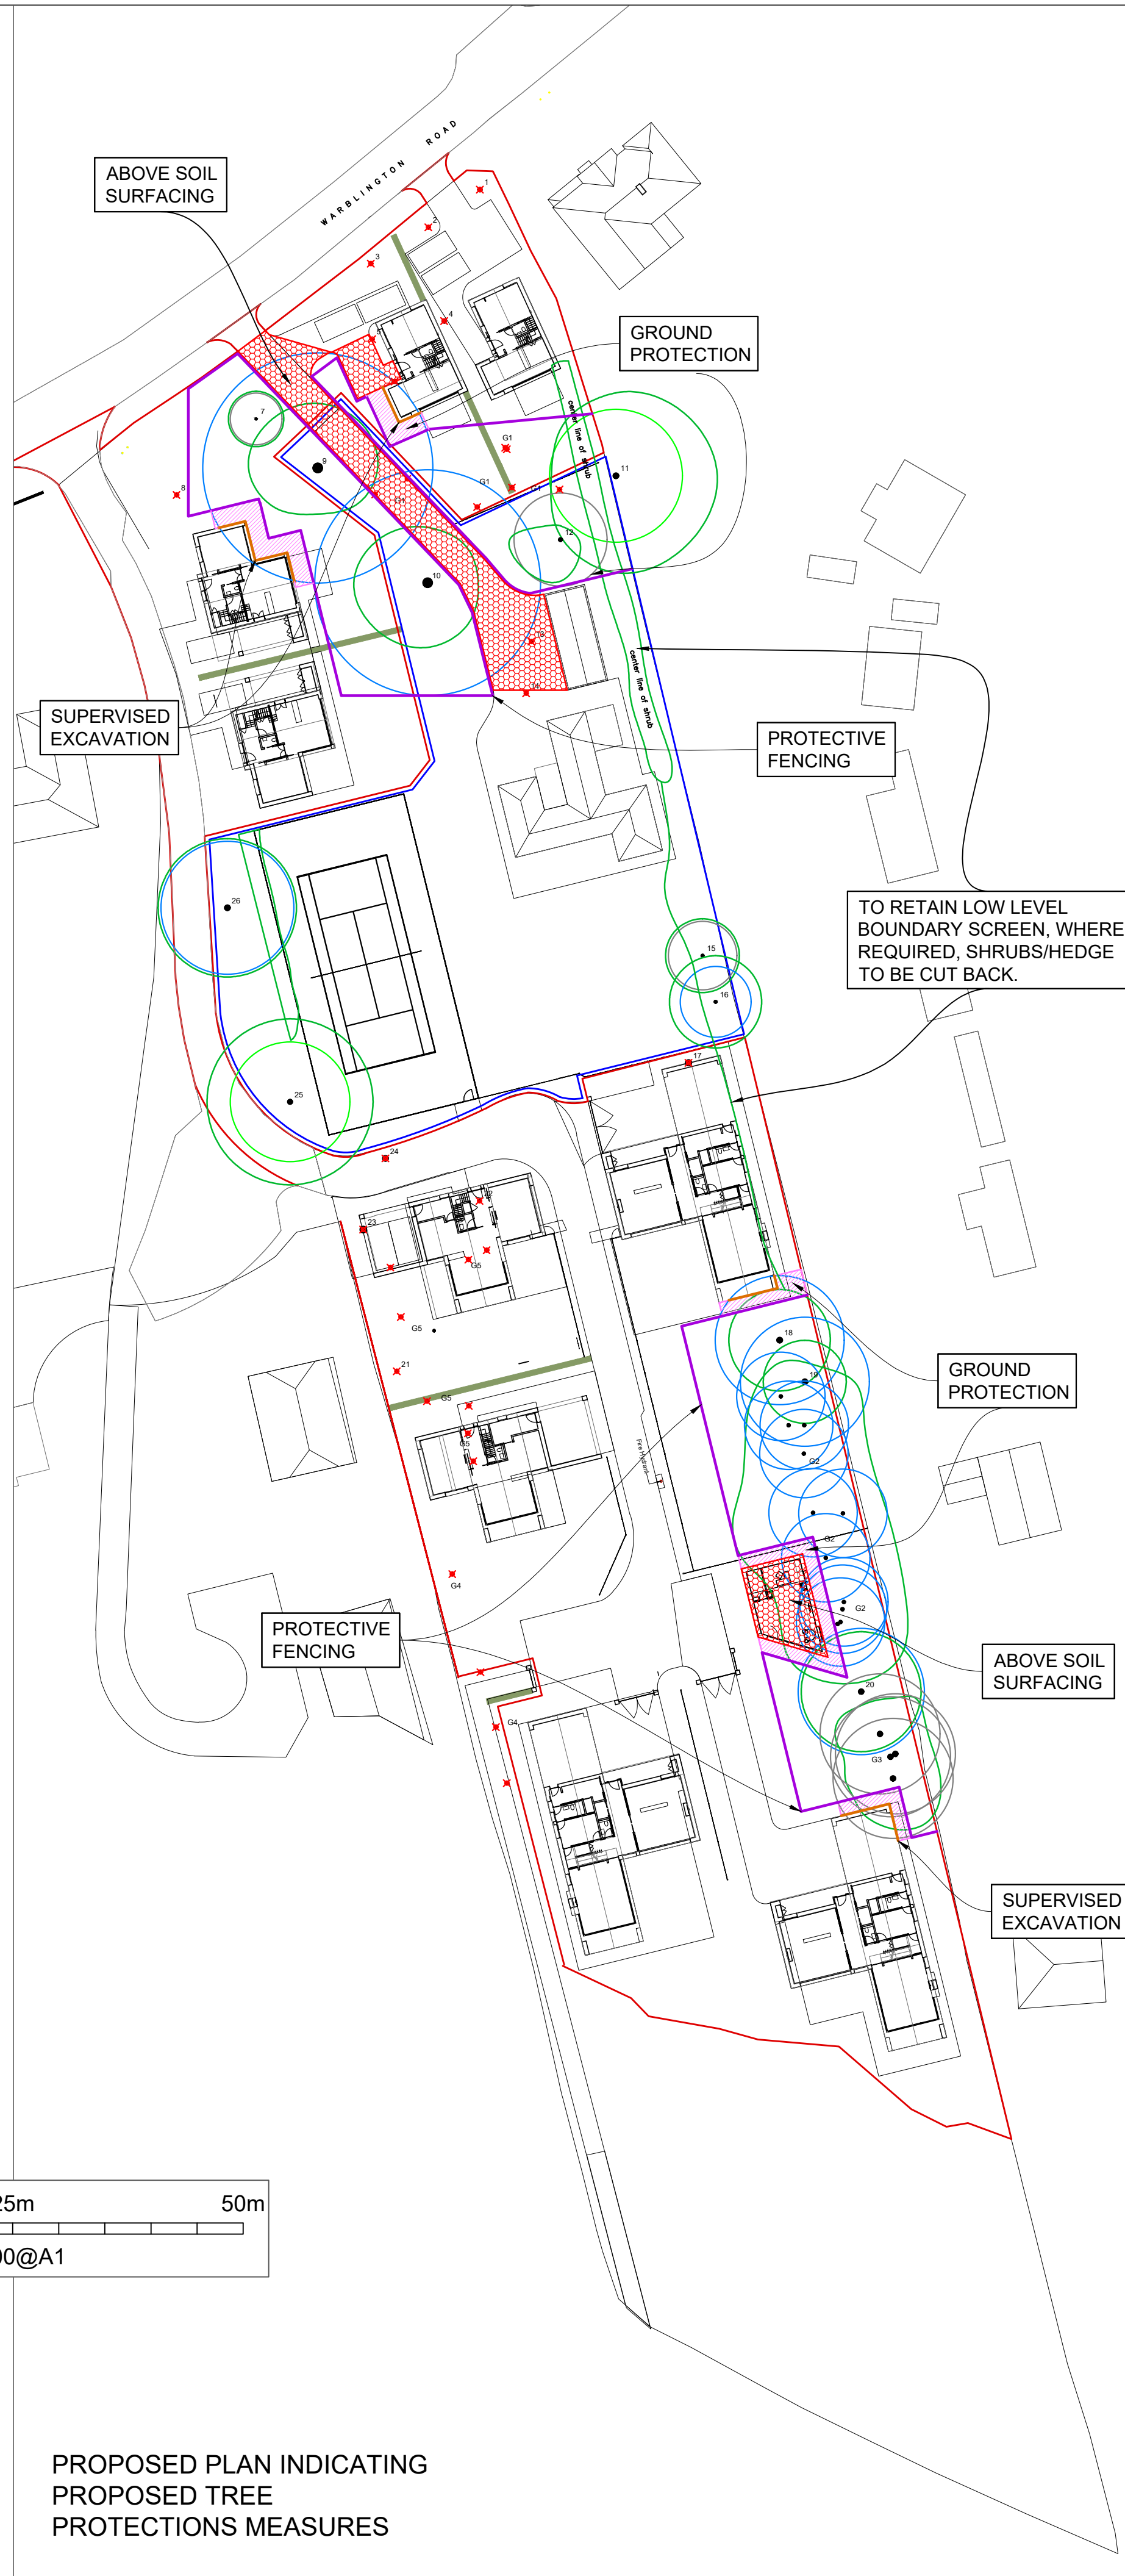
PROPOSED PLAN INDICATING  
PROPOSED TREE  
PROTECTIONS MEASURES

4.1 No vehicles of any kind shall enter the site, nor any works commence, until the root protection areas of the retained trees, as shown on the Tree Protection Plan (TPP), have been protected by the erection of protective fencing to the specification found in BS 5837, Section 6.2. The location of the fencing is denoted by the continuous, bold purple lines on the TPP.

- 5.1 In order to protect the structure of the soil within the RPAs of trees adjacent to areas of construction, temporary ground protection shall be put in place for the duration of the construction period, in the locations shown by pink hatching on the TPP. This ground

- 7.1 Small sections of the foundations for the proposed plots are within the RPAs of trees nos. 9, 18 & Group G3.
- 7.2 The first 750mm depth of these sections of the foundations, as denoted by continuous, bold, orange lines on the TPP, shall be excavated using hand tools and/or an airspade only, under direct arboricultural supervision.

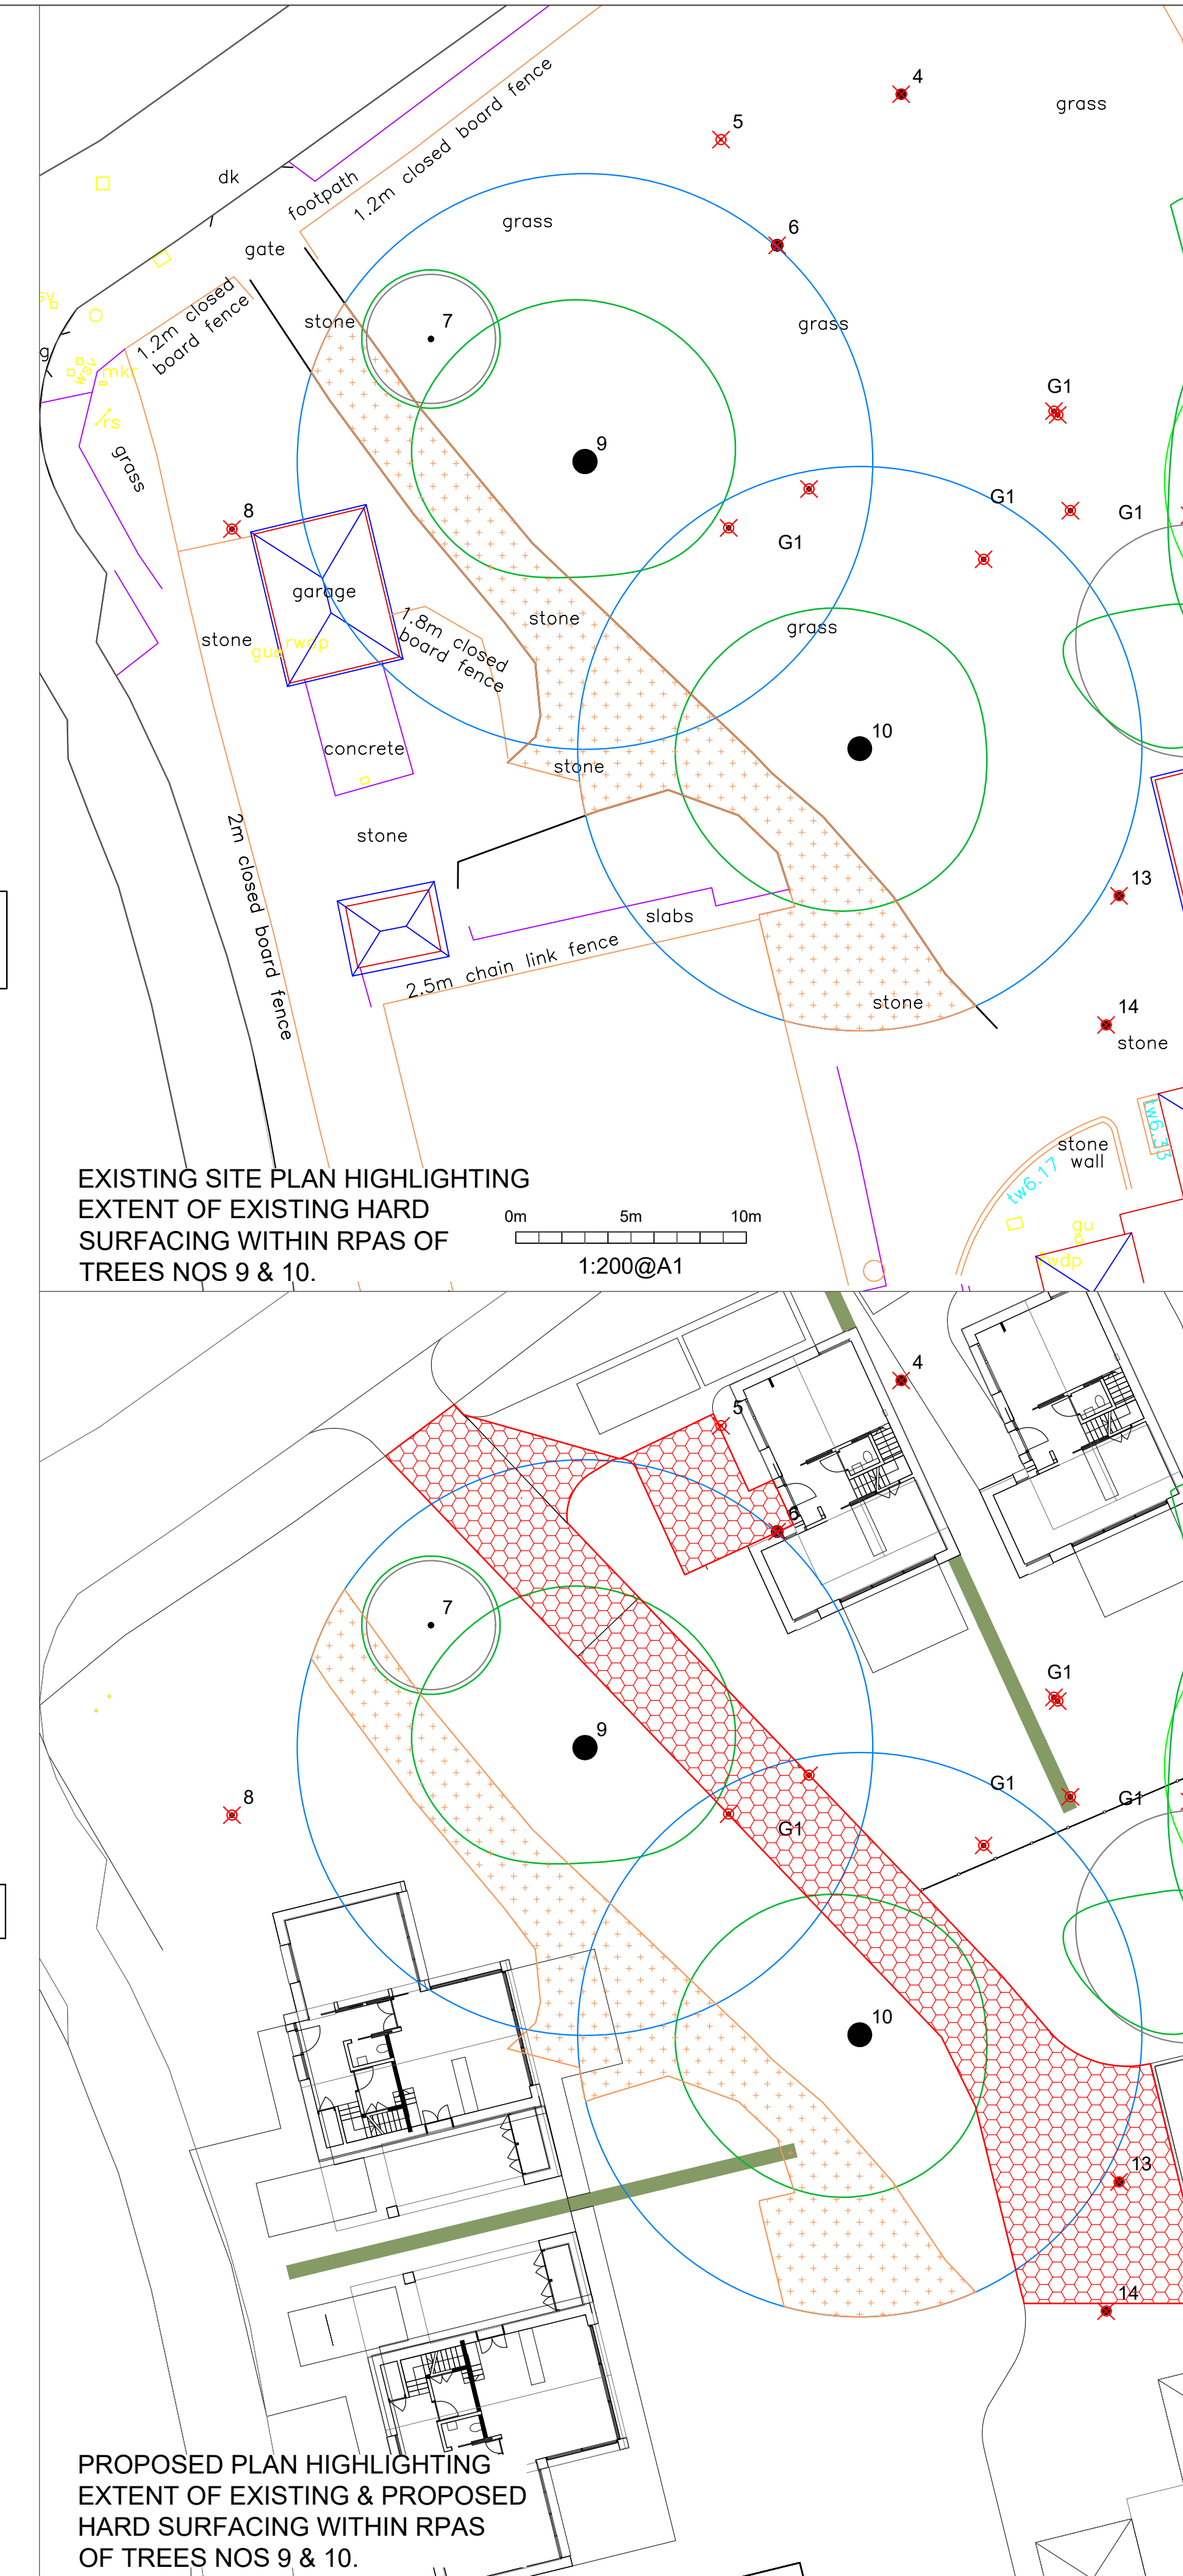
PROPOSED PLAN HIGHLIGHTING  
EXTENT OF EXISTING & PROPOSED  
HARD SURFACING WITHIN RPAS  
OF TREES NOS 9 & 10.

- 6.3 If existing hard surfacing is to be removed within the RPAs of retained trees, particularly in the case of T9 & T10, it shall be undertaken as detailed below, under direct on-site arboricultural supervision.

- 8.1 Prior to the commencement of any construction works (other than the erection of protective fencing), the proposed access drive and garden studio for Plot 1 as denoted by red honeycomb hatch on the TPP, shall be constructed to the specification detailed below and in accordance with the recommendations of Section 7.4 in BS 5837.

- 8.2 The new access drive replaces the existing drive which will be removed and re-instated by soft landscaping. Some soil remediation in the form of 'Terralifting' may be required if it is found that the subsoil under the drive is unduly compacted. The new access will be 'above existing soil' thus there will be a net gain in the rooting environment of the two Monterey Pines (T9 & T10).
