Title: FRONT (WEST) ELEVATION : EXISTING AND PROPOSED  
Project: 7 BRIDGEFOOT PATH EMSWORTH PO10 7EA  
Client: JUDITH CONDON  
Scale 1:50 @ A3  
Date: 14/03/20  
Drawn: ACB Sheet size: A3

Drg. No. 901/EL1  
Rev: A

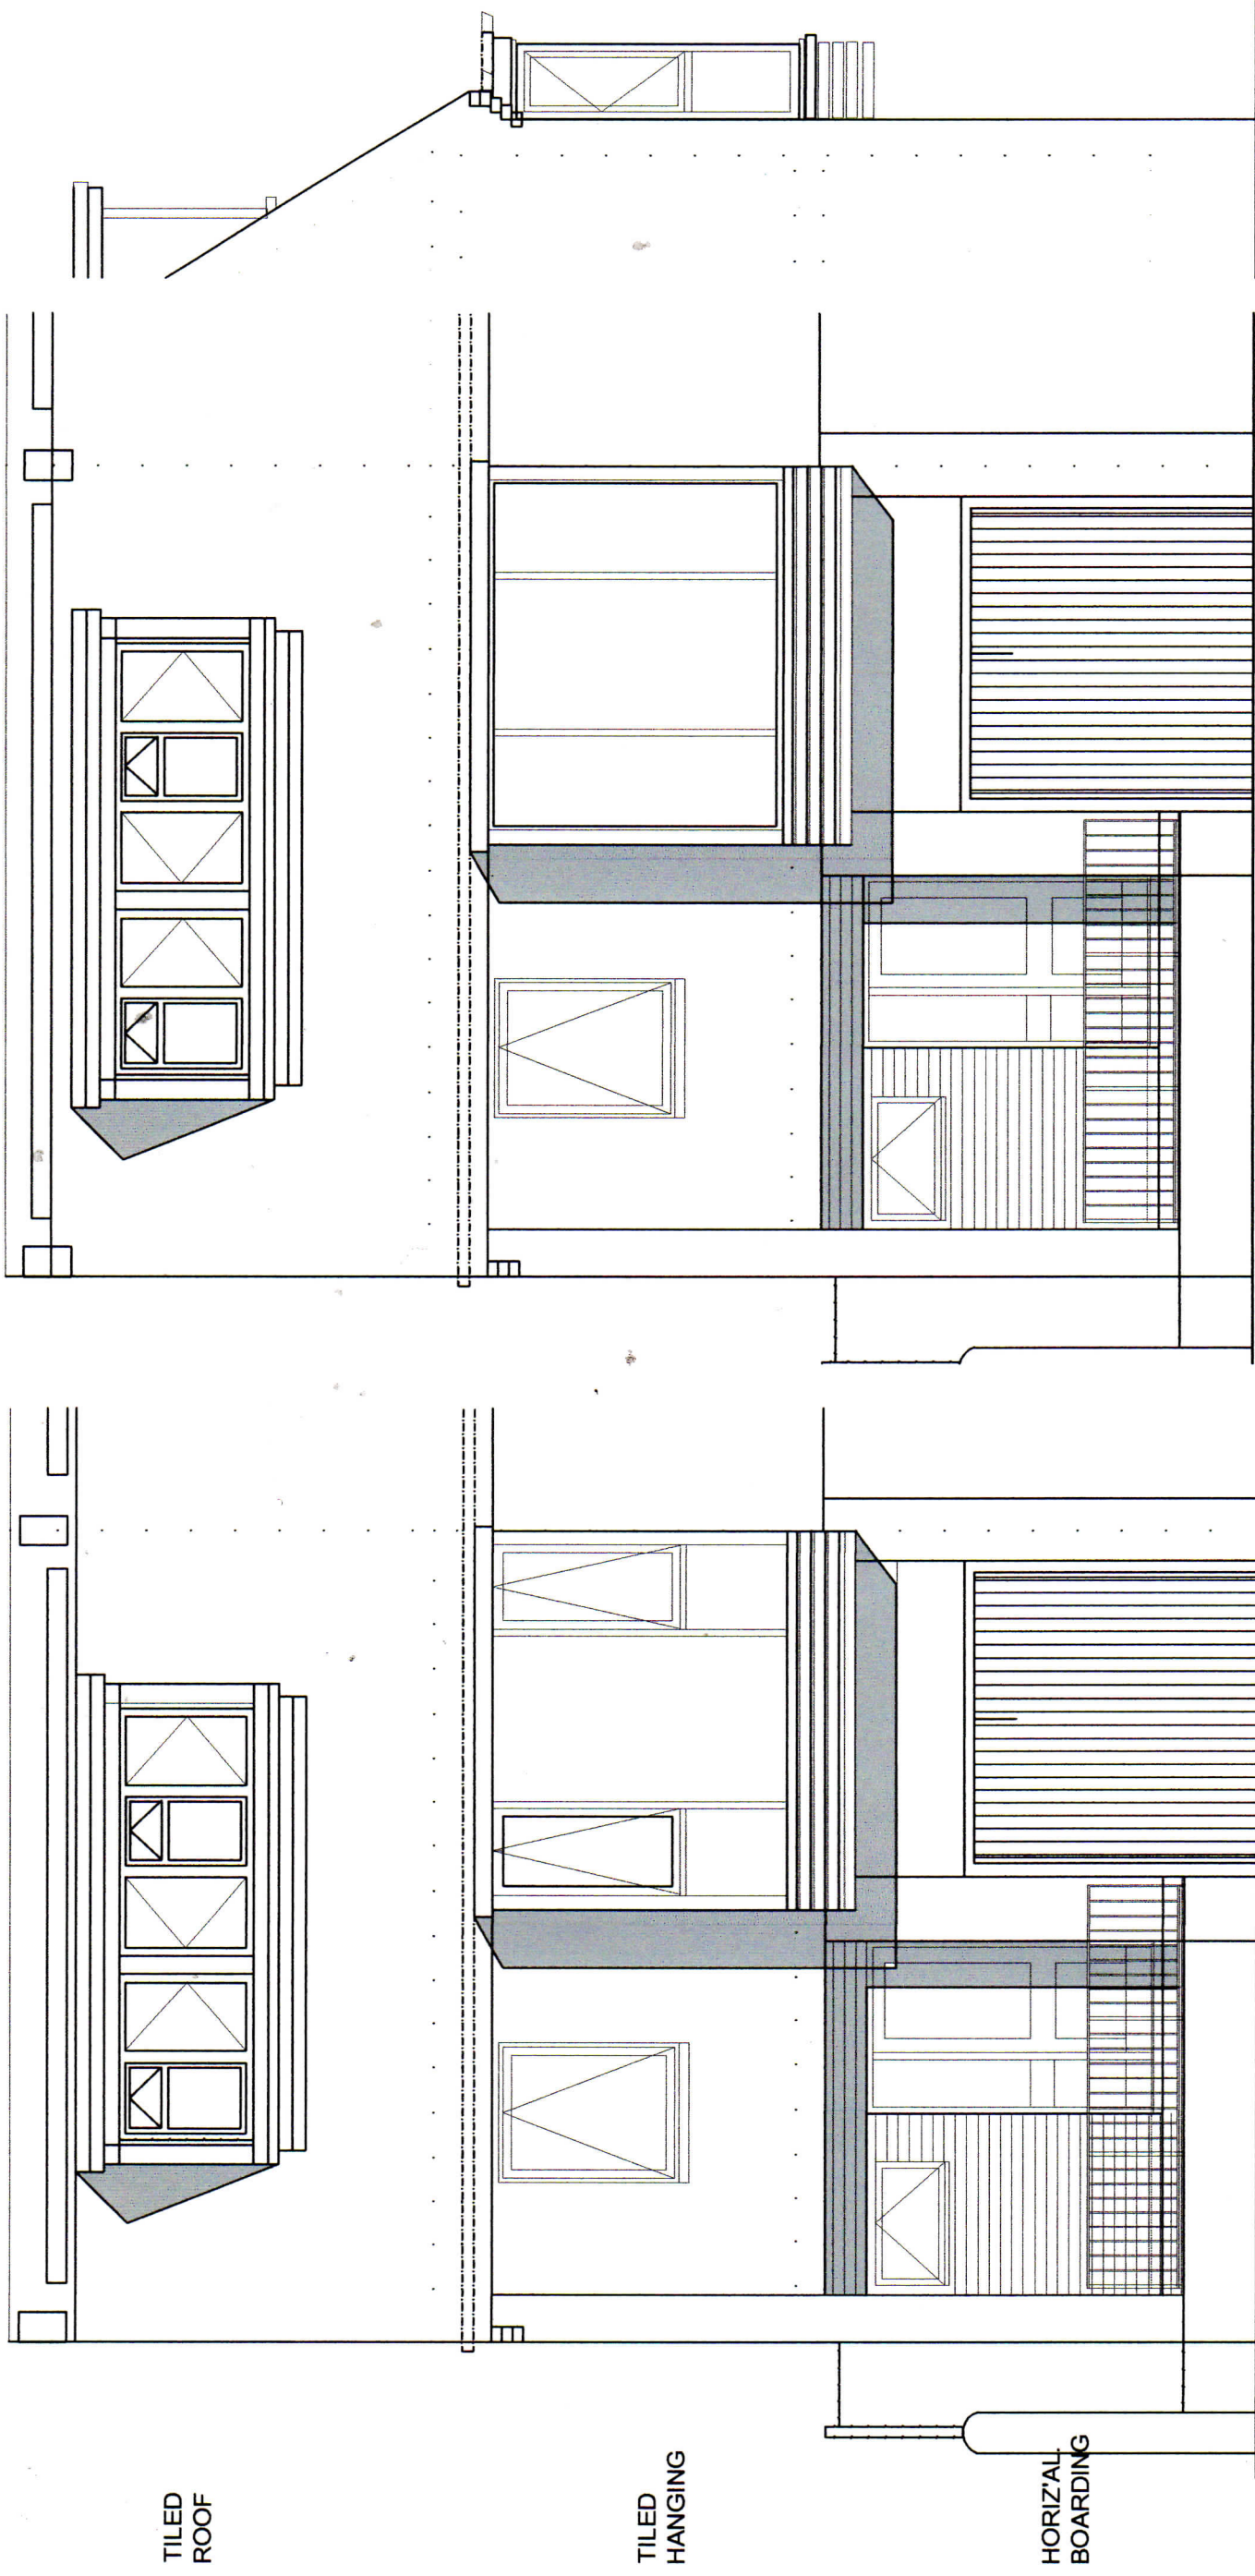
EXISTING FRONT (WEST) ELEVATION

NOTES ON WINDOWS:  
SECOND FL.: uPVC D/GLAZED WINDOW IN WOOD FRAMED PAINTED DORMER  
FIRST FL.: SMALL WINDOW - D/GLAZED WOOD : LARGE - D/G WOOD FRAME.  
GROUND FL.: WOOD / GLASS ENTRANCE SCREEN AND WC WINDOW  
GARAGE DOOR - PAINTED STEEL- UP AND OVER

PROPOSED FRONT (WEST) ELEVATION

NOTES ON WINDOWS:  
SECOND FL.: WHITE PAINTED IN WOOD FRAMED PAINTED DORMER - REPAIRED .  
FIRST FL.: SMALL WINDOW - WOOD D/G : LARGE - D/G SILICONE JOINTED WOOD COVER  
PIECES - SIDE PANELS WITH SIDE HUNG CASEMENT IN WOOD FRAME .  
GROUND FL.: WOOD / GLASS ENTRANCE SCREEN AND WC WINDOW  
GARAGE DOOR - PAINTED WOOD- UP AND OVER .
