## **Arboricultural assessment & method statement**

Land East of Castle Avenue, Havant, Hampshire

10<sup>th</sup> September 2018 18295-AA-AN

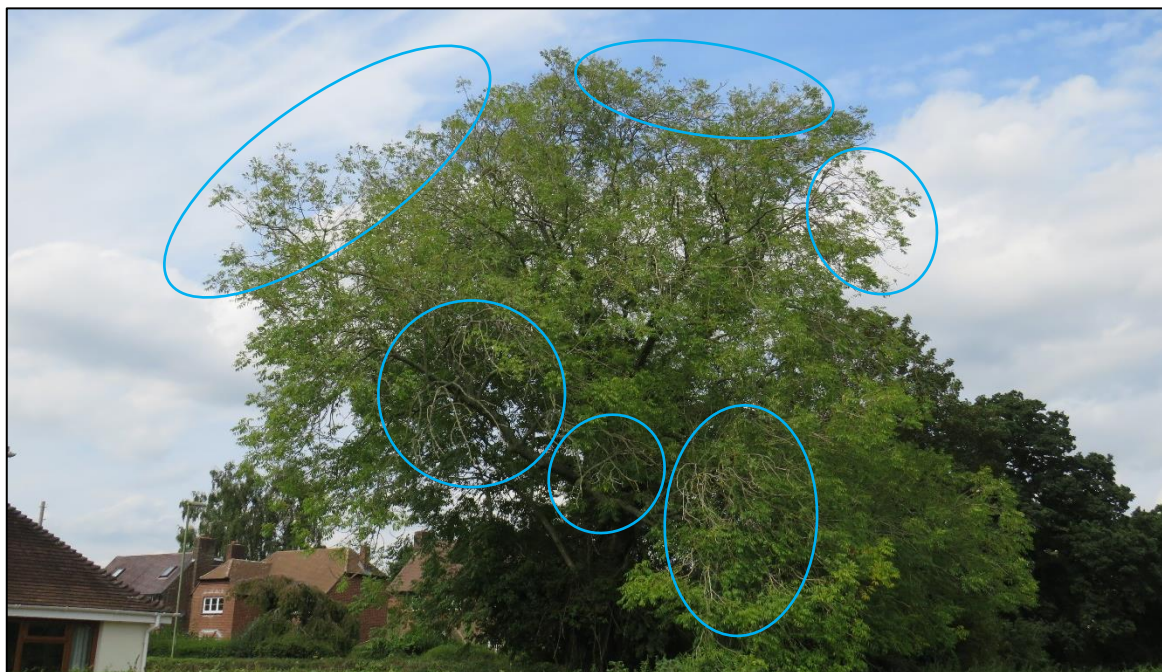
**T1:** This C category tree is visible from St George's Avenue where it forms a modest landscape feature. (photo 1). It is located at the end of the avenue within a quiet cul-de-sac serving five private houses. The tree offers some public visual amenity along the avenue, but it is not prominent beyond the immediate landscape.

**Photo 1:** Showing T1 with areas of dieback and sparse leaf coverage at crown extremities.

In my opinion the loss of T1 is inevitable regardless of development, and this loss will affect the local landscape in the short term only. The proposed development will offer the opportunity to secure the replacement of this tree elsewhere within the new landscape, through enforceable planning conditions.

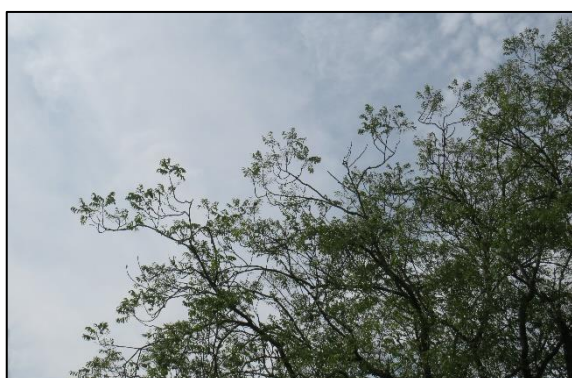
The tree is showing signs of dieback in the crown which is very likely to be early symptoms of the highly pathogenic ash dieback disease (*Hymenoscyphus fraxineus*) (photo 2 and 3). This disease is now epidemic within the south east of England and there is no known treatment. It causes the death of infected trees over a short period. As such, the anticipated life expectancy of this tree is no more than 3–5 years. I also note that it is located at the edge of the public highway within the footpath where any replacement may be impractical.

**Photo 2:** Showing T1 crown dieback and leaf coverage.

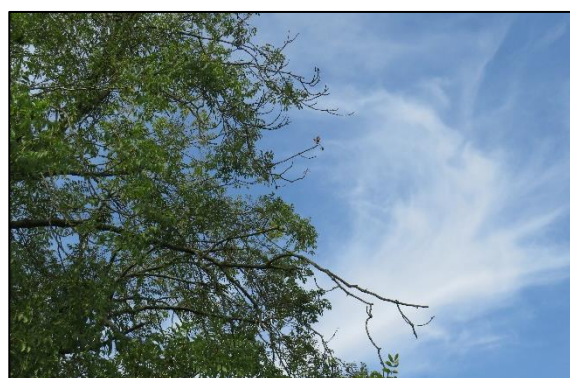
**Photo 3:** Showing T1 crown dieback.

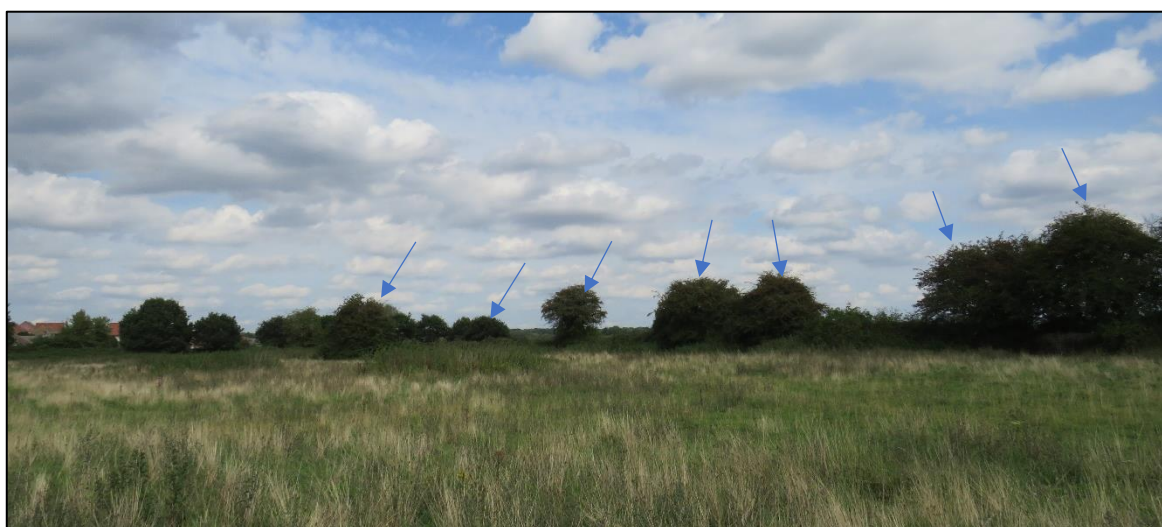
**T13, T14, G15 (part), T22, and T23:** These C category trees are growing within an unmanaged field boundary hedgerow and are noticeable only by virtue of a lack of larger landscape features within the adjacent fields (photo 4). They are not prominent as skyline features from outside the site and their loss will not have a long-term impact on local character. Management of the hedgerow by the owner would reasonably seek to significantly reduce the height and spread of these trees regardless of the proposal, and as such I do not consider them a sustainable long-term landscape feature.

**Photo 4:** Showing the unmanaged field boundary hedgerow trees within G15 situated in the wider landscape.
