## DESK TOP STUDY REPORT

DUNSBURY WAY, HAVANT, HANTS

PART 6 OF 6

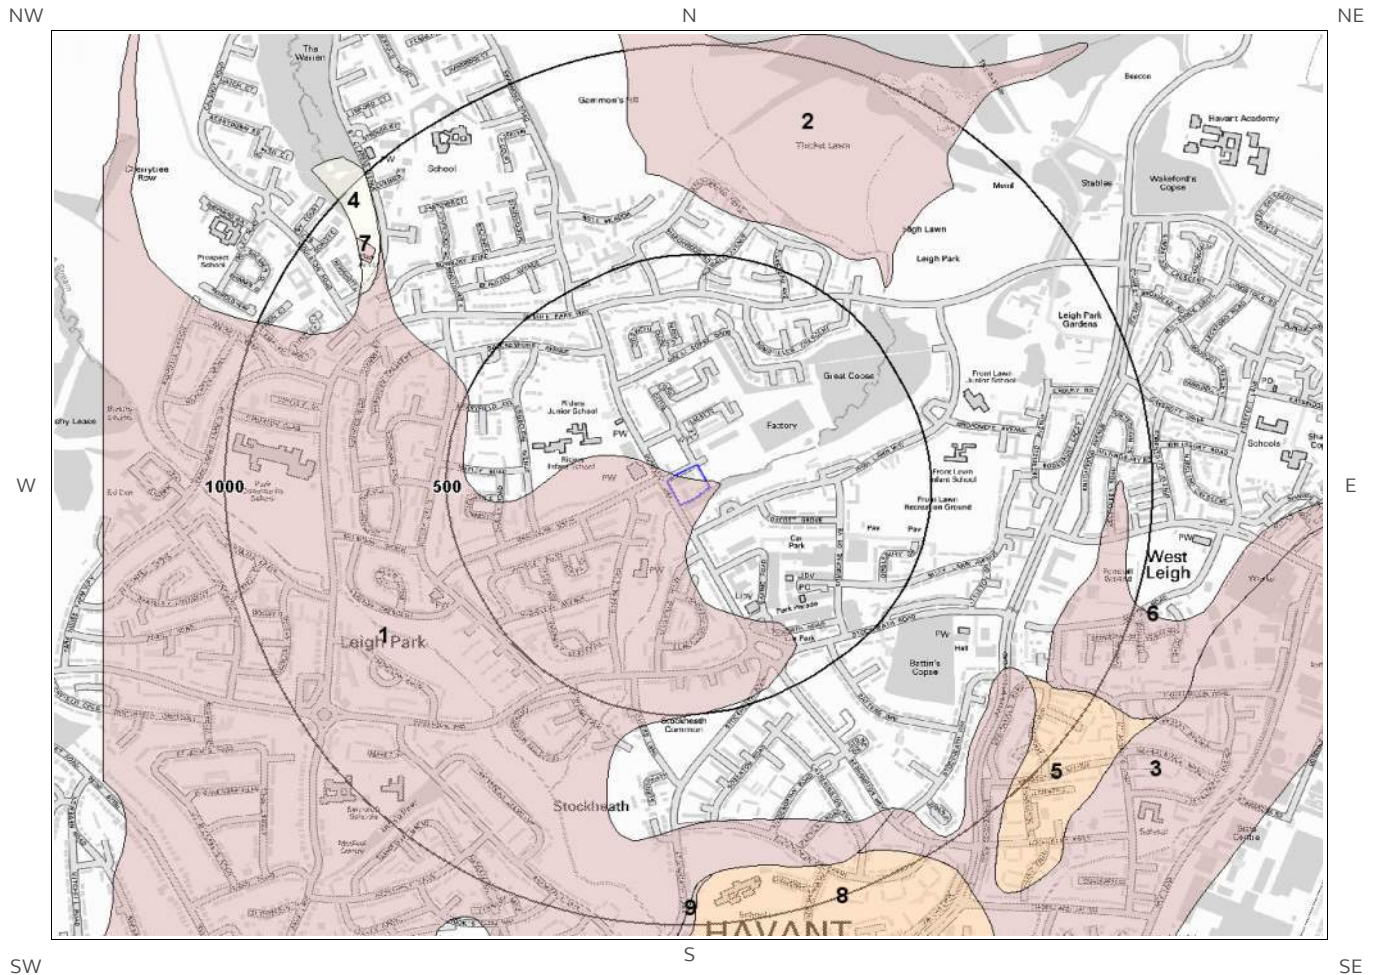
# 1.2 Superficial Deposits and Landslips Map (1:10,000 scale)

Are there any records of Superficial Deposits/ Drift Geology within 500m of the study site boundary at 1:10,000 scale? Yes

| ID | Distance (m) | Direction | LEX Code | Description | Rock Description |
|---|---|---|---|---|---|
| 1 | 0.0 | On Site | HEAD-XCZSV | Head - Clay, Silt, Sand And Gravel | Clay, Silt, Sand And Gravel |

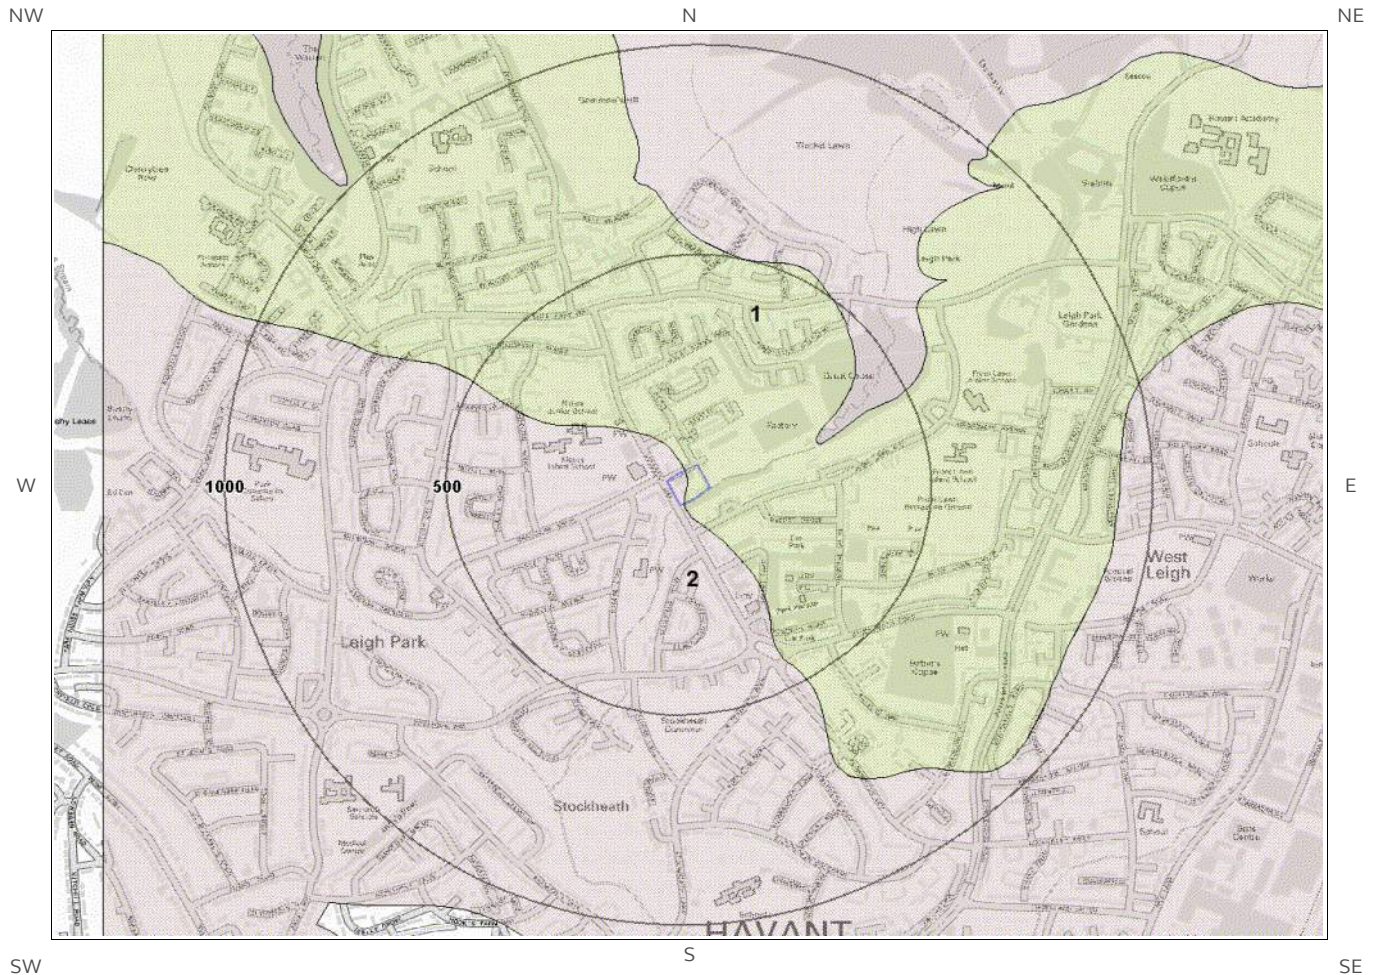
# 1.3 Bedrock and Faults Map (1:10,000 scale)

Records of Bedrock/Solid Geology within 500m of the study site boundary at 1:10,000 scale.

| ID | Distance (m) | Direction | LEX Code | Description | Rock Age |
|---|---|---|---|---|---|
| 1 | 0.0 | On Site | BOSA-SANDU | Bognor Sand Member - Sand | Eocene Epoch |
| 2 | 0.0 | On Site | LC-CLSISA | London Clay Formation - Clay, Silt And Sand | Eocene Epoch |

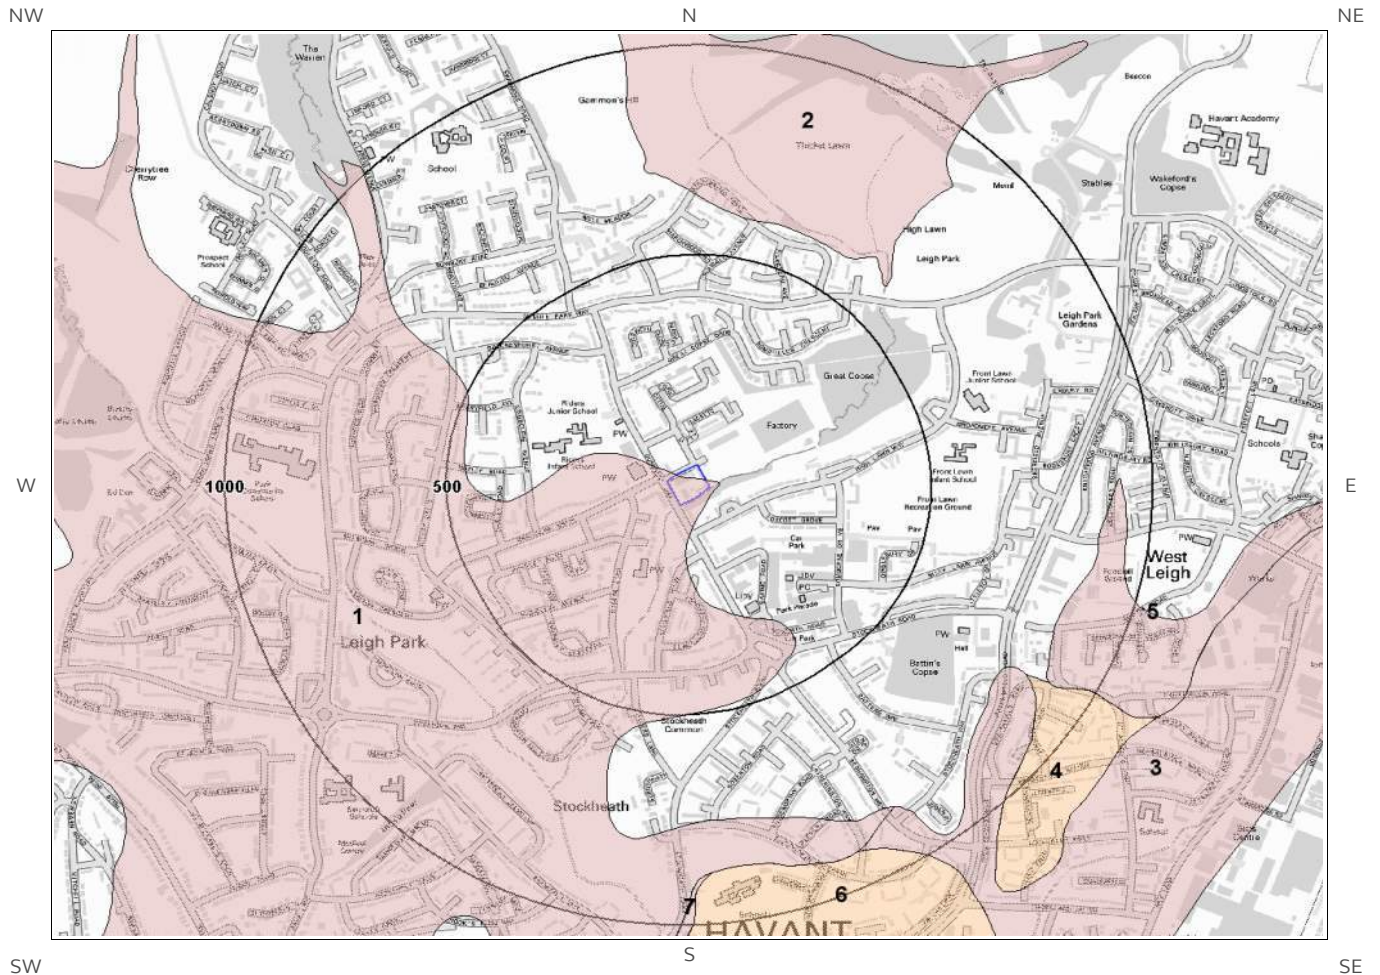
## 2.2 Superficial Deposits and Landslips Map (1:50,000 scale)

Are there any records of Superficial Deposits/ Drift Geology within 500m of the study site boundary? Yes

| ID | Distance | Direction | LEX Code | Description | Rock Description |
|---|---|---|---|---|---|
| 1 | 0.0 | On Site | HEAD-XCZSV | HEAD | CLAY, SILT, SAND AND GRAVEL |

Are there any records relating to permeability of superficial ground within the study site boundary? Yes

| Distance (m) | Direction | Flow Type | Maximum Permeability | Minimum Permeability |
|---|---|---|---|---|
| 0.0 | On Site | Mixed | High | Very Low |

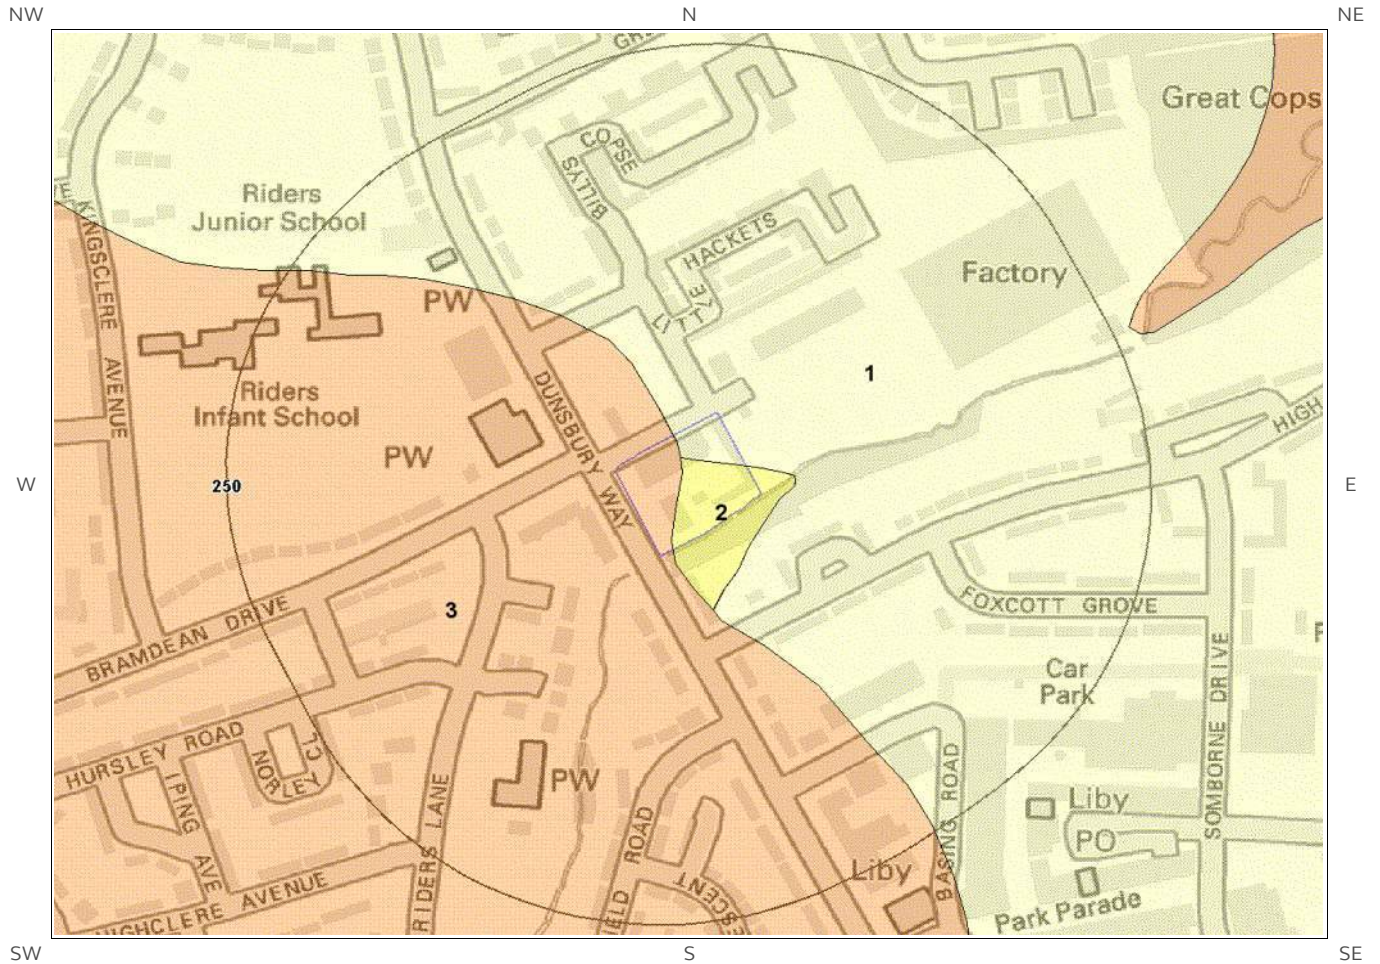
## 6.1 Shrink-Swell Clay Map

| ID | Distance (m) | Direction | Hazard Rating | Details |
|---|---|---|---|---|
| 1 | 0.0 | On Site | Negligible | Ground conditions predominantly non-plastic. No special actions required to avoid problems due to shrink-swell clays. No special ground investigation required, and increased construction costs or increased financial risks are unlikely likely due to potential problems with shrink-swell clays. |
| 2 | 0.0 | On Site | Very Low | Ground conditions predominantly low plasticity. No special actions required to avoid problems due to shrink-swell clays. No special ground investigation required, and increased construction costs or increased financial risks are unlikely due to potential problems with shrink-swell clays. |
| 3 | 0.0 | On Site | Low | Ground conditions predominantly medium plasticity. Do not plant trees with high soil moisture demands near to buildings. For new build, consideration should be given to advice published by the National House Building Council (NHBC) and the Building Research Establishment (BRE). There is a possible increase in construction cost to reduce potential shrink-swell problems. For existing property, there is a possible increase in insurance risk, especially during droughts or where vegetation with high moisture demands is present. |

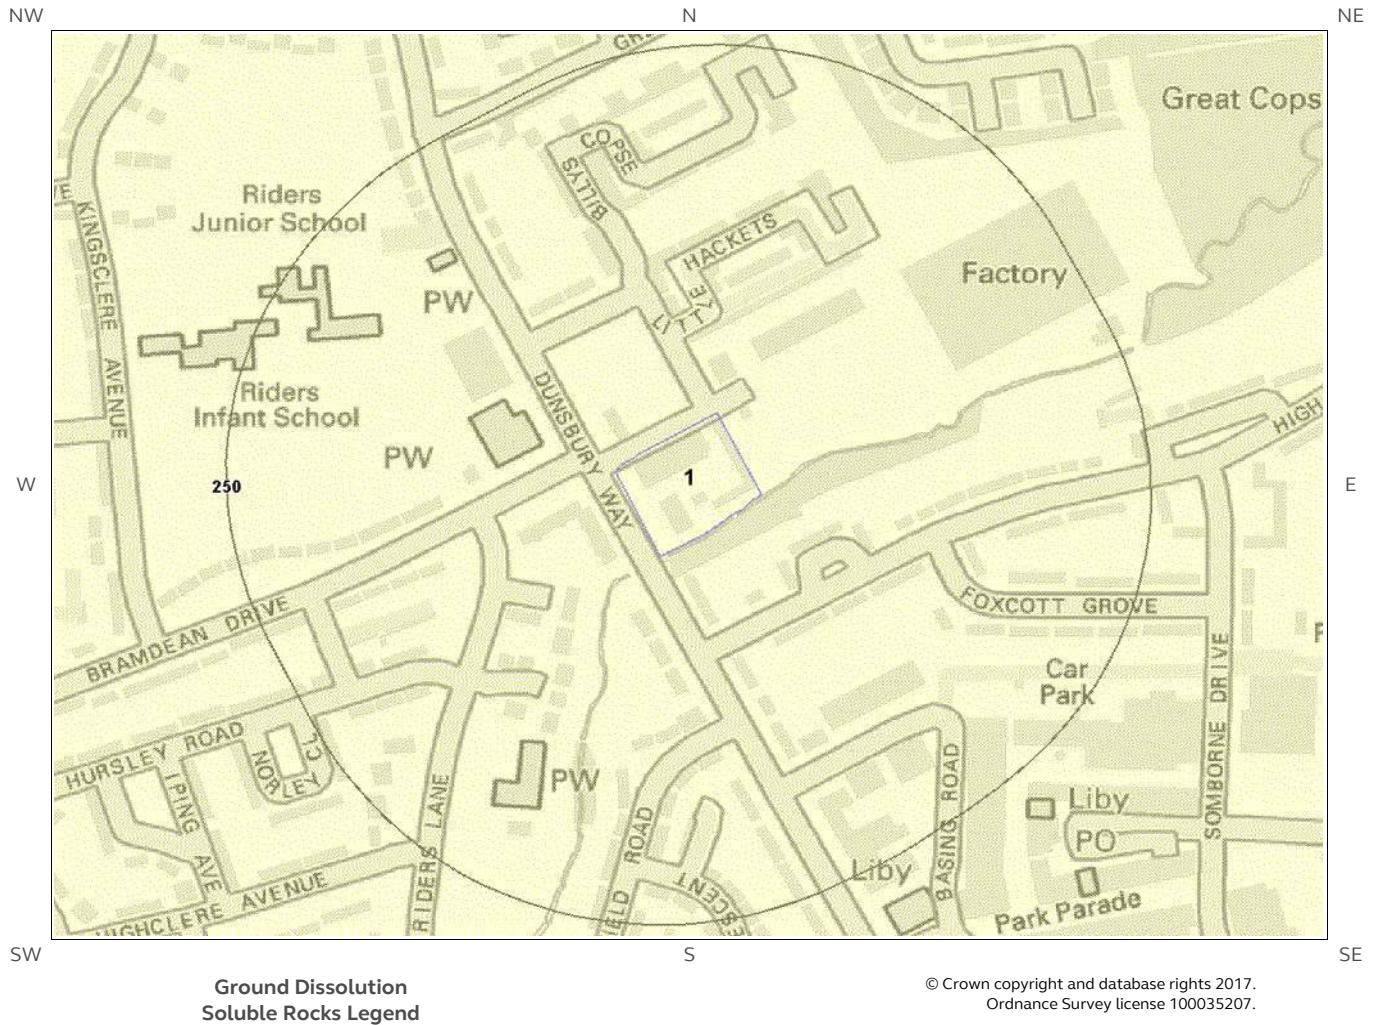
## 6.3 Ground Dissolution of Soluble Rocks Map

| ID | Distance (m) | Direction | Hazard Rating | Details |
|---|---|---|---|---|
| 1 | 0.0 | On Site | Negligible | Soluble rocks are present, but unlikely to cause problems except under exceptional conditions. No special actions required to avoid problems due to soluble rocks. No special ground investigation required, and increased construction costs or increased financial risks are unlikely due to potential problems with soluble rocks. |

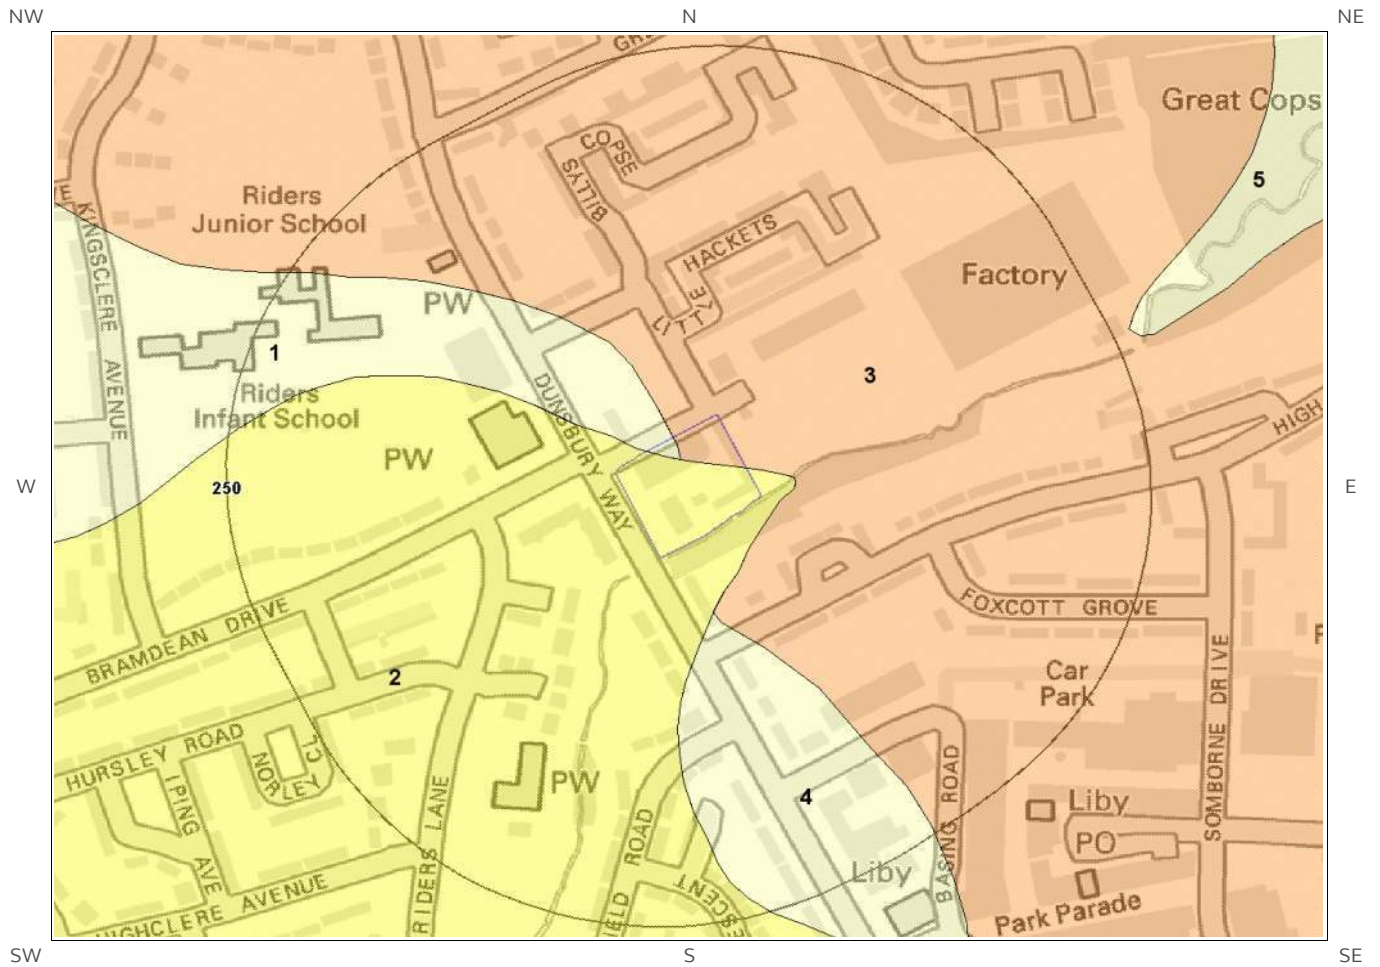
## 6.6 Running Sand Map

| ID | Distance (m) | Direction | Hazard Rating | Details |
|---|---|---|---|---|
| 3 | 0.0 | On Site | Low | Possibility of running sand problems after major changes in ground conditions. Normal maintenance to avoid leakage of water-bearing services or water bodies (ponds, swimming pools) should reduce likelihood of problems due to running sand. For new build - consider possibility of running sand into trenches or excavations if water table is high or sandy strata are exposed to water. Avoid concentrated water inputs to site. Unlikely to be an increase in construction costs due to potential for running sand. For existing property - no significant increase in insurance risk due to running sand problems is likely. |
| 4 | 48.0 | SE | Negligible | No indicators for running sand identified. No special actions required to avoid problems due to running sand. No special ground investigation required, and increased construction costs or increased financial risks are unlikely due to potential problems with running sand. |

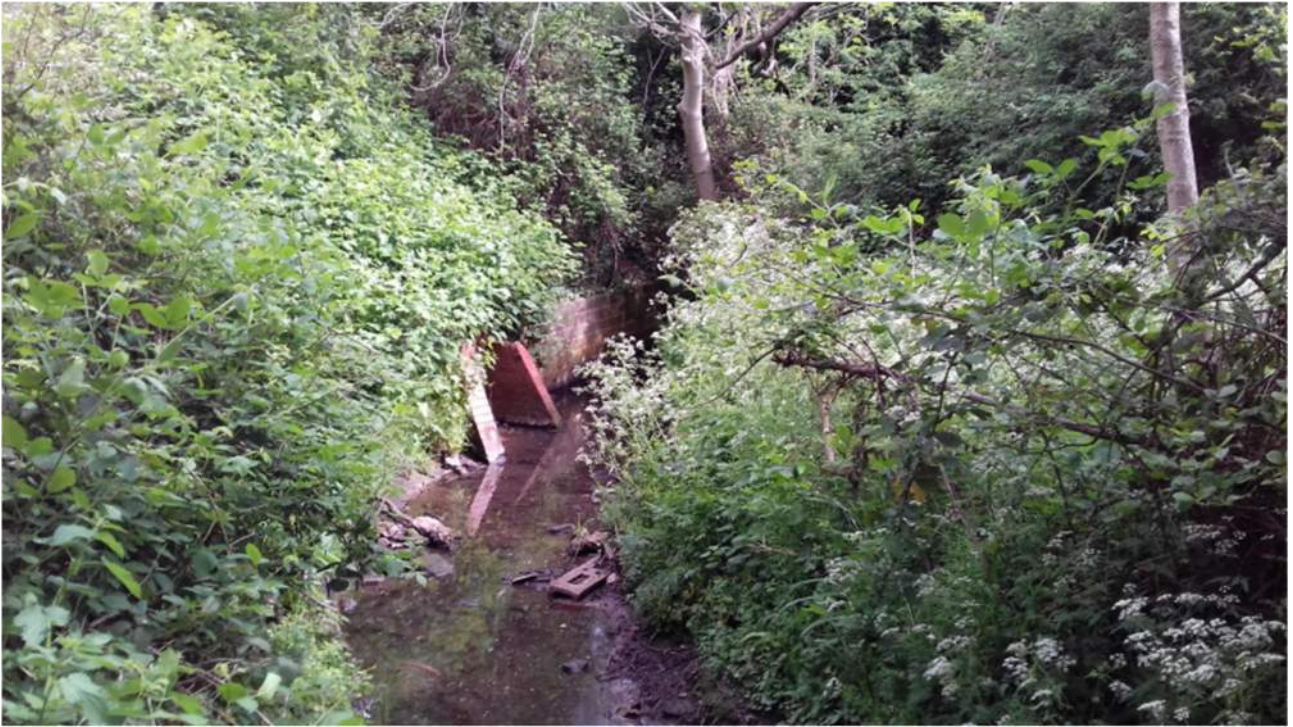
Plate 5. View of the stream adjacent south of the site (2017).

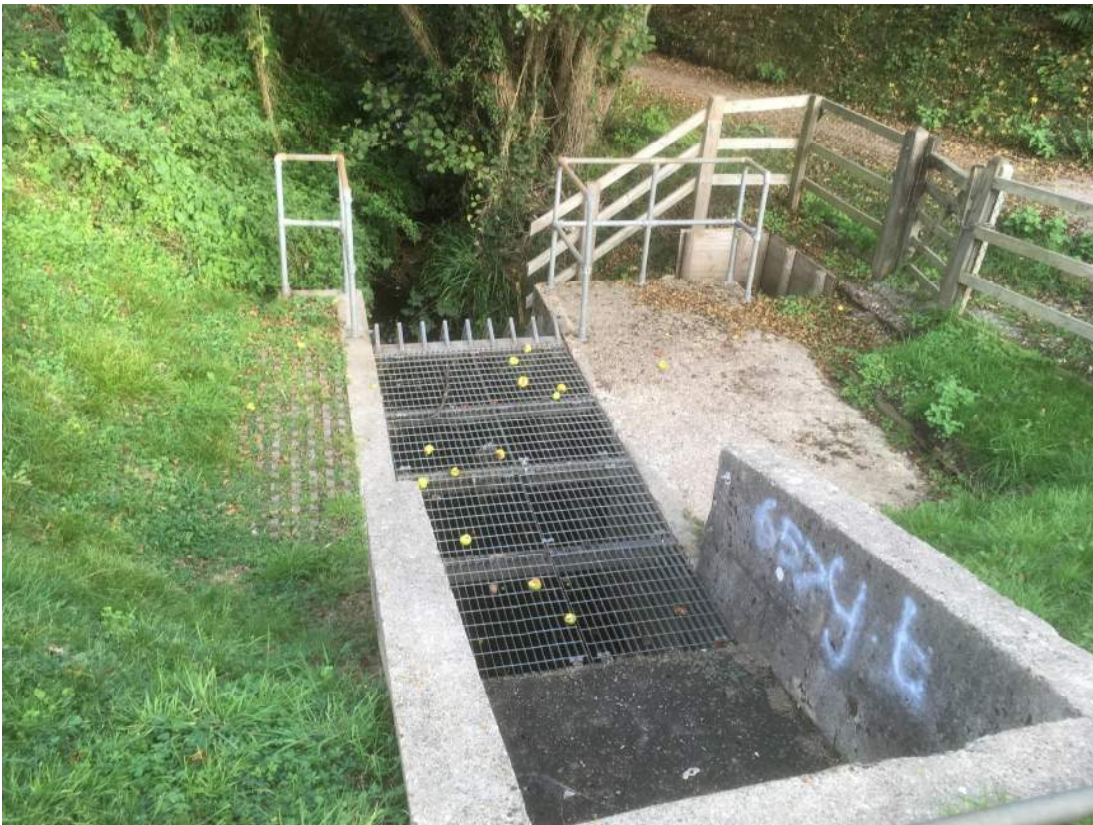
Plate 6. Drainage feature associated with stream adjacent south of the site (2018).
