## **Havant and Southdowns College Bancroft Way – Tree Constraints**

Please find my comments below relating to Havant College Bancroft Way to widen the footway adjacent to the college boundary and the installation of a replacement perimeter fence.

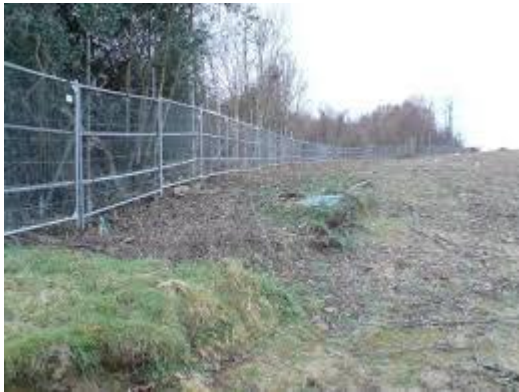
Example of Heras type protective fencing

The RPA surrounding retained trees that must be protected from above and below ground disturbance by the construction activity. In practice, this can be done by any combination of fencing and ground protection, to be finalised and agreed at the pre-commencement meeting. Whether the RPA is protected by fencing or ground protection, all the protective measures should be installed before the start of any site works that could affect trees. No protective measures should be removed or temporarily dismantled without consulting the supervising arboriculturist.

Where it is not practical to protect the RPA by the use of fencing alone, BS 5837 (2012) allows for the fencing to be set back and the soil protected by ground protection. This allows improved access during construction, with the ground protection preventing damage to the RPA outside the protection of the fencing.

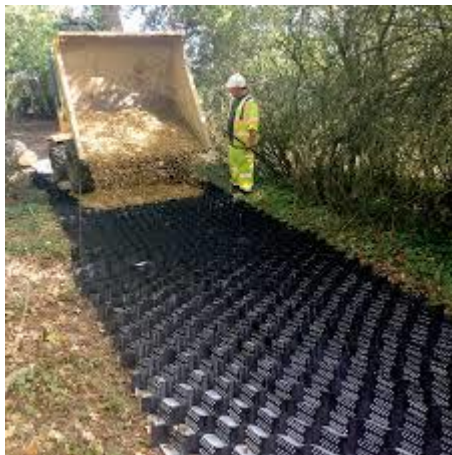
Photo shows Cell-web in situ being back filled.

BS 5837 (2012) sets out that no-dig, three dimensional cellular confinement systems can be used as the basis for extending hard surfacing into RPAs. It is my experience that this type of surfacing can be installed in the majority of situations without any significant adverse impact on adjacent trees, provided that proper consideration is given to all the circumstances.

- The heavy-duty plastic that can be pulled apart to open into cells.
- These are then filled with washed stone, after the product is spread over the ground and pinned in place.
- A base layer that acts as a floating raft, spreading the load across the whole construction width.
- The base layer can be topped with a variety of finishes.

Once the sub-base has been formed, the load spreading construction is installed on top without compaction. In principle, the load spreading formation will normally be cellular and filled with crushed stone, although the detail may vary with different products. In this instance my belief is that the preferred finish for the footpath is tarmac. Tarmac is acceptable due to the minor changes in the surface coverage within the RPA of the trees – adequate gaseous and moisture exchange is achievable in this setting.
