Project Staunton Park,  
Havant

Title Tree Protection & Removal Plan  
Sheet 3 of 3

Drawing Number Rev  
706 B

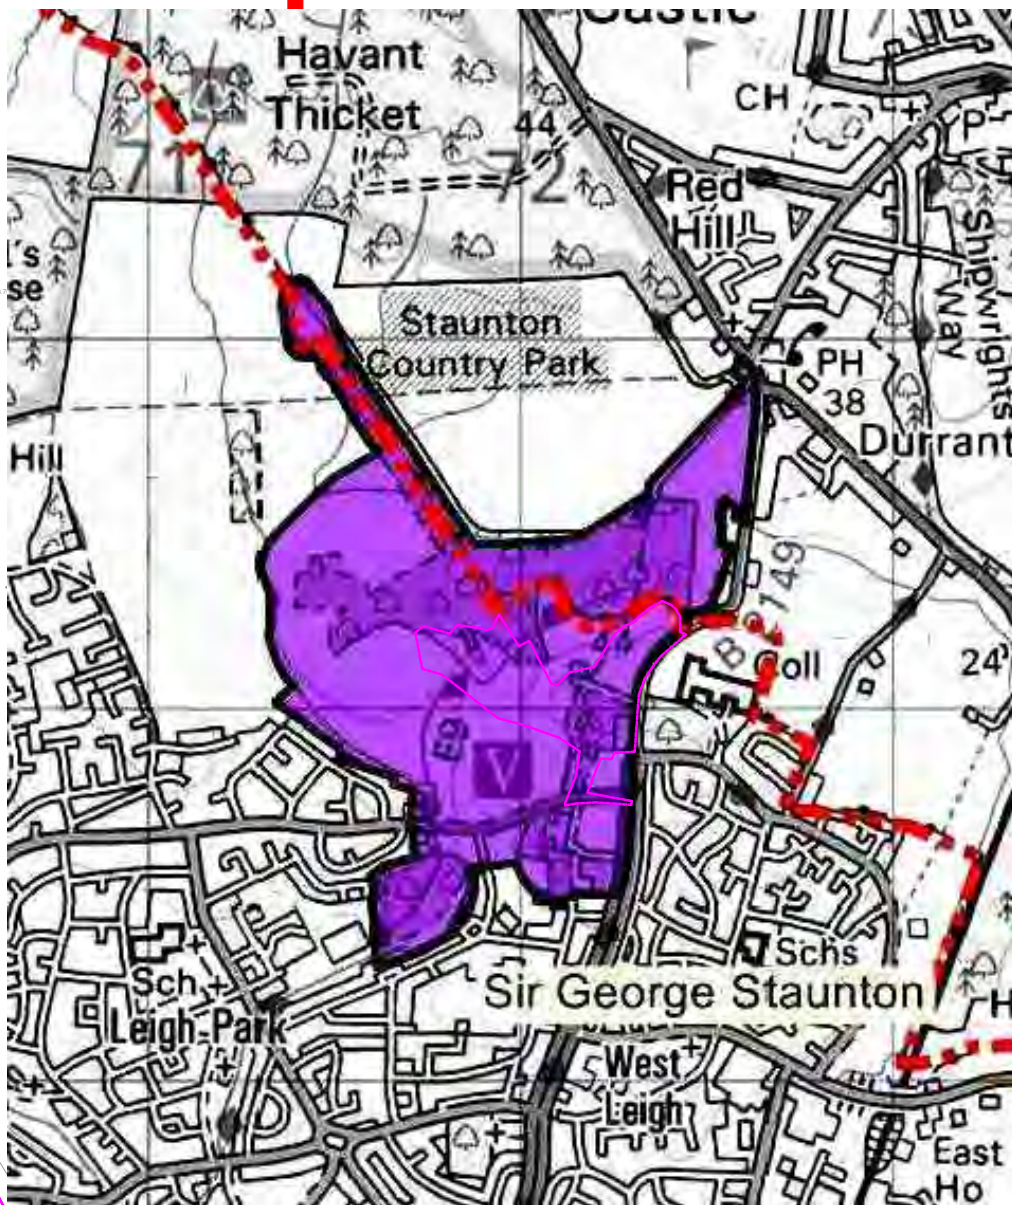
Plan 706  
Plan 705

Survey boundary line within Conservation Area Extents. Image taken from Havant Borough Council website.
