**PRE-DEVELOPMENT ARBORICULTURAL SURVEY  
AND  
ARBORICULTURAL IMPACT ASSESSMENT**

2 Wigan Crescent  
Bedhampton, Havant,  
Hampshire

A Report to Mr Paul Cole

Report Number: C061802-01

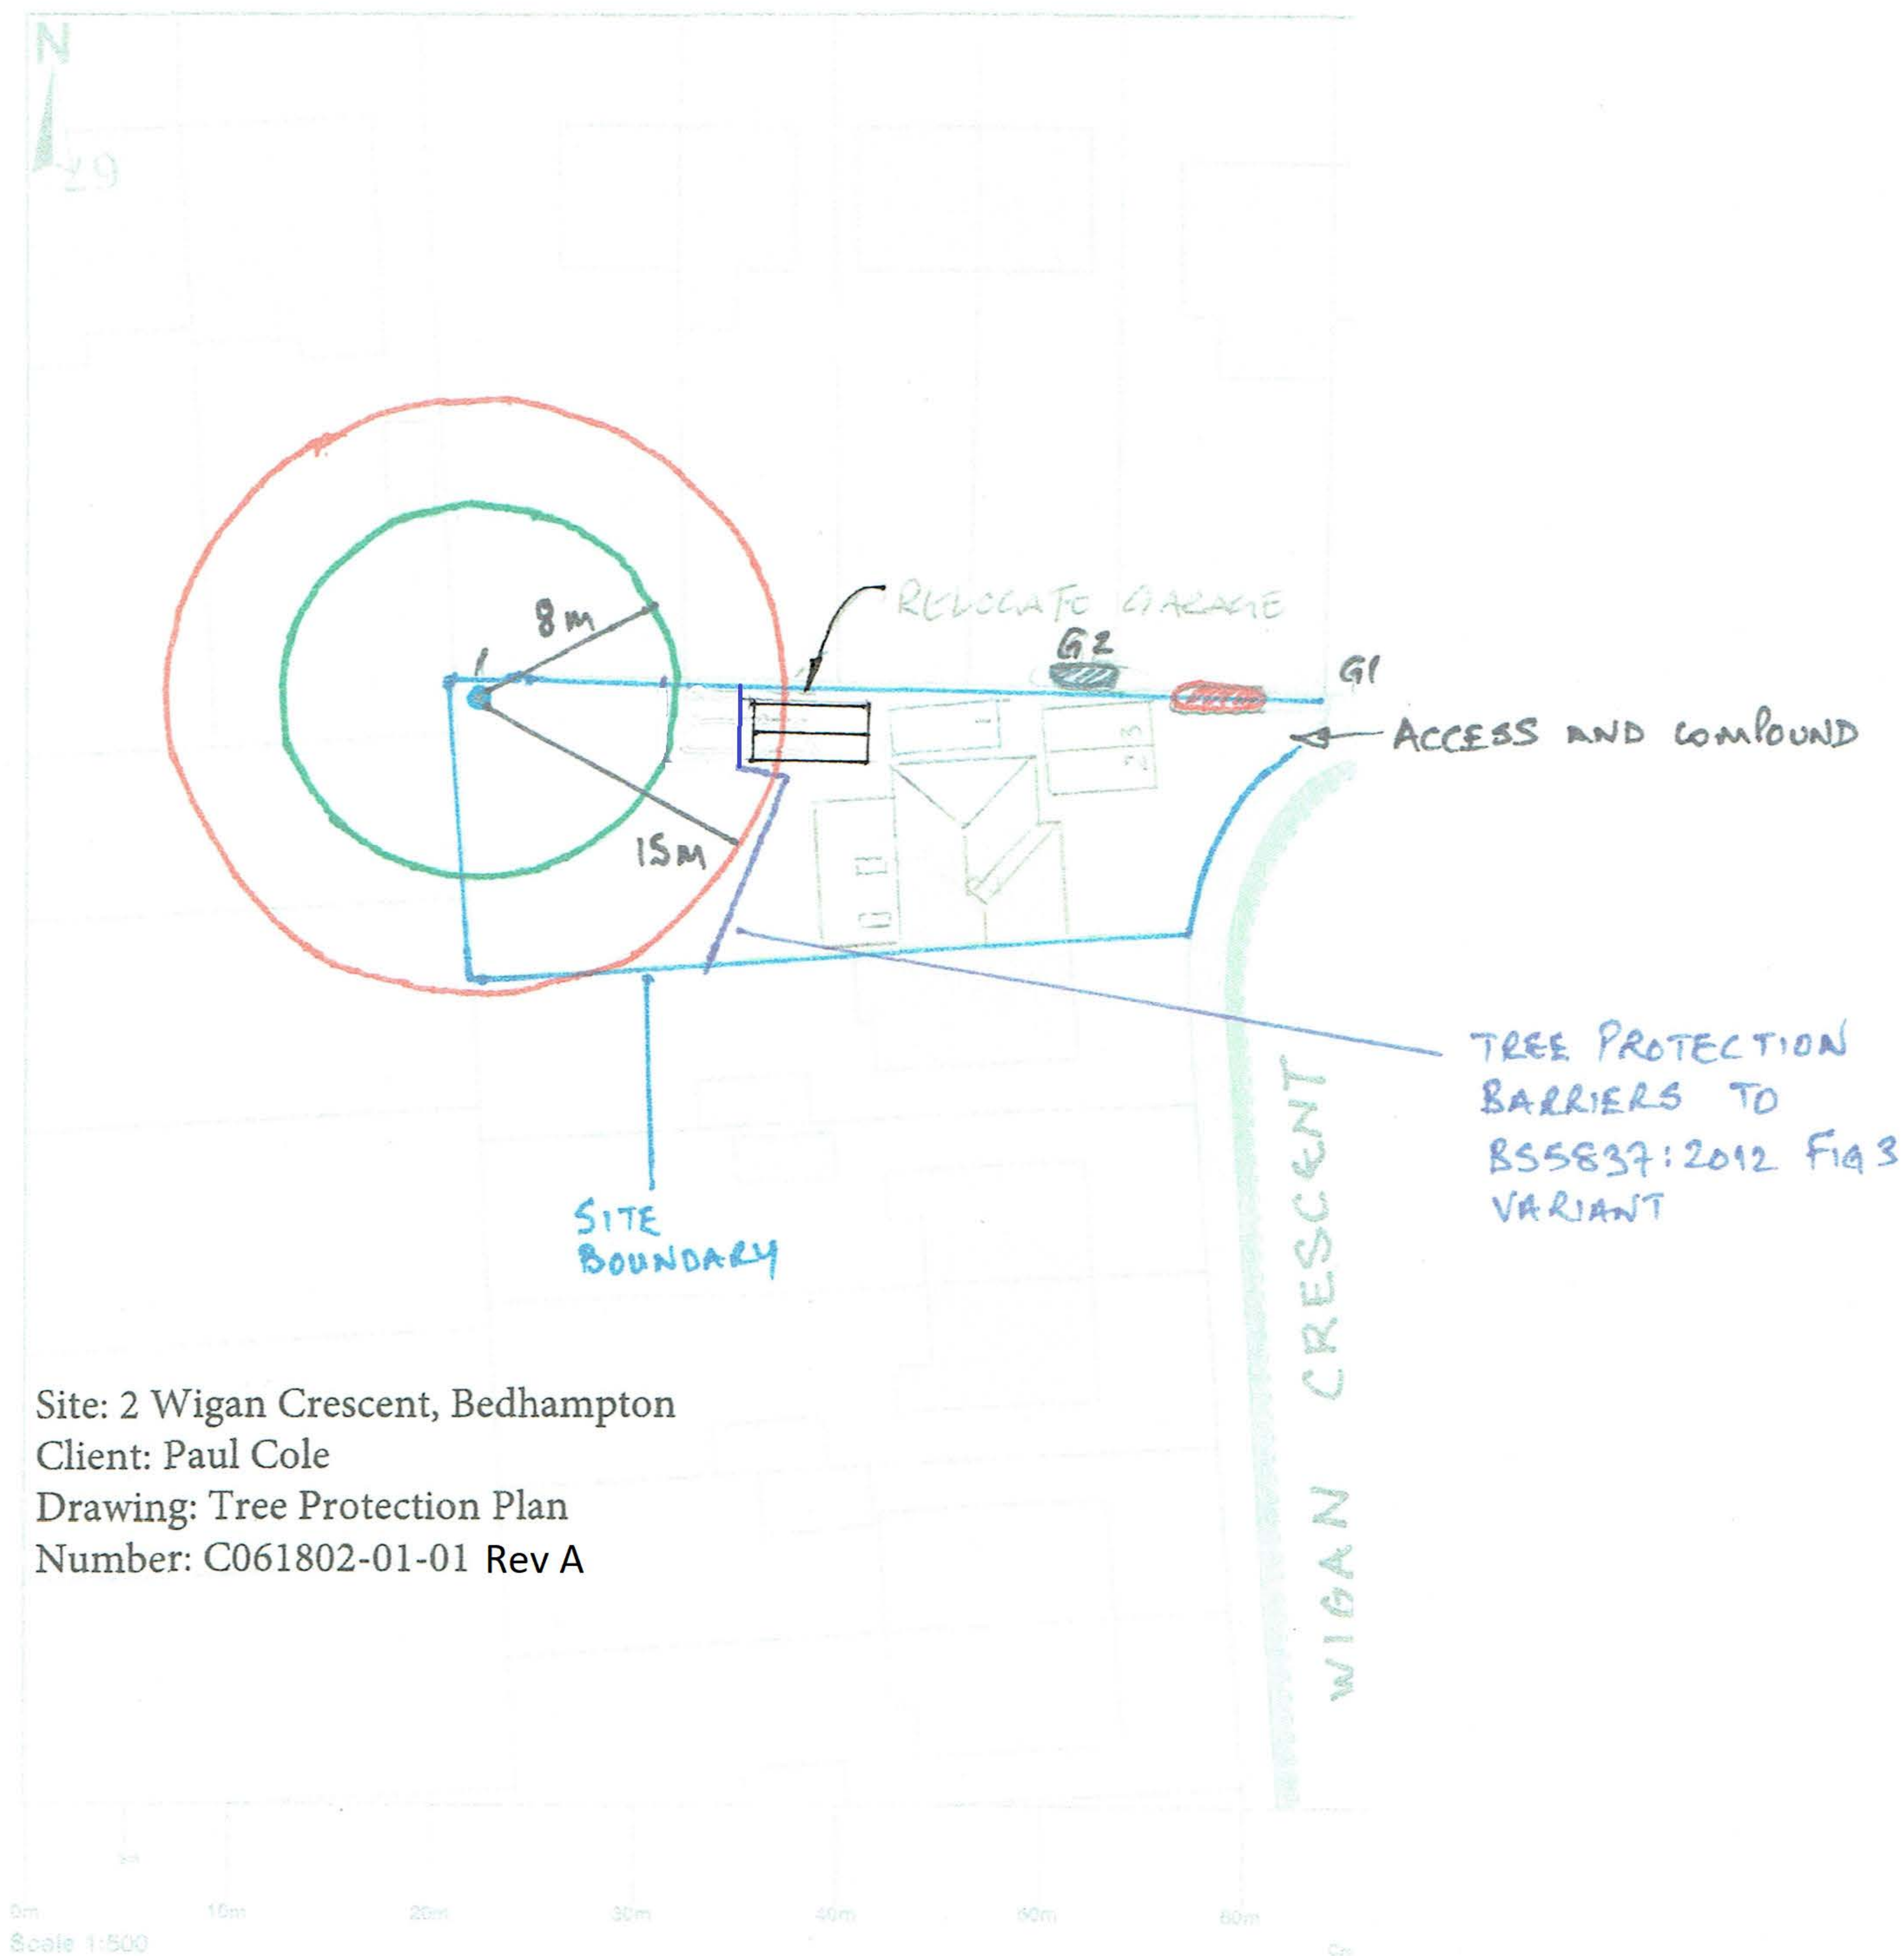
Drawing Number C061802-01-01 Rev A Tree Protection Plan

The RPA and canopy spread of each tree to be retained is shown on Drawing Number C061802-01-01 Rev A, Section 6. Additionally, a schedule of the trees surveyed can be found within Appendix 1. The Root Protection Areas for each tree in BS5837:2012 Category A, B or C is shown in Appendix 2.

The potential for direct damage to the stems of the tree will be controlled by the installation of protective barriers as shown on Tree Protection Plan Drawing Number C061802-01-01 Rev A, Section 6.

The location of the Monterey Cypress tree considered within this document can be found on Arbor Call Ltd Drawing Number C061802-01-01 Rev A, Section 6.

All trees within and closely surrounding the site have been surveyed and each has been identified with a unique number. The locations of the trees are shown on Arbor Call Ltd Drawing Number C061802-01-01 Rev A in Section 6. A schedule of the tree surveyed can be found within Appendix 1. The Root Protection Area for the tree in BS5837:2012 Category A, B or C is shown at Appendix 2.

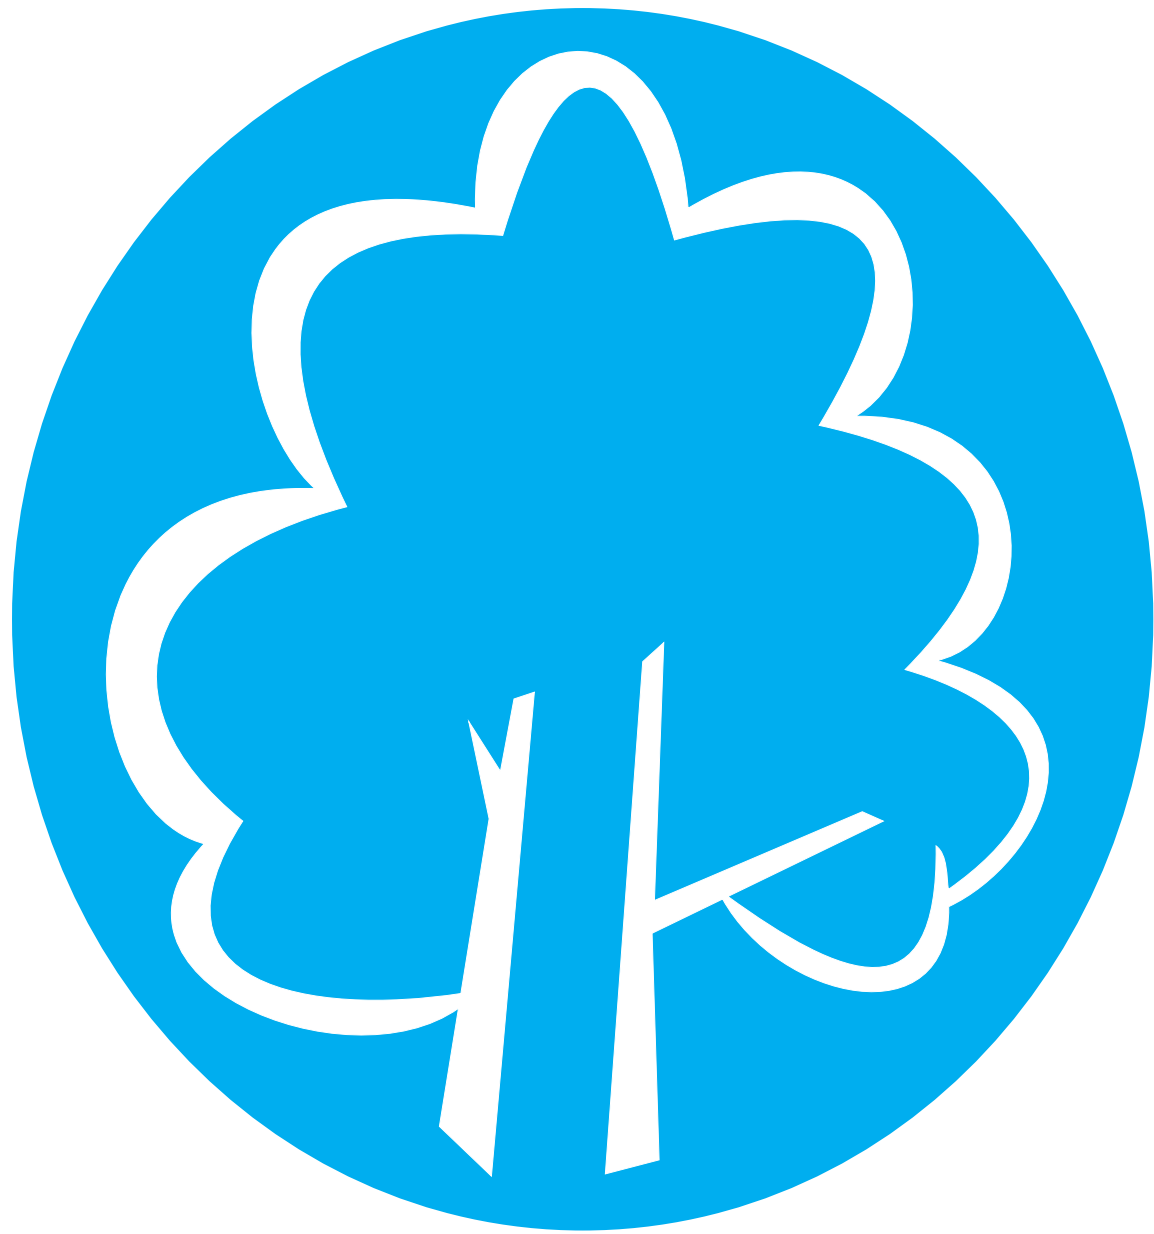
**PROTECTIVE FENCING. THIS  
FENCING MUST BE  
MAINTAINED IN ACCORDANCE  
WITH THE APPROVED PLANS  
AND DRAWINGS FOR THIS  
DEVELOPMENT.**

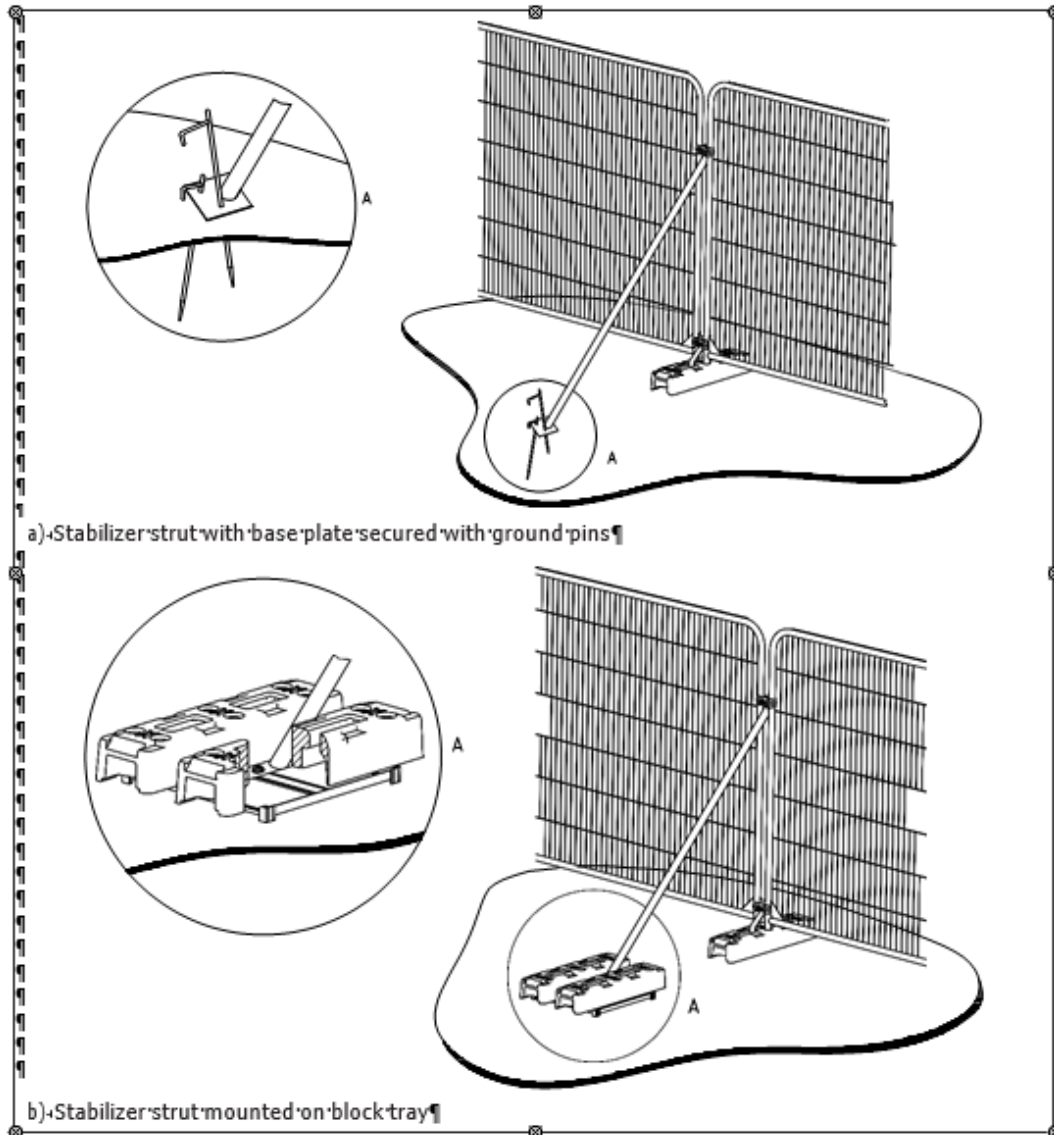
Figure 3 → Examples of above-ground stabilizing systems

### Details of Protective Barrier
