**Flint wall reconstruction detail - 1:100  
(north of Main House west wing)**

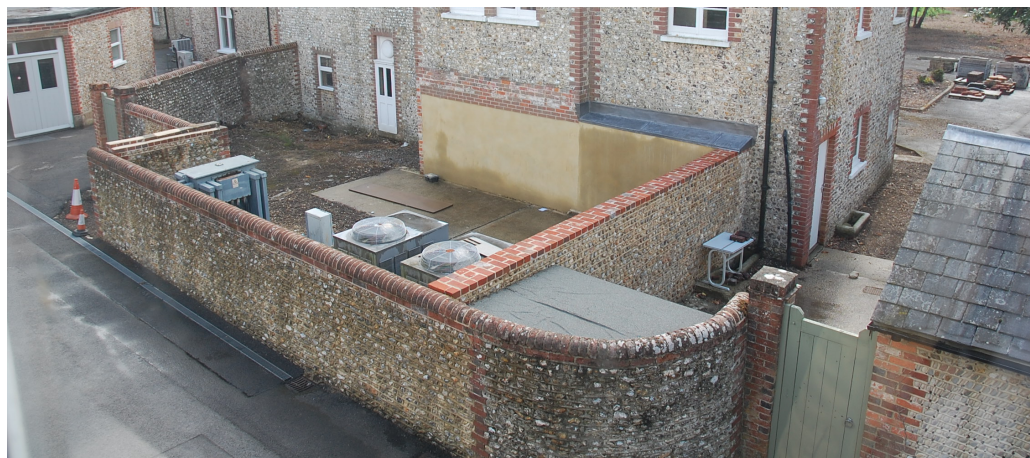
Existing flint wall.

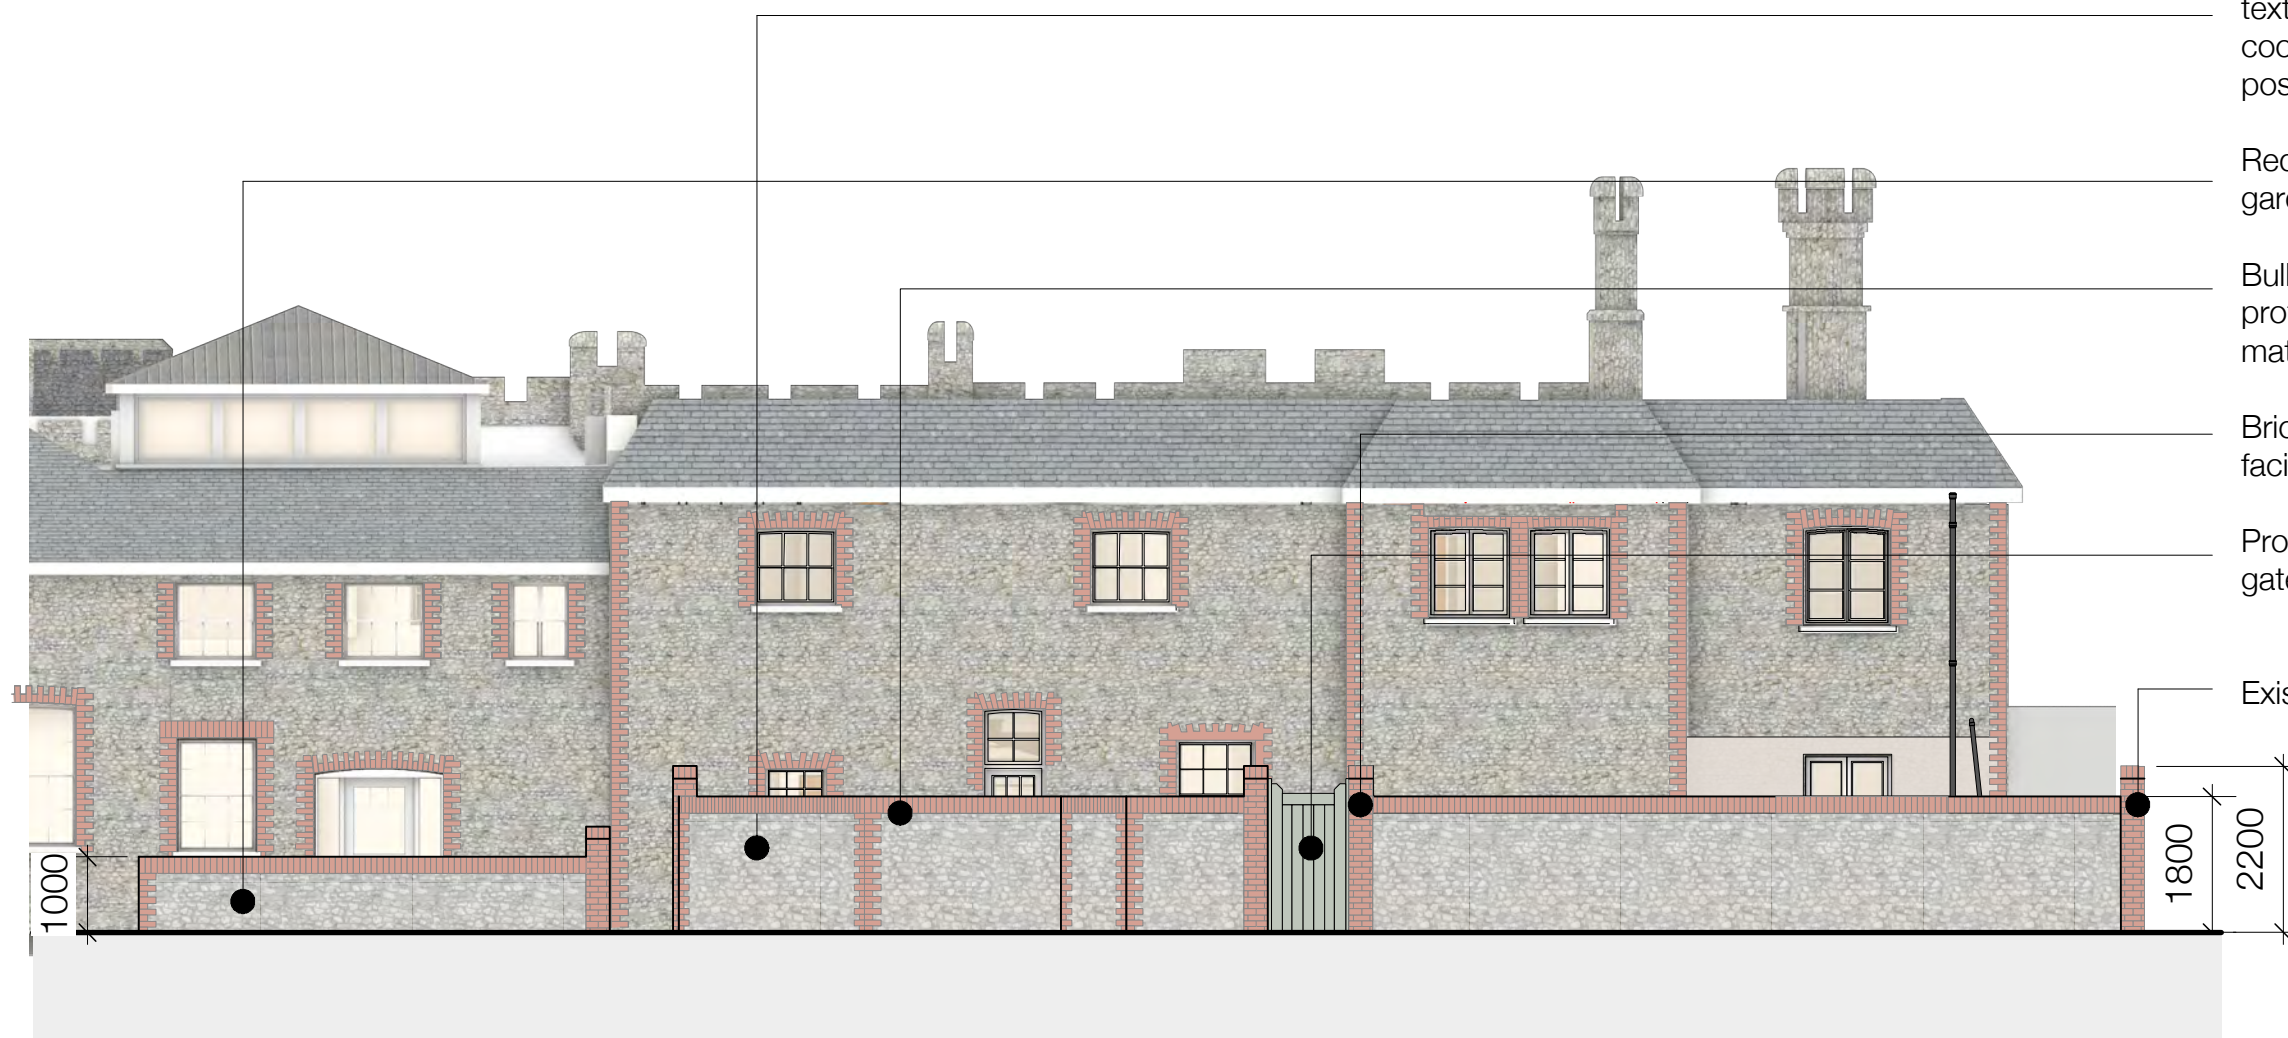
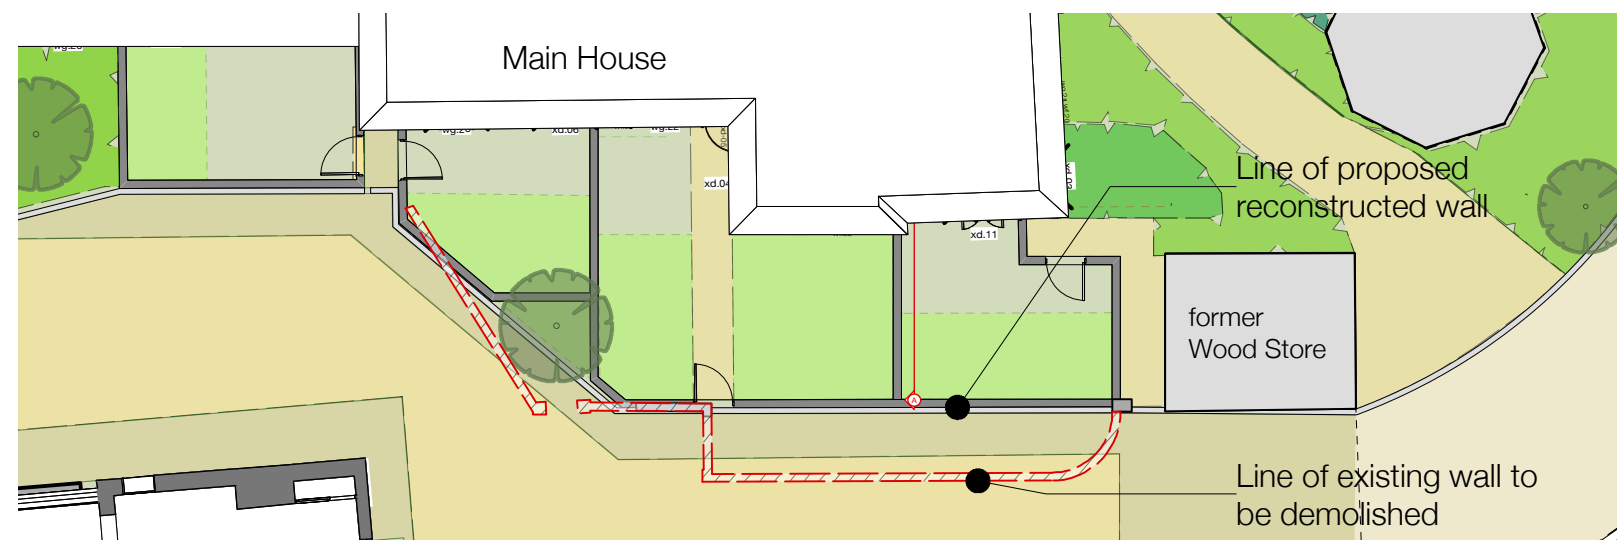
Reconstructed garden wall - Colour and texture of flint & mortar to be selected to coordinate with existing to match as closely as possible. Existing to be reused where possible.

Reduced height to section to townhouse 6 rear garden

Bullnose Capping brick & soldier course - profile and colour to match existing. Existing materials to be reused where possible.

Brickwork pier - Stretcher bond brickwork facing, size and profile to match existing.

Proposed ledged, braced & fronted timber gate to match existing.

Existing corner pier retained

Dimensions to match existing
