coach house first floor east elevation - Windows into existing opening

**Reference - co.wf.02, co.wf.03 & co.wf.04**

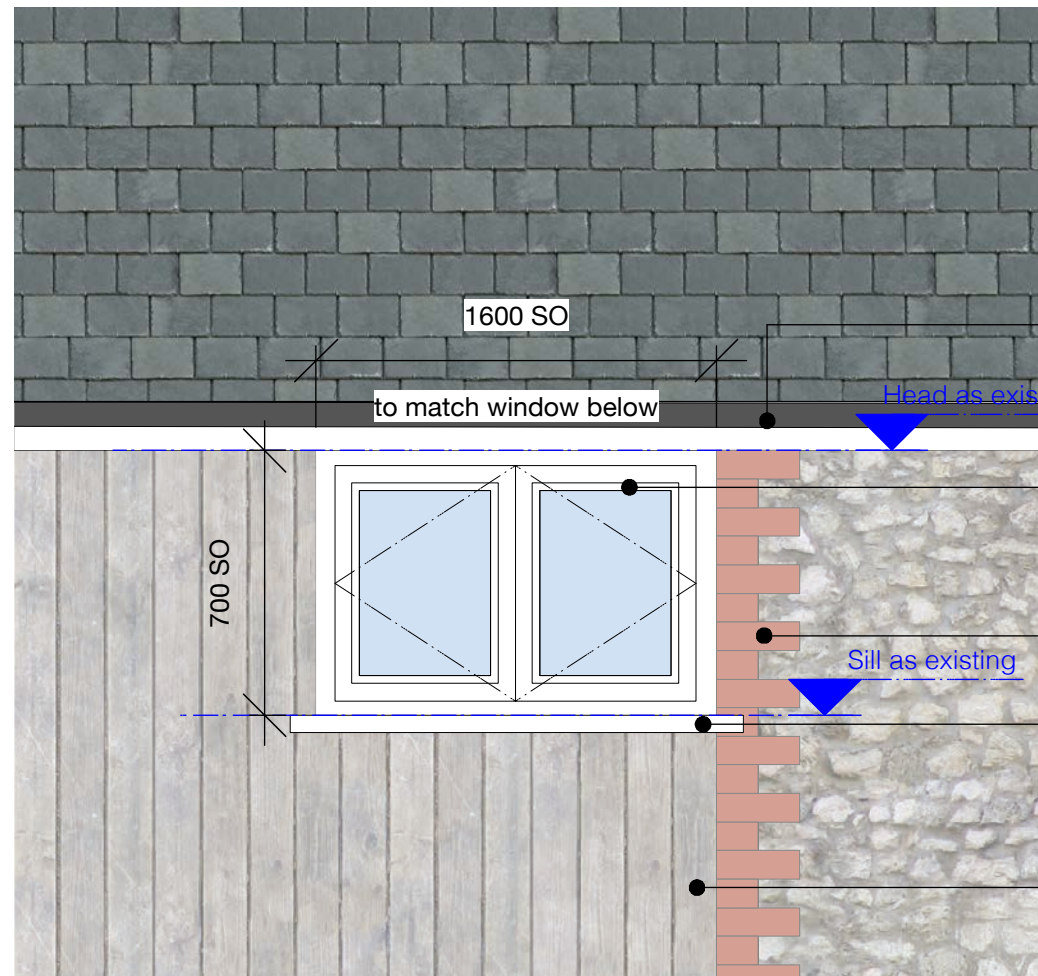
1:20 ELEVATION

Timber fascia retained

New double side-hung casement - high performance pre-finished timber double-glazed windows into existing opening

Brick reveals retained (where applicable)

Integral timber sill

Proposed vertical timber cladding - naturally durable timber species (to later selection) left to weather to natural 'silver' colour

New window into existing opening (similar configuration to existing co.wf.03)  
- high performance timber framed doors & windows to later detail, pursuant to planning condition

co.wf.04 illustrated
