**Arboricultural Assessment & Method Statement**  
East Leigh House, Bartons Road, Havant

17 May 2017  
15362-AA3-DC

## Report purpose, validation statement and tree protection plan

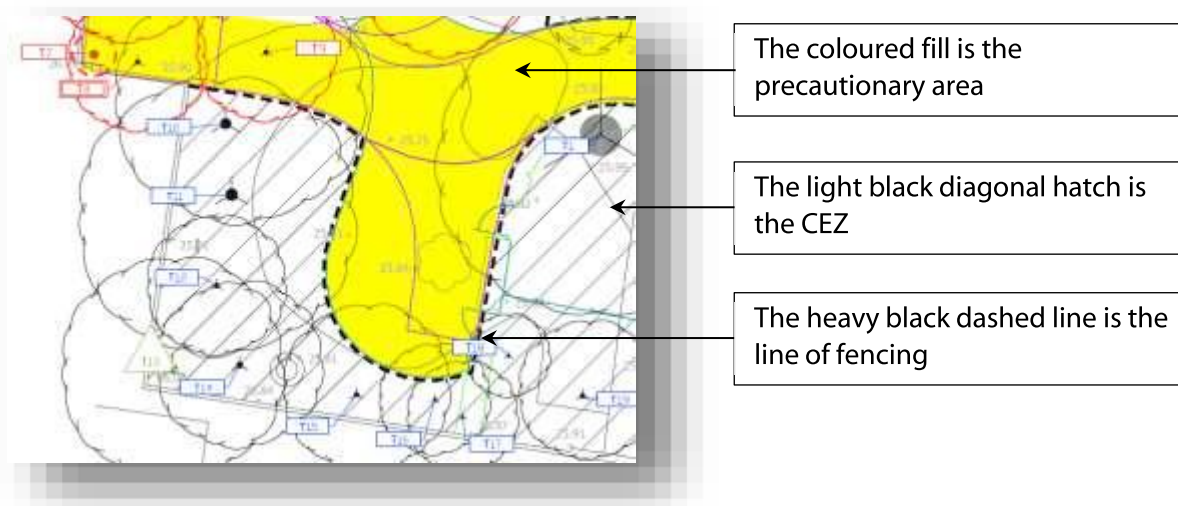
The tree protection plan (typical annotation illustrated below) shows all the areas where protective measures are necessary. The construction exclusion zone ("CEZ") boundary is shown on the plan as the heavy dashed black line, with the lighter diagonal hatching behind. If necessary, further precautionary areas outside the CEZ are shown on the plan as a coloured fill, where a high level of care is required.

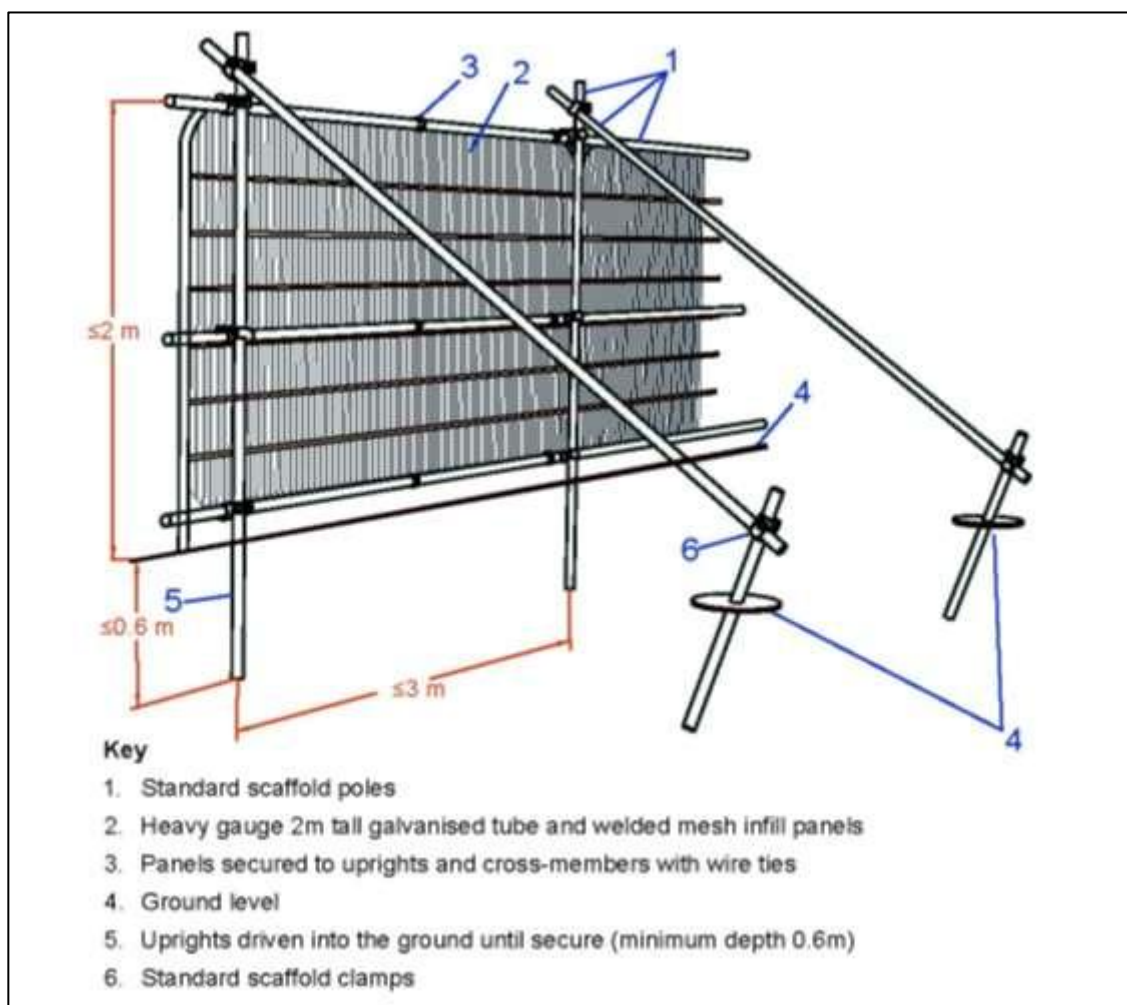
**Fencing image 1:** Recommendations taken from figure 2 of BS 5837.

The precise form of the fencing can vary, provided it is fit for purpose in that it effectively restricts access and damaging activities within the RPA that it encloses. More specifically, behind the fencing, there should be no vehicular access; no fires; no storage of excavated debris, building materials or fuels; no mixing of cement; no service installation or excavation; no raising or lowering of soil levels; and no excessive cultivation for landscape planting. Any variations to these restrictions should be agreed by the supervising arboriculturist.

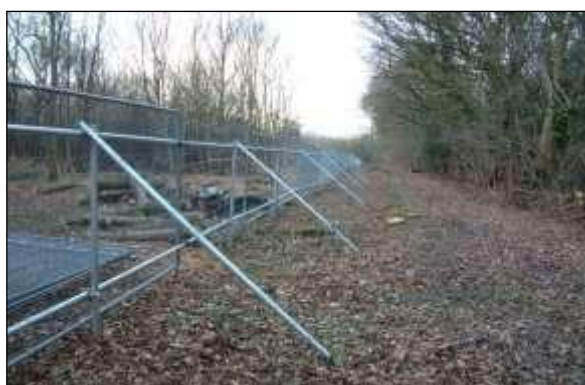
**Fencing image 2:** Heras fencing wired to scaffold braced posts is a robust and effective interpretation of the BS specification.

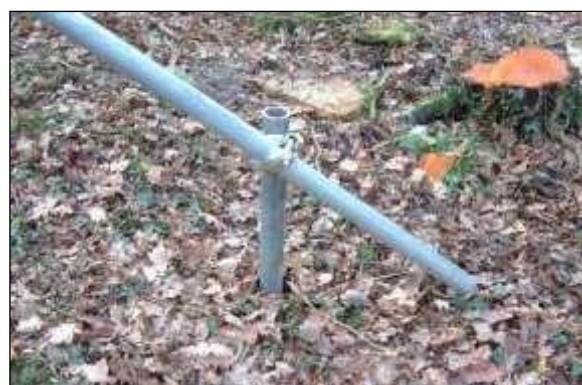
**Fencing image 3:** Close up of bracing detail, essential for increasing the stability of the vertical framework.

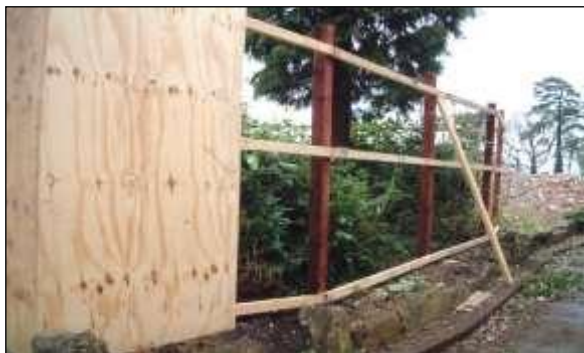
**Fencing image 4:** Board specification on secure wooden posts is a suitable alternative to the standard braced scaffold design.

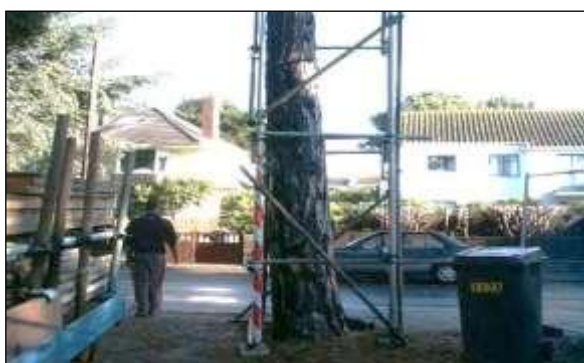
**Fencing image 5:** A scaffold-braced framework surrounding the trunk reduces the risk of accidental impact.

Where individual trunks or branches are vulnerable to impact damage, a framework of scaffold or wood can be constructed to provide protection (Fencing images 5 and 6).

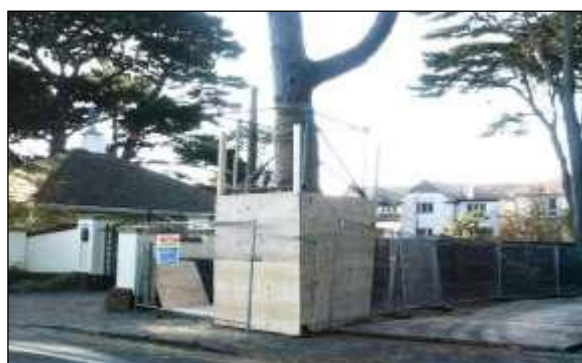
**Fencing image 6:** Board secured to scaffold framework adds another layer of protection for vulnerable trunks and branches

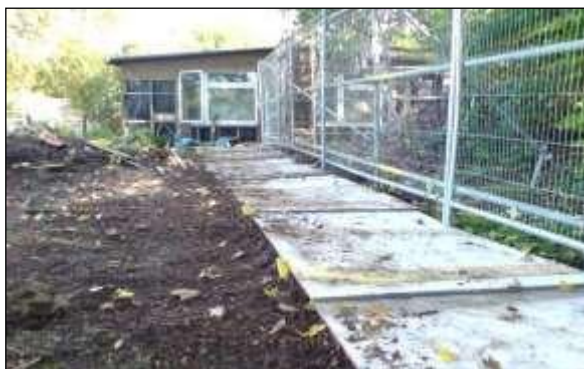
**Ground protection image 1:** Heavy-duty plywood set onto a compressible woodchip layer and pinned into position is suitable to spread the loading from pedestrian access.

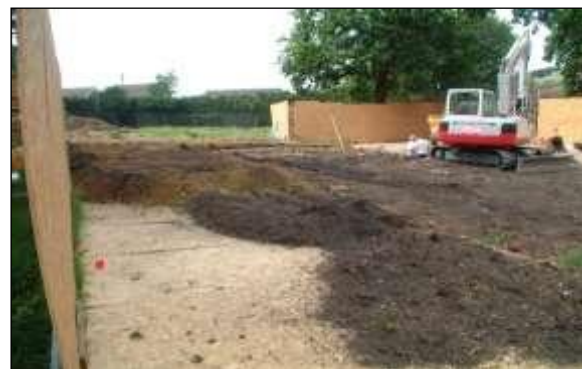
**Ground protection image 2:** Spreading soil excavated from footings is an effective way of buffering the plywood surface from the wear of light vehicles.

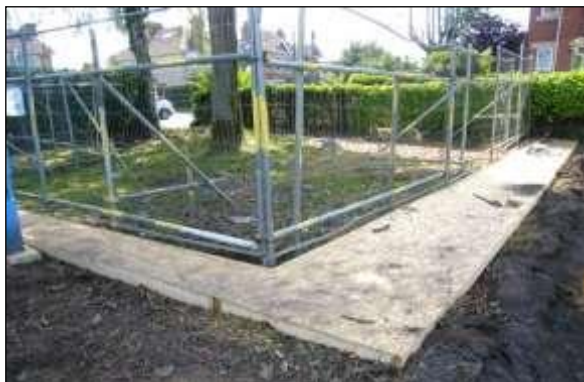
**Ground protection image 3:** Plywood fixed to a wood frame is another effective method of protecting soil from pedestrian compaction.

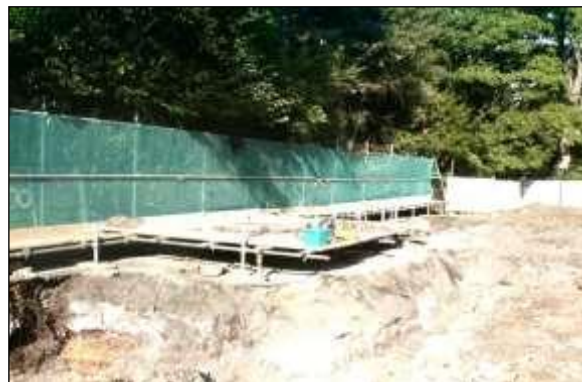
**Ground protection image 4:** A scaffold framework attached to the main scaffold fencing can be used to support either scaffold planks or plywood to create an elevated platform with a gap beneath.

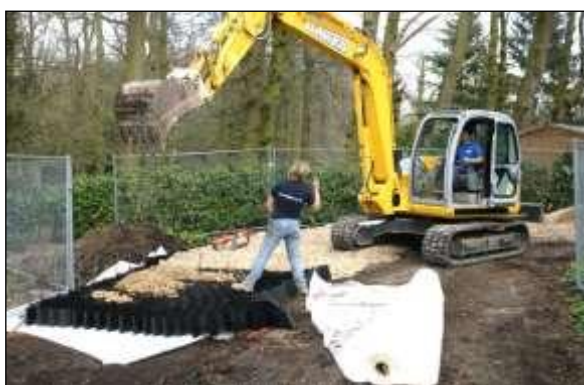
**Ground protection image 5:** Cellular products are a very effective means of providing ground protection where heavy vehicle use is expected. Here, it is being used to temporarily widen an existing road, to be removed once the construction is finished.

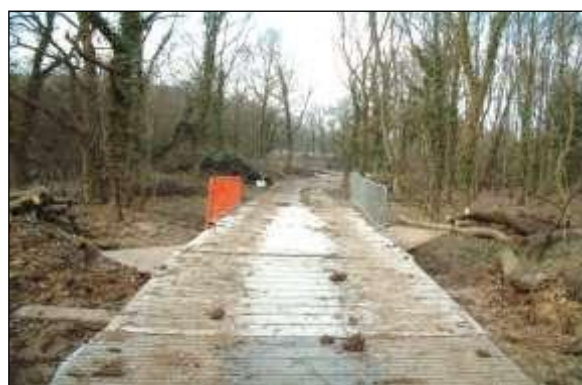
**Ground protection image 6:** Custom designed sectional tracks can be joined to support very heavy traffic use through sensitive areas.

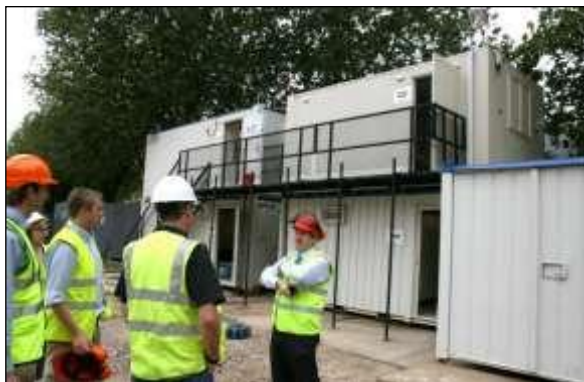
**Ground protection image 7:** A combination of retaining existing surfacing and using temporary construction cabin accommodation can be a very effective means of preventing damage to sensitive areas.

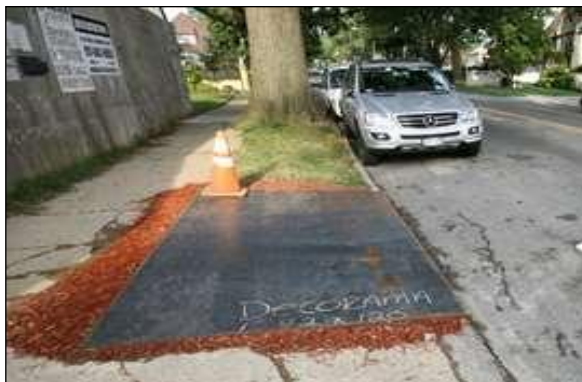
**Ground protection image 8:** Steel plates can be an effective way of temporarily reinforcing weak surfacing over a construction access during the development activity.

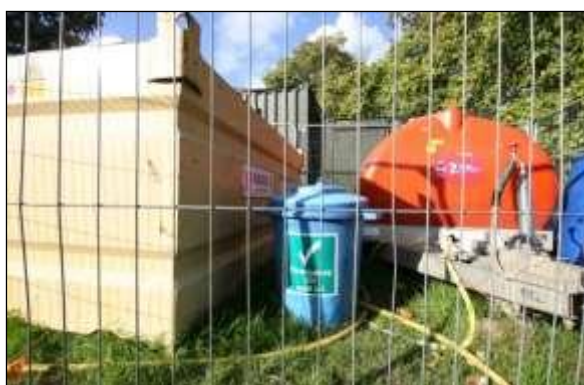
**Pollution image 1:** Where fuel or other chemicals are stored on site, it is now standard practice to have emergency spillage kits available to restrict the environmental impact of accidents.

Spilt chemicals that can soak into RPAs will kill existing roots and may prevent new roots growing, so provision must be made to minimise the risk of contamination to soil within the normal risk management protocols for the site. This would normally include means of containing spillages and procedures for clearing them up if they occur (Pollution image 1). All cement mixing and vehicle washing points must be located outside RPAs, with provision to contain any spillages. Where the contours of the site create a risk of polluted water or toxic liquids running into RPAs, a precautionary measure of bunding or a frame, sealed with heavy-duty plastic sheeting sufficient to prevent contamination (Pollution image 2), must be used to contain accidental spillages.

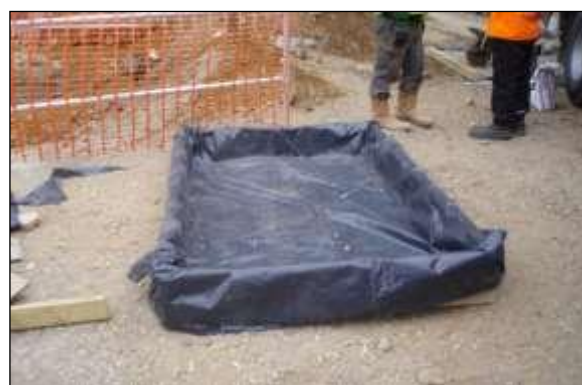
**Pollution image 2:** Soil bunding or a supporting framework covered in heavy-duty plastic sheeting is essential where there is a risk of spillages contaminating RPAs. This specifically applies to cement mixing areas and vehicle washing facilities.

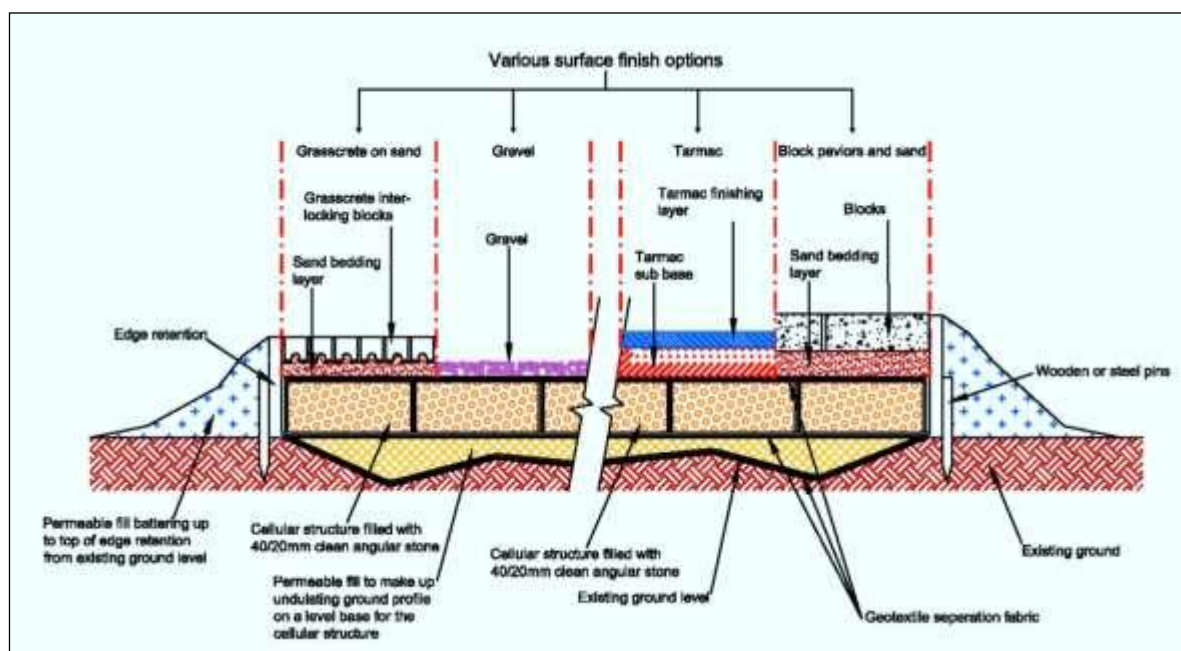
**New surfacing image 1:** This conceptual cross-section illustrates the structural elements of the system and the multiple surfacing options that can be used with it.

made from heavy-duty plastic that can be pulled apart to open into cells. These are then filled with washed stone, after the product is spread over the ground and pinned in place. This forms a base layer that acts as a floating raft, spreading the load across the whole construction width. The base layer can be topped with a variety of finishes as illustrated in New surfacing image 1. New surfacing images 2 and 3 show the product spread over the ground and then filled with stone to produce the base layer.

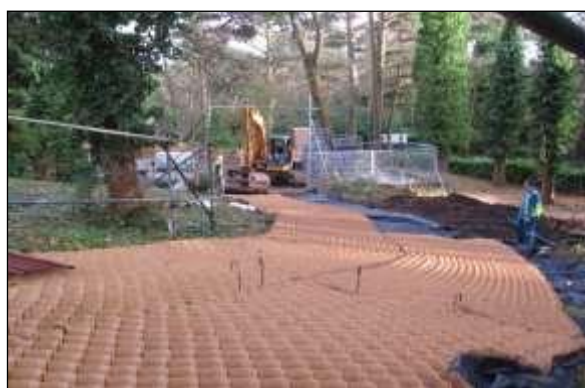
**New surfacing image 2:** The three-dimensional cells are opened up, spread across the area to be surfaced and pinned in place ready for the stone filling.

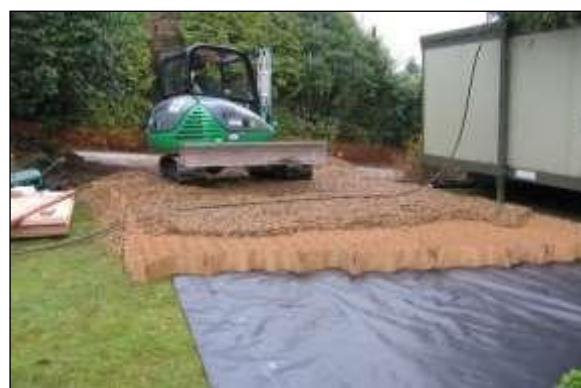
**New surfacing image 3:** The stone-filled cells spread the load of traffic and the geotextile membrane on the ground prevents migration of the stone into the soil profile.

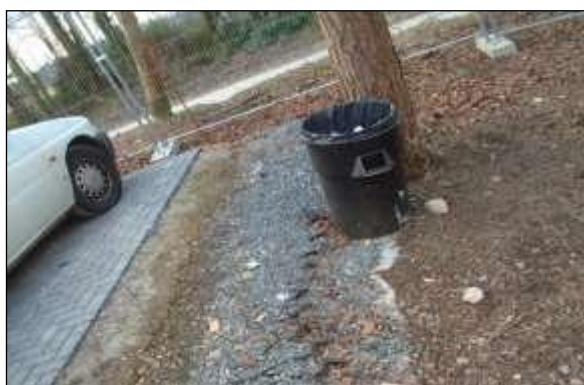
**New surfacing image 4:** A conventional concrete haunching can be used to retain new surfacing as long as it is not dug into a trench - here it is placed on top of the CellWeb layer.

Conventional kerb edge retention set in concrete-filled excavated trenches is likely to result in damage to roots and should be avoided. Edge retention in RPAs must be designed to avoid any significant excavation into existing soil levels (BS 5837, 7.4.3) and there are a number of approaches that are fit for this purpose. For block pavements, the use of pre-formed edging secured by metal pins is effective and can be reinforced by concrete supports as long as there is no excavation into the soil (New surfacing image 4). Railway sleepers (New surfacing image 5) pinned in place or wooden boards (New surfacing image 5) are two options, depending on the expected loading of the surfacing. A permeable soil fill can then be used to batter the grade back down to the existing soil level.

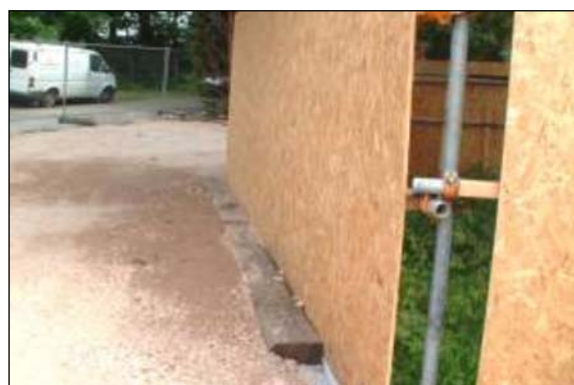
**New surfacing image 5:** Although this is only a temporary surface, railway sleepers pinned into the ground can be used to retain the edges of new surfacing.

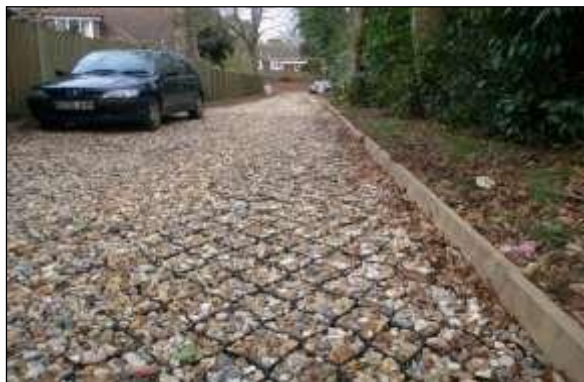
**New surfacing image 6:** Wooden board pinned in place or held in position with backfilled topsoil can provide more informal and rustic surface edging.

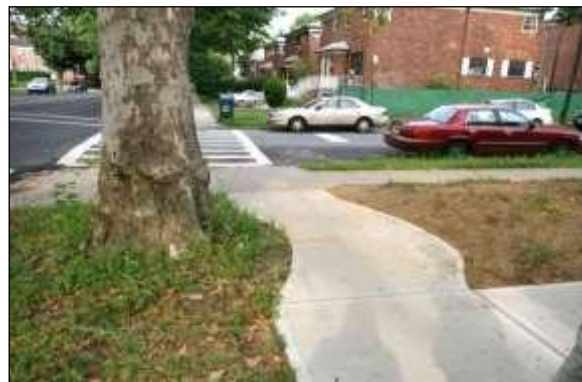
**New surfacing image 7:** In some situations, it may be appropriate to cast a free floating concrete surface directly onto the soil surface provided provision is made to prevent soil contamination while the concrete is being poured, i.e. an impermeable membrane separating the concrete from the soil.

In some situations, limited-width floating concrete rafts constructed directly onto the soil surface may be acceptable for both pedestrian (New surfacing image 7) and vehicular access (New surfacing image 8), but the design must not include any strip-dug supports. If concrete is poured directly, precautions must be taken to ensure that no toxic fluids can contaminate the adjacent soil. Alternatively, elevated paths supported on low impact frames or post supports allow a decking surface to cross sensitive areas (New surfacing images 9 and 10). Where paths are installed very close to trunks, provision must be made for distortion from future root growth by selecting flexible components for the supporting frame and surfacing (New surfacing image 11).

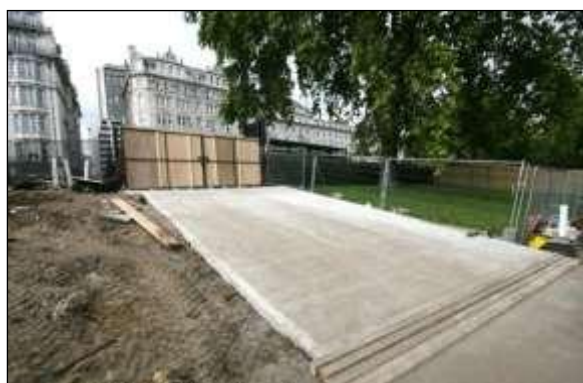
**New surfacing image 8:** This temporary access for heavy construction traffic on the outer edge of a RPA is a concrete slab cast above ground level and will be removed when the project is completed.

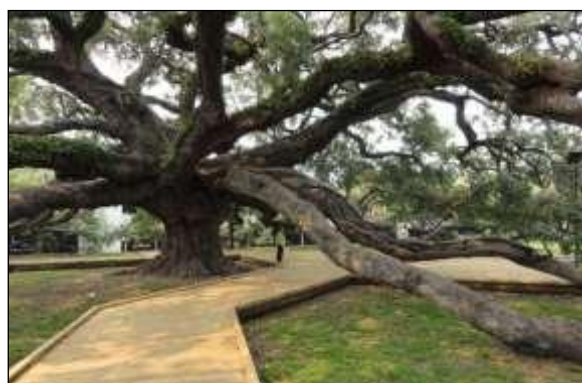
**New surfacing image 9:** Board walks supported on posts or a light frame are another way of providing pedestrian access across sensitive RPAs (photo courtesy of Philip van Wassenaer).

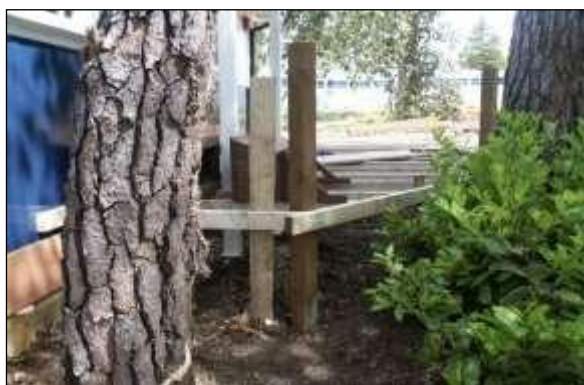
**New surfacing image 10:** New surfacing can be supported above the ground on posts leaving the soil surface beneath undisturbed.

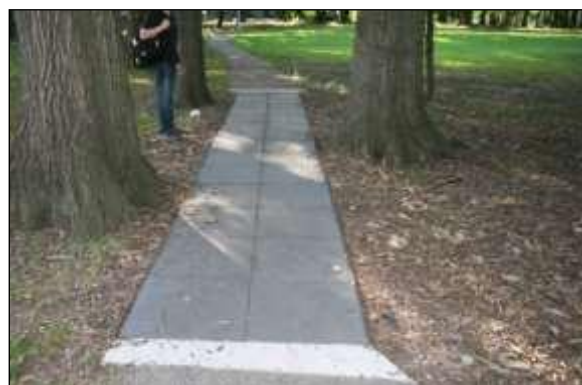
**New surfacing image 11:** Where surfacing is needed close to rapidly growing buttress roots, a light metal frame with rubberised surfacing will allow the path to distort without cracking as the roots grow.

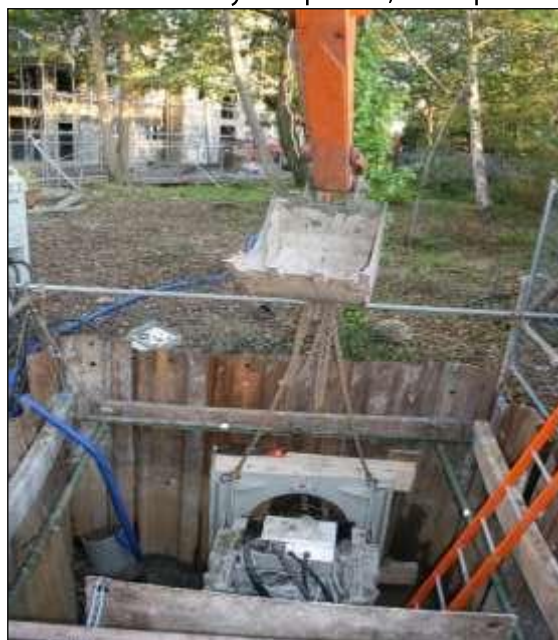
**Services image 1:** If possible, thrust boring is the preferred option for installing service routes through the RPAs of important trees, but there has to be space at the start and finish to dig substantial working pits.

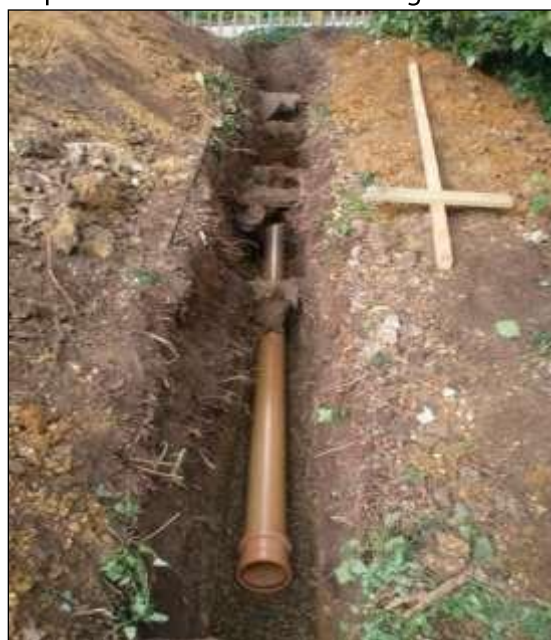
**Services image 2:** Continuous trenches dug by hand so that important roots can be retained (with the service ducting threaded beneath) is an effective means of minimising damage (note the ground protection boards with soil piled on top on the left).

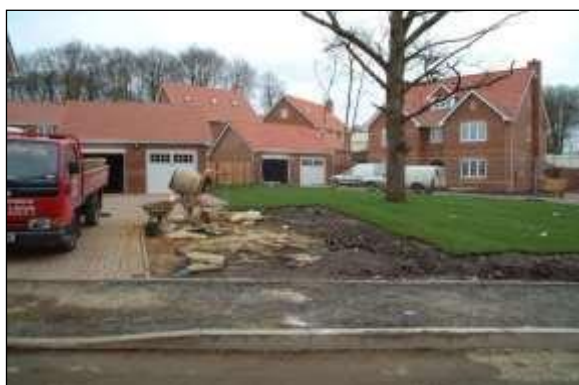
**Landscaping image 1:** The RPA of this tree was not effectively protected during construction and excessive compaction of the soil meant it died soon after this turf covered up the damage.

Soft landscaping activity after construction can be extremely damaging to trees. No significant excavation or cultivation, especially by rotovators, should occur within RPAs. Where new designs require levels to be increased to tie in with new structures or the removal of an existing structure has left a void below the surrounding ground level, good quality and relatively permeable top soil should be used for the fill. It should be firmed into place, but not over compacted, in preparation for turfing or careful shrub planting. Ideally, all areas within 1m of tree trunks should be kept at the original ground level and have a mulched finish rather than grass to reduce the risk of mowing damage (Landscaping images 1 and 2).

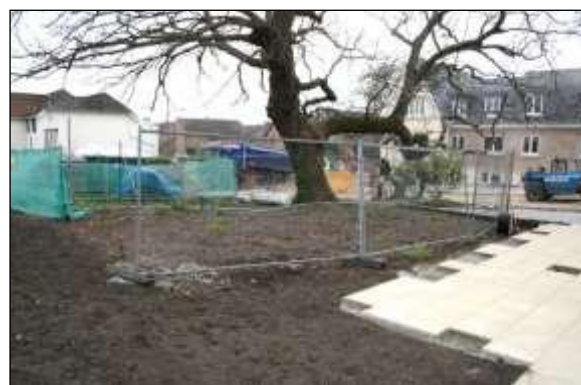
**Landscaping image 2:** This tree had tarmac parking within its RPA that was removed and replaced with an organic mulch near the trunk and limited no-dig surfacing on the outer edges of its RPA.
