# Arboricultural Implications Assessment and Method Statement for Land at Long Copse Lane, Emsworth

Arboricultural Implications Assessment and Method Statement

**Land at Long Copse Lane, Emsworth**

Report Ref: **201273A - AIA 4**

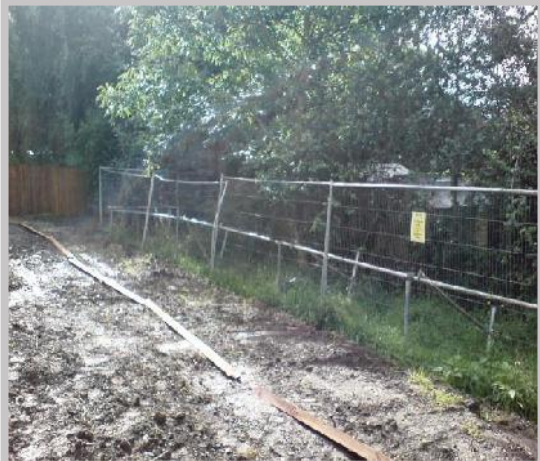
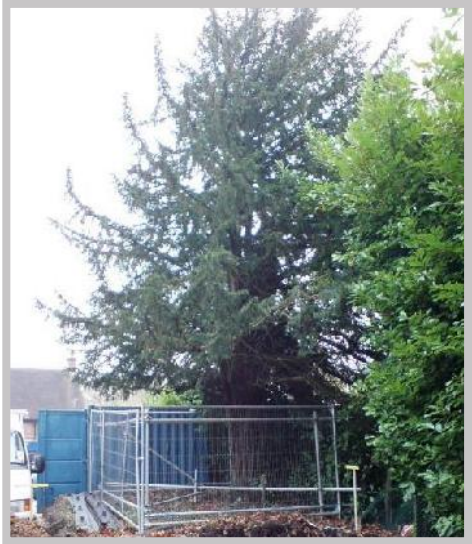
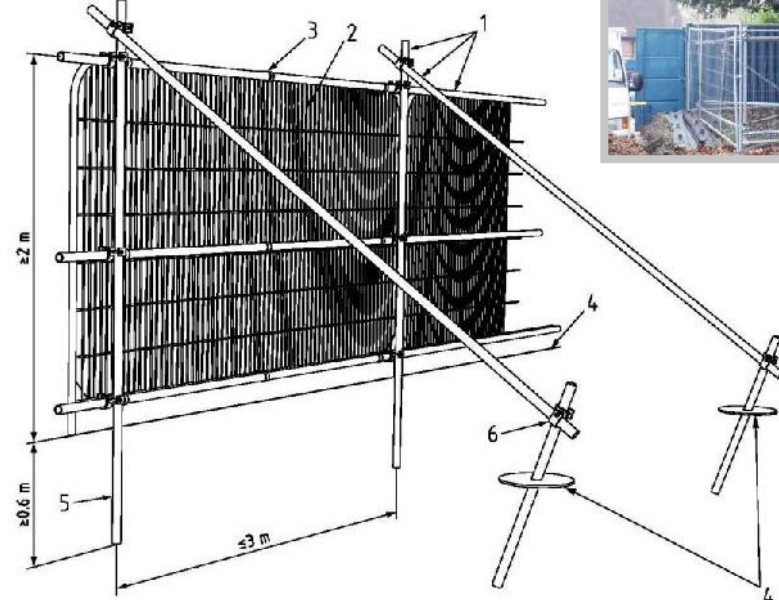
| | <p>Illustration taken from British Standard 5837 (2012): Trees in relation to design, demolition and construction – Recommendations.</p> |
| <p><b>Key</b></p> <ul style="list-style-type: none"> <li>1 Standard scaffold poles</li> <li>2 Heavy gauge 2 m tall galvanized tube and welded mesh infill panels</li> <li>3 Panels secured to uprights and cross-members with wire ties</li> <li>4 Ground level</li> <li>5 Uprights driven into the ground until secure (minimum depth 0.6 m)</li> <li>6 Standard scaffold clamps</li> </ul> <p>The default specification should consist of a vertical and horizontal scaffold framework, well braced to resist impacts. The vertical tubes should be spaced at a maximum interval of 3 m and driven securely into the ground. Onto this framework, welded mesh panels should be securely fixed.</p> <p style="text-align: right;">– BS 5837 (2012)</p> | |

- 5.1.2 **Protective barriers:** The approximate location of the barriers is illustrated on the plan in Appendix 1 and information on barrier design based on BS 5837 (2012) guidance is included in Appendix 3. The protective barriers will be erected before any materials or machinery are brought onto the site and before any clearance or construction activities occur. With the exception of the barrier positions around tree T7 (see 5.1.3 below), once the protective barriers have been positioned, these will stay in situ for the duration of the construction, unless previously agreed with the arboricultural consultant or council's tree officer. There will be no access into the protected areas and the storage of excavated debris and building materials will be prohibited, unless authorised by the arboricultural consultant, after discussion with the council's tree officer. No fires or fuel storage will be allowed within or near to protected areas under any circumstances.

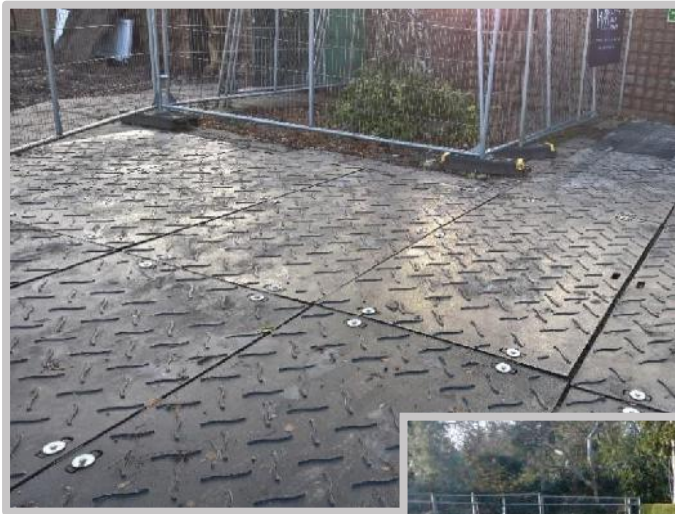
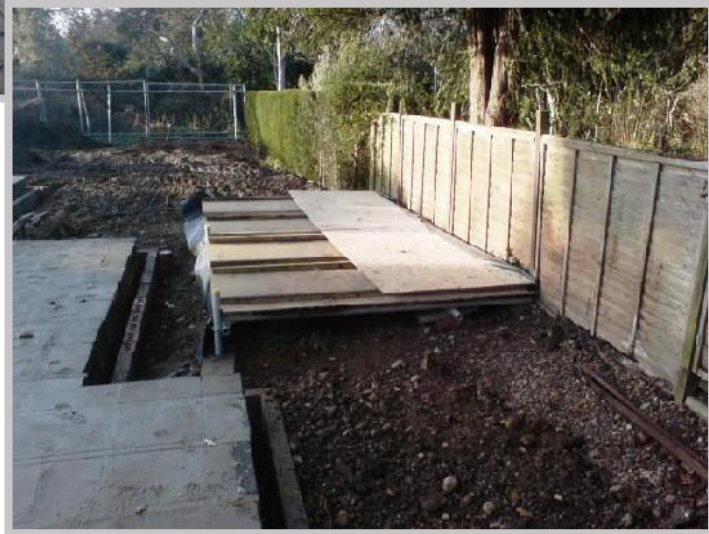
## Appendix 4: Illustrative Specification for Ground Surface Protection

New temporary ground protection should be capable of supporting any traffic entering or using the site without being distorted or causing compaction of underlying soil.

5.1.4 **Ground protection measures:** Where the positioning of tree protection barriers is not feasible due to the need for construction access, then ground protection measures will be needed to safeguard RPAs. The position of ground protection is shown on the plan included in Appendix 1, with guidance for ground protection design included in Appendix 4. The ground protection will be installed before any materials or machinery are brought onto the site and before any clearance or construction activities occur. Again, once the ground protection has been positioned, it will stay in situ for the duration of the construction phase, unless previously agreed with the arboricultural consultant or council's tree officer.

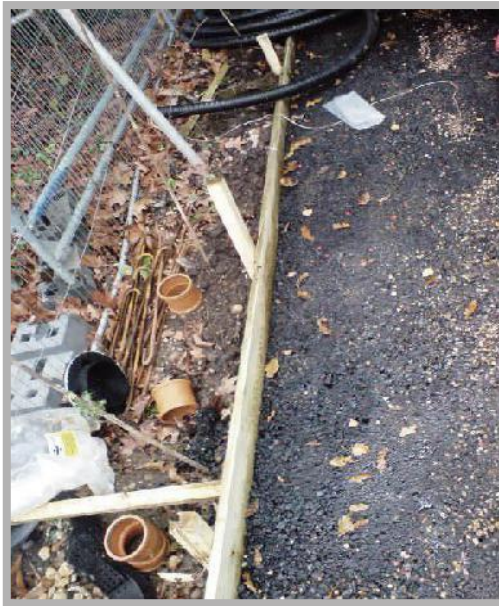
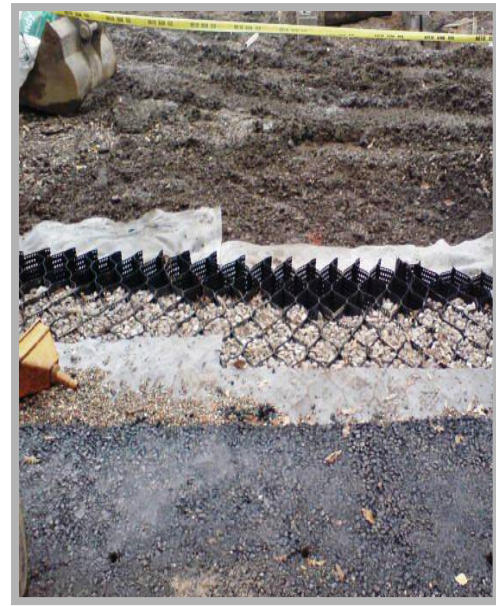
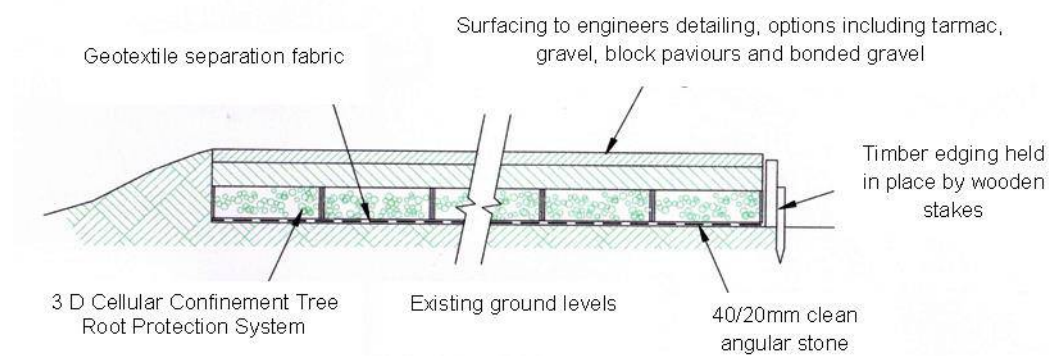
Drawing No. NDS 1

Illustration adapted from original drawings provided by Geosynthetics Ltd.

*Appropriate sub-base options for new hard surfacing include three-dimensional cellular confinement systems. Alternatively, piles, pads or elevated beams can be used to support surfaces to bridge over the RPA or, following exploratory investigations to determine location, to provide support within the RPA while allowing the retention of roots greater than 25 mm in diameter.*

5.2.2 **Installation of new surfacing:** Trees T18, T19 and T20 may be affected by the installation of new surfacing. I have shown the minimum extent of 'low invasive' type surfacing required to successfully retain these trees on the plan included in Appendix 1 and the extent of this is based on their BS derived RPAs. The use of a cellular confinement system is suggested in BS 5837 (2012) as one appropriate way to achieve hard surfacing over tree roots and the following guidance is based on this principle. The cellular system will act as ground protection for the parts of the RPAs that are outside the protective barriers and so will need to be installed before any other construction activity occurs on site. However, before implementation the following specifications and guidance will need to be reviewed by an engineering specialist, to ensure that the final construction is appropriate from an engineering viewpoint and suitable for the purpose intended.

- **Illustrative specifications:** Final drawings will be prepared by the project engineer. These will be based on the illustrative manufacturers specifications for special surfacing included in Appendix 5, or an alternative 'low invasive' construction technique. These definitive plans can be secured by way of a suitably worded planning condition and approved by the council before any construction activity occurs on site.
