## **ARBORICULTURAL IMPACT ASSESSMENT**

**BEREWOOD PHASE 8,  
BEREWOOD,  
WATERLOOVILLE, HAMPSHIRE**

**BLOOR HOMES SOUTHERN LTD**

**Report Number: MB240801-01**

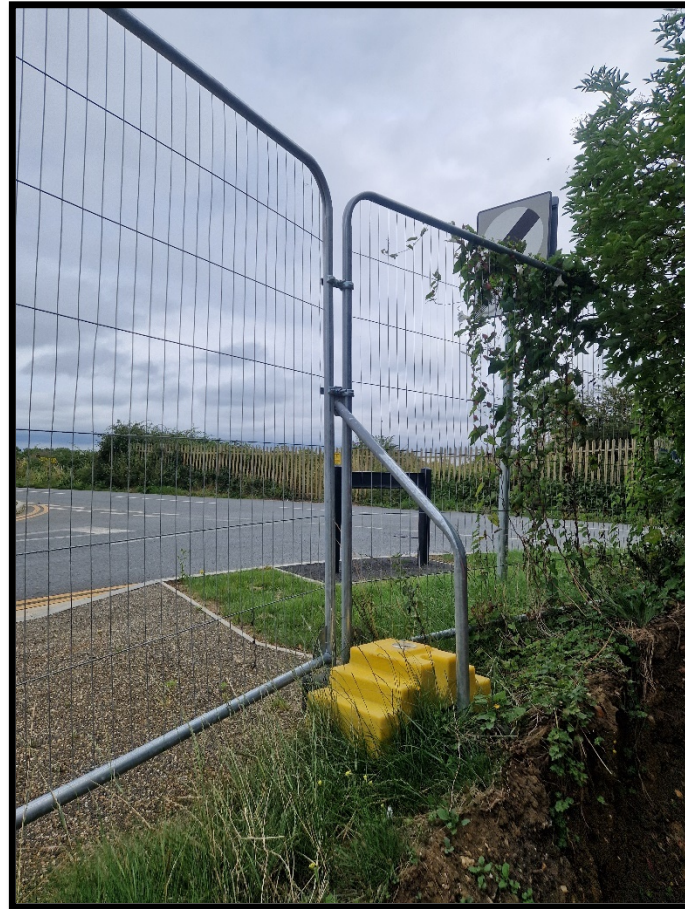
**Fig 1: Proposed Tree Protection Configuration.**

To minimise the potential for harm to occur to the root systems and canopies of retained trees during development it will be necessary to implement construction exclusion zones throughout the site. These are areas surrounding the trees' RPAs and canopies in which no demolition or construction works, or related activities, will be undertaken. These zones will be demarcated by the erection of tree protection barriers prior to any works (with the exception of tree works) being carried out. The tree protection barriers can be installed as shown on Fig 1 below in order to reduce the impact to the ground by using the default system within BS5837:2012. These can be secured to the ground using road pins but the weight of the support barrels will be difficult to move.

It is recommended that the exclusion zones are afforded protection at all times through the use of tree protection barriers and ground protection (specified in accordance with BS5837:2012). It must be noted that any hoarding and tree protection barrier uprights driven into the ground must adopt the procedures as specified within Section 3.3.9.

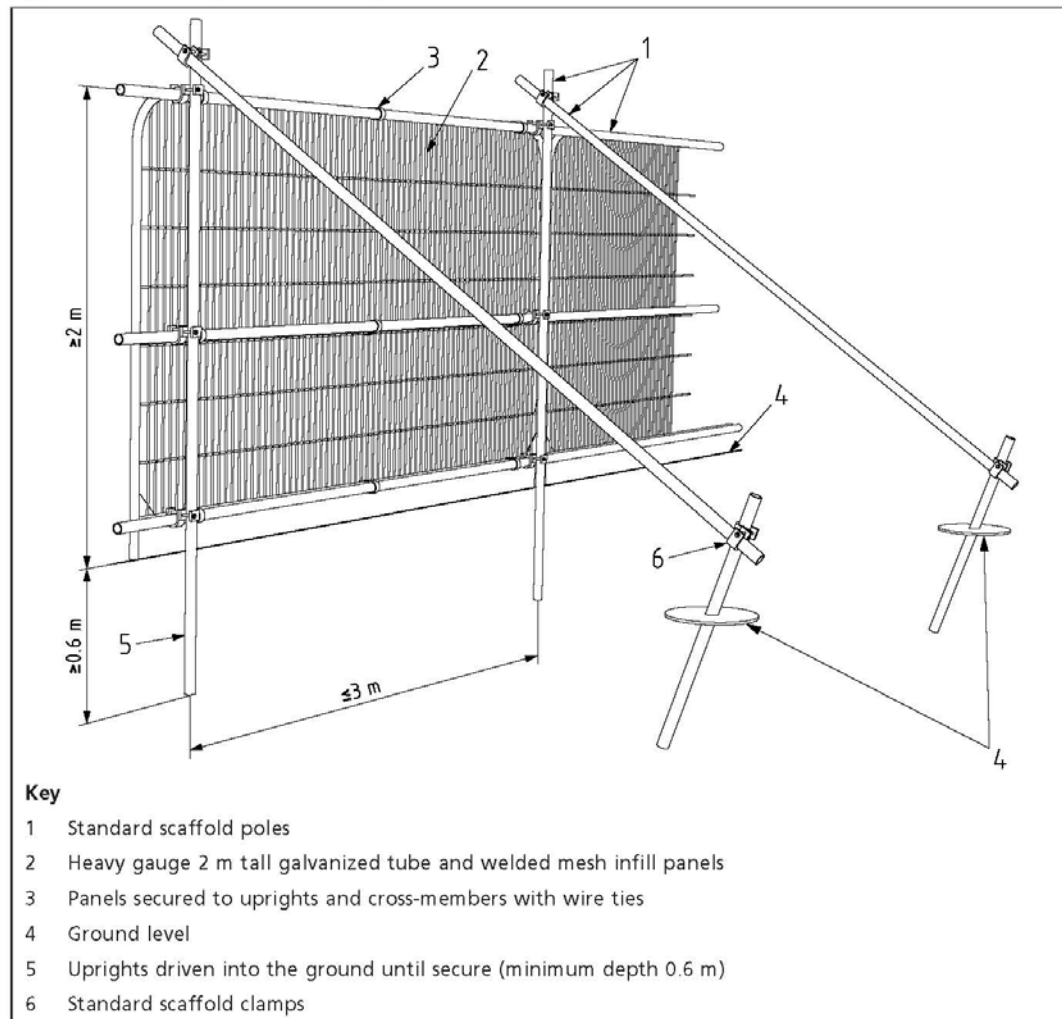
Figure 2 Default specification for protective barrier

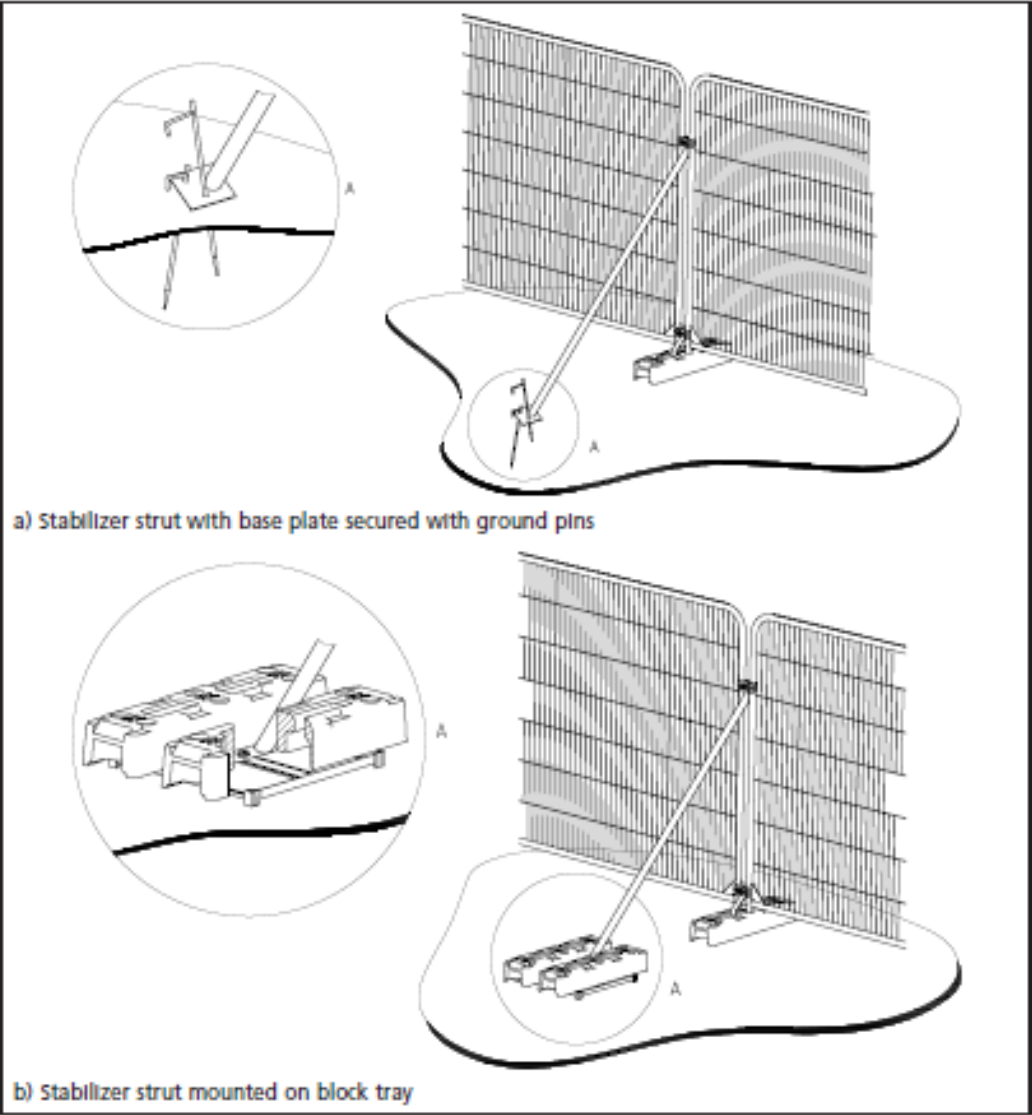
Figure 3 Examples of above-ground stabilizing systems

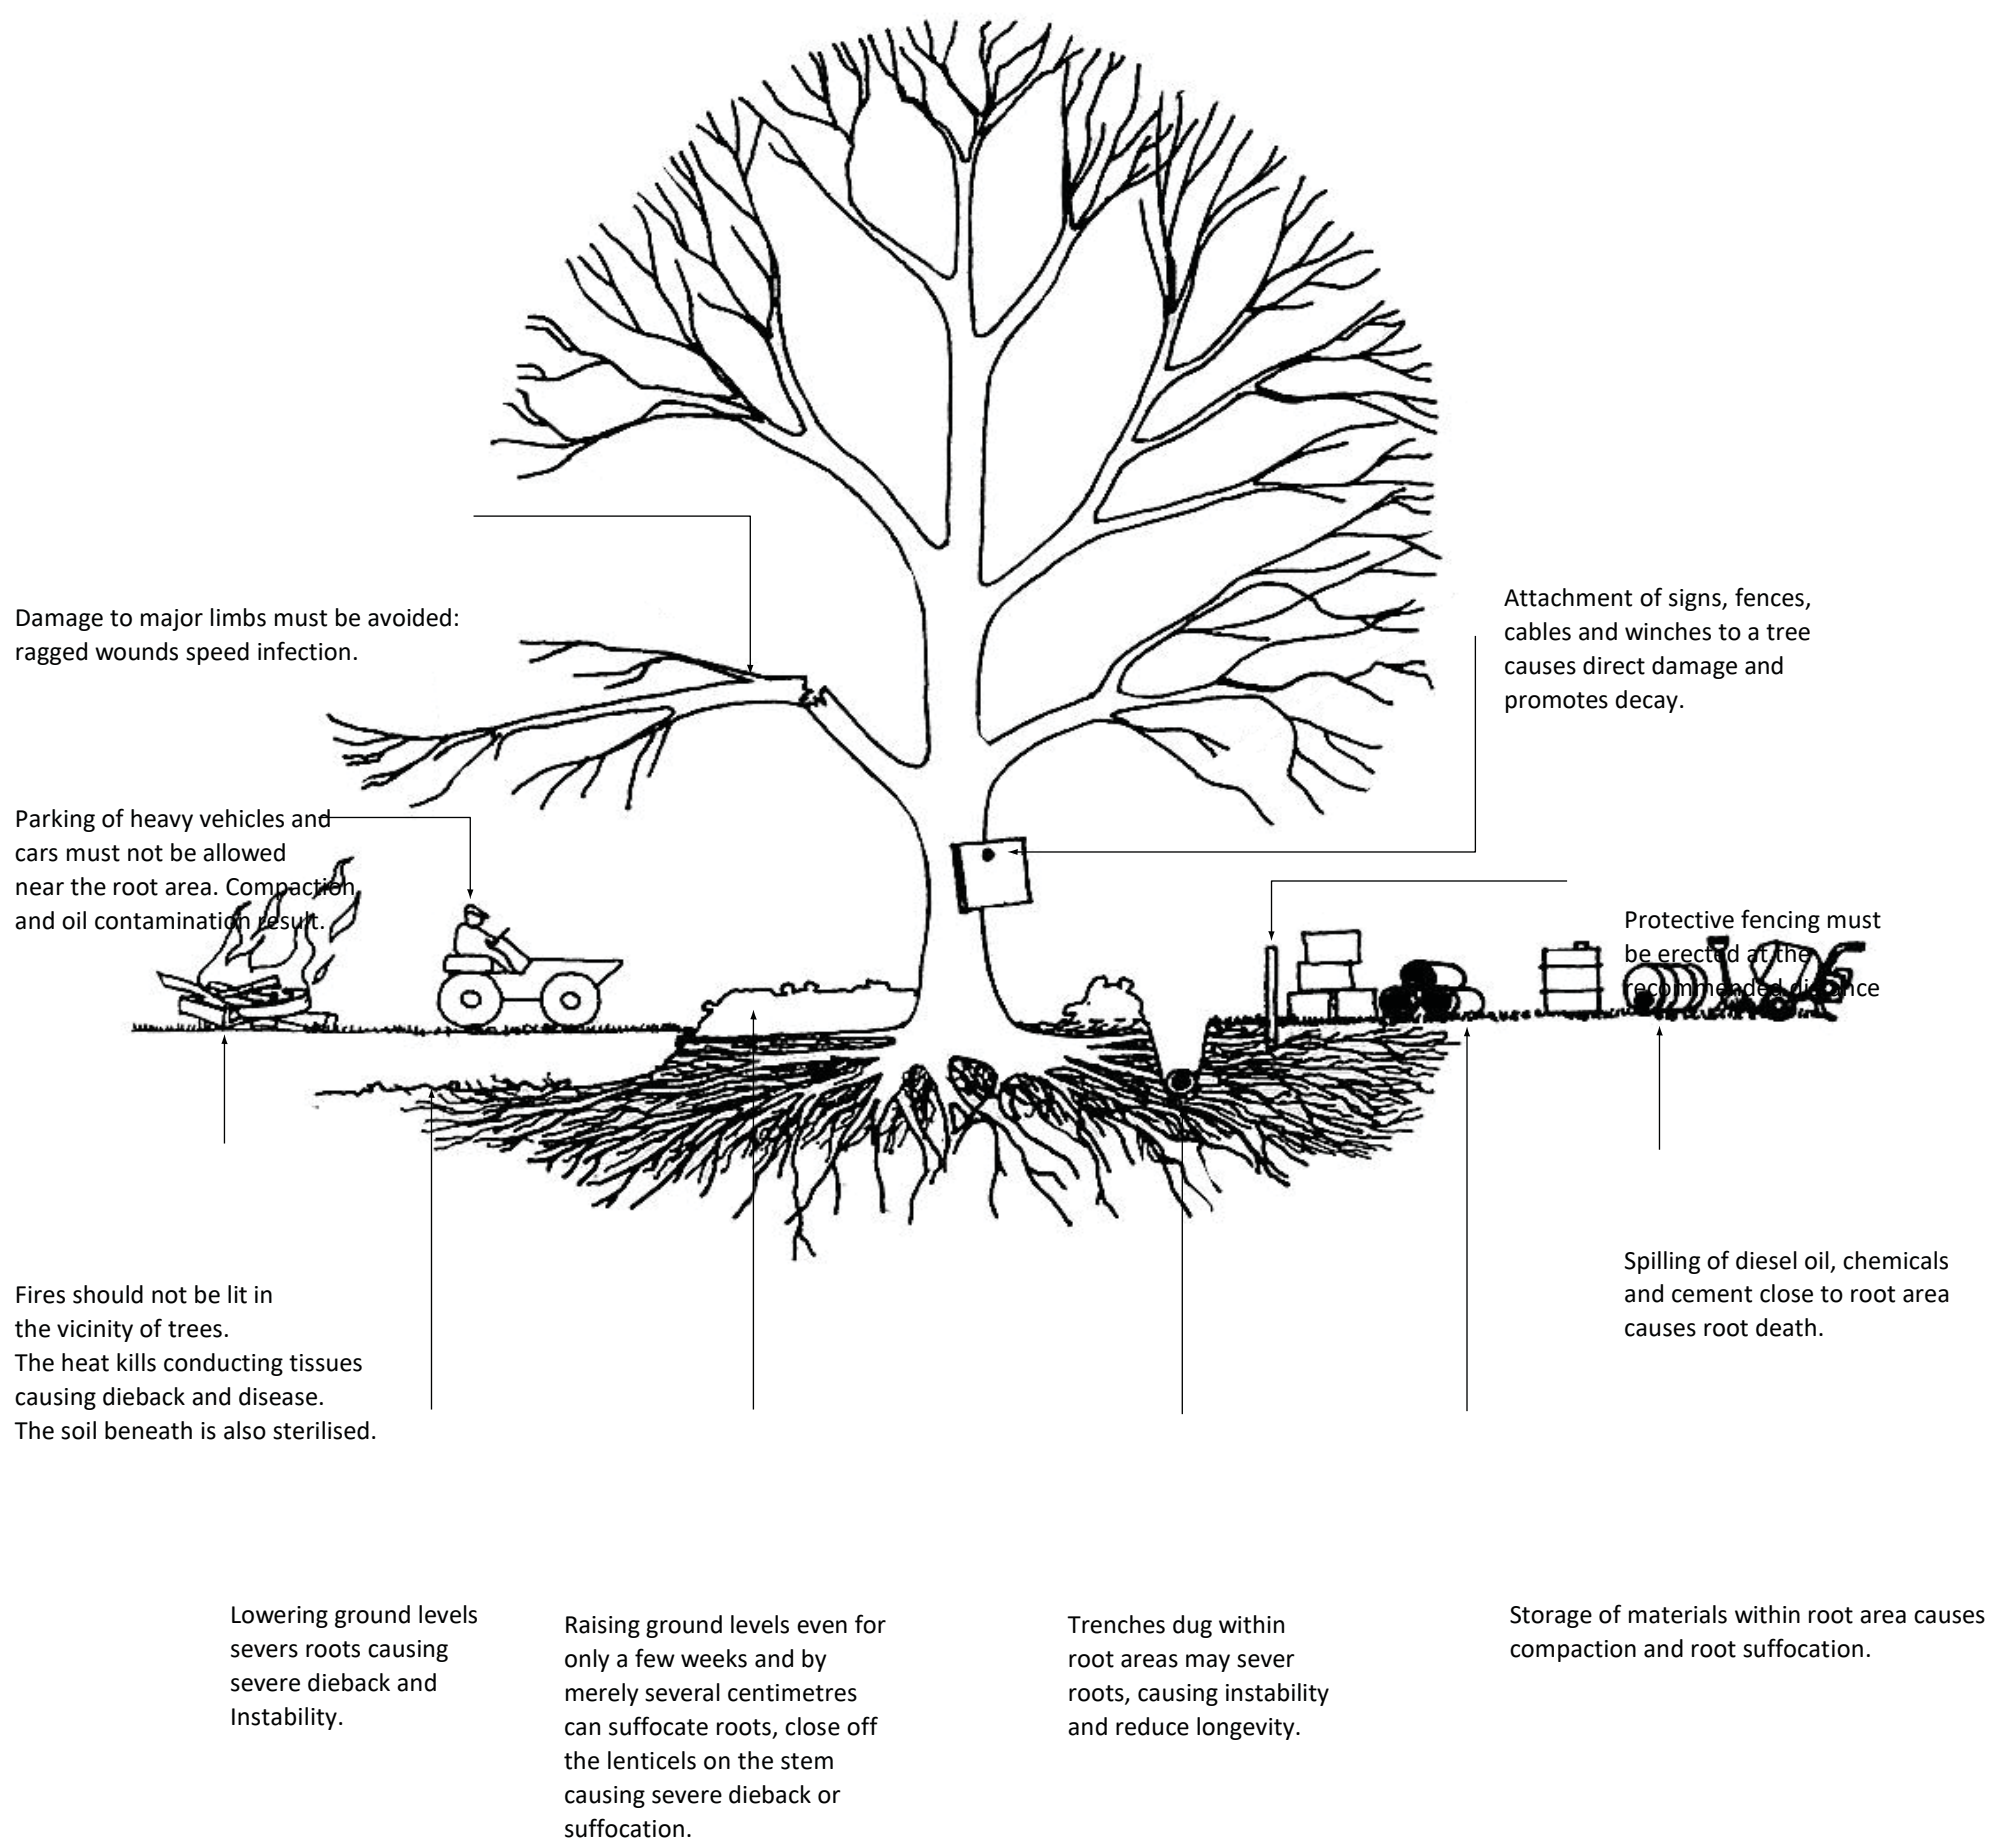
## Common Causes of Tree Death

The use of properly positioned protective fencing can prevent tree deaths occurring. For site offices and contractors.
