**Swanmore Road  
Havant  
PO9**

**PROPOSED SITE ACCESS, INFORMAL CROSSINGS & INTERNAL  
LAYOUT**

**STAGE 1 ROAD SAFETY AUDIT**

Report No. EC/2022/04/GTA2

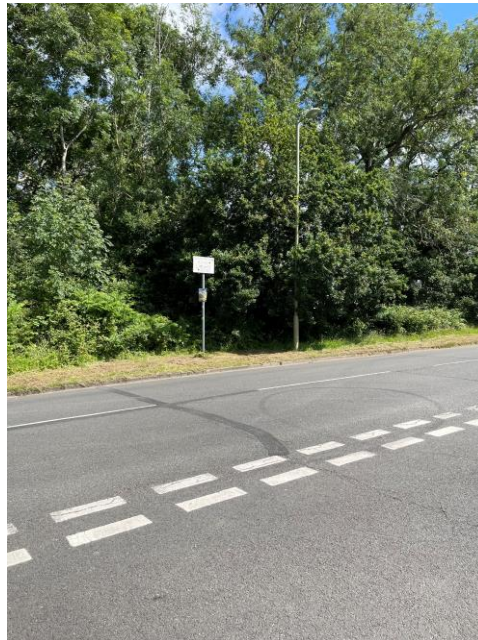
Location: Swanmore Road (northern side)

Summary: Risk of cycle and pedestrian injury due to footway obstructions.

**Detail:** There are currently various items of street furniture in place where the new proposed footway will be provided. This includes lamp columns, signposts, overhanging vegetation, and trees. The shared use path would require a level surface and one without pinch points and obstructions. If these are not relocated to suitable positions, they would be a road safety concern resulting in injury to cyclists or pedestrians.

Footway obstructions to be removed and street furniture to be relocated where appropriate.

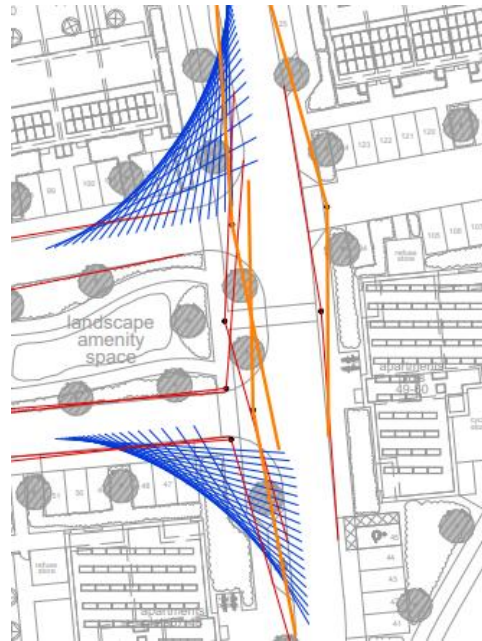
Location: Various junctions within the proposed development

Summary: Risk of failure to give way type collisions and side swipe collisions.

A visibility splay plan has been provided to the Audit Team that shows the forward visibility and general sightlines at each junction. Whilst it would be expected vehicle speeds would be low within the development, drivers will be required to give way on the approach to each junction with the 'main' through road or 'spine' road running through the development. However, the plan indicates new trees and planting close to the junctions. It is unclear at this stage the size of the proposed trees and the type. Many of the sightlines appear to be obstructed by such trees and as such could result in drivers failing to give way to oncoming vehicles. This could risk side swipe collisions occurring.

Trees removed from sightlines to always ensure good and unobstructed visibility.
