# NOISEWALL

**Noisewall®** Single Sided Reflective Timber  
Sound Screen On Steel Section Posts  
(for illustration purposes only)

RANS/Noisewall®/Steelpost/001

**BS EN 1793-2 : 1998**

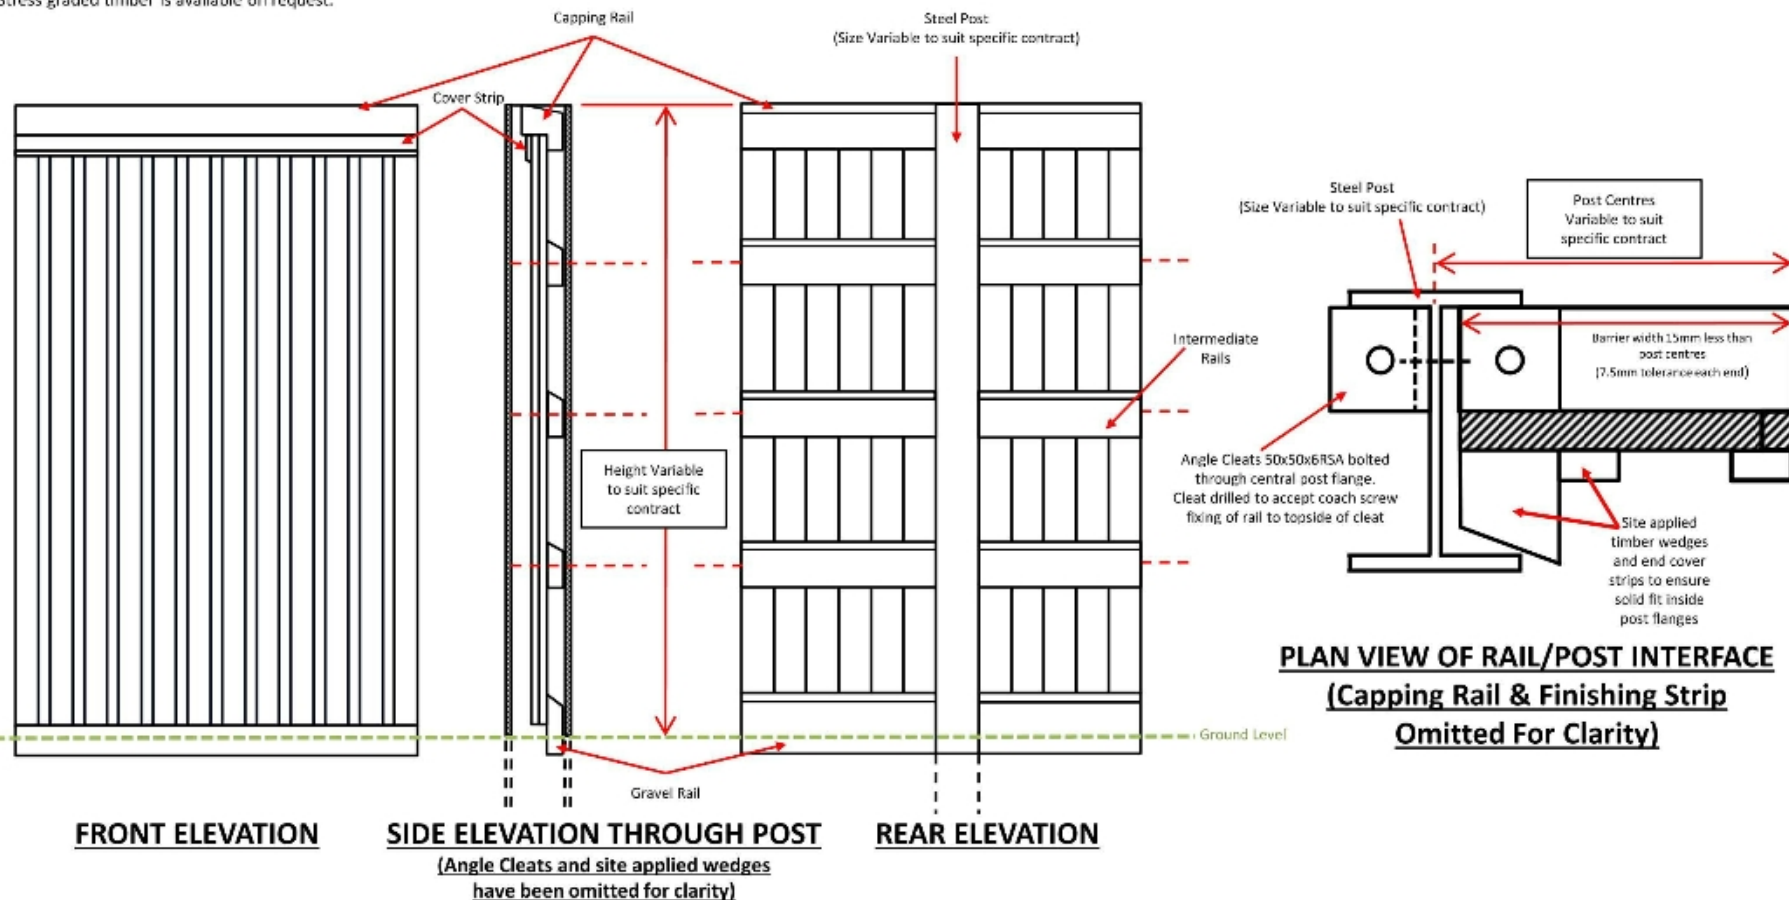
Design of Screen is dependant on individual specifications and the drawing shown is for illustrative purposes only.

Posts are of steel construction – The exact design criteria for special structures should be specified by a professional designer and qualified for intended purpose by a structural engineer.

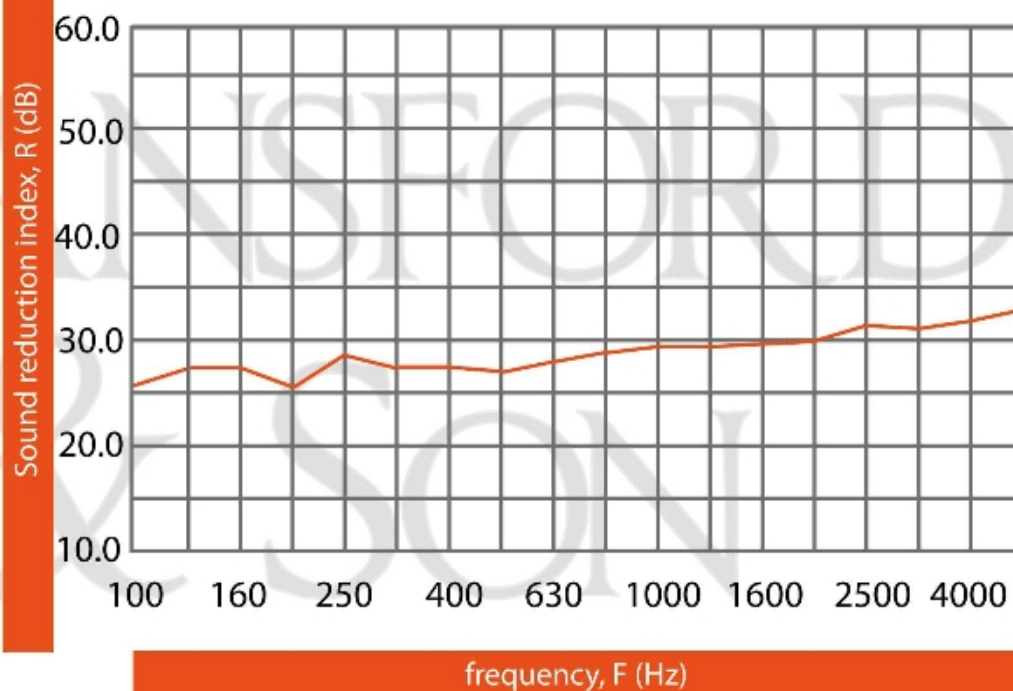
**Test reference number:** 44-18

**Acoustics- Road traffic noise reducing devices**

**Object:** Noisewall® - Single Sided Reflective Barrier with Vertical Boards & Cover Strips

$DL_R = 29$

**Category:** B3
