Copy of Email: 10 Dec 2021

Subject: 27A Queens Road - Further information in support of Application  
APP/21/01110

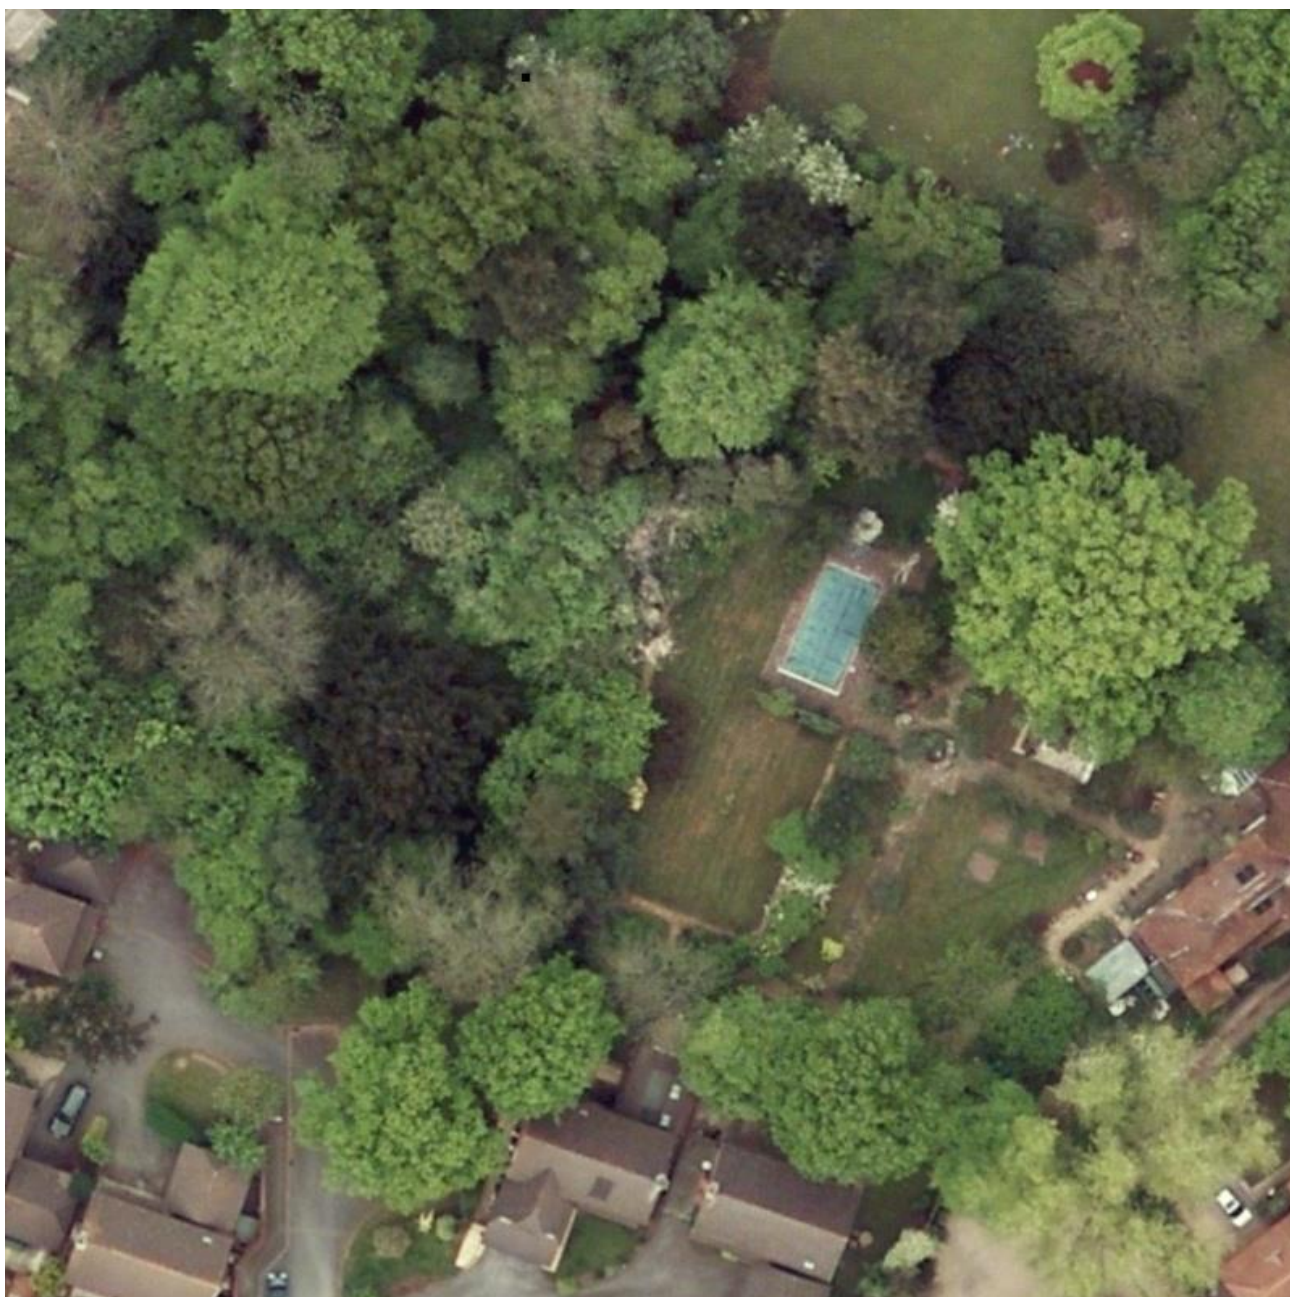
The picture in Image 1. below is an Ariel photograph taken in 2004, for reference purposes the large light green tree to the right of the swimming pool is the Oak tree (with a T4 designation on the current proposal) also please note the top of this image faces North.

You can see the swimming pool together with large areas of concrete paving and brickwork patios and pathways that had been constructed in and around the oak tree and leading into the woodland area at the top of the picture. Concrete steps are also visible as is the Pool House which itself stood on a concrete foundation, with further patios and paths to the south and east of the Oak Tree. When construction of the new houses were undertaken it appears that most of these pavings, pathways and swimming pool installations were left insitu, covered over with a thin layer of soil and then seeded. Trial dig holes as shown below on Images 7 -13 confirms this point.

**Image 1. Ariel image of plot dated 2004 and as per site prior to demolition and construction circa 2011** - depicts the site with the earlier house No 27 Yew Tree Cottage, to the bottom right. Please note existing concrete paving with brickwork walls creating pathways and patios around the oak tree, swimming pool and pool house. Steps, water fountain and pathways leading into woodland to North (top of picture) are also shown. It is not clear from this picture but I understand, from discussions with the former owner, that there were also concrete paths behind the Oak tree, leading from the Pool House, up towards the main house

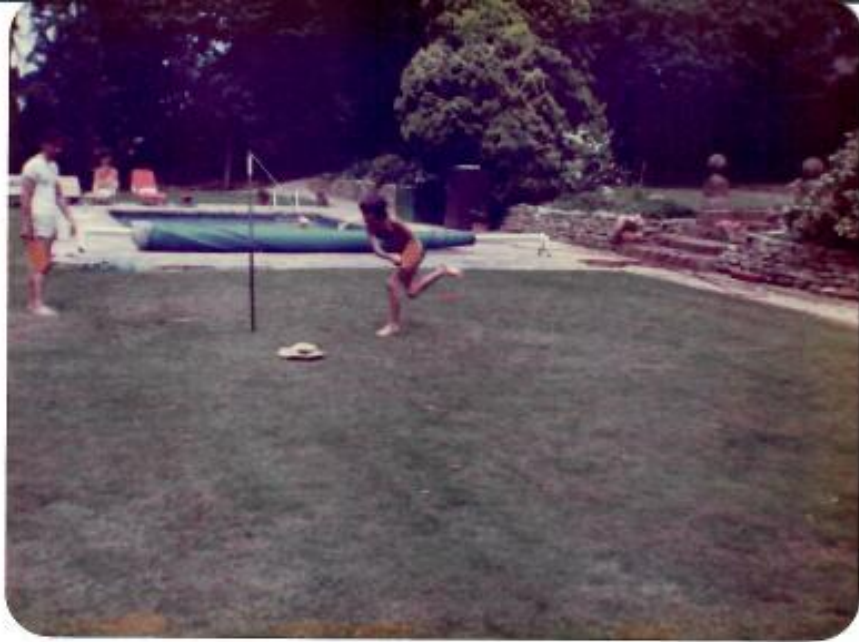
**Image 2. The pool area , patio and steps with chestnut tree, upper centre, in front of the Pool House - see Image 3 below**

The chestnut tree was felled, I understand, as part of the construction of the new house

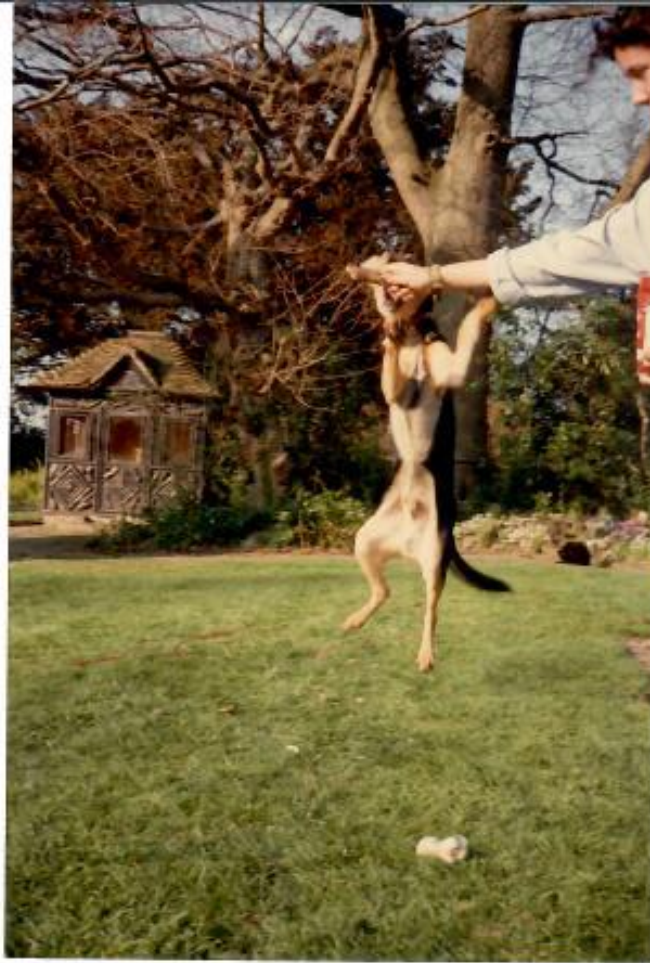
**Image 3. Shows the Pool House to the left and set further back into the plot of the Oak tree**

This building was demolished in 2012.

It was on the site of the now proposed garages

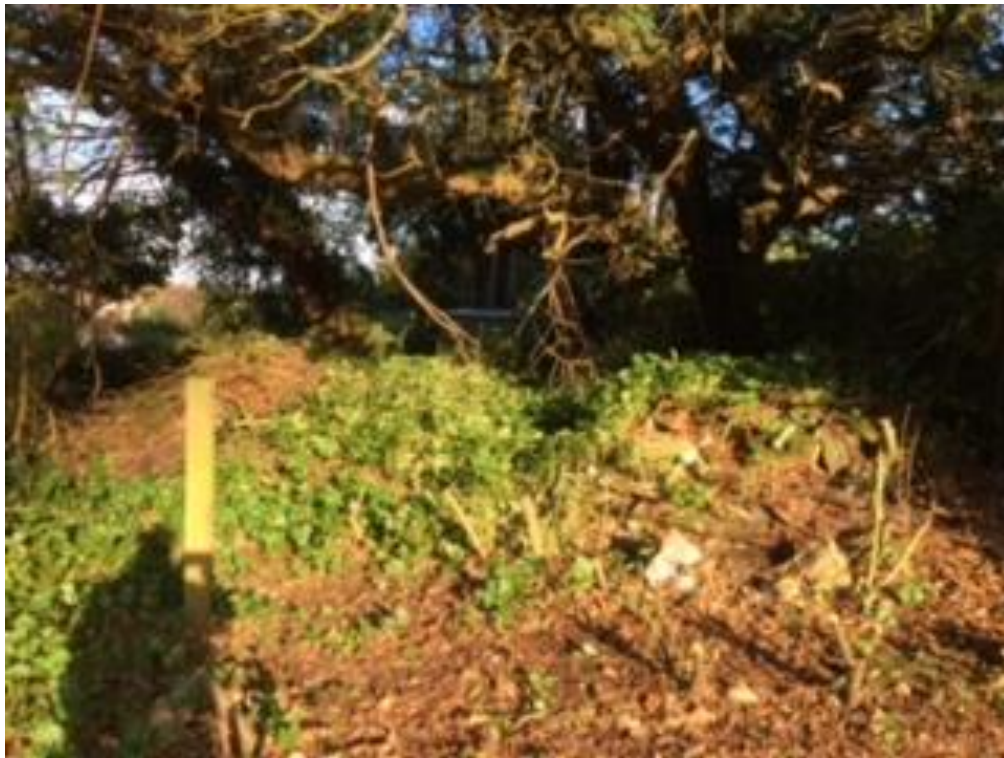
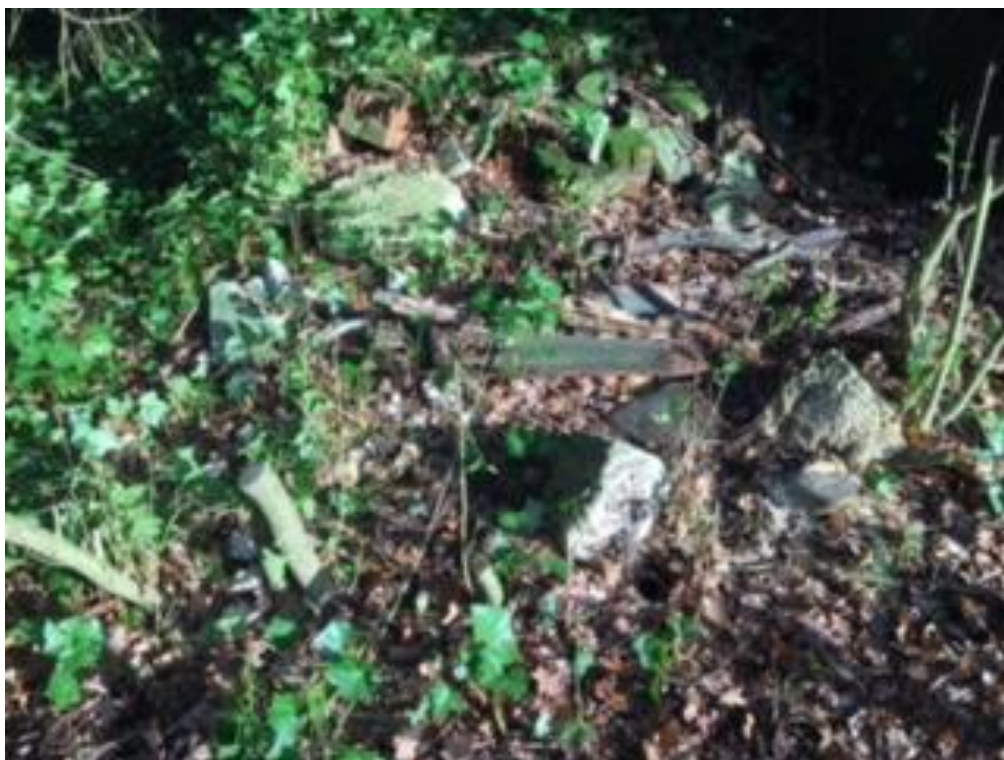
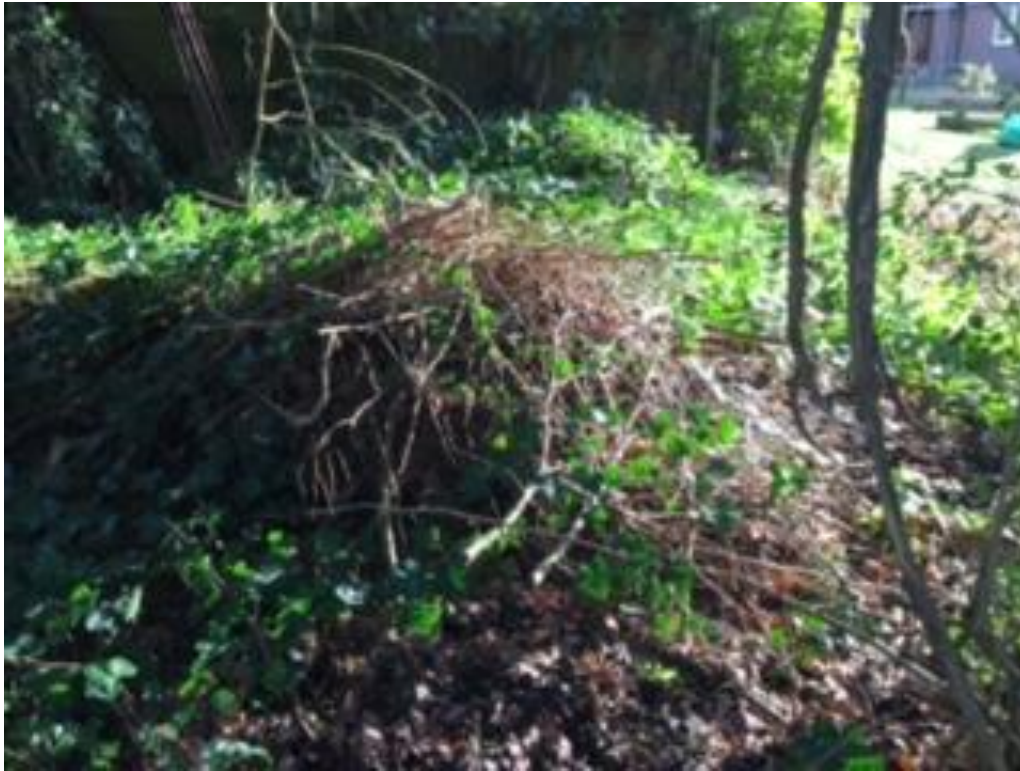
**Images 4. 5 and 6** These show the large piles of brickwork and rubble, broken glass and rusty nailed timber etc that had been dumped at some previous date, I understand this occurrence happened prior to 1982 when the previous owners of No 27 Queens road first moved into the property.

We removed several tons of building rubble and waste from this area in an effort to clean up the space and make it safe.

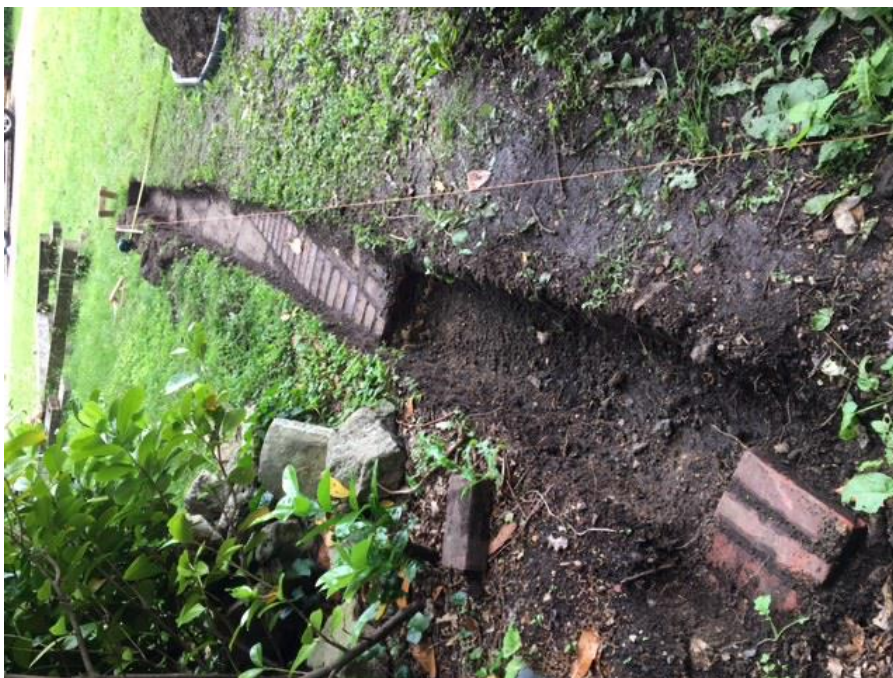
**Image 7. below shows the shallow trench that I excavated and uncovered brickwork and concrete paving**

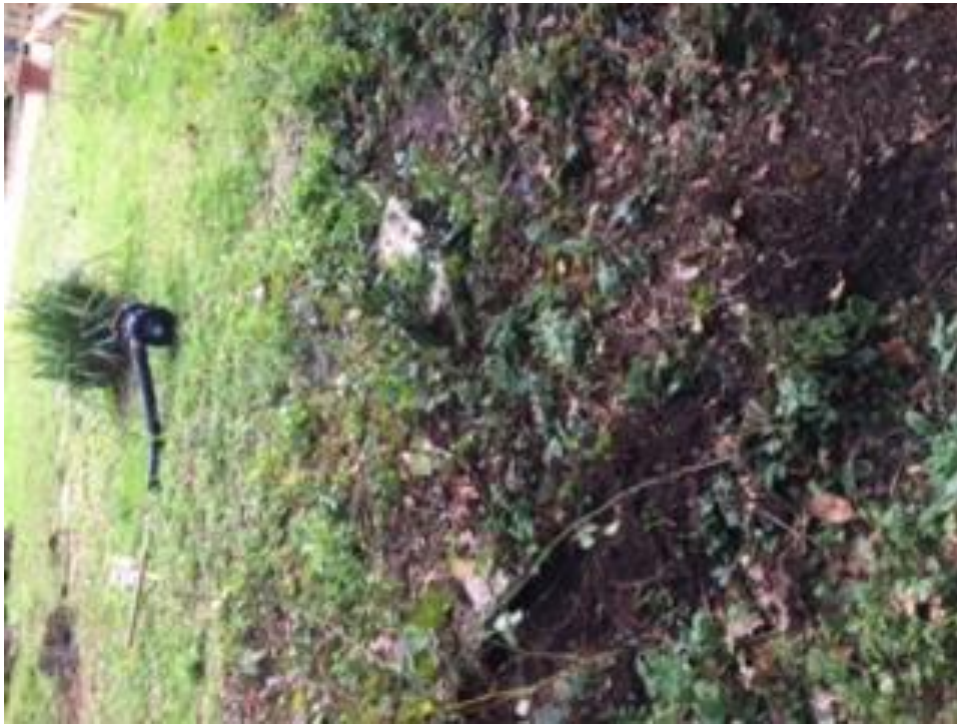
**Image 8**

**Images 8. 9. and 10. Below shows uncovered brickwork and concrete paving to the rear of the old Pool House and into the woodland**

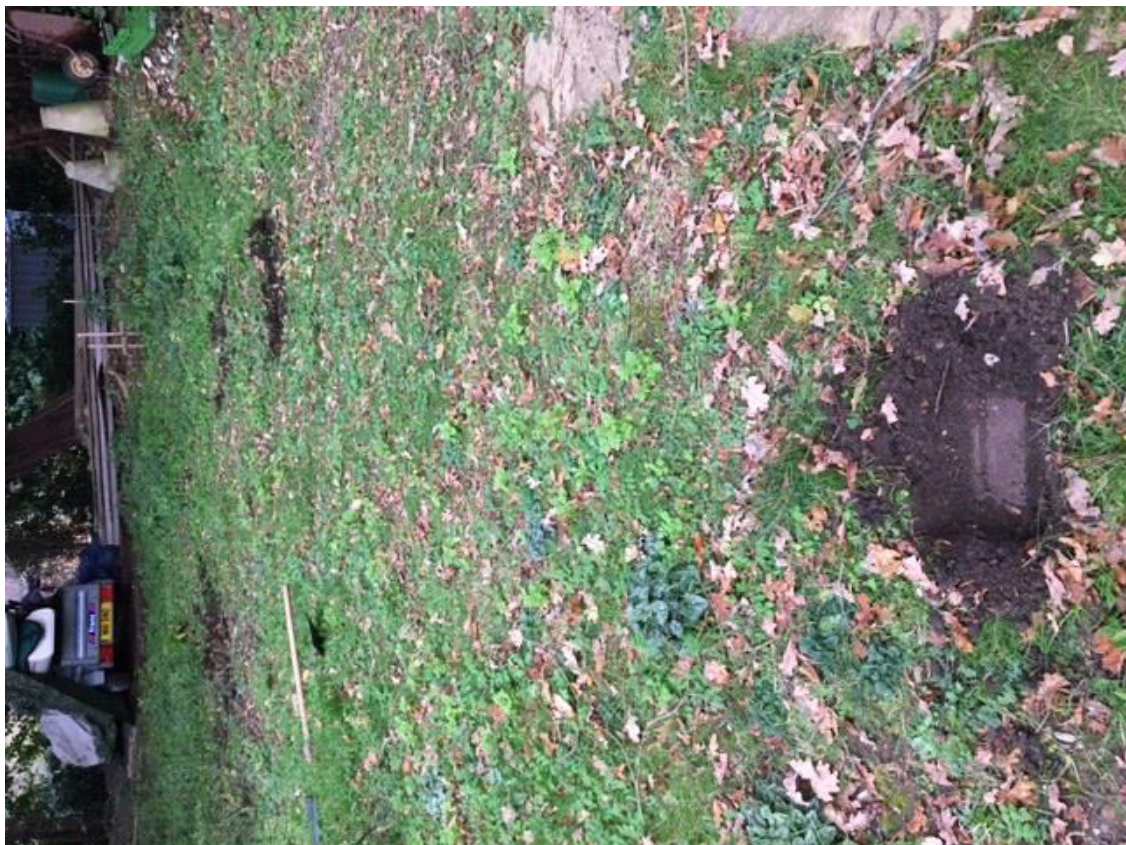
Image 11.

Images 11, 12 and 13 show further limited depth trial holes that have uncovered the earlier pavings and construction, these three holes are located on a line along the central north south axis of the proposed garage
