## Drainage Strategy and Flood Risk Statement

### Land Adjacent 54 Long Copse Lane Emsworth, Hants

**Reference:** 20053

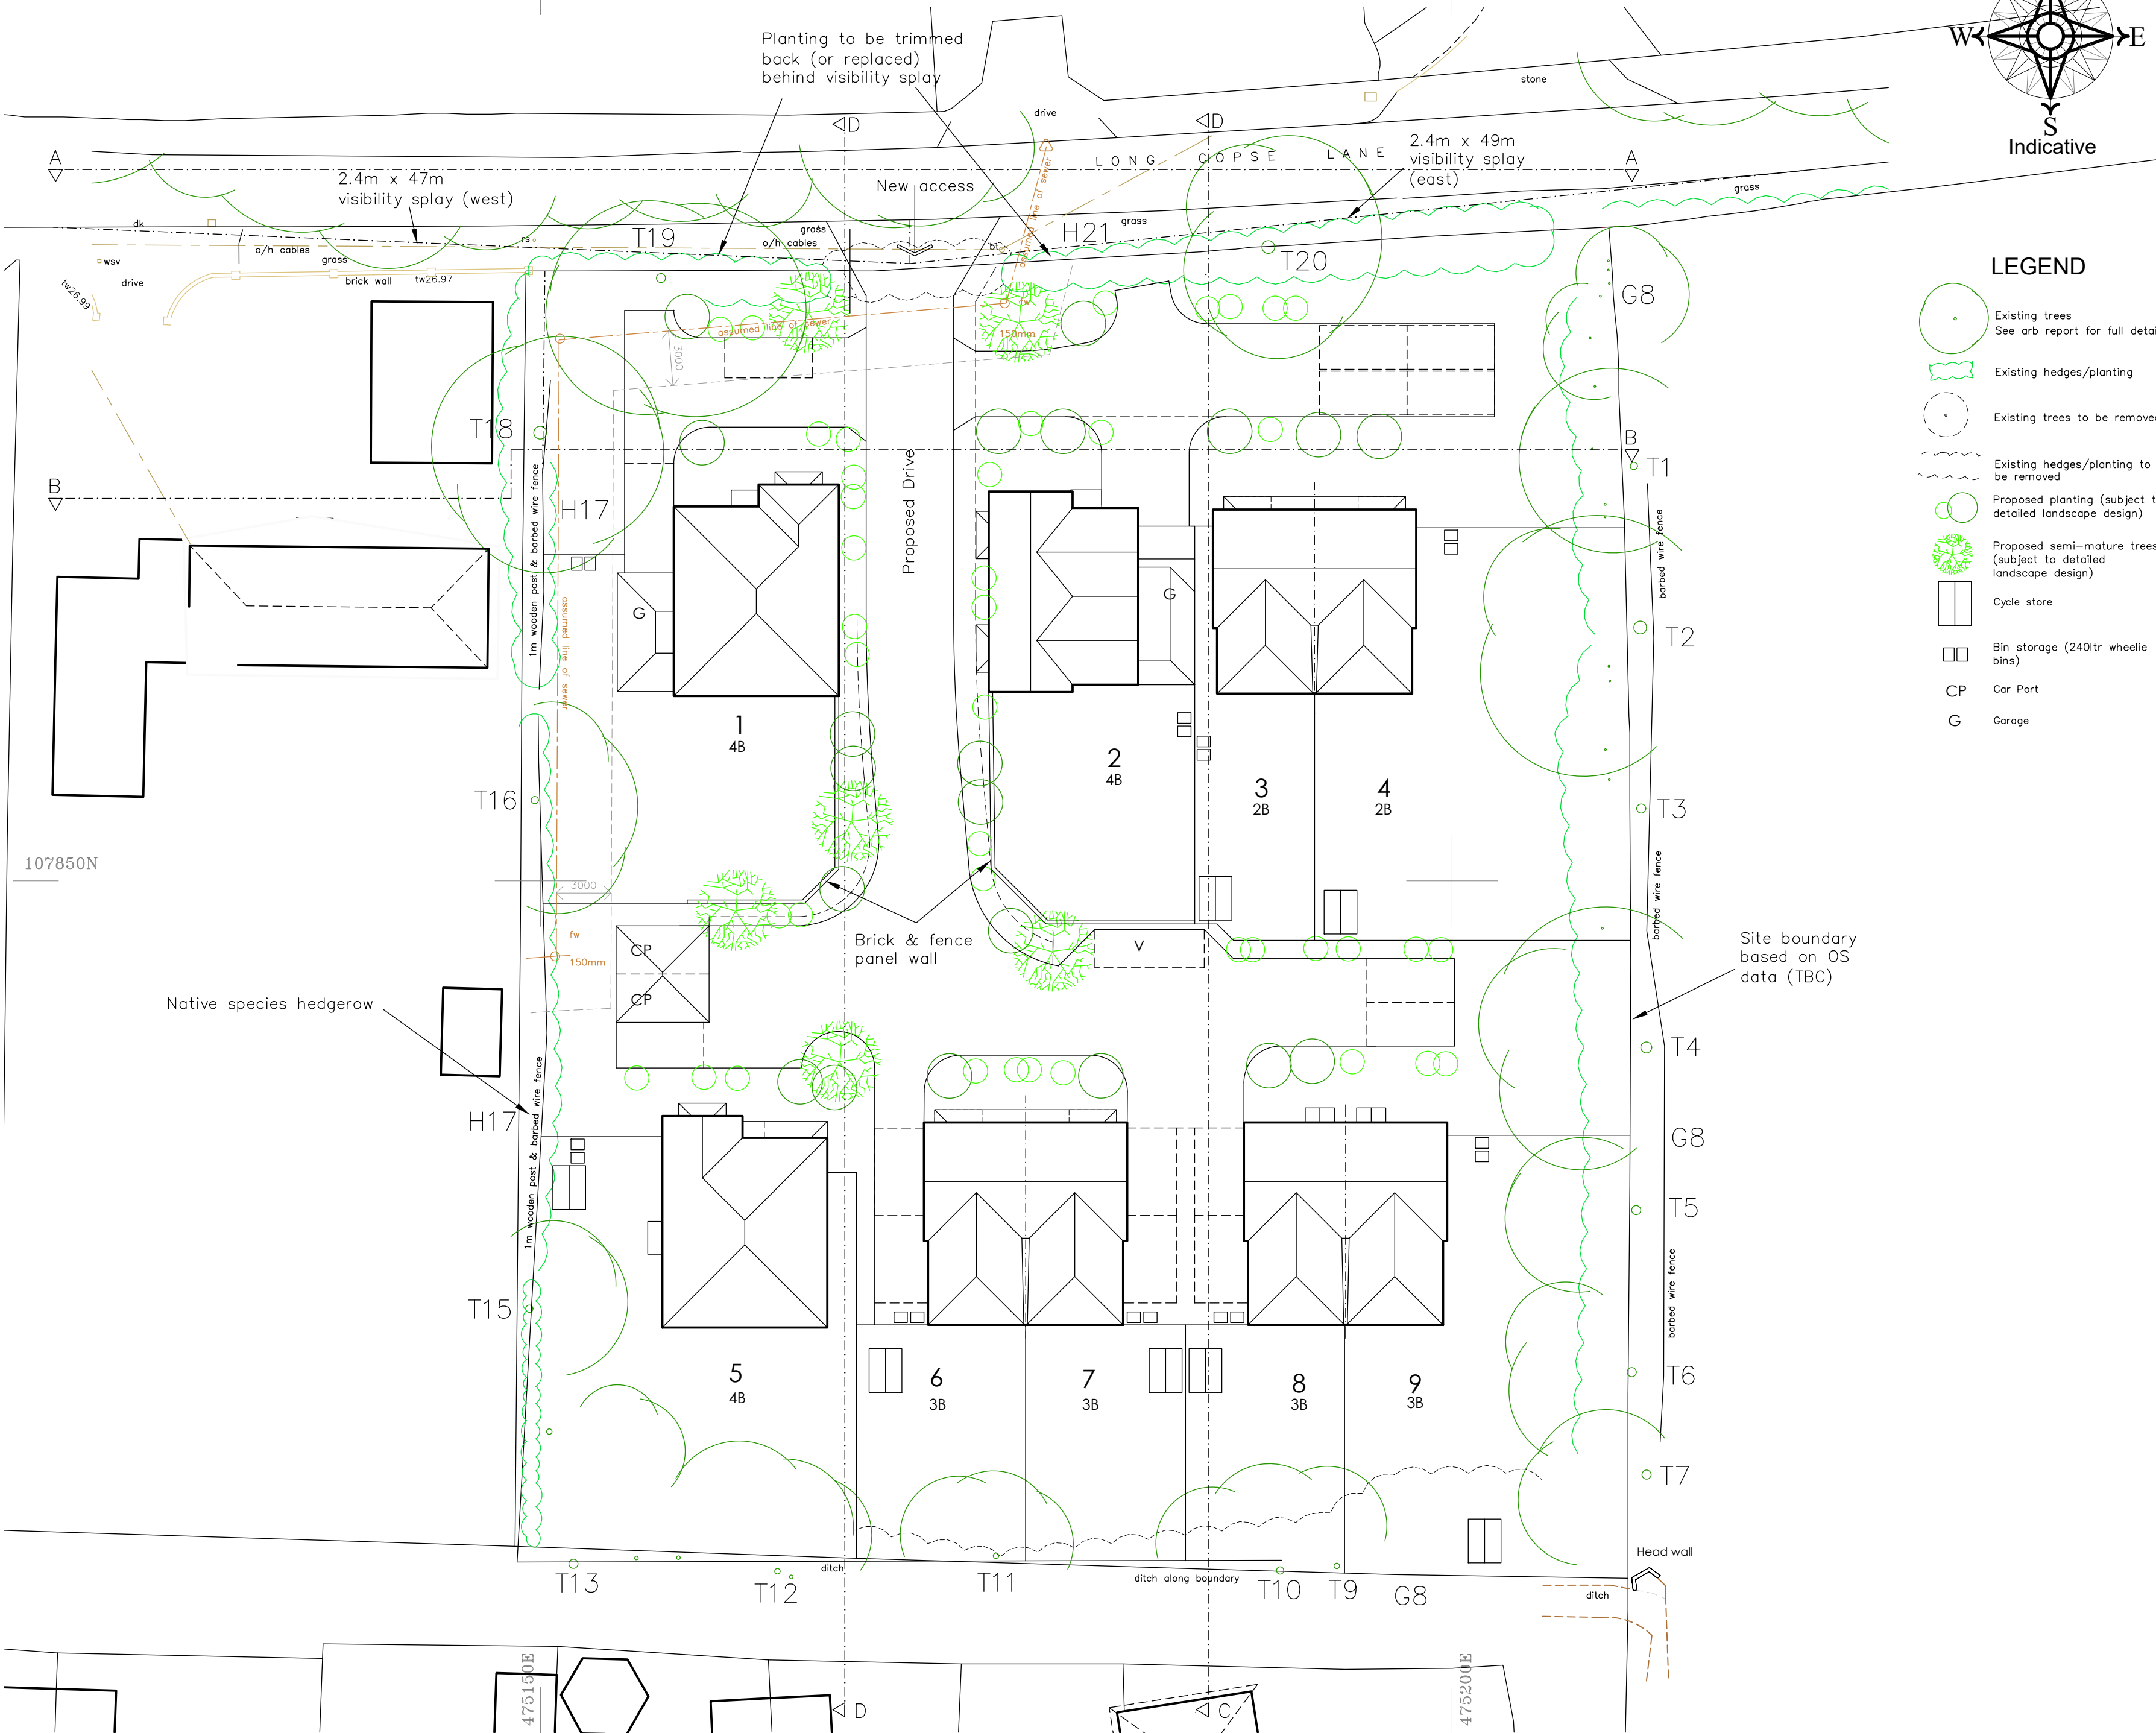
**Site Layout**

- 2.1 The site comprises some 0.44Ha of land to the south of Long Copse Lane, Emsworth, Hants (grid ref 475175 107850). The site extents are indicated on the annotated aerial photograph in Appendix A. The existing topography is shown on P Stubbington drawing 6323/01 contained in Appendix A of this report.
- 2.2 The site comprises a small paddock.
- 2.3 It is proposed to develop the site for 9 dwellings. The proposed layout is identified on ADP Architects drawing number 1882-01-J contained in Appendix A of this report.

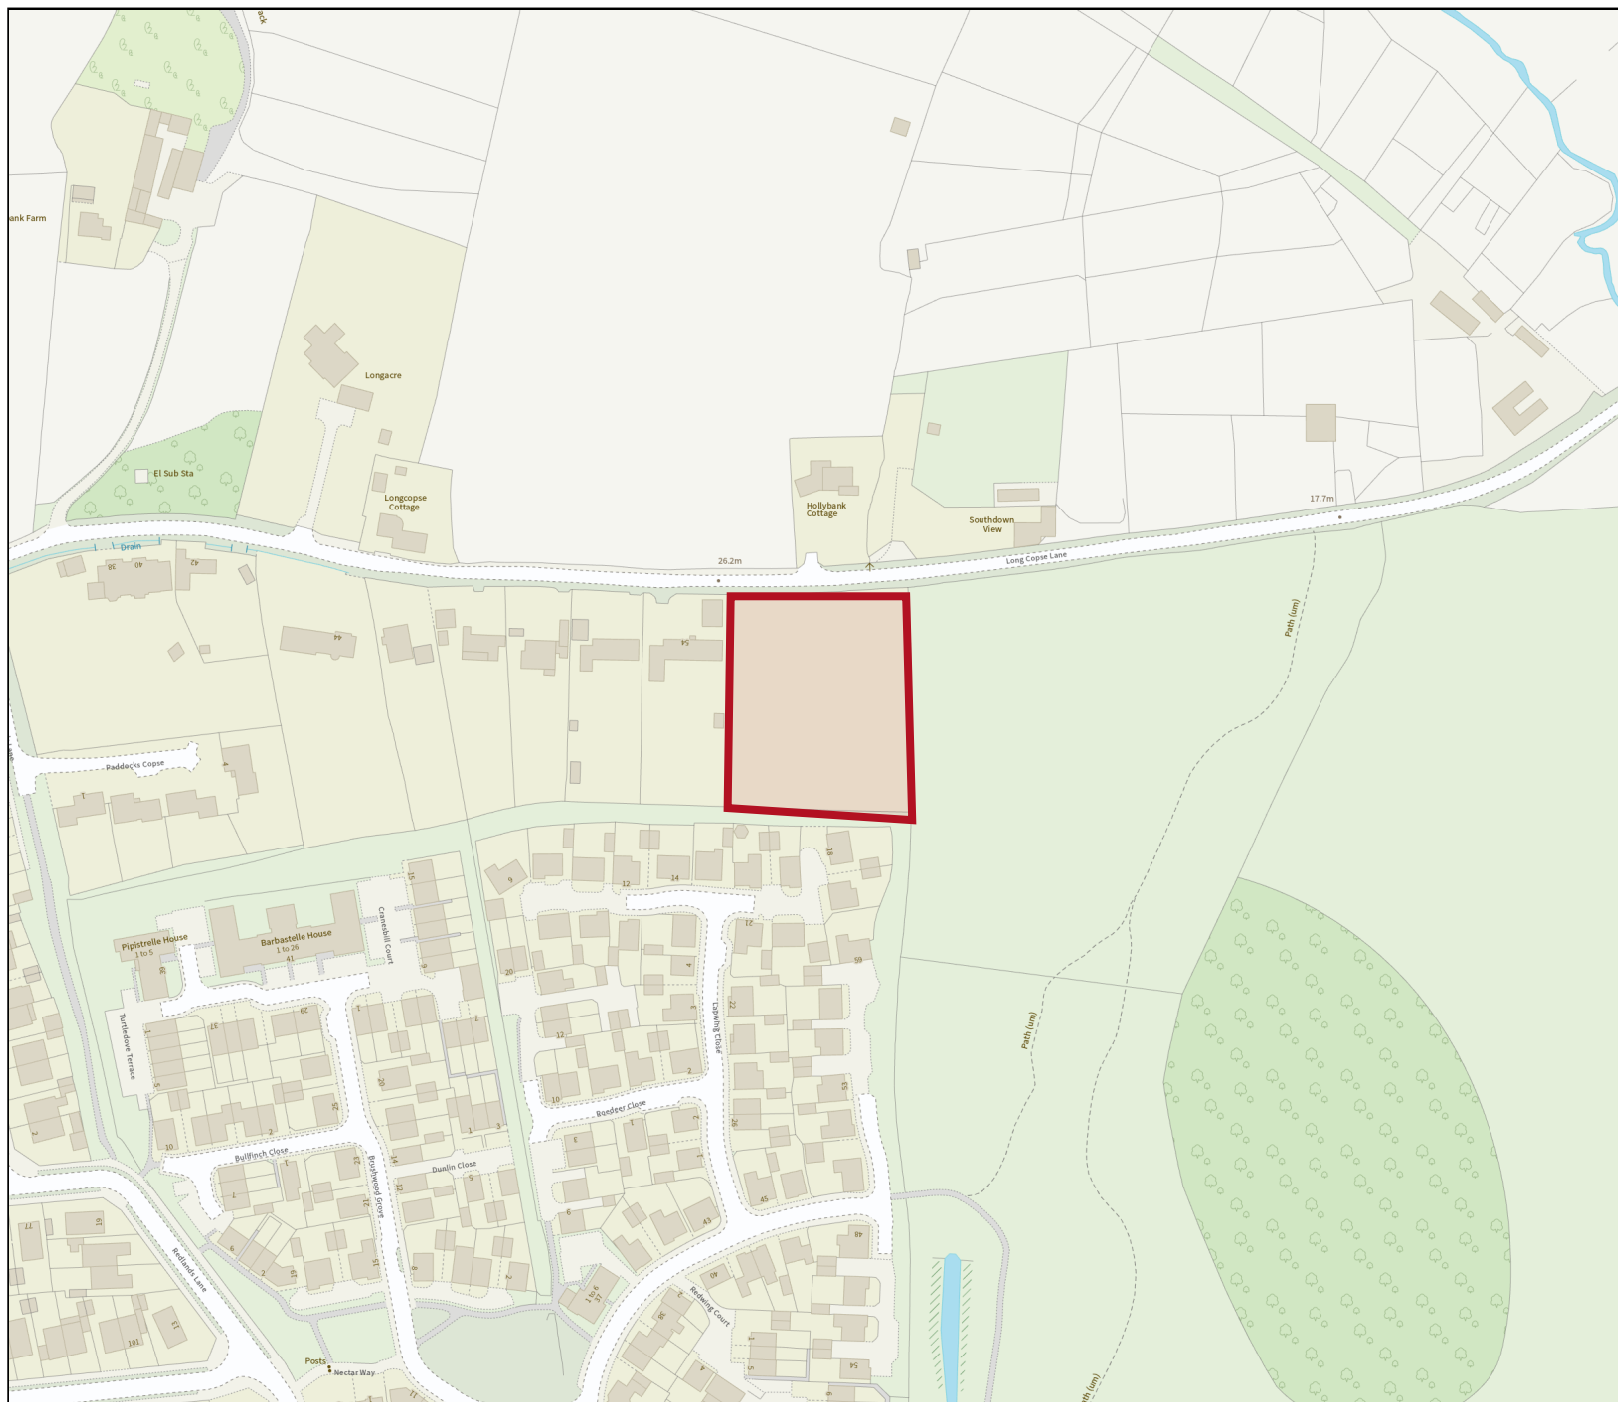
## Flood map for planning

- 5.1 The site is at an elevation of some 22 mAOD and is not susceptible to tidal flooding.
- 5.2 The EA flood mapping indicates that the site is wholly in Flood Zone (FZ) 1. The site is therefore at low risk of fluvial flooding (<0.1% AEP).

- 6.2 The site is wholly in flood zone 1.

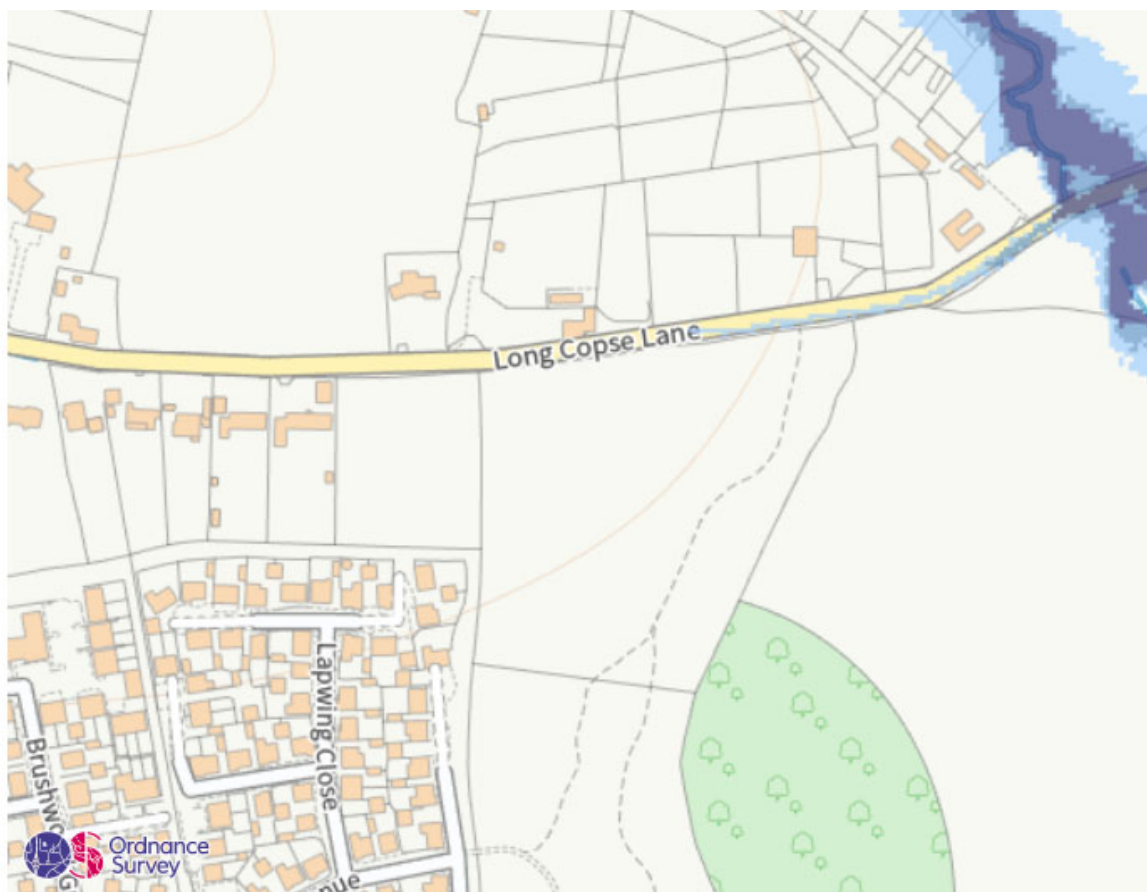
Extent of flooding from surface water

- 5.3 The EA mapping indicates the site is not at risk of reservoir flooding.
- 5.4 The EA mapping indicates the site is at very low risk of surface water flooding (<0.1%AEP).

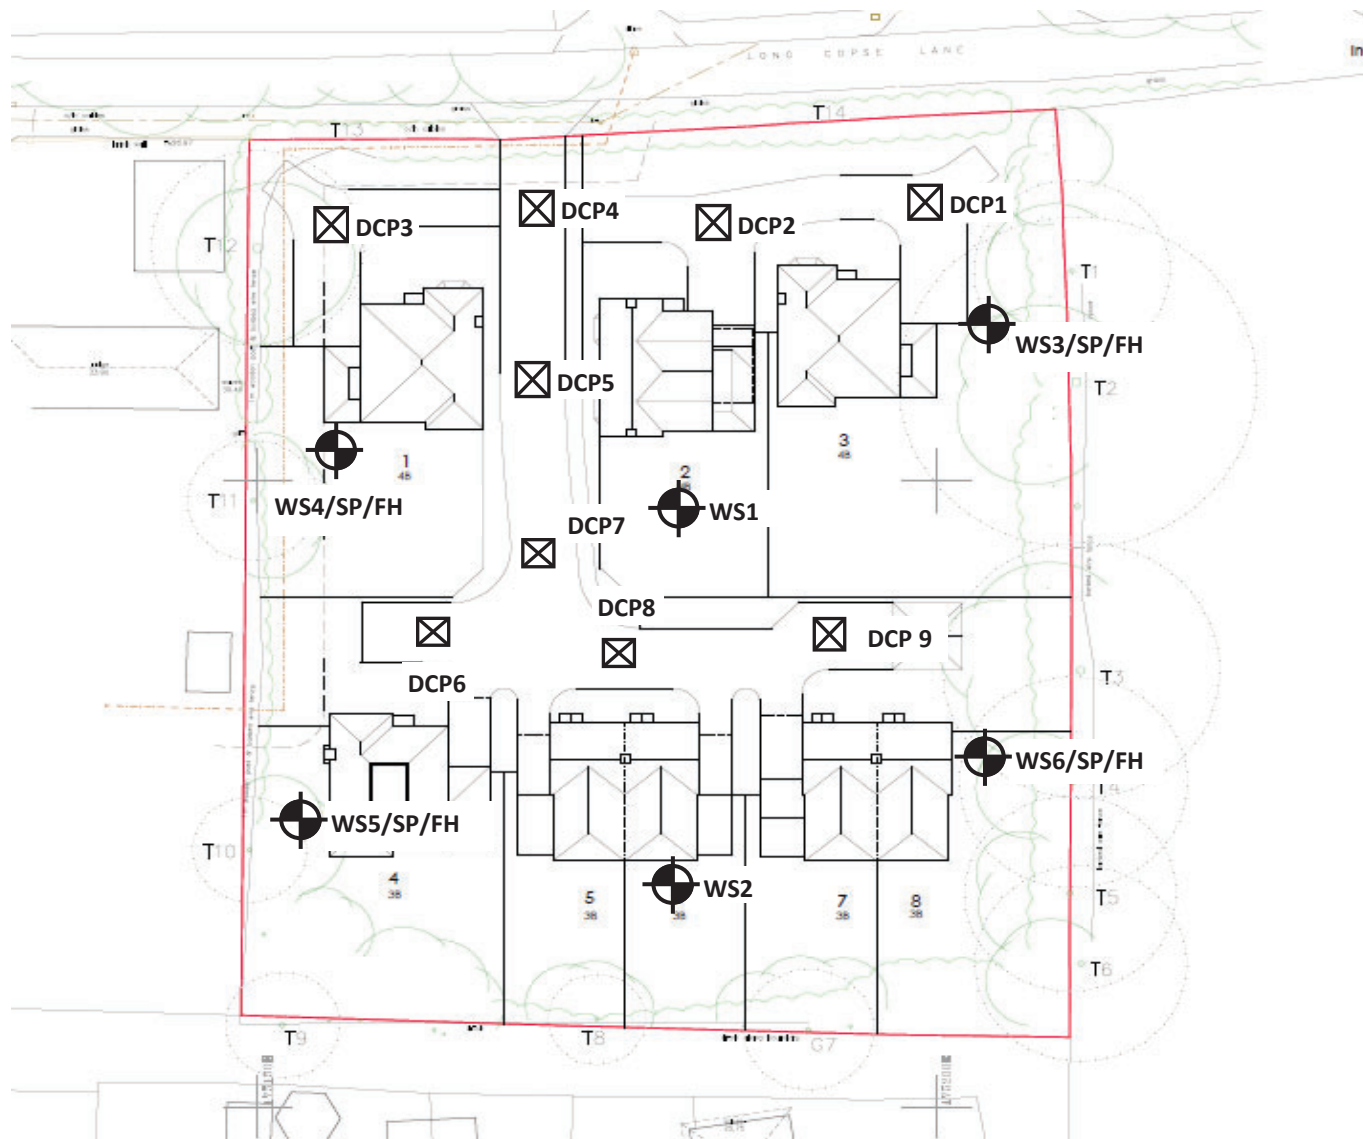
| <b>Project:</b> Long Copse Road, Emsworth PO10 7UR | | <b>Title</b> Proposed Exploratory Hole Locations | |

- 4.2 A geotechnical investigation of the site was undertaken by Messrs GESL (report GE19085-GARv2 Sept 2020). A series of 6 holes were made to 4.0mbgl which encountered gravelly CLAY Head deposits to around 0.6mbgl overlying CLAY and sandy CLAY bedrock of the London Clay Formation.

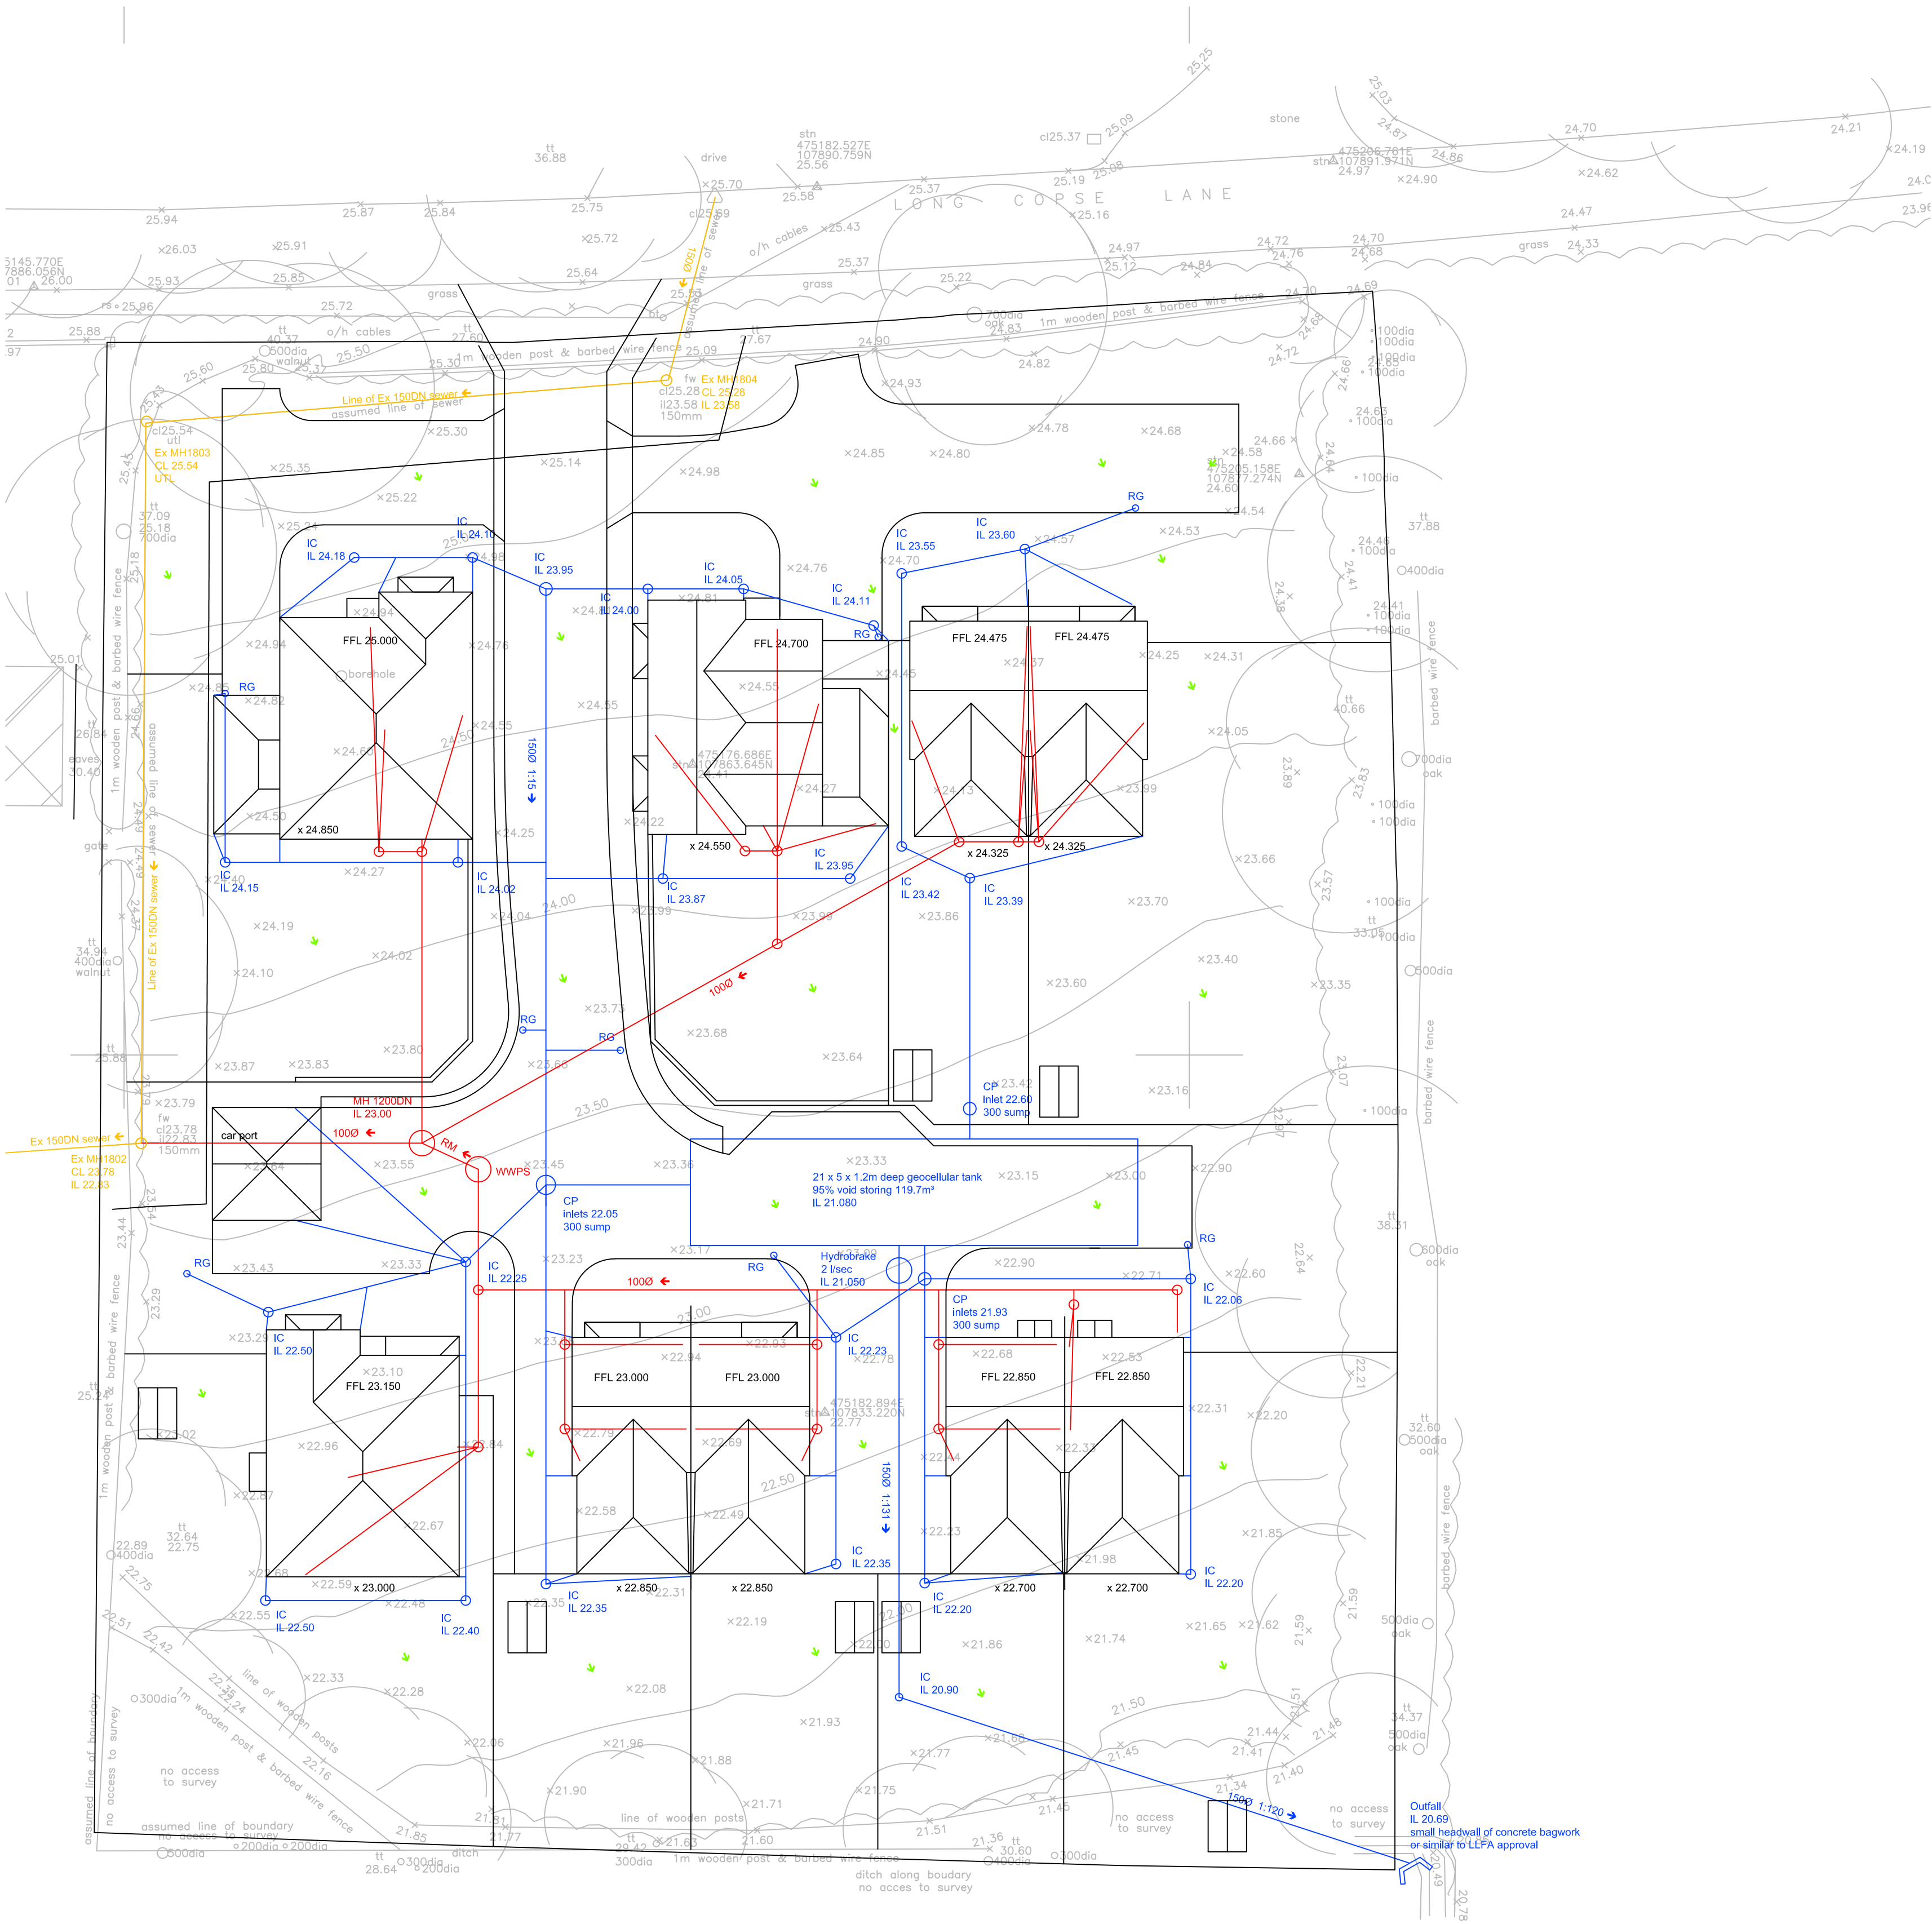
| Rev. | Amendment | Date | Original Sheet Size A1 (841 x 594) | | Project | |
| | | | 0 10 mm 50 | | Land adjacent<br>54 Long Copse Lane<br>Emsworth | |

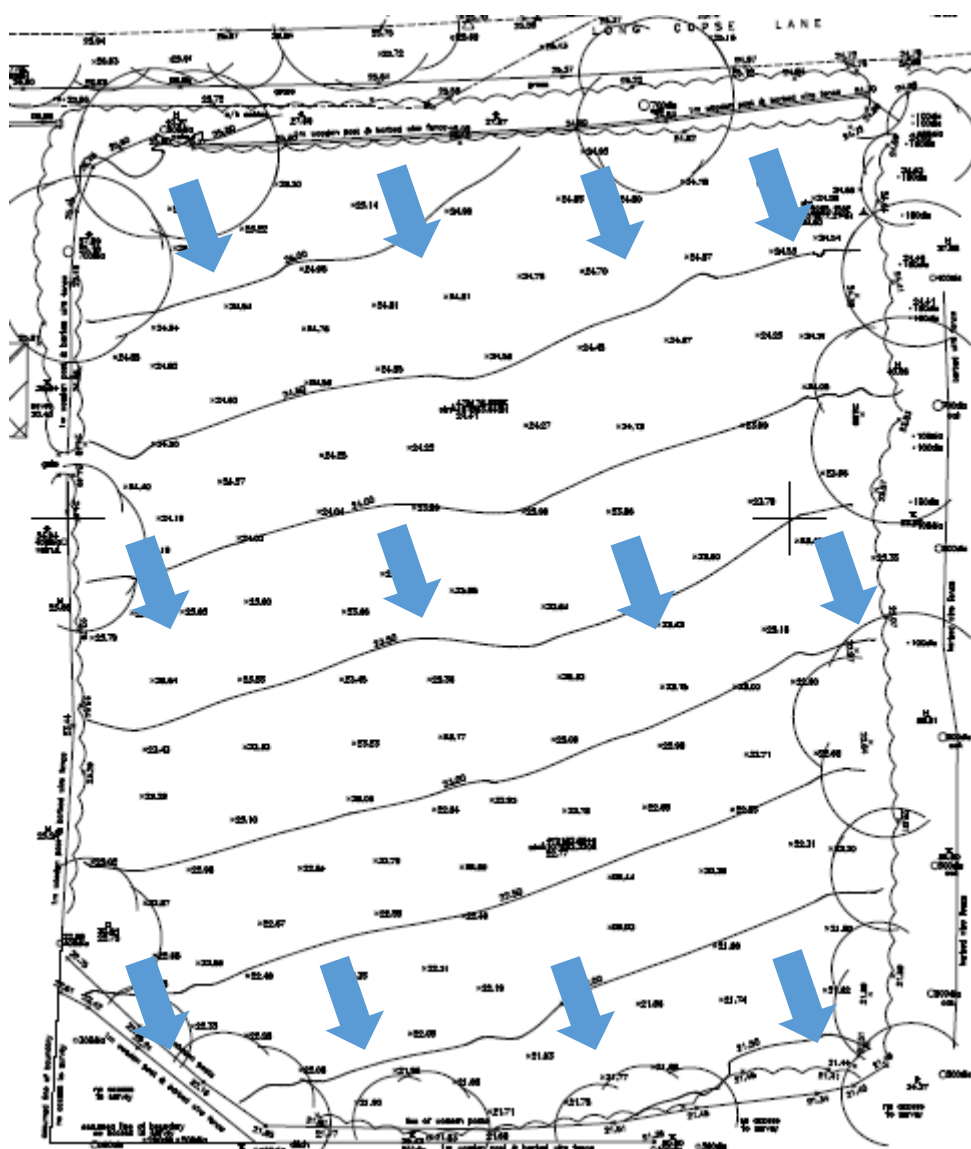
Existing exceedance flow pathways

- 4.18 Calculations are contained in Appendix C which demonstrate there will be no increase in discharge as a result of the proposed development.
- 4.19 The existing flood flow path is north to south across the site. The proposed development will maintain the north to south fall across the site. A pre and post development flow route plan is contained in Appendix C.
