Langstone Technology Park

Langstone Technology Park Havant

Exploratory Hole Location Plan

## Appendix II

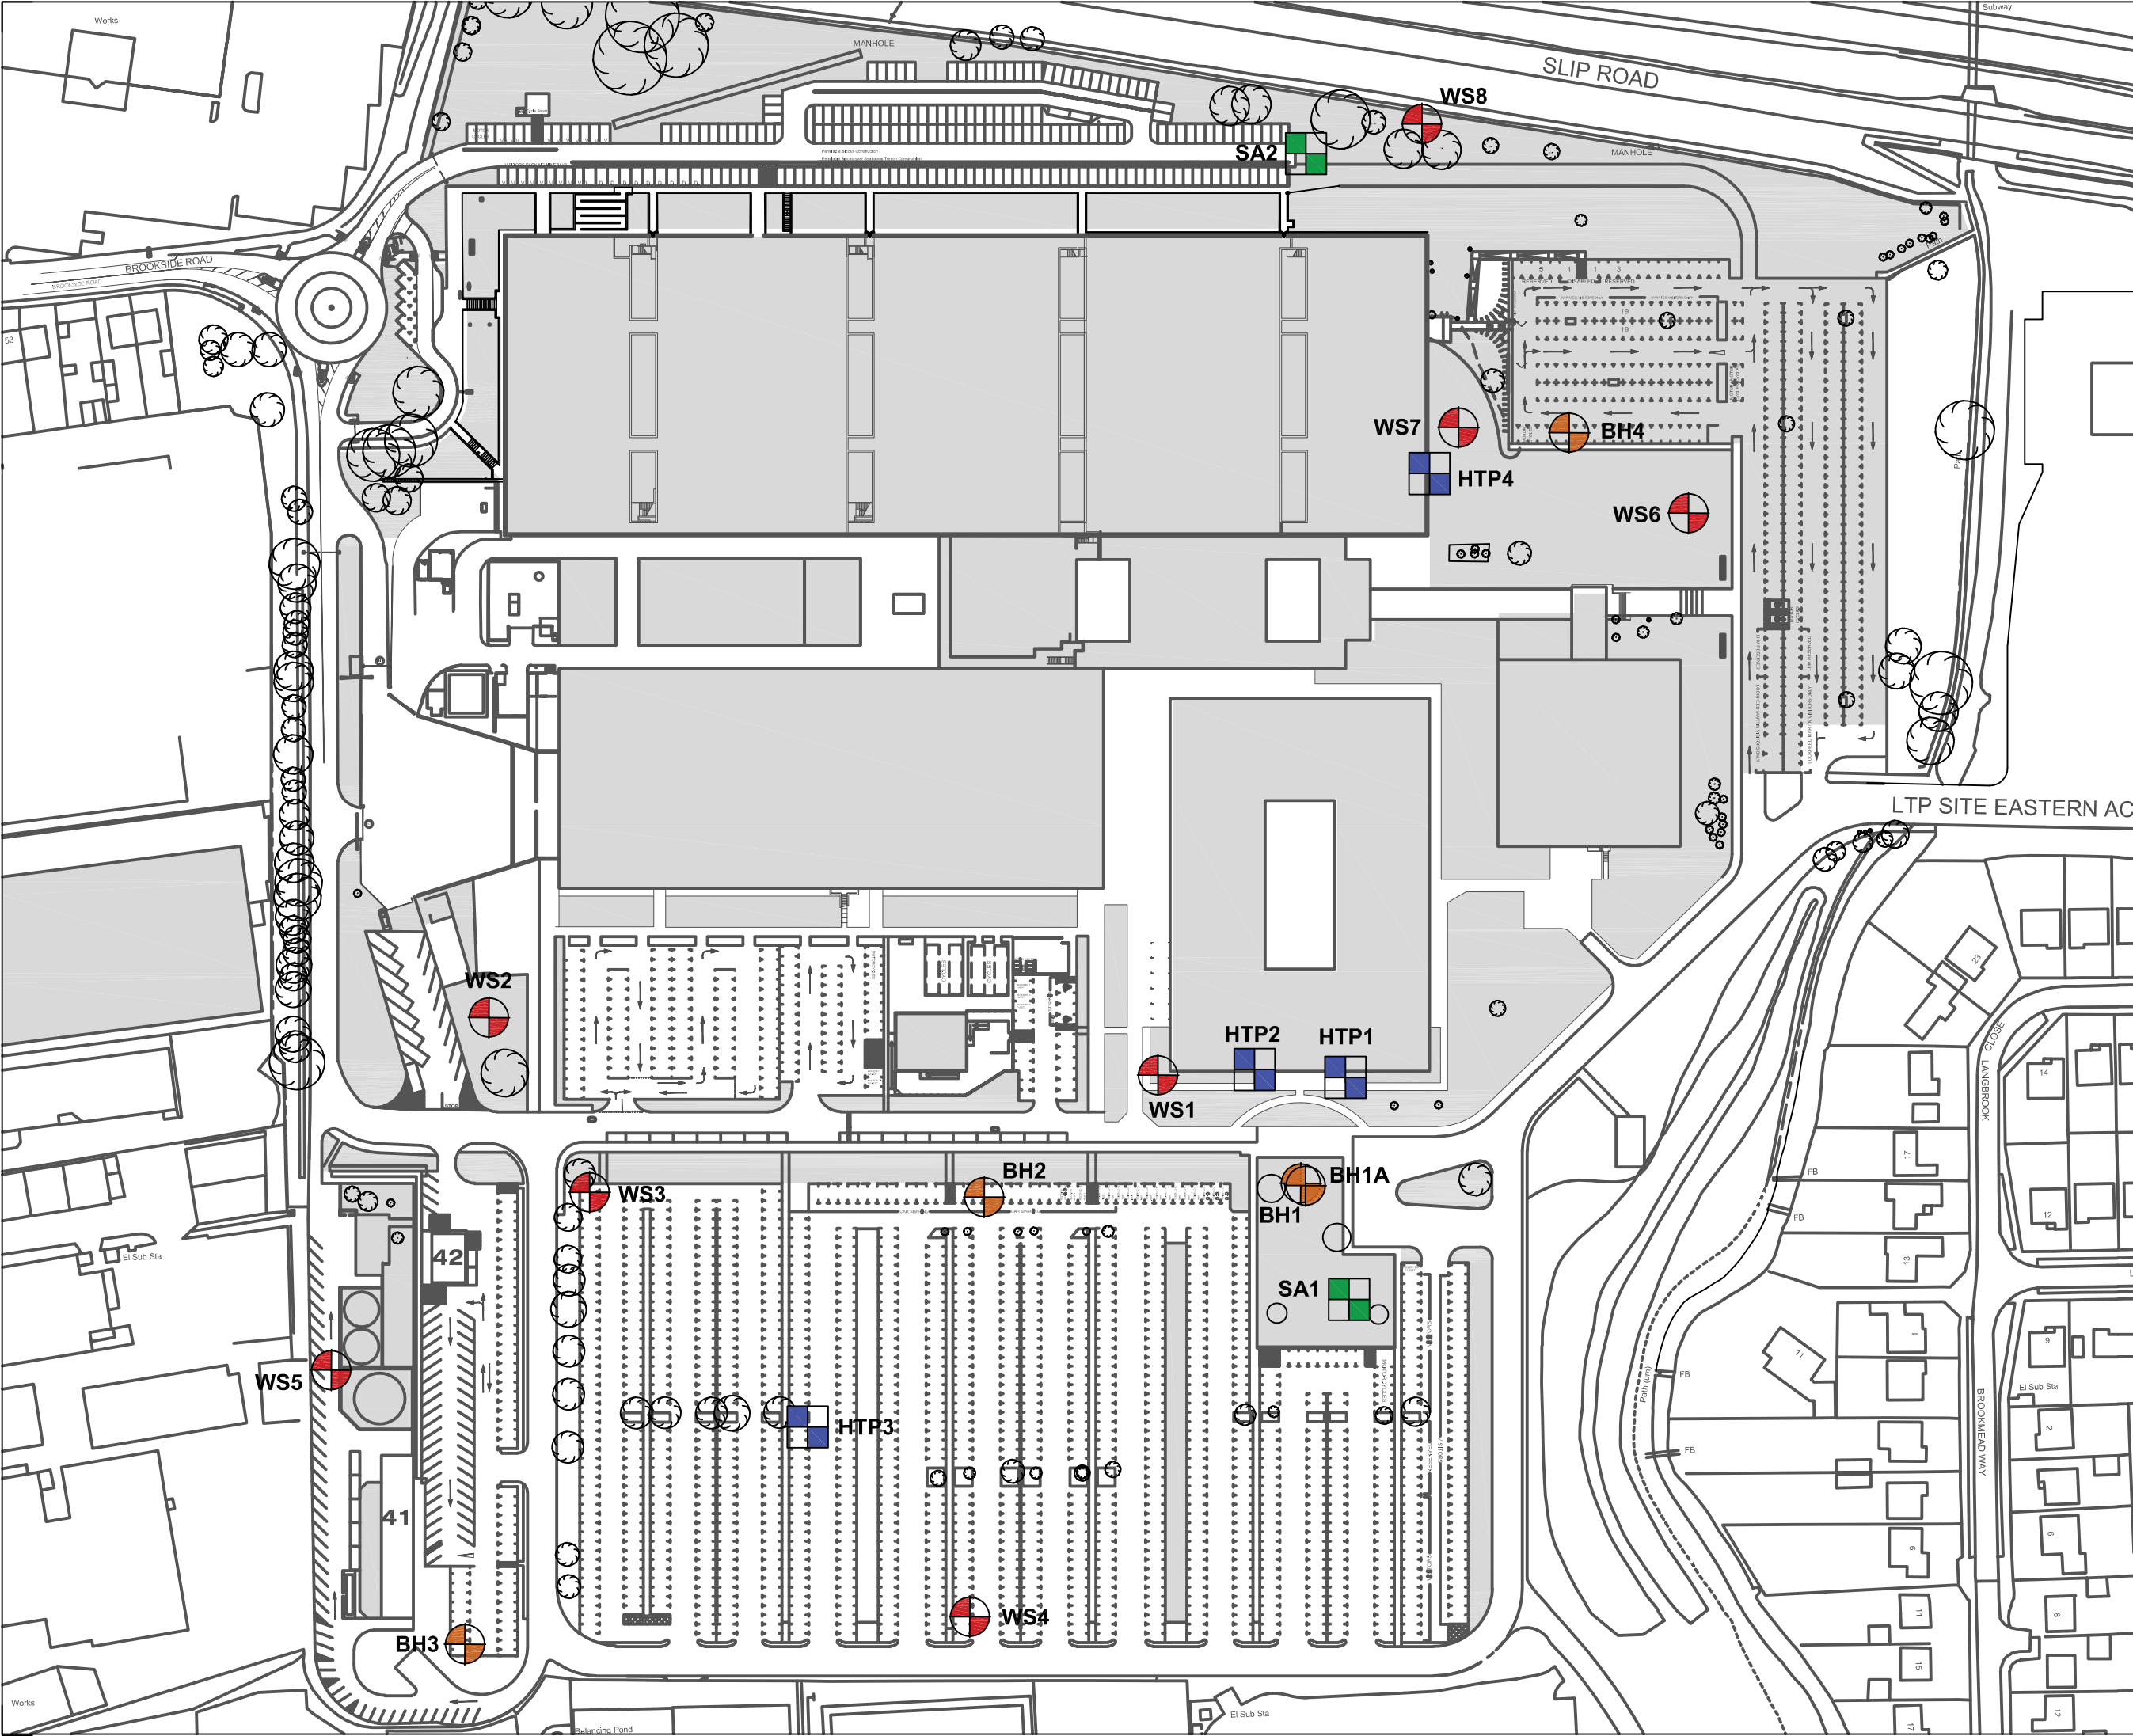
Cable Percussive Borehole

Window Sample

Borehole

Hand Excavated Trial Pit

Soakaway Test Trial Pit
