**Town Park Phase B, Berewood, Waterlooville**

**Drainage Strategy**

# **Berewood, Town Park Phase B**

## **Ground Investigation Report**

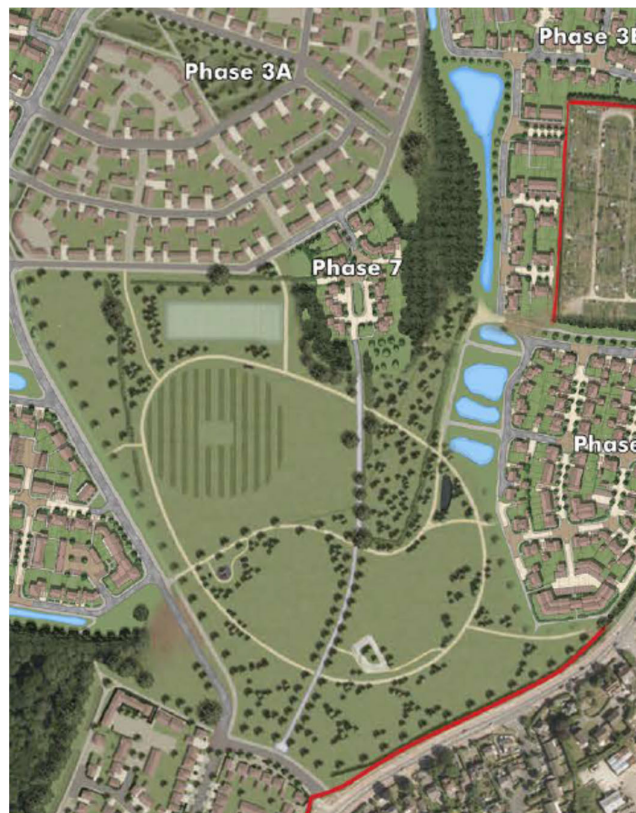
- 1.1 As part of the S106 obligations, Grainger are required to construct a new Town Park at the Berewood Development, Waterloooville. The Town Park will cover a total area of 15Ha. Phase A (Area 5.3Ha) of the park was completed in August 2019 and is now open to the public. Phase B (Area 9.7Ha) is due to commence construction in Summer 2021.
- 1.2 Figure 1.1 below is an extract from the masterplan layout, which was produced as part of the outline planning application and indicates the general layout and extent of the Town Park scheme.

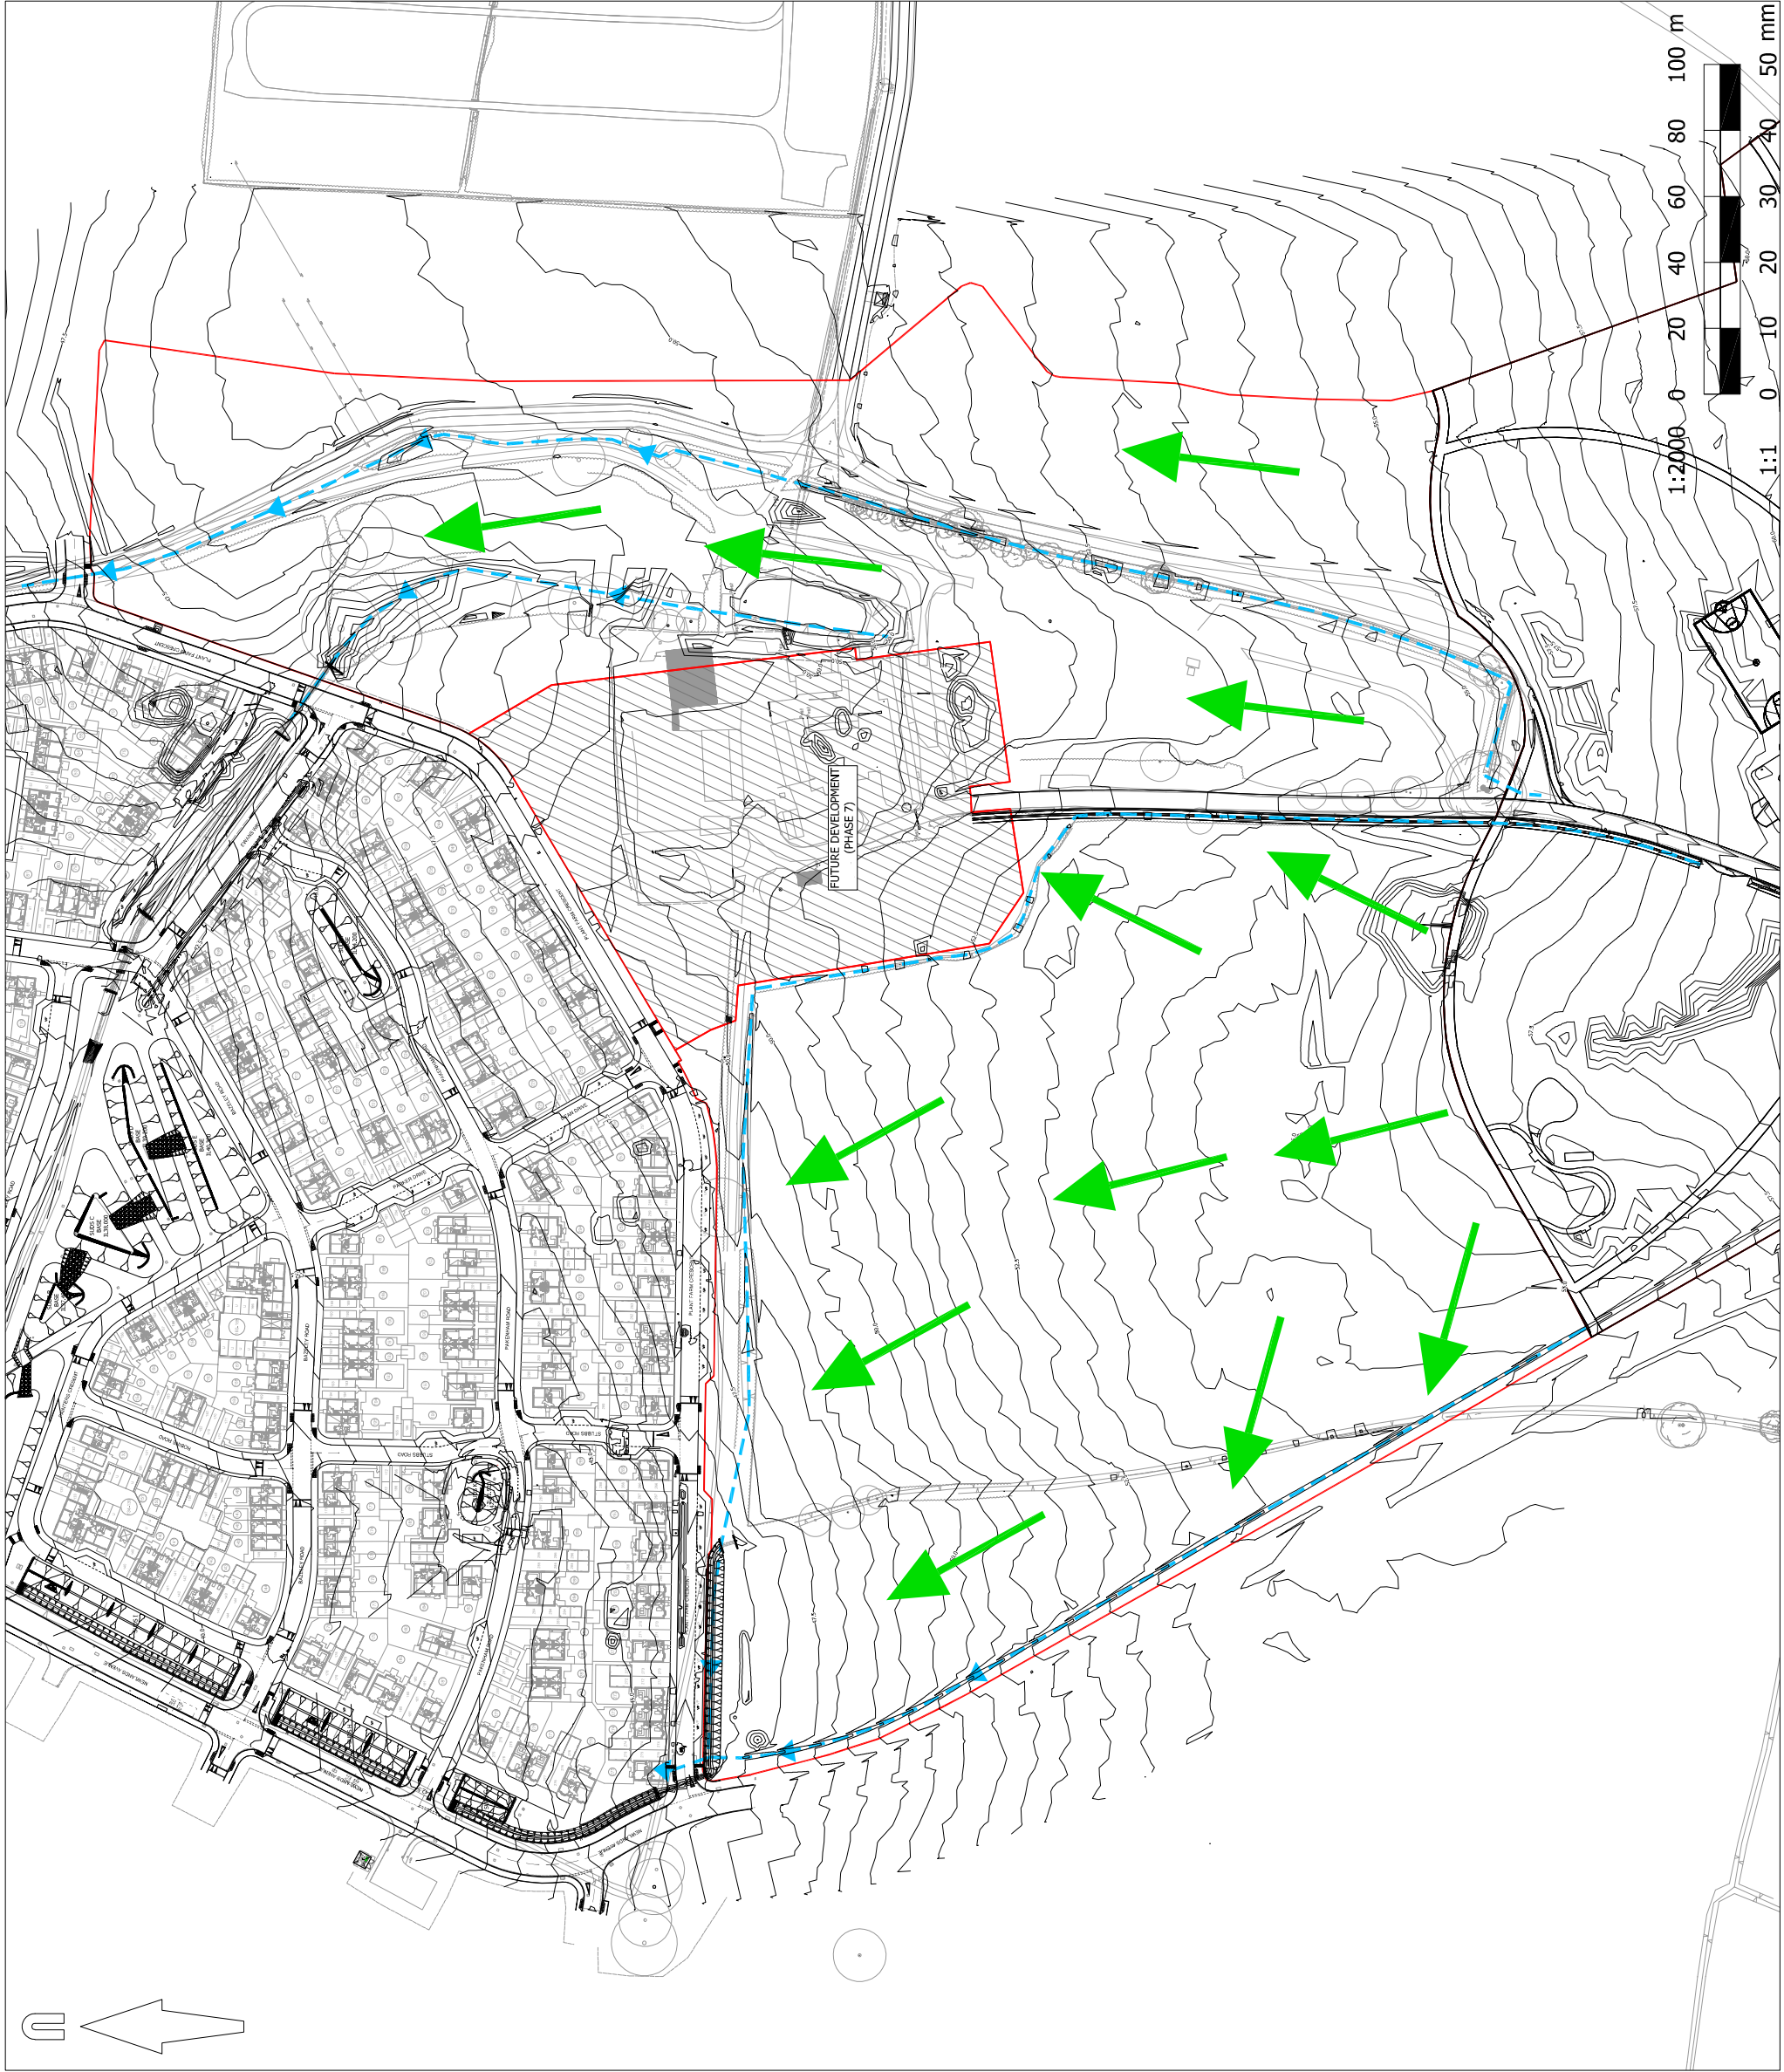
Client: **granger plc**  
Project: **BEREMOOD, WATERLOOVILLE TOWN PARK PHASE B**  
Scale: 1:500 | Drawn by: NT/L/S | Checked by: RHA  
Date: OCTOBER 2020 | Cad file: DR\_OLD.DWG  
Title: PROPOSED TOWN PARK DRAINAGE  
Drawing number: GTWVILLE\_TP2/DR/01  
Rev: C

- 1.4 The as built layout of Phase A, including drainage provision is shown on Dwg. GTWVILLE\_TP\_DR\_02\_AB1.
- 1.5 The proposed layout for Phase B is shown on Dwg. GTWVILLE\_TP2/DR/01.
- 1.6 The overland surface water flow paths are shown on Dwg. GTWVILLE\_TP2/DR/04.
- 1.7 Hampshire County Council Flood Risk Management Team (FRMT) commented on the initial plans in February 2021. A copy of FRMT's comments is contained in Appendix B.
- 1.8 This Technical note explains the existing and proposed drainage provision for Phase B and how flood risk will be mitigated.

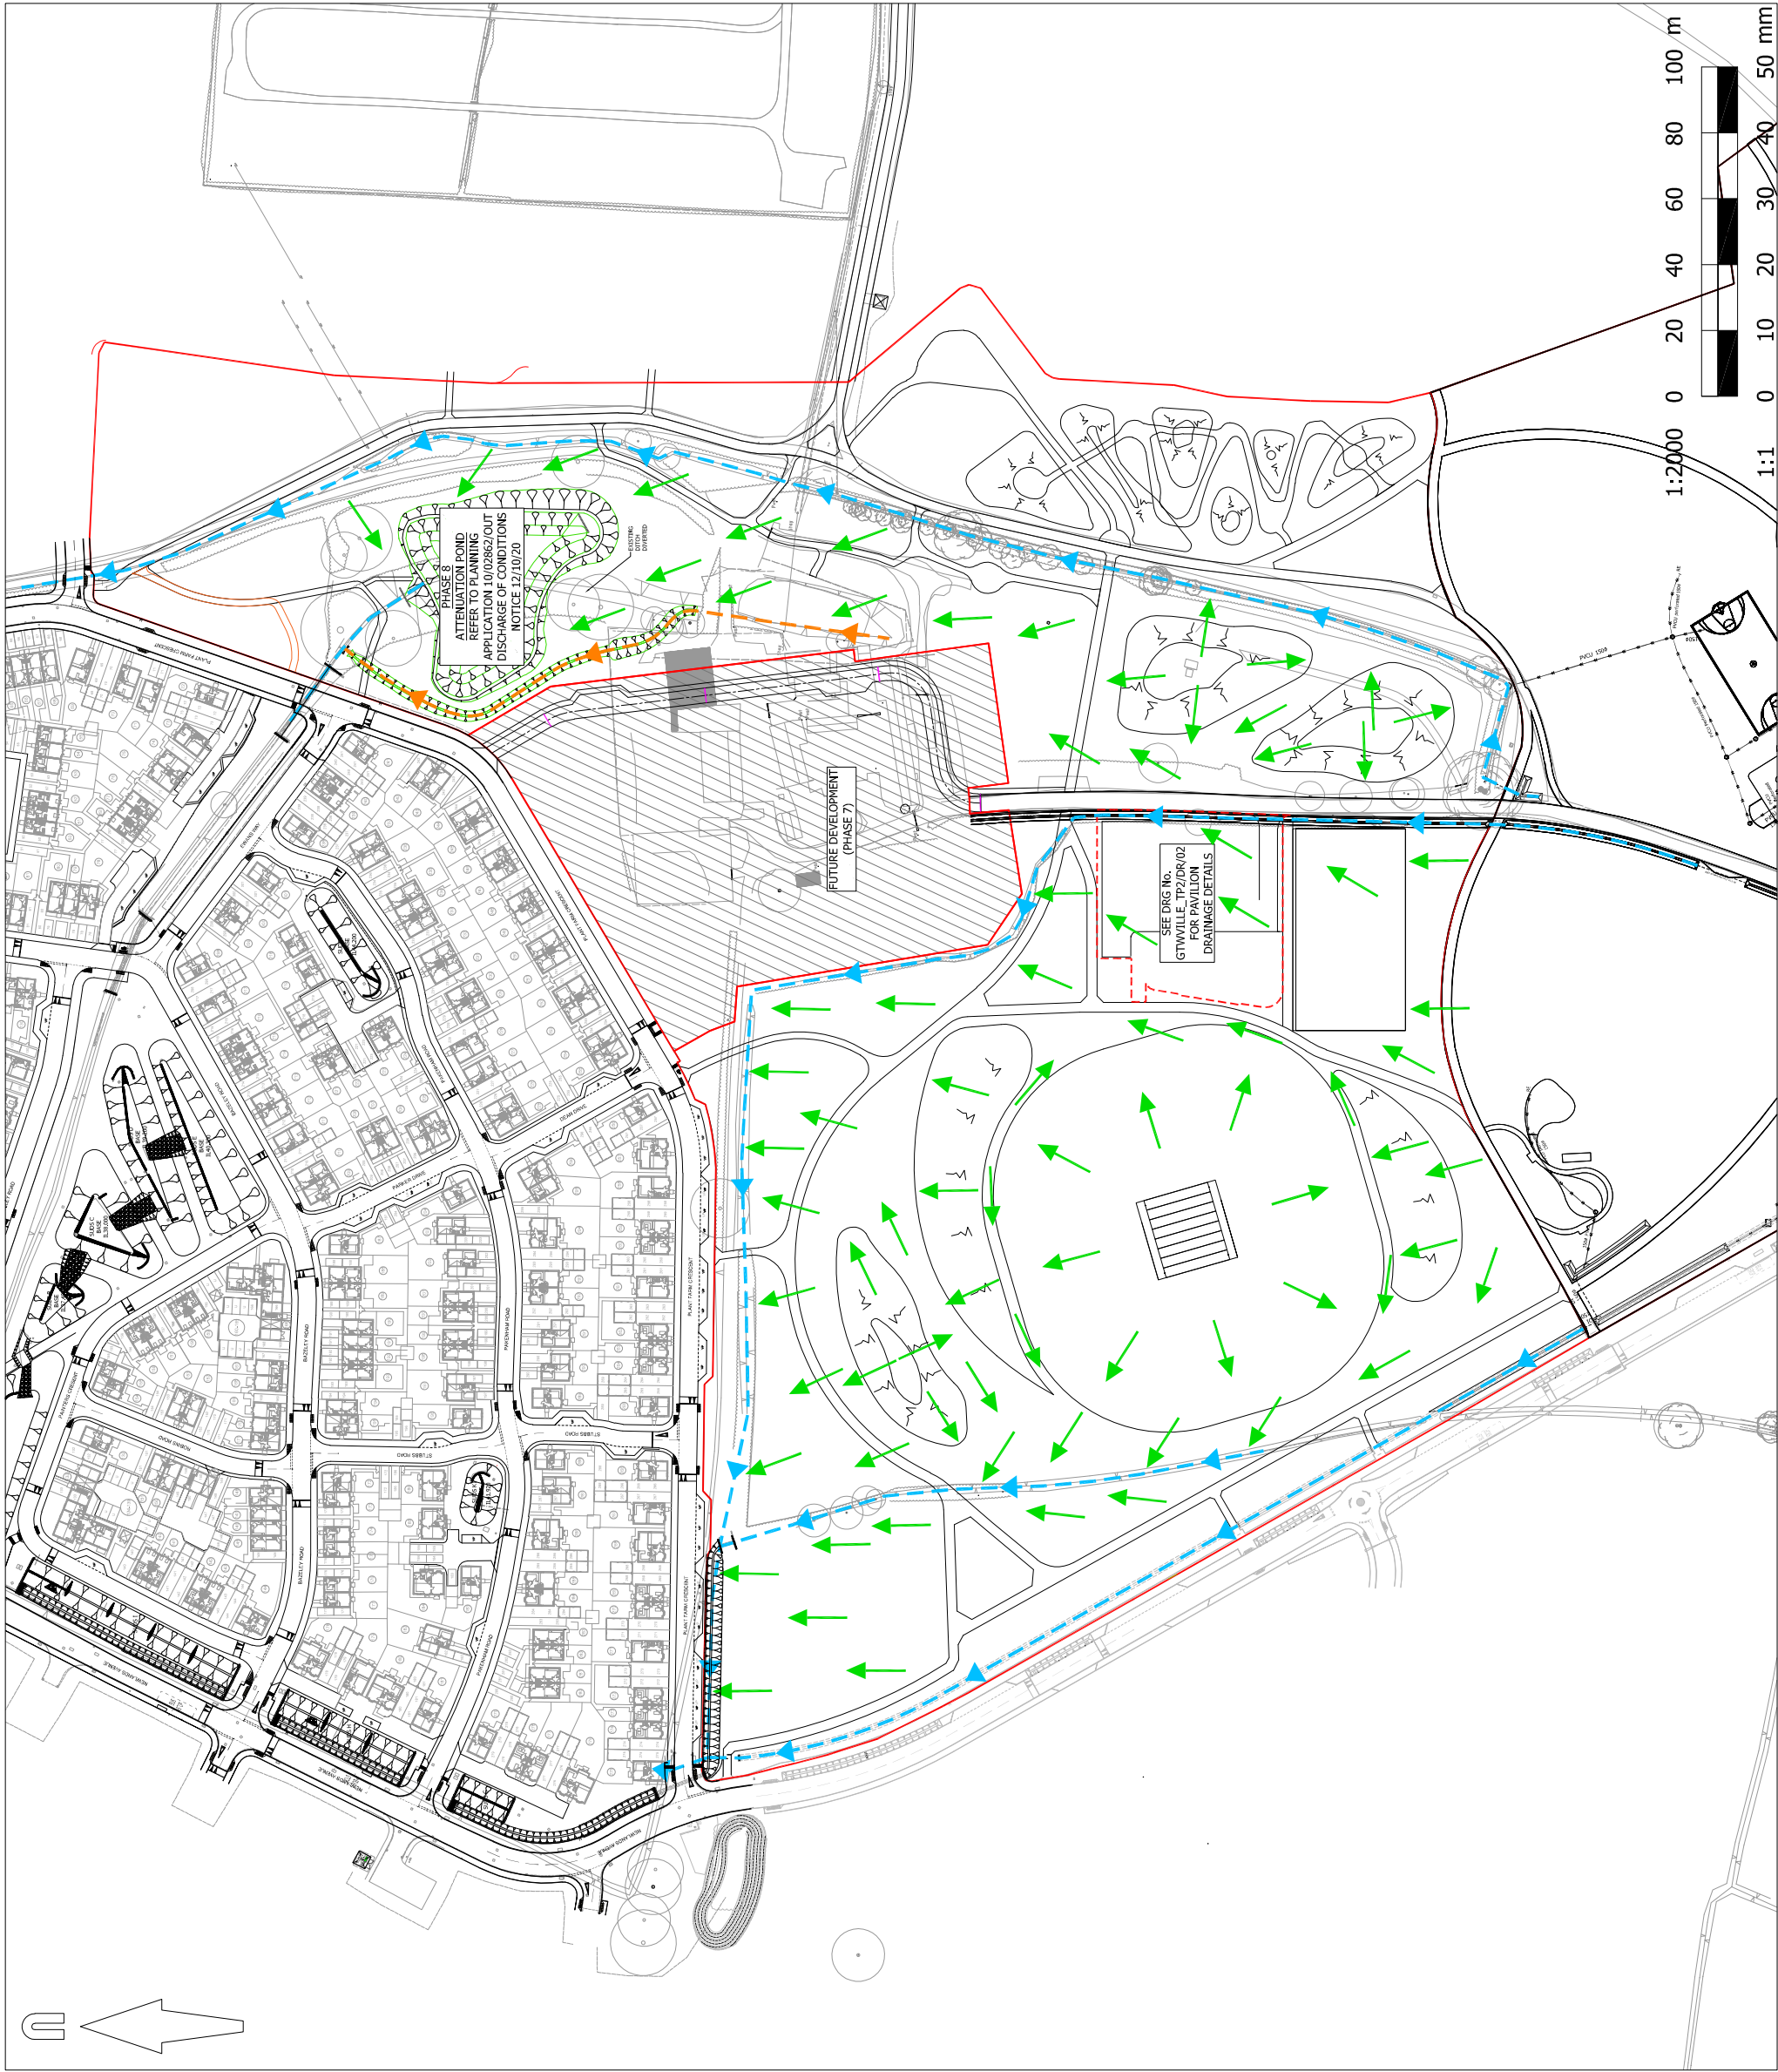
| drawing number | GTWVILLE_TP2/DR/04 |

- 1.13 The above referred report indicates that the QBAR greenfield run-off rate for the site is 5.06l/s/Ha. (Ref. 'PROPOSED OUTLINE SUDS STRATEGY STATEMENT' Section 3.6). Dwg. GTWVILLE\_TP2/DR/04 (in Appendix A) shows the existing overland flow paths and existing watercourse/ditch network. All of the proposed Phase B Town Park catchment drains to the north and eventually discharges via the ditch which runs along the southern edge of Plant Farm Crescent. The Table below shows the discharge rate for a range of storm events based on the QBAR greenfield run-off rate and relevant growth factors.

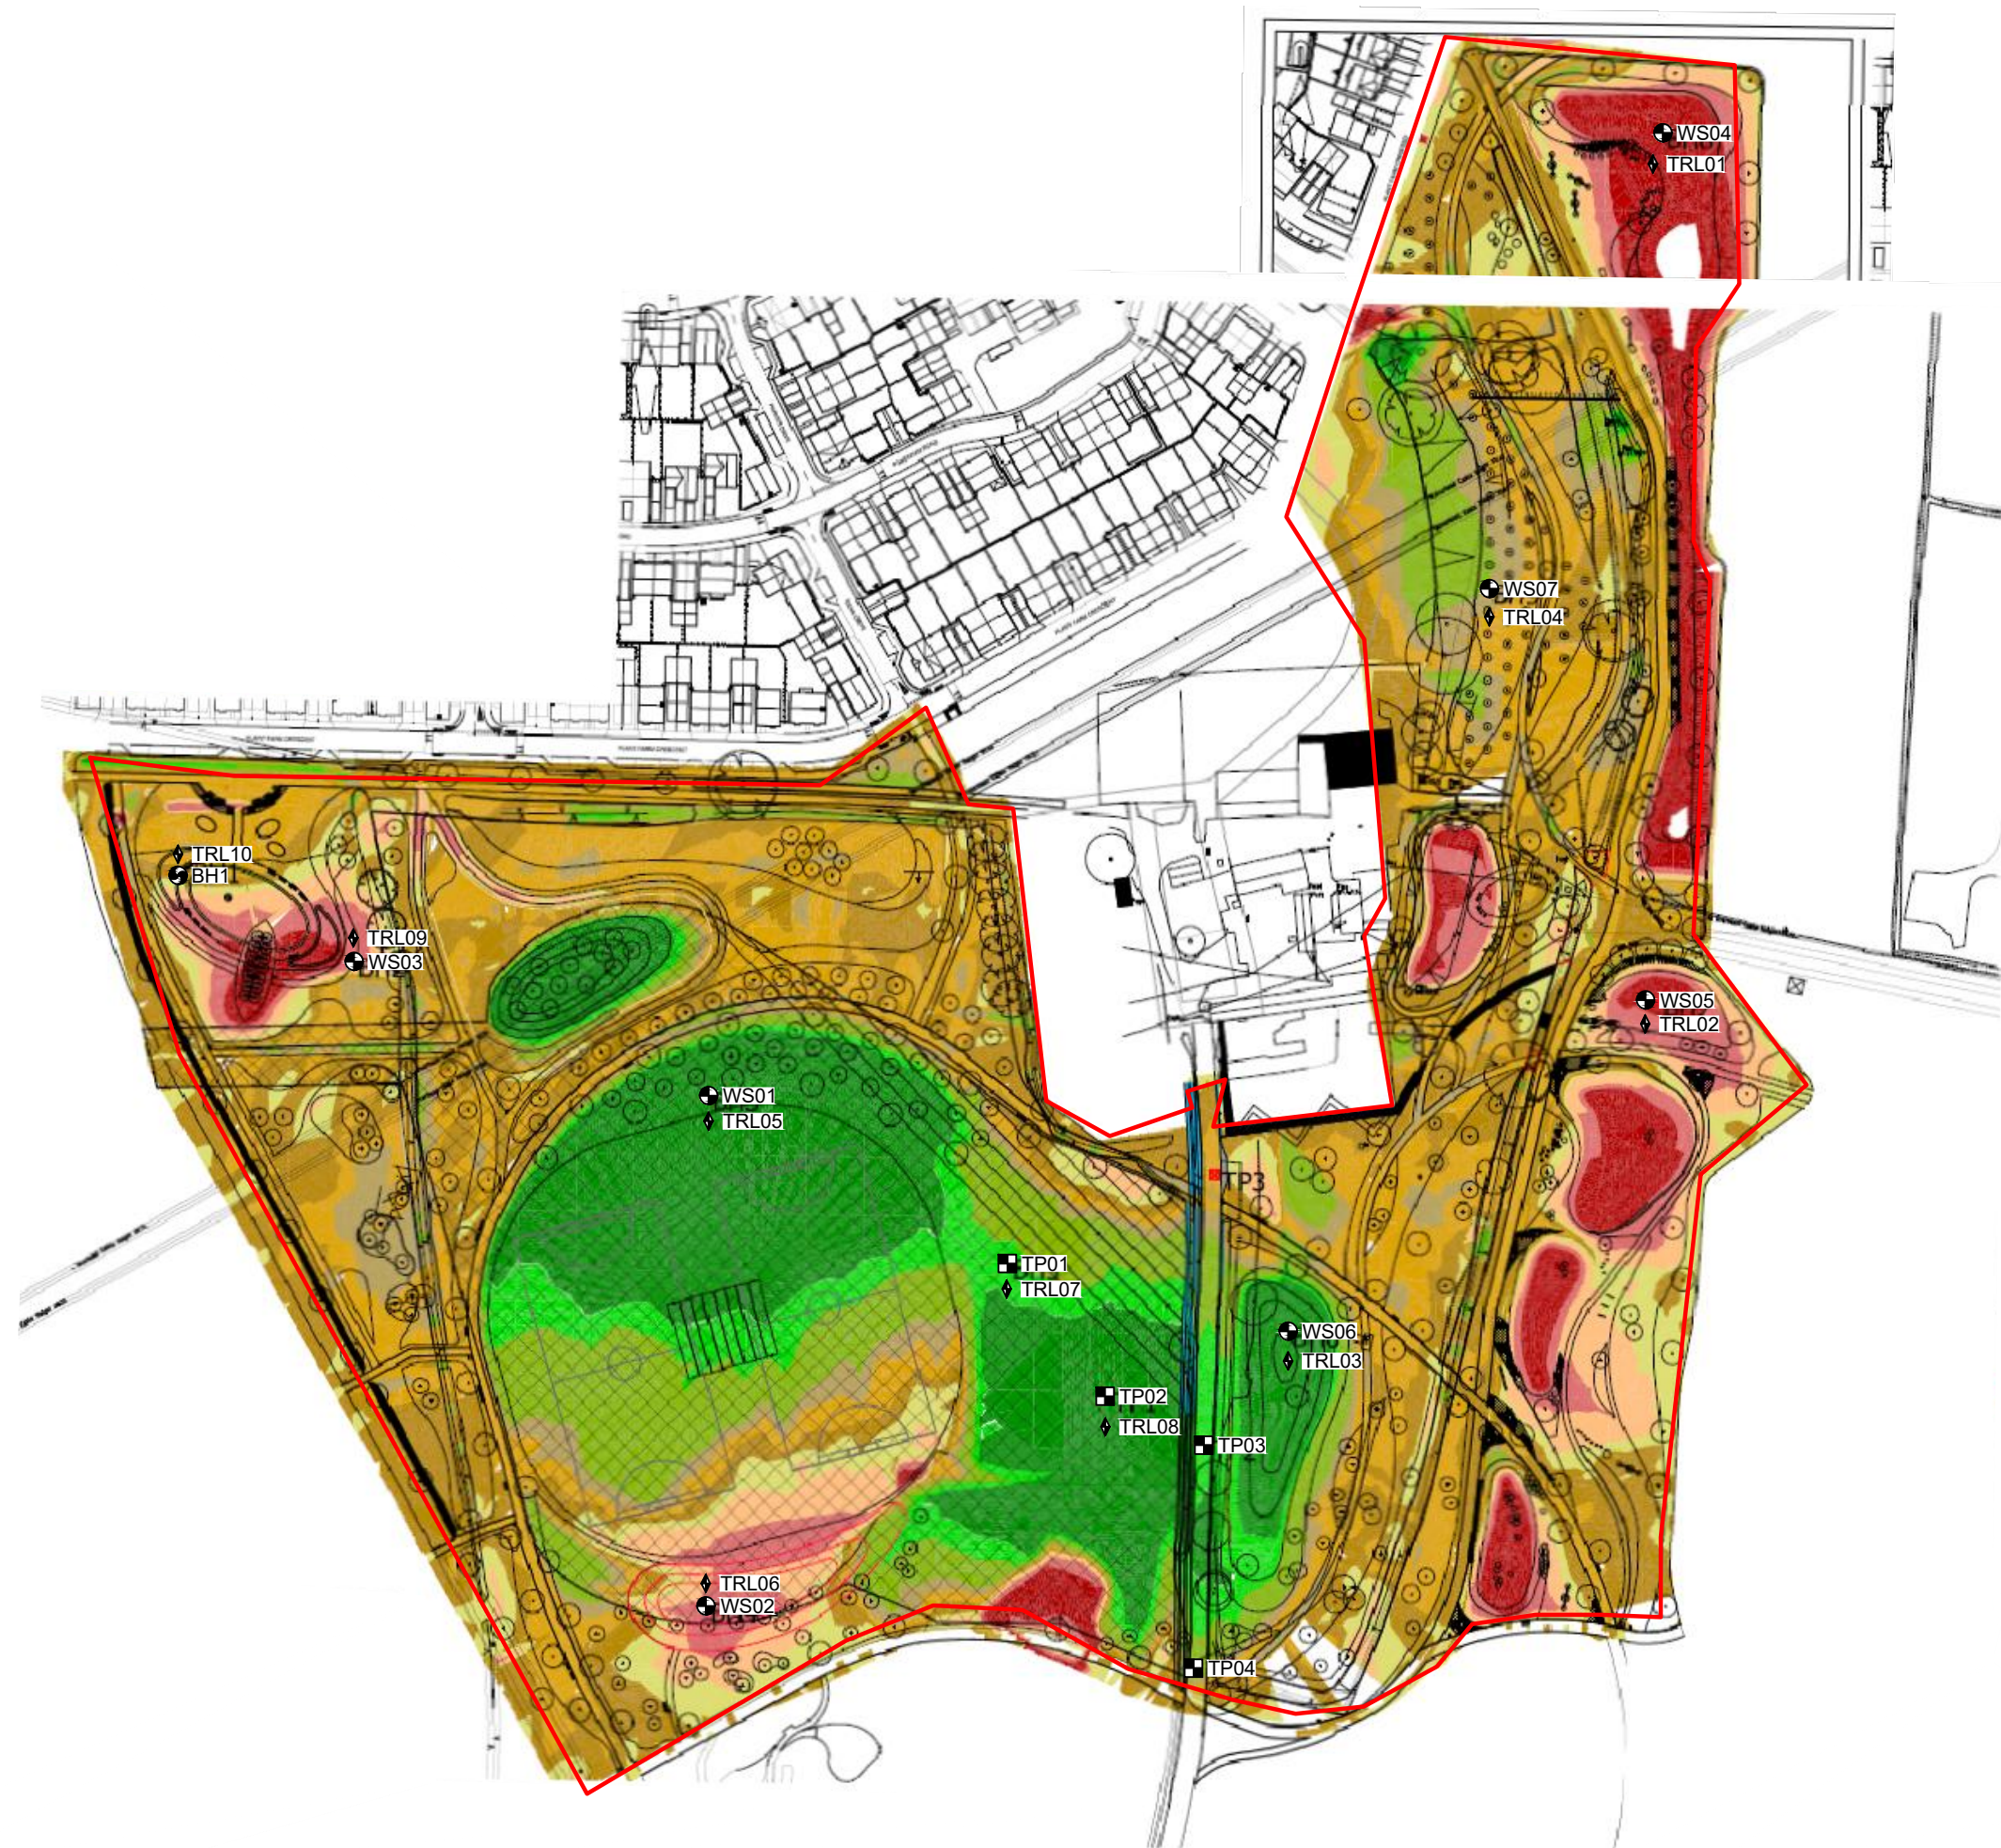
Base Map  
Company: - Mayer Brown Limited  
DWG Title: - Proposed GI Test Locations  
DWG Number: - GTWVILL\_TP2/SK/06  
Date: - July 2019

- Rotary Borehole Locations (BH1)
- Windowless Sampling Locations (WS01 - WS07)
- Trial Pit Locations (TP01 - TP04)
- ◆ TRL Locations (TRL01 - TRL10)
- Site Boundary

The trial pit was positioned as per the client's specification as show on the exploratory hole location plan contained within Appendix A. Infiltration tests were not completed in areas of the site where made ground was encountered.

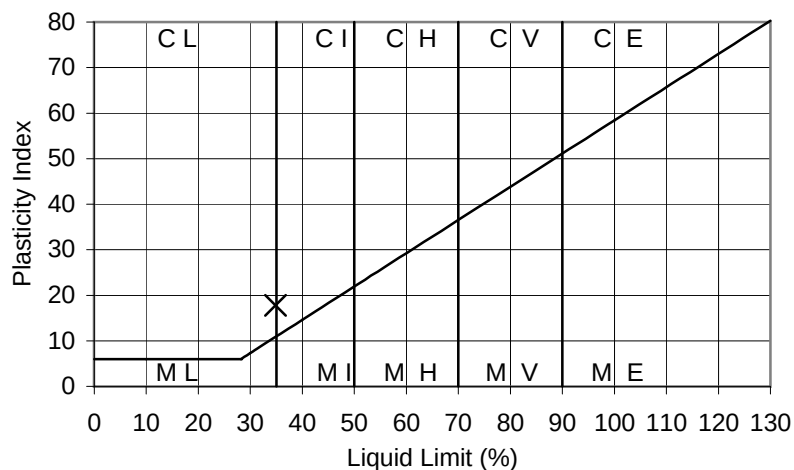
Non Engineering Description : Brown weathered MUDSTONE.

As Received Moisture Content : (BS1377:Part 2:Clause 3:1990) 19 %  
 Percentage retained on 425µm sieve : 0 %  
 Liquid Limit : 35 %  
 Plastic Limit : 17 %  
 Plasticity Index : 18

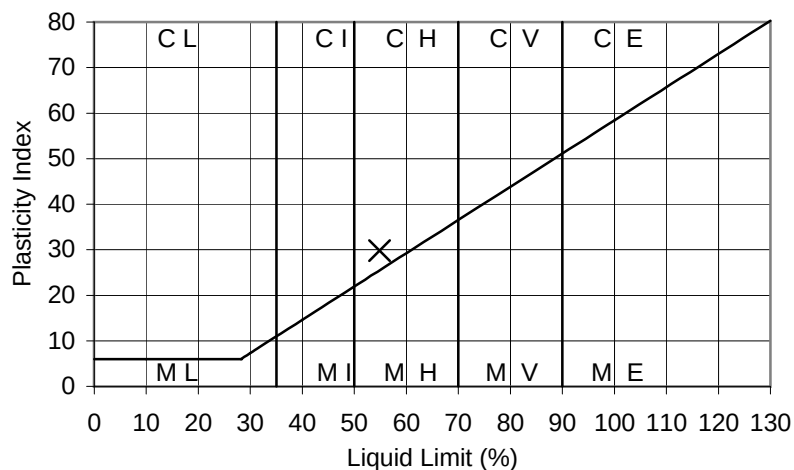
Non Engineering Description : Brown weathered MUDSTONE.

As Received Moisture Content : (BS1377:Part 2:Clause 3:1990) 20 %  
 Percentage retained on 425µm sieve : 0 %  
 Liquid Limit : 55 %  
 Plastic Limit : 25 %  
 Plasticity Index : 30

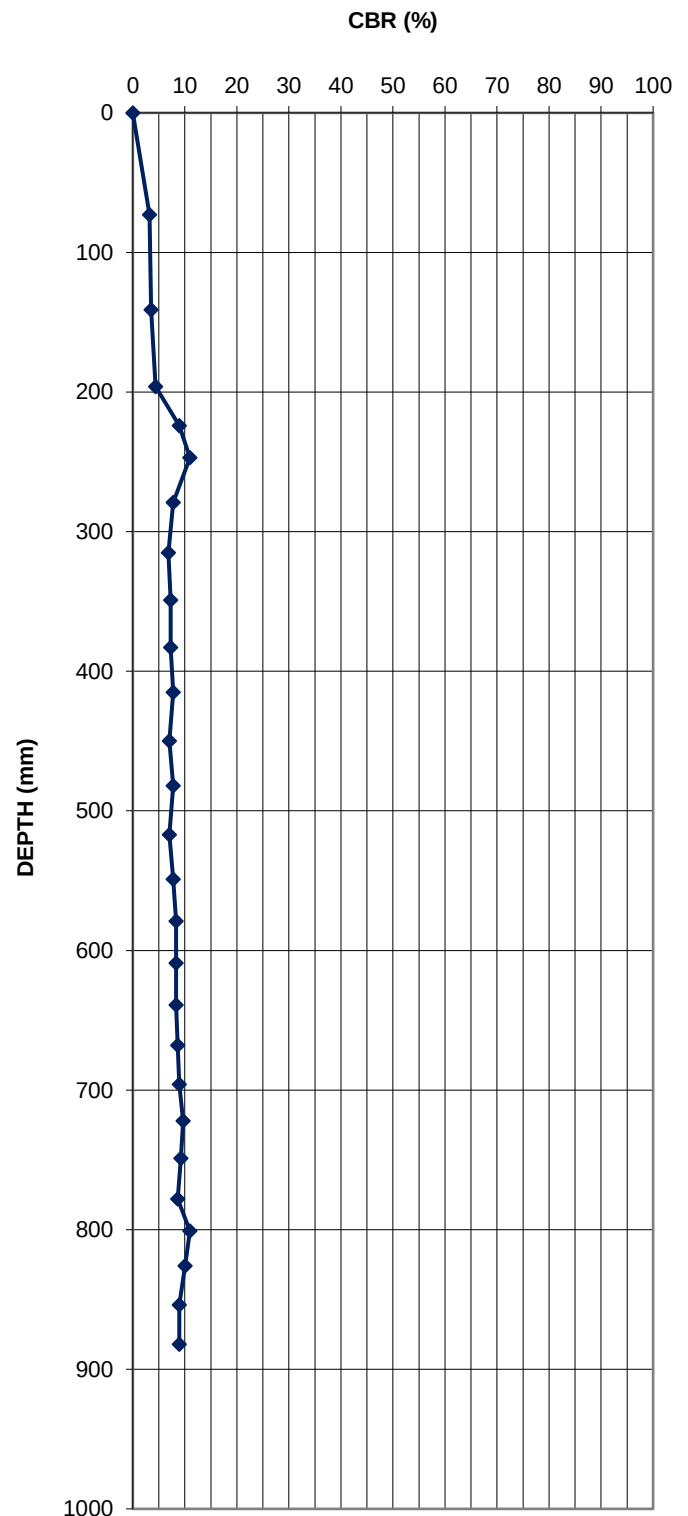
Figure 8

CBR correlation based on IAN 73/06:  $\text{Log}_{10}(\text{CBR}) = 2.48 - 1.057 \times \text{Log}_{10}(\text{mm/blow})$

# Dynamic Cone Penetrometer & CBR Relationship from IAN 73/06 (2009)

Based on the test results a design CBR value of 2.5% is recommended subject to firm cohesive soils being encountered at formation level. It should be noted however that where revealed the clay soils are moisture sensitive and will be prone to deterioration to give lower CBR values if

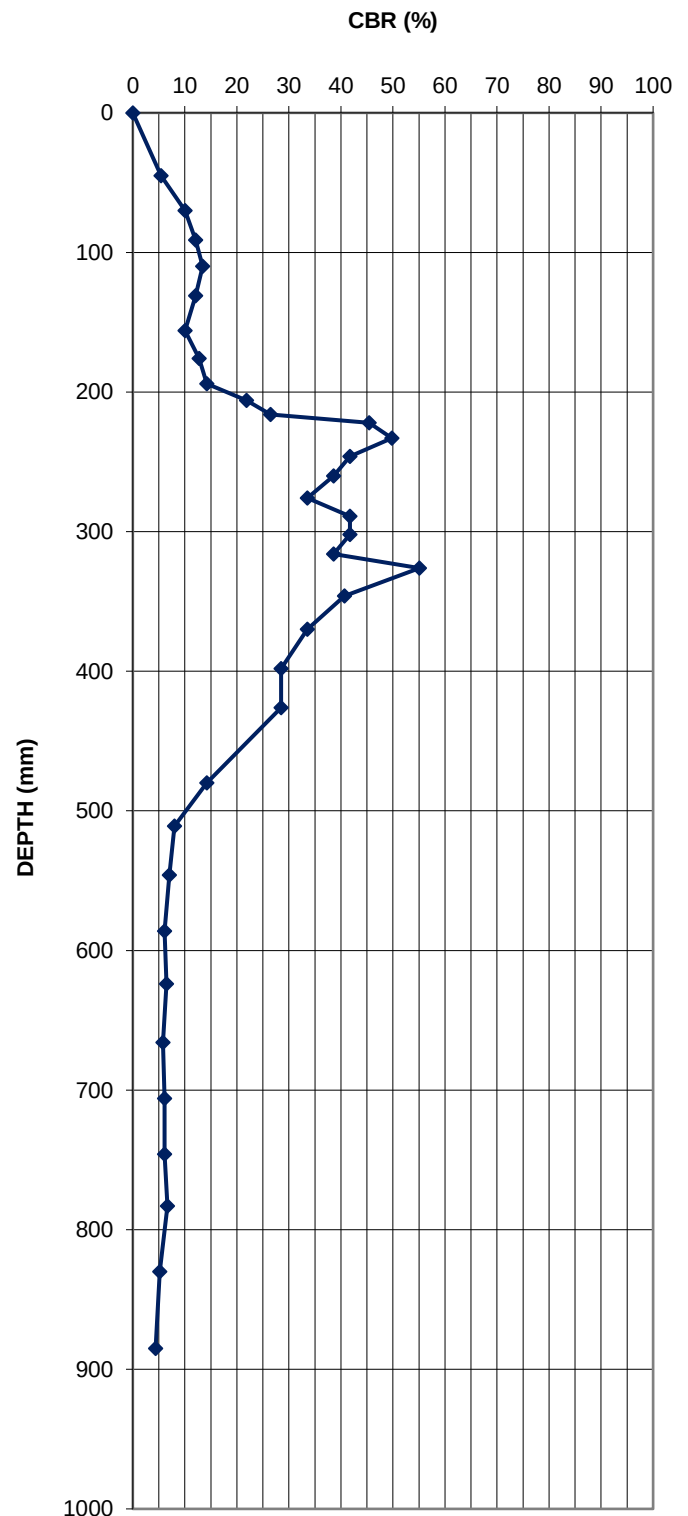
CBR correlation based on IAN 73/06:  $\text{Log}_{10}(\text{CBR}) = 2.48 - 1.057 \times \text{Log}_{10}(\text{mm/blow})$

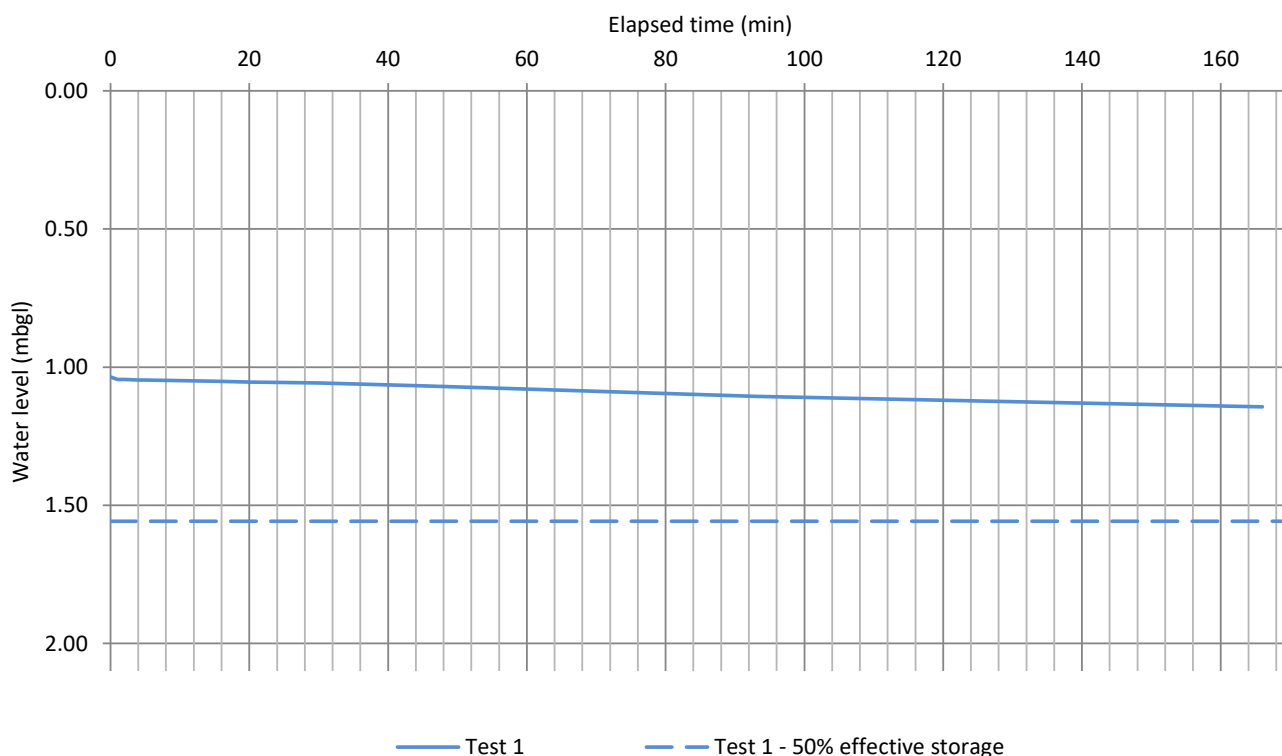
| | | | | | | Soil infiltration rate <i>f</i> (m/s) | | | | | | 3.01E-06 | | | |
| | | | | | | Design soil infiltration rate <i>f</i> (m/s) | | | | | | n/a (not BRE365 compliant) | | | |

Where highlighted in red, results have been inferred from the graph.

The calculated infiltration rates indicate the soils beneath the site have relatively poor infiltration characteristics which is reflective of the clay encountered within the shallow weathered London Clay Formation.
