REBUILDING OF EXISTING STRUCTURALLY DAMAGED GARAGE AT:-

5 WICKOR WAY, EMSWORTH  
HANTS PO10 7RE

DRWG. NO. CJD/PO107RE/01 Issue 03

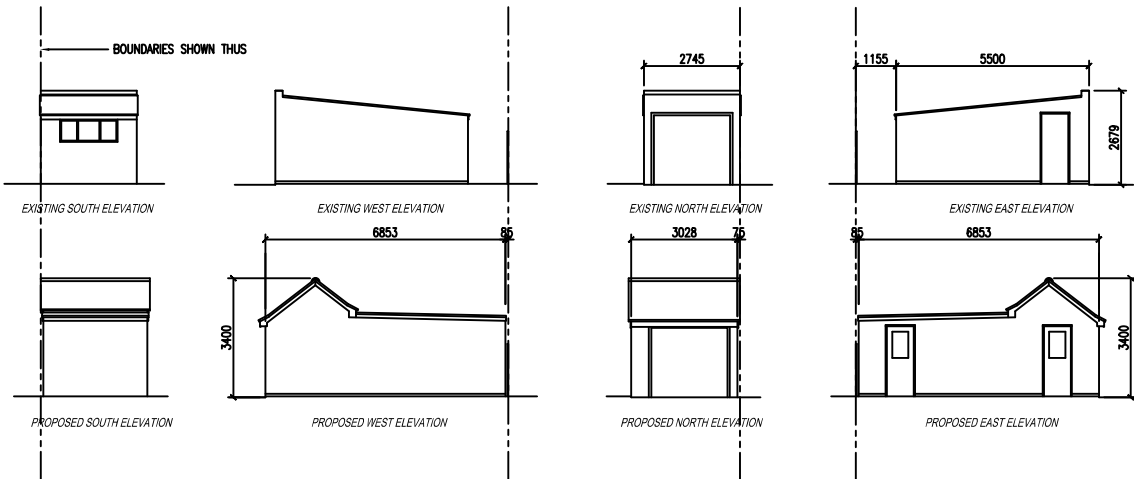
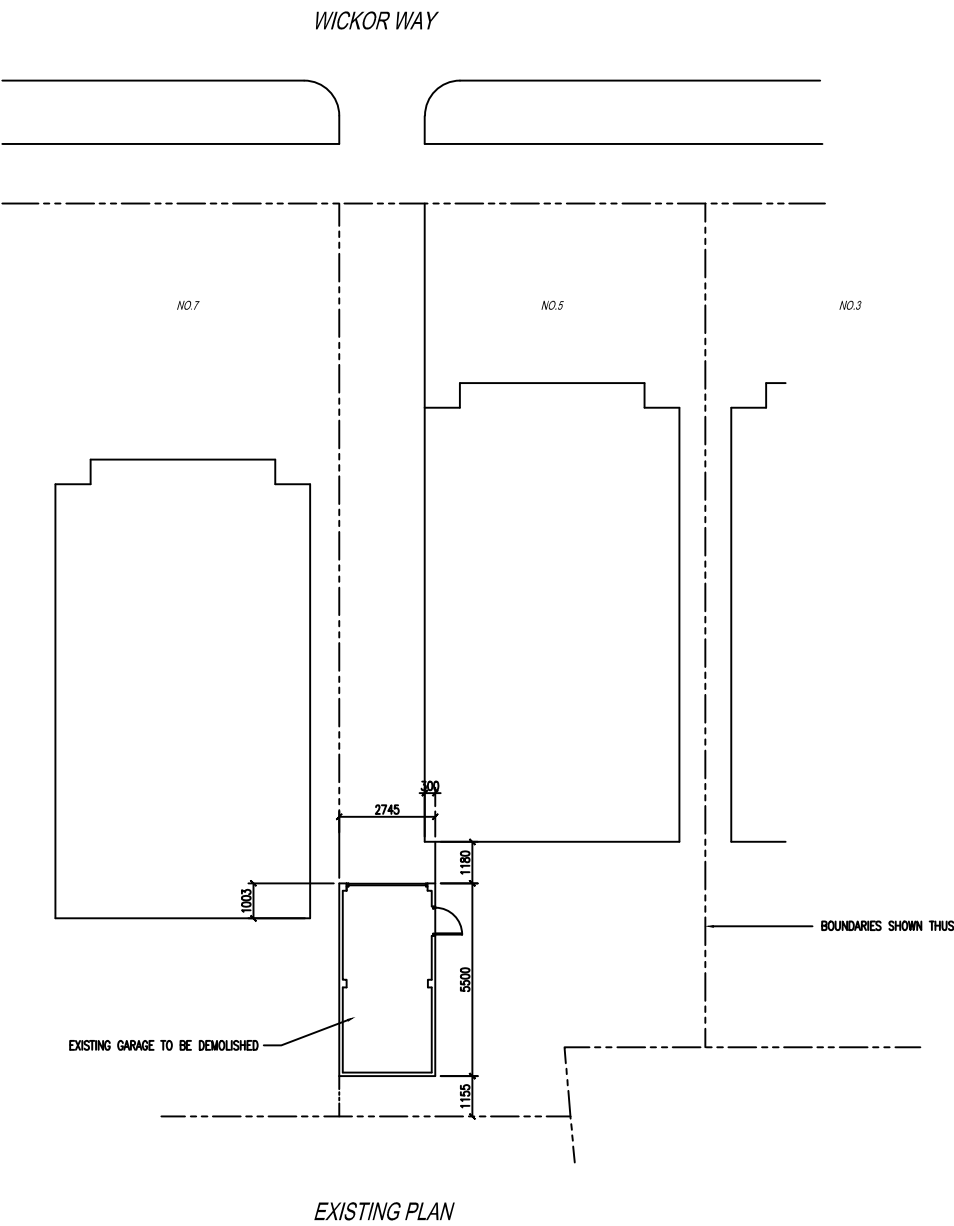
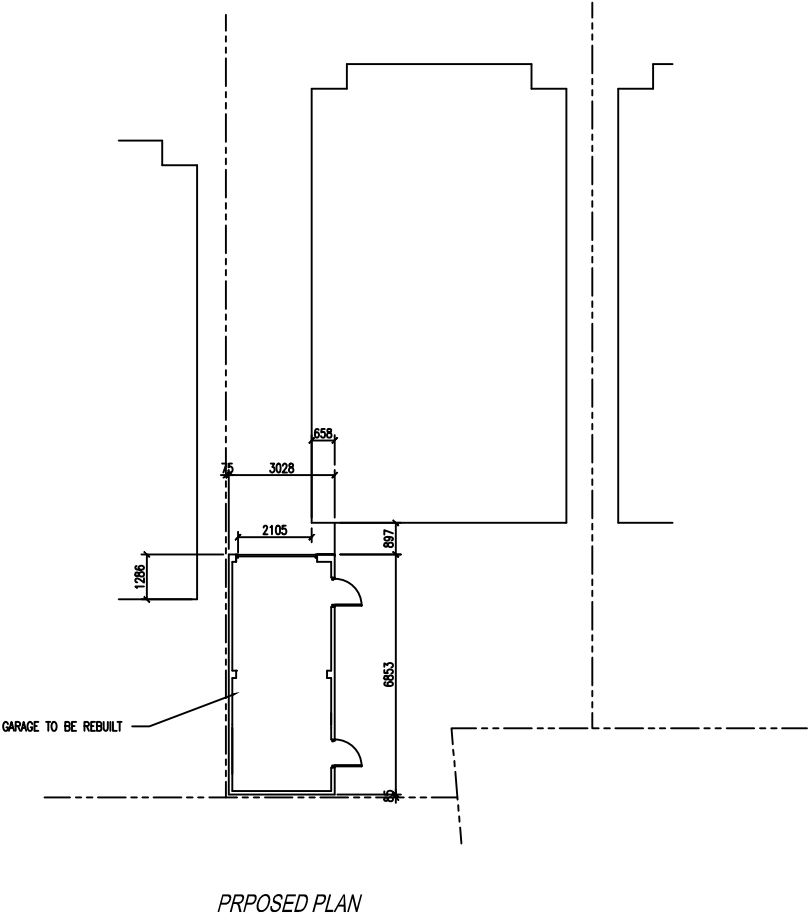
EXISTING GARAGE ROOF - FIBROUS CEMENT CORRUGATED SHEETING.  
EXISTING GARAGE BRICKWORK - LBC SAND FACED FLETTON BRICKS LAID IN STRETCHER BOND.  
NEW GARAGE ROOF - REDLAND FENLAND PANTILES, TUDOR BROWN.  
NEW GARAGE BRICKWORK - FLETTON BRICKS TO MATCH EXISTING DWELLING LAID IN STRETCHER BOND.  
NEW GARAGE PERSONNEL DOORS IN WEST ELEVATION TO BE TIMBER WITH SAFETY GLASS PANEL.
