**Arboricultural Impact Assessment  
Arboricultural Method Statement  
Tree Constraints Plan,  
&  
Tree Protection Plan**

1A Beech Road, Emsworth, Hampshire

26<sup>th</sup> May 2016

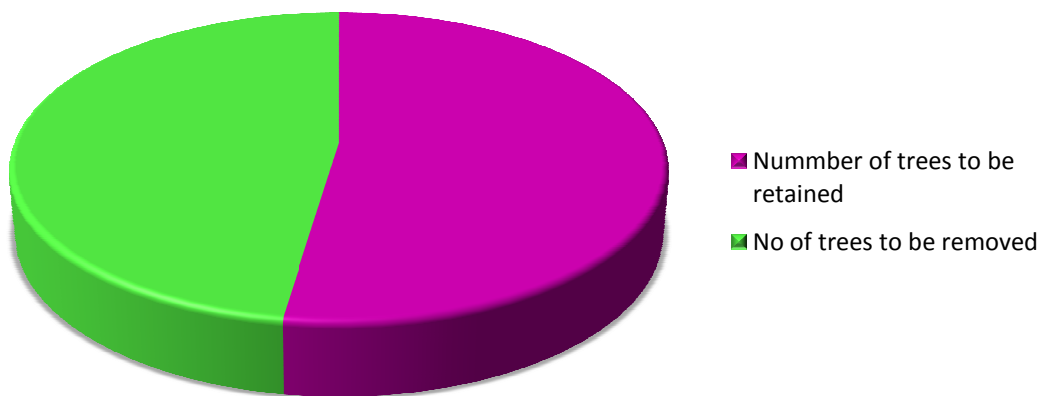
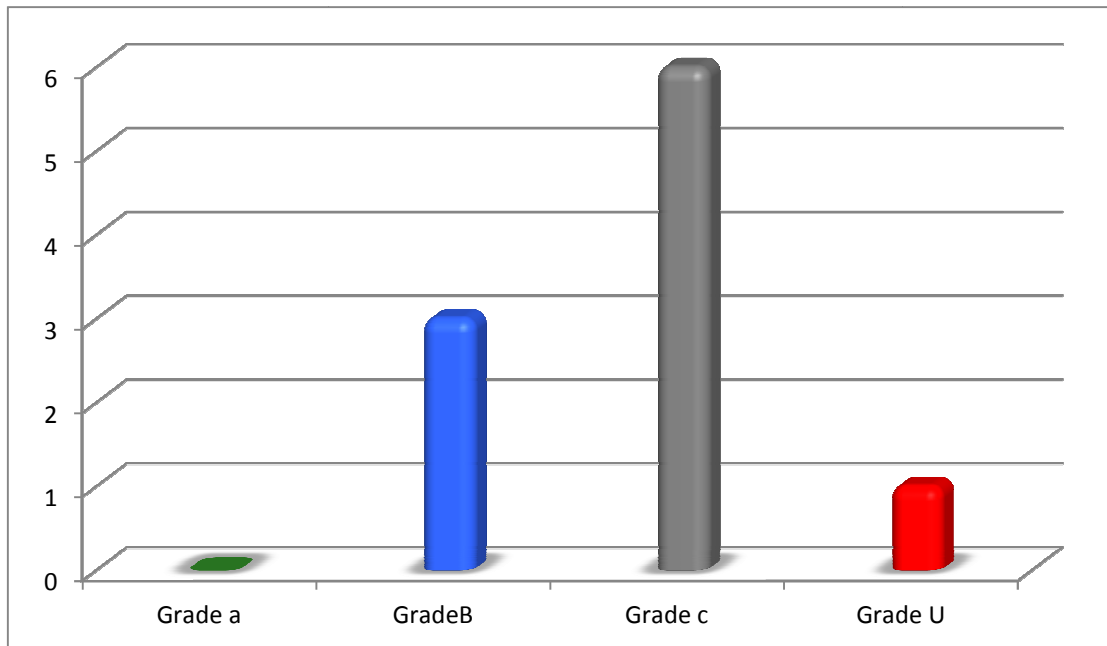
#### Removal of Trees

### 3.2 Removal of trees

Nine trees will be removed due to direct conflict with the proposed development, and one will be removed due to it being a category U tree. This is in line with the thinking of sound arboricultural management.

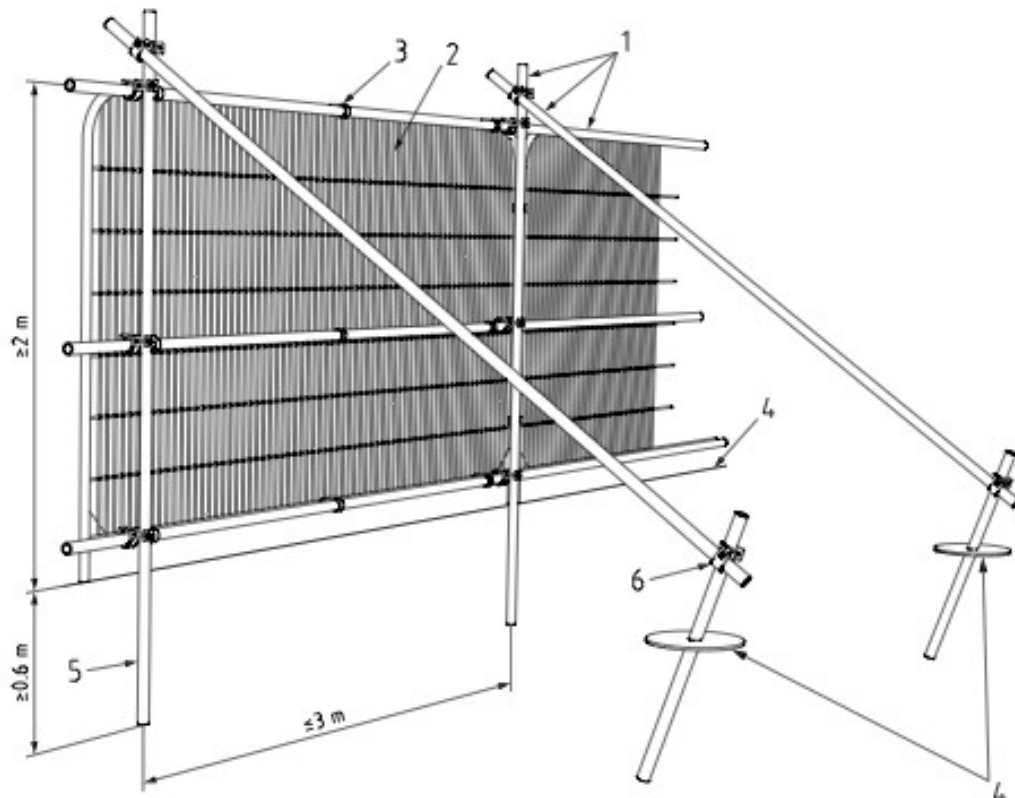
The Tree Protective fencing will be 2.4m Heras fencing as specified in the BS. The fencing will be supported by a scaffold framework with supporting struts firmed into the ground on the side of the trees. The purpose of the supports is to prevent the fencing being moved during the development. Clear signs will be attached to the fencing (e.g. Tree Protective Fencing – Keep Out).

- 1 Standard scaffold poles
- 2 Heavy gauge 2 m tall galvanized tube and welded mesh infill panels
- 3 Panels secured to uprights and cross-members with wire ties
- 4 Ground level
- 5 Uprights driven into the ground until secure (minimum depth 0.6 m)
- 6 Standard scaffold clamps

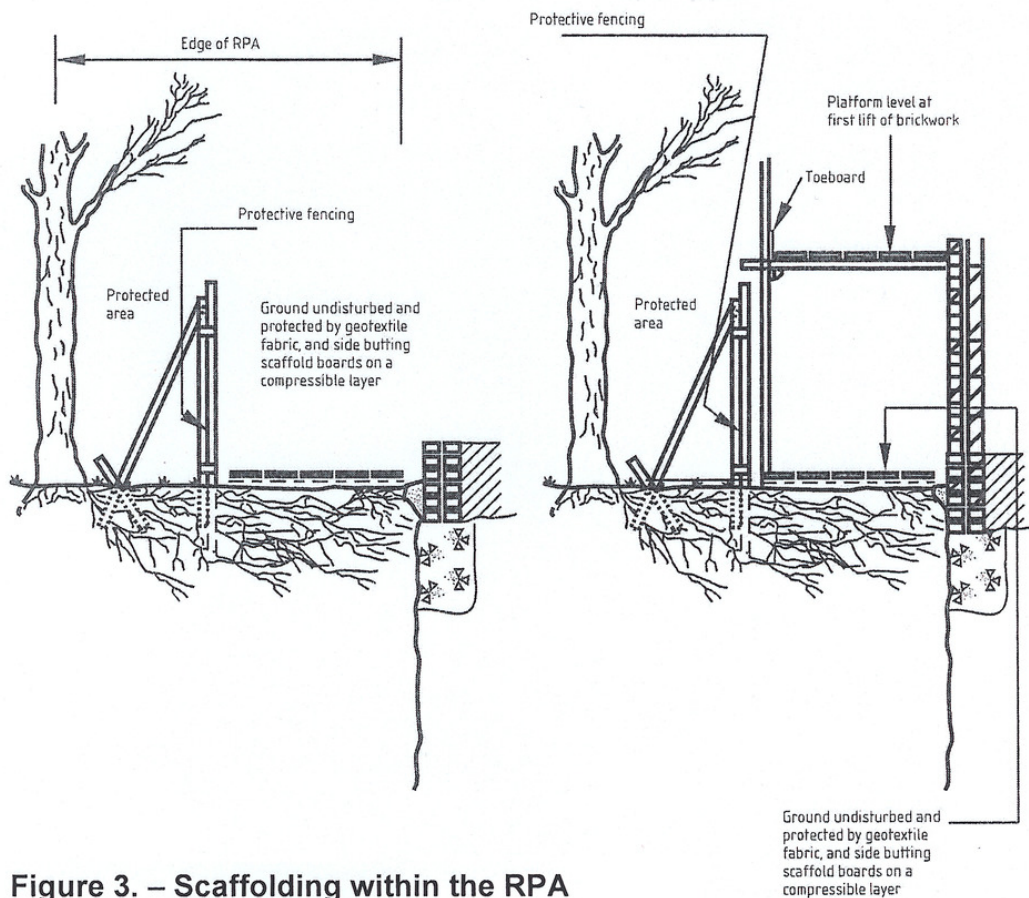
**Figure 3. – Scaffolding within the RPA**

Where required, Scaffolding can be erected on top of a ground protection system as illustrated in the diagram below.

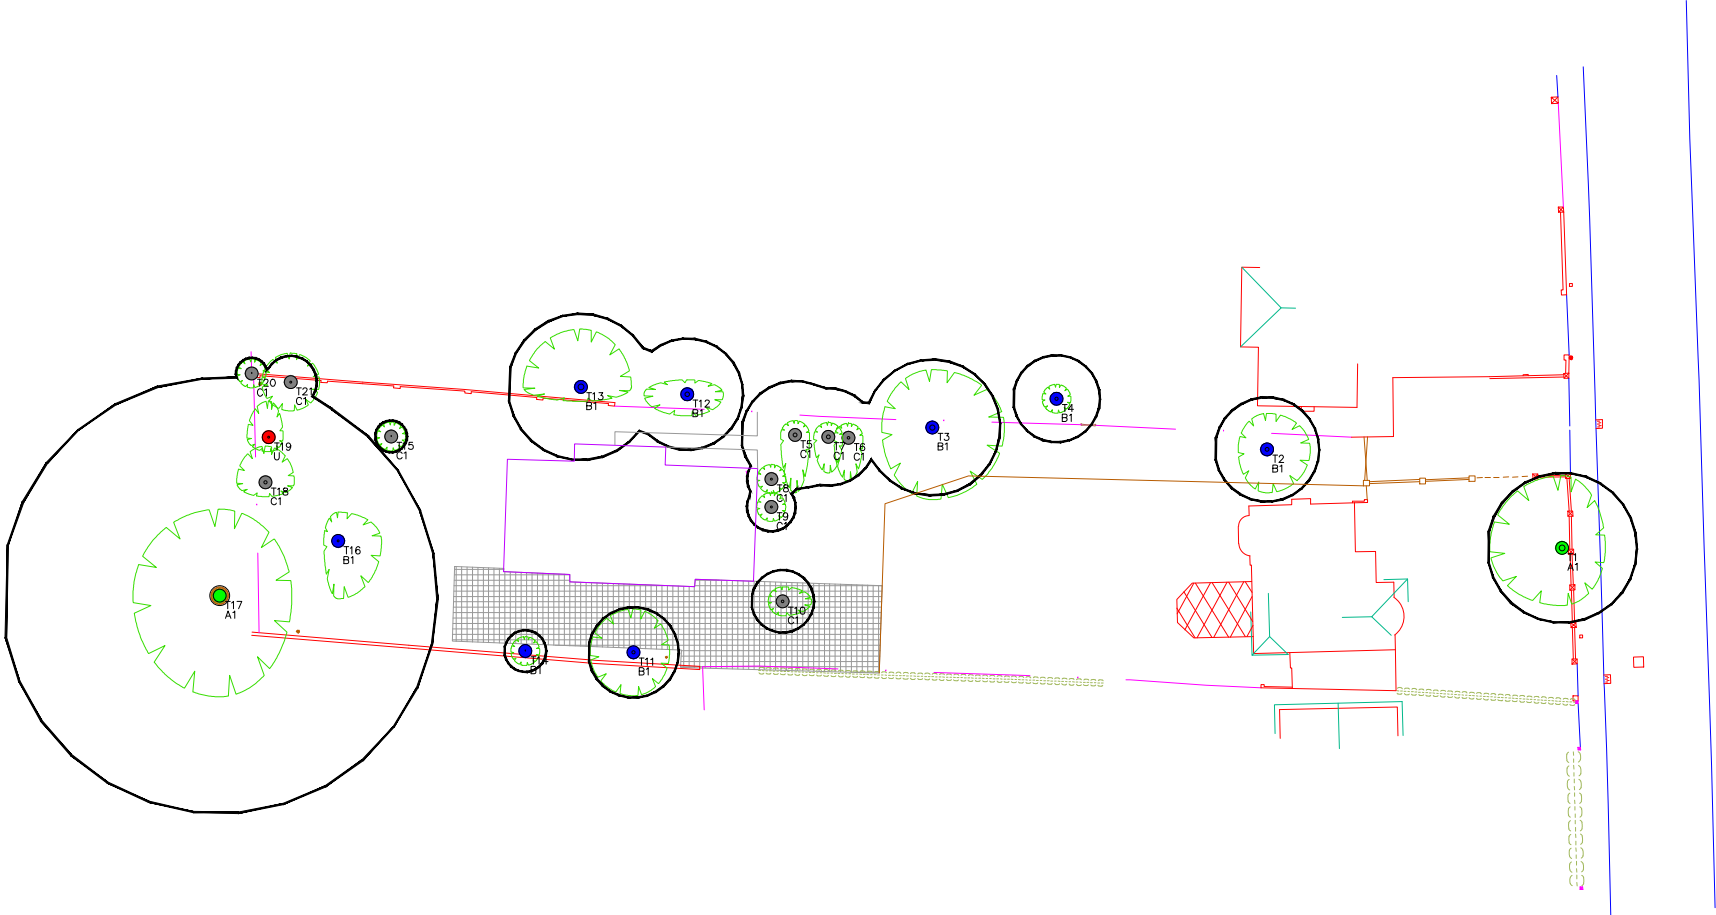
Tree Constraints Plan

- Proposed new fencing
- Proposed new Hard surface treatment
- Proposed new dwelling

1a Beech Road  
Scale @ A3 1:500

With regard to their desirability for retention, the trees surveyed have been graded with their trunks colour coded on the tree constraints plan, and tree protection plan using the criteria contained in BS5837:2012. A summary of this grading is as follows.

In our survey schedule, the RPA for each tree is indicated as the radius of a circle as well as in M<sup>2</sup>. This is also plotted on the tree constraints plan and tree protection plan denoted by a heavy black line which merges the individual RPAs together where there is more than one tree.

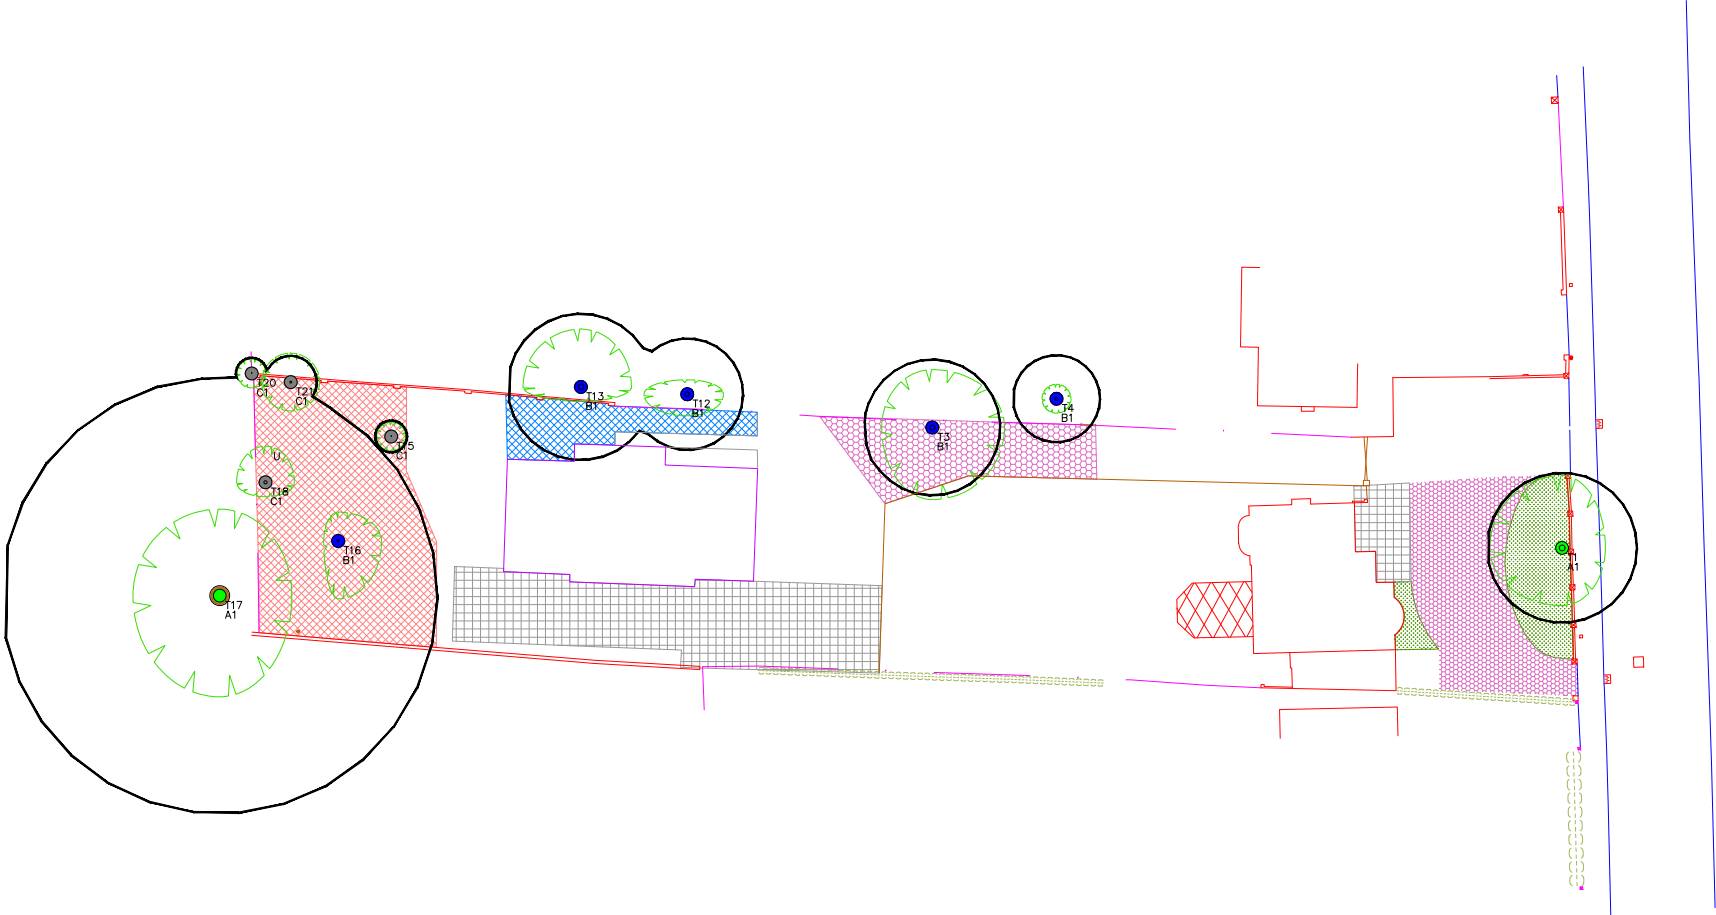
Tree Protection Plan

- Proposed new fencing
- Proposed new Hard surface treatment
- Proposed new dwelling
- Area where cellular confinement surfacing will be used
- CEZ surrounded with type 1 tree protective fencing
- BS5837:2012 specification ground protection system

1a Beech Road  
Scale @ A3 1:500

| Incursions into RPAs of retained trees | | |
|---|---|---|
| New access road | T3, and T4 | Use no dig cellular confinement with a porous asphalt top layer |
| Foundations for new dwelling | T13 | Line foundation trench with a plastic membrane where within the RPA of T13 |
| New driveway at the front of the site | T1 | Use no dig cellular confinement with a porous asphalt top layer |

The required tree protective fencing should be installed to fence off the construction exclusion zone(s), or CEZ, shown on the tree protection plan (Figure 2). This must only be altered or moved as agreed in writing by the Local Planning Authority following advice from a competent Arboricultural Consultant.
