REBUILDING OF EXISTING STRUCTURALLY  
DAMAGED GARAGE AT:-

5 WICKOR WAY, EMSWORTH  
HANTS PO10 7RE

DRWG. NO. CJD/PO107RE/01 Issue 02

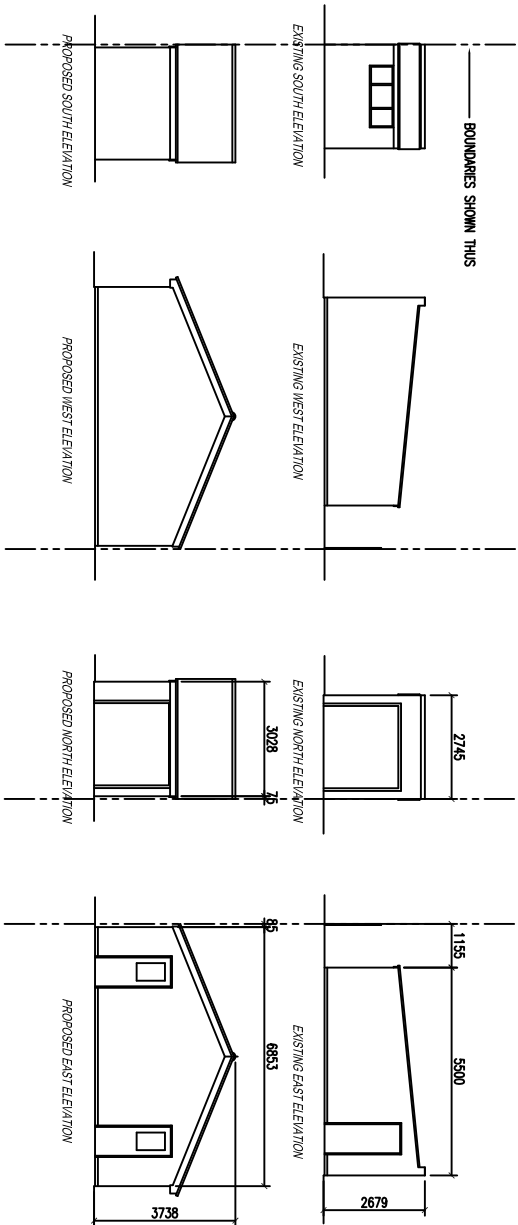
EXISTING GARAGE ROOF – FIBROUS CELEST CORRUGATED SHEETING.  
EXISTING GARAGE BRICKWORK – LB'S SAND FACED FLETTON BRICKS Laid IN STRETCHER BOND.  
NEW GARAGE ROOF – REDLAND FENLAND PAINTILES, TUDOR BROWN.  
NEW GARAGE BRICKWORK – FLETTON BRICKS TO MATCH EXISTING DWELLING Laid IN STRETCHER BOND.  
NEW GARAGE PERSONNEL DOORS IN WEST ELEVATION TO BE TIMBER WITH SAFETY GLASS PANEL.
