## **Manor Cottage, Old Bedhampton**

This Design, Heritage and Access Statement is written in support of Planning and Listed Building applications to build a single storey extension to the west side of the house and to carry out internal repairs. These works are as follows: -

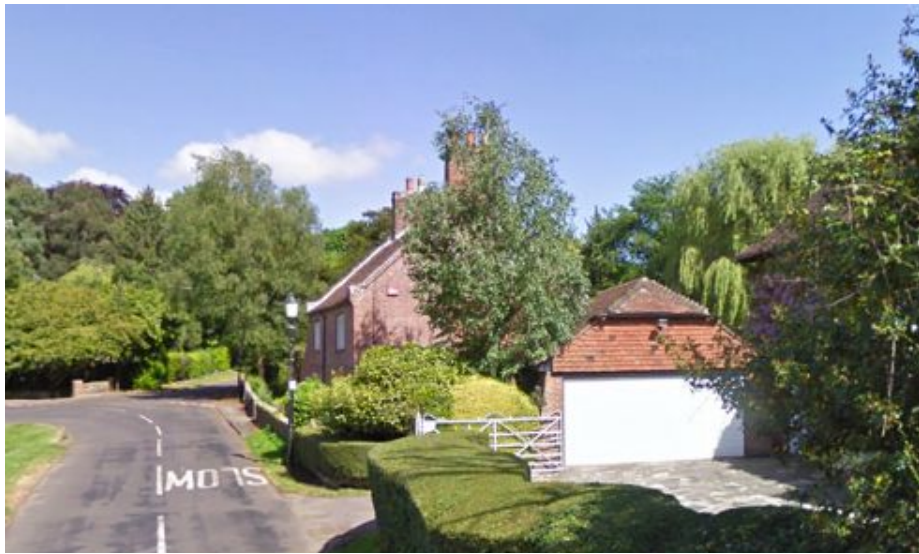
West gable of the cottage with the neighbour's garage in the foreground

The yard on the west side of the house is an unused section of the garden due to its limited size. The space lies behind the garage belonging to number 3 Lower Road and the boundary wall. A structure in this location will therefore have a little impact on the amenity of the neighbouring property.

The photograph above shows a birch tree in the garden of 3 Lower Road. The canopy of the tree is wholly in the neighbour's garden and therefore its root system should not be affected by the proposed extension on the west side of Manor Cottage.

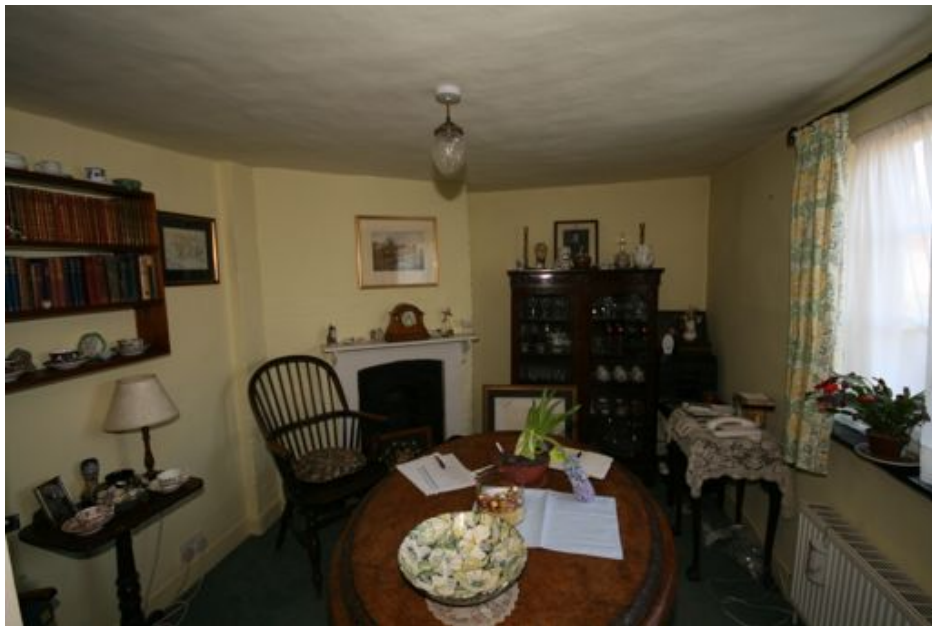
The study to become Oliver's bedroom

The study is surplus to the families requirements and will therefore provide a suitable ground floor bedroom, which can be connected to a new bathroom in an extension to the west of the house, by making a door opening in the external wall of the house.

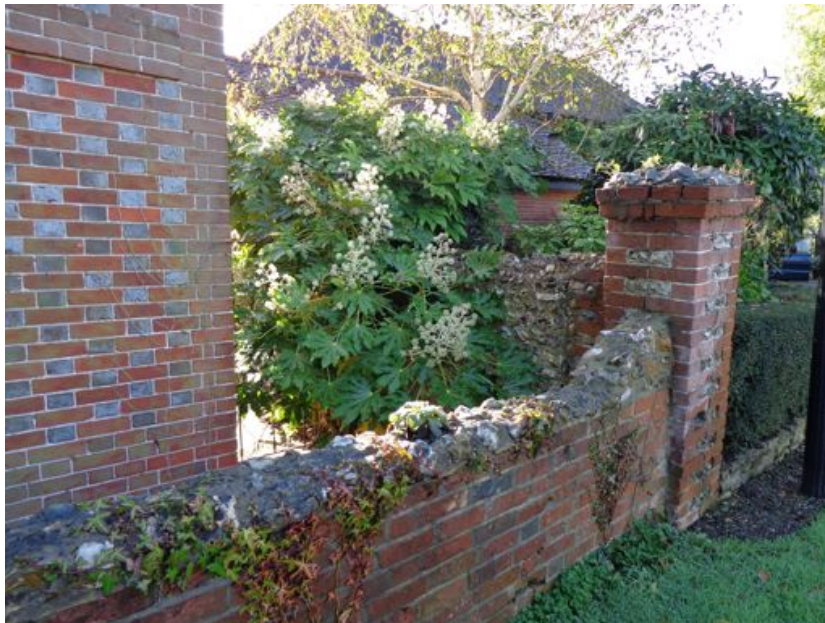
View of the boundary wall to the road, which will not be affected by the works.

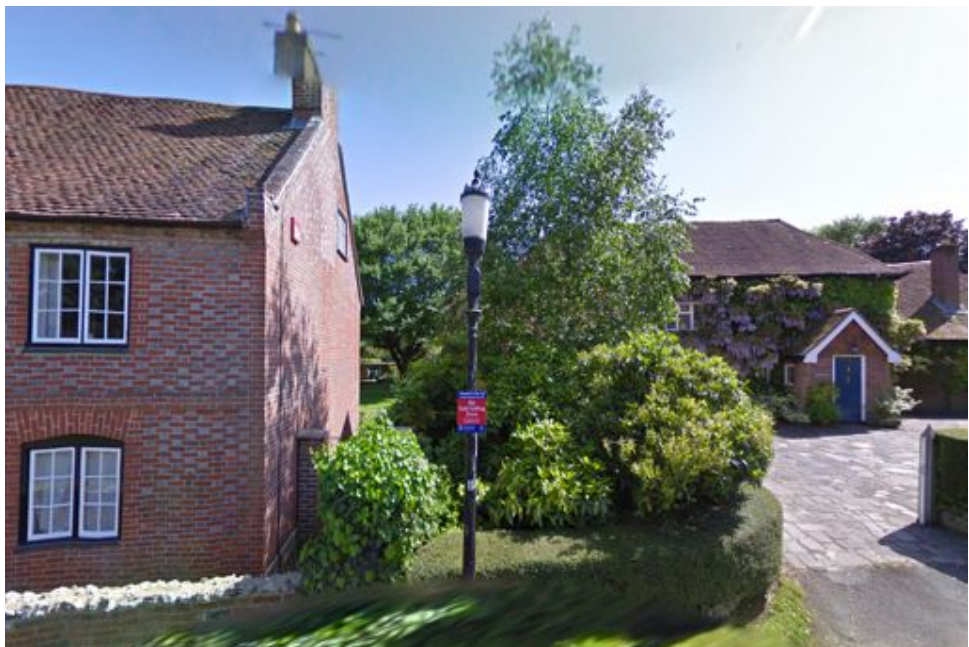
View of west gable of the cottage showing the boundary with number 3 Lower Road

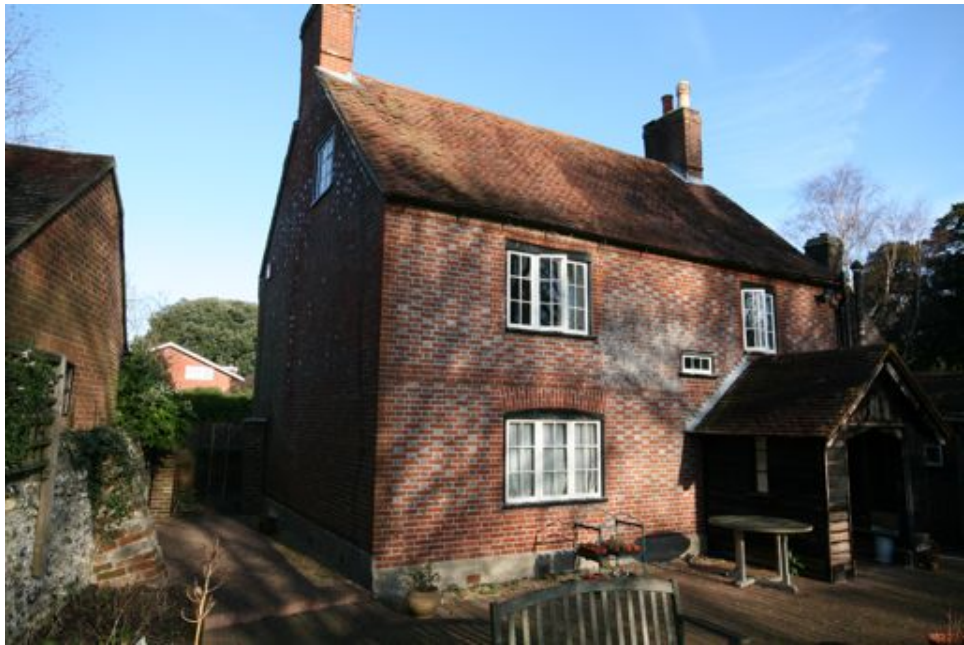
View looking north showing the site of the proposed extension

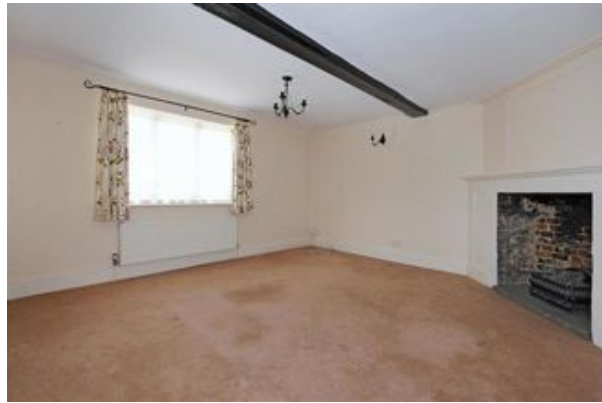
View of living room looking towards the proposed bay in the west wall

The new opening will be made to the left of the carriage beam.

In order to provide space in the living room for the son's wheelchair and his activities, it is proposed to create a bay off the living room within the enclosure of the extension. This bay will provide a desk area and French doors linking the living room with the garden. Although this alteration necessitates an opening being made in the external wall of the original cottage it is argued that the alteration does not detract from the special architectural interest of the cottage and the benefit to the child by making this alteration is considerable.

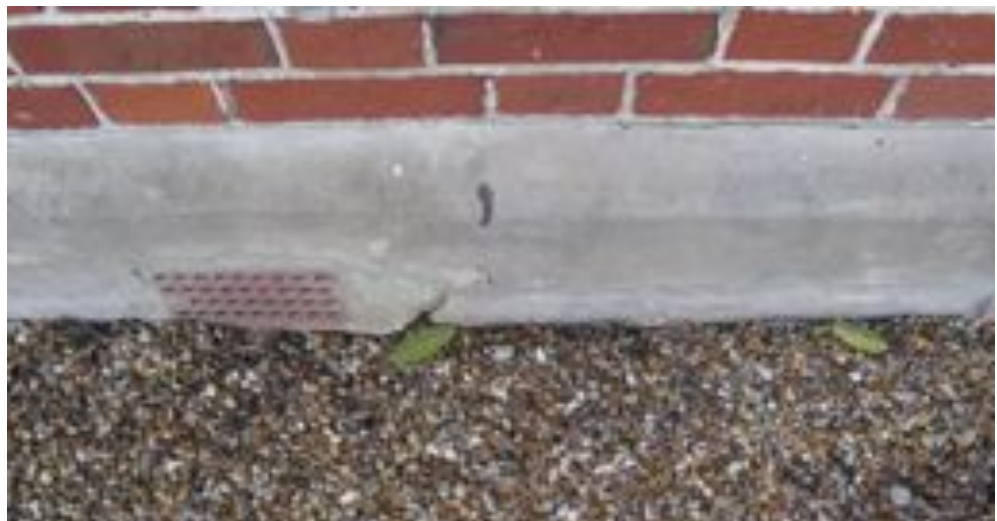
The sand-cement render to the external brick plinth will be replaced with a hydraulic lime render, using NHL 3.5. Only brick already covered in cement bound mortar will be rendered over.

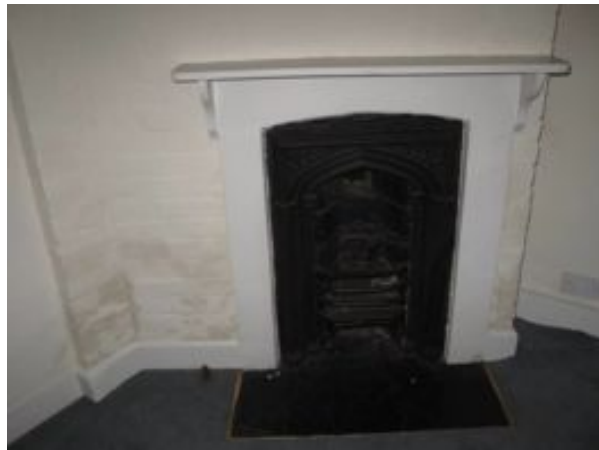
The injected dpc is not functioning. It is therefore proposed that new softwood panelling be installed around the fireplace in the old study, which is to become the front ground floor bedroom. The new ventilated wall panelling will match the living room panelling and disguise the effect of rising damp.

The damp fireplace wall

It is proposed that the timber panelling over the chimney breast be copied and be installed over the exposed brickwork in the new bedroom in order to hide the spoilt decorations, caused by rising damp. The new panelling will be isolated from the wall and the space behind ventilated.

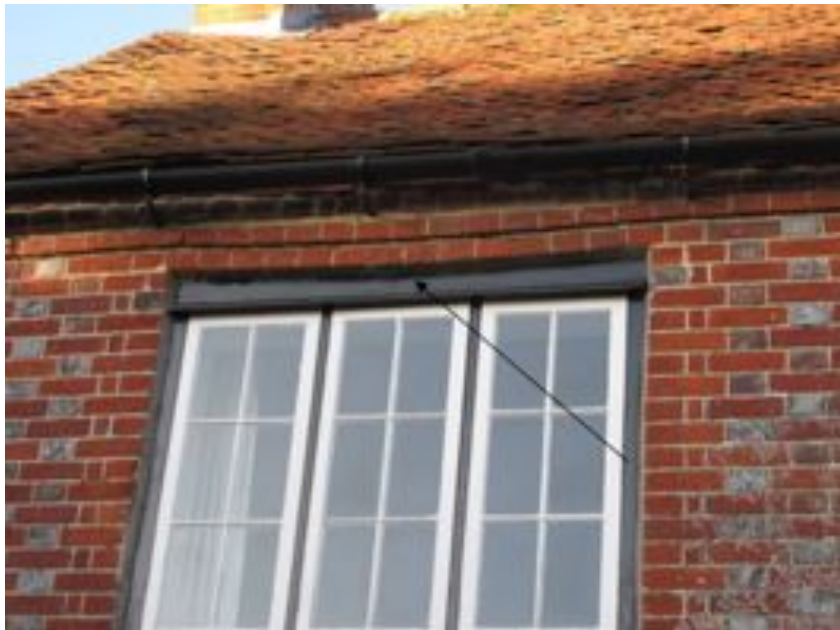
The extent of necessary work to repair the rotten window lintel in the rear first floor bedroom requires a more intrusive survey. This survey will be carried out by the builder and the conservation architect. Probing to date has revealed that the end of the oak lintel has rotted causing disruption of the external brickwork and movement internally in the plaster. The extent of the decay is not known but consent is required to replace the oak lintel and make good the brickwork externally as found necessary, all to match existing. (No new bricks should be required.) Consent is also requested to make any necessary repair to the end of the carriage beam in the vicinity of the lintel bearing. Any such work will be carried out in an unobtrusive way preserving the fabric and the appearance of the room. Mortar and pointing will be carefully matched.

Fallen brickwork over window head
