# Heritage Statement & Schedule of Repair Accolaid/14/00212/CMP

## Alterations, Additions For Restaurant Conversion.

25 South Street, Emsworth  
Hampshire, PO10 7EG.

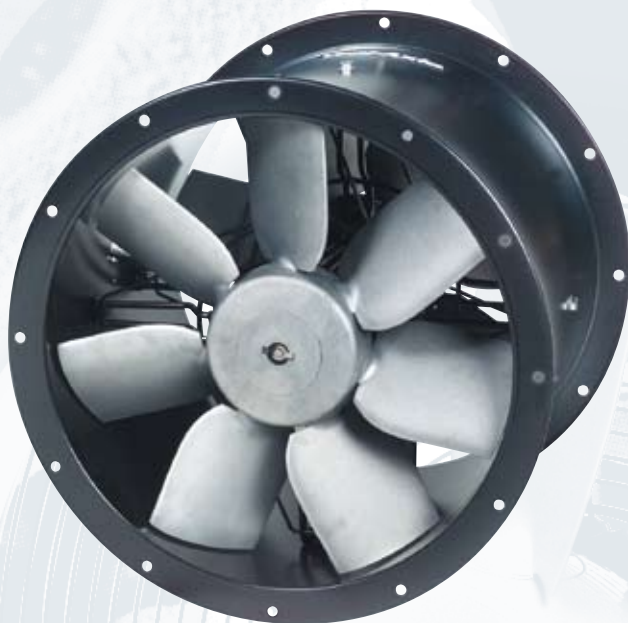
### TCBBx2 / TCBTx2 Series

Range of cylindrical cased axial fans fitted with aluminium impellers and manufactured from high grade rolled galvanised steel and protected against **corrosion by cataforesis primer and black polyester paint finish.**

Fitted with **2 contrarrotating complementary impellers** manufactured from die-cast aluminium. All models are supplied with pre-wired wiring junction box located on the outside of the fan casing for easy wiring access.

10.12 As 10.11.A above, details are attached at Appendix III, of Soler & Palau industrial fan – Model TCBBx2/4-450 and Attenuator SIL-CZO (450 dia.). Also Jasun Filtration activated carbon filter, Model DC 242412/8-7C.
