| REVISION | DATE | COMMENTS | TITLE | | AUTHOR / CHECKED | |
|---|---|---|---|---|---|--|
| | | | HOUSE SH39 (PORTSDOWN) | | | |
| | | | DETAIL | | | |
| | | | PLANNING 2 of 2 | | | |
| | | | 10774 - P.01.41 | - | AC/PF | |

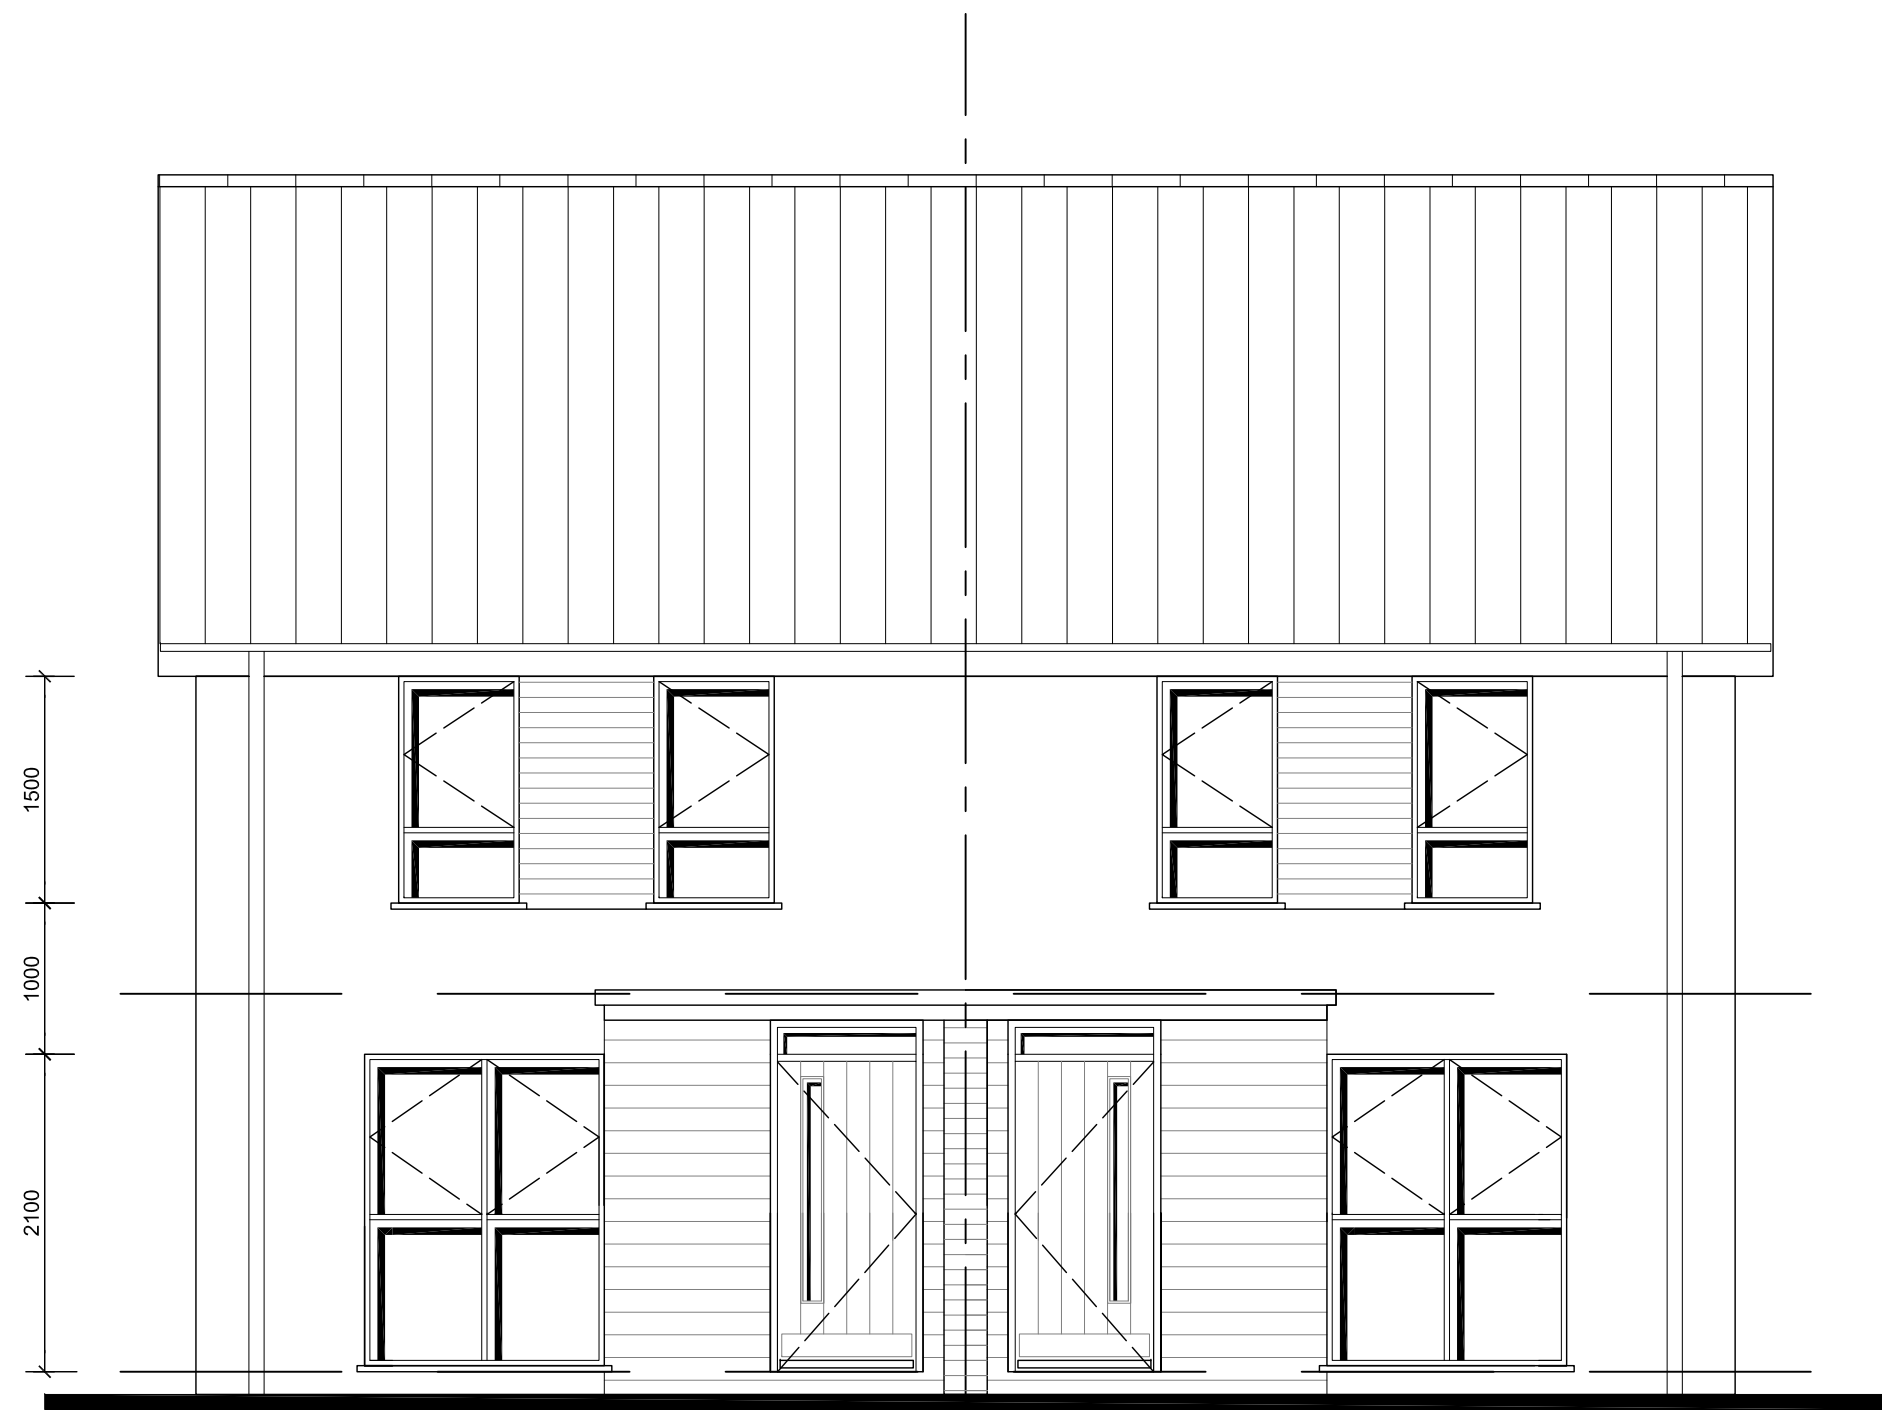
FRONT ELEVATION

- angular ridge tile
- concrete interlocking roof tiles
- upvc rainwater goods
- upvc eaves & verge
- artificial timber weatherboarding
- clay facing brickwork
- lead covered porch roof
- upvc windows
- timber door with fanlight
