Tree protection plan  
Location of trees & protection/management proposals at Scratchface Lane, Bedhampton

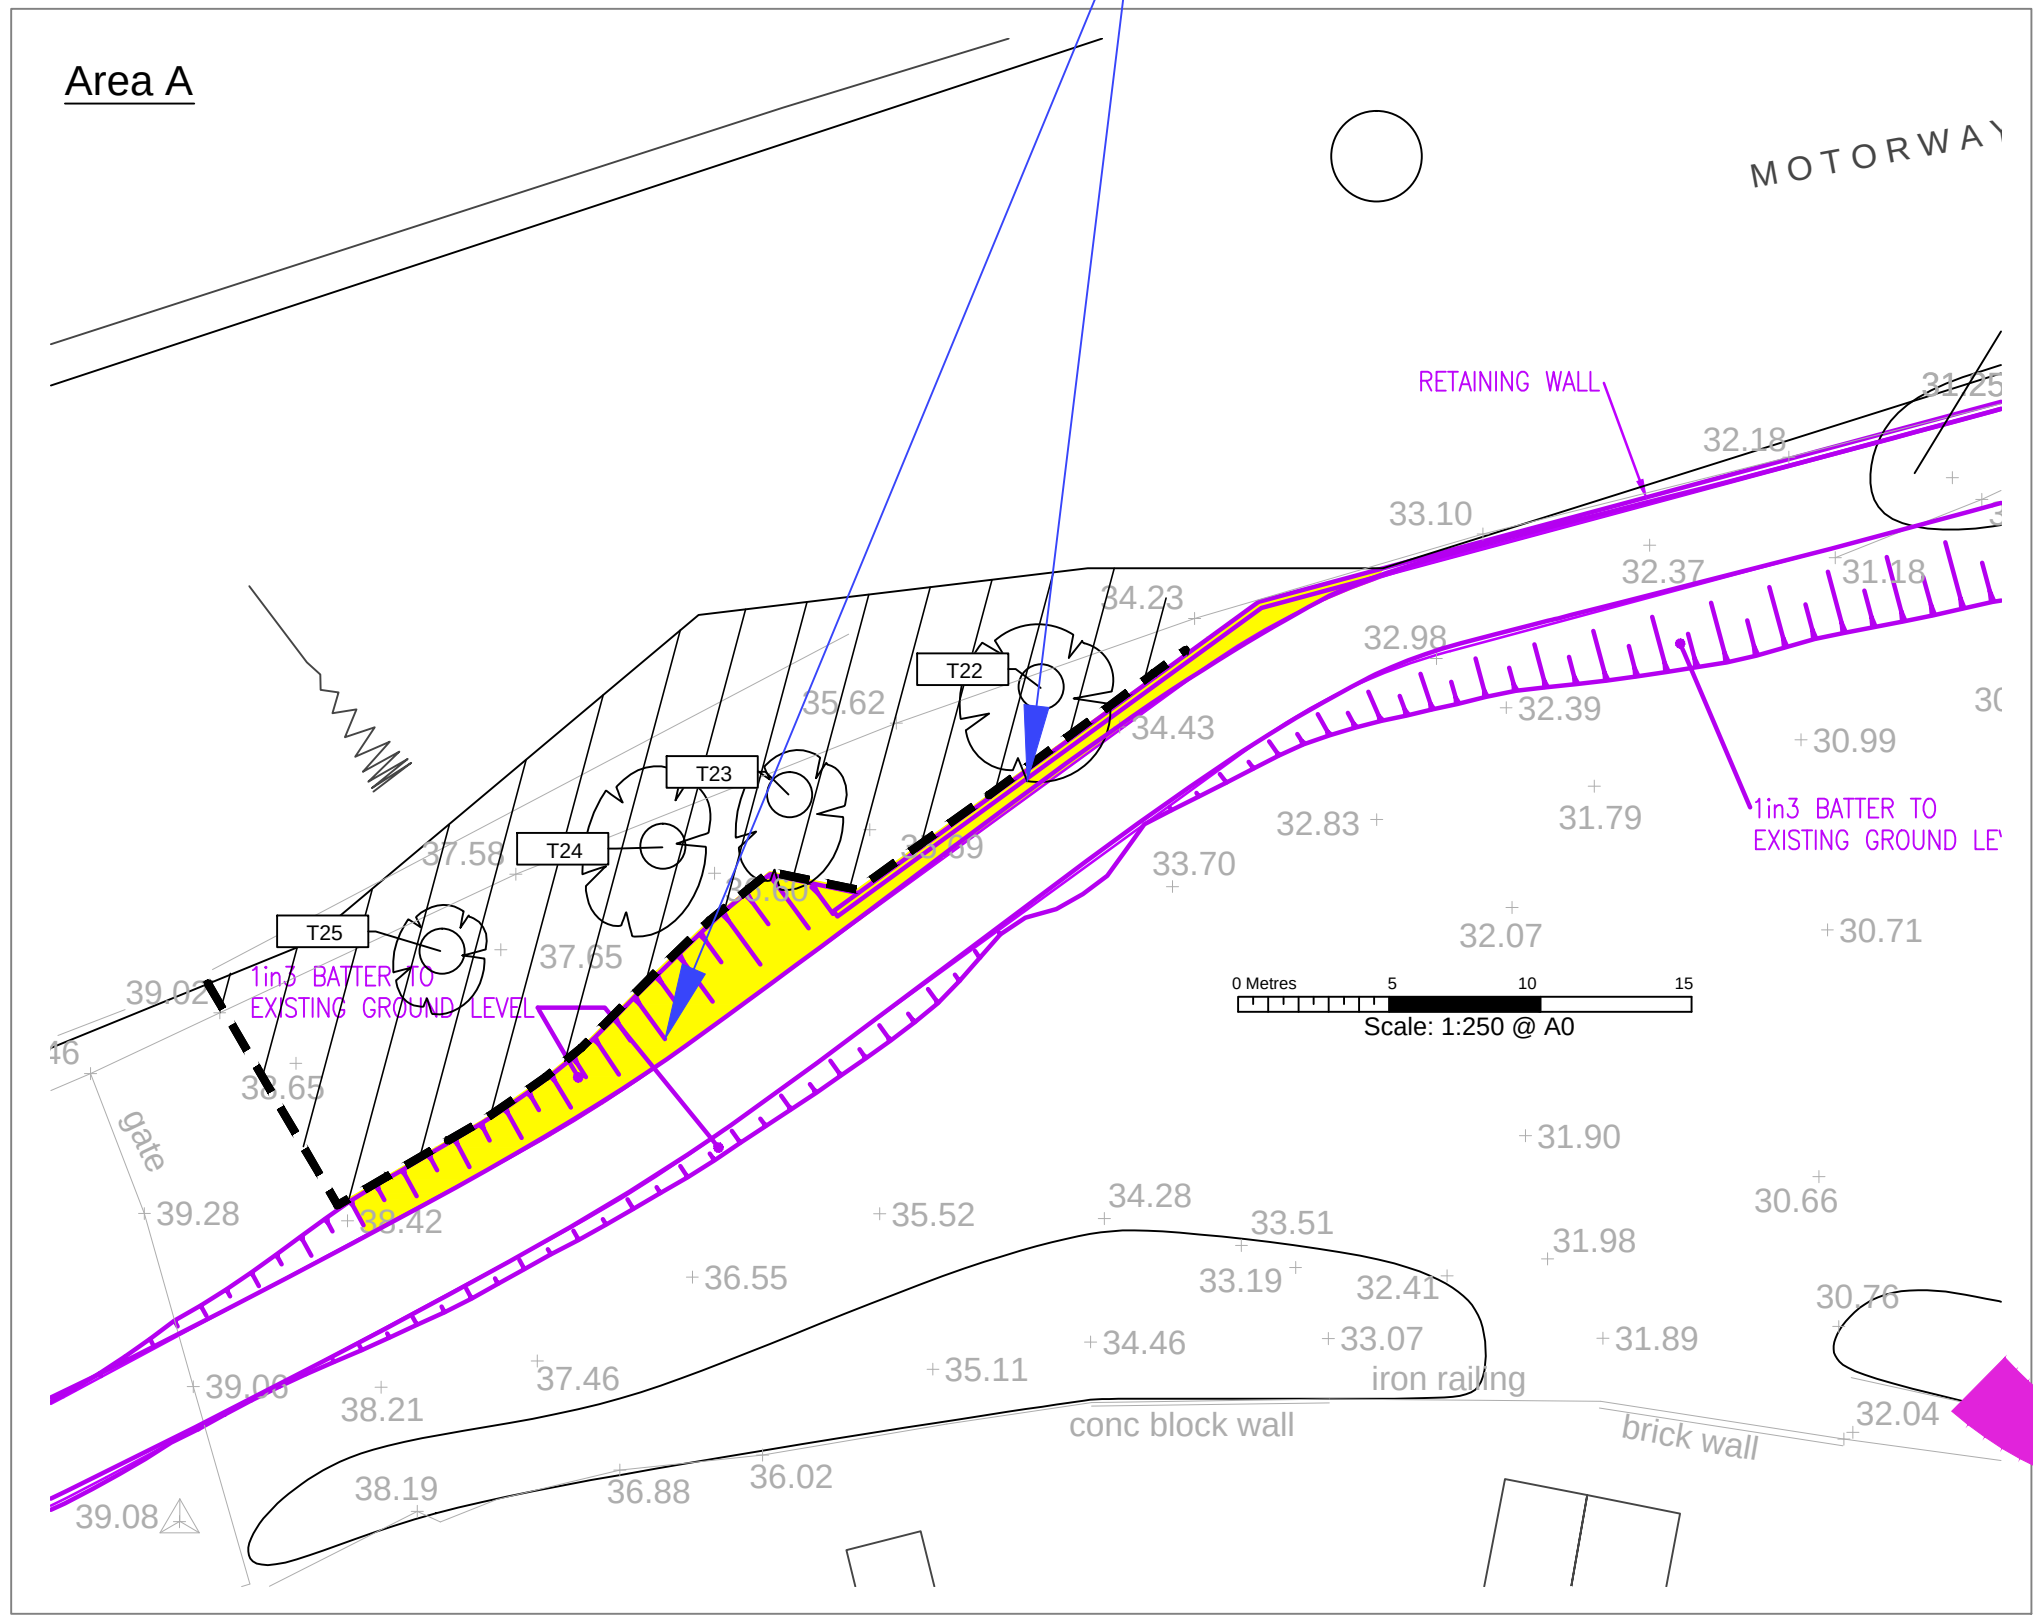
Careful hand digging close to these trees must be supervised by the arboricultural consultant to fully assess the extent of root growth before any construction works for installing the wall are undertaken. All operations close to the trees must be in accordance with the working details provided in the arboricultural watching brief and method statement by Barrell Treecare. Once the situation has been fully assessed by the arboricultural consultant the tree officer will be contacted and fully briefed about the situation. A detailed method of operations to construct the wall in a way that minimises harm to trees will be provided before any works within root protection areas start.

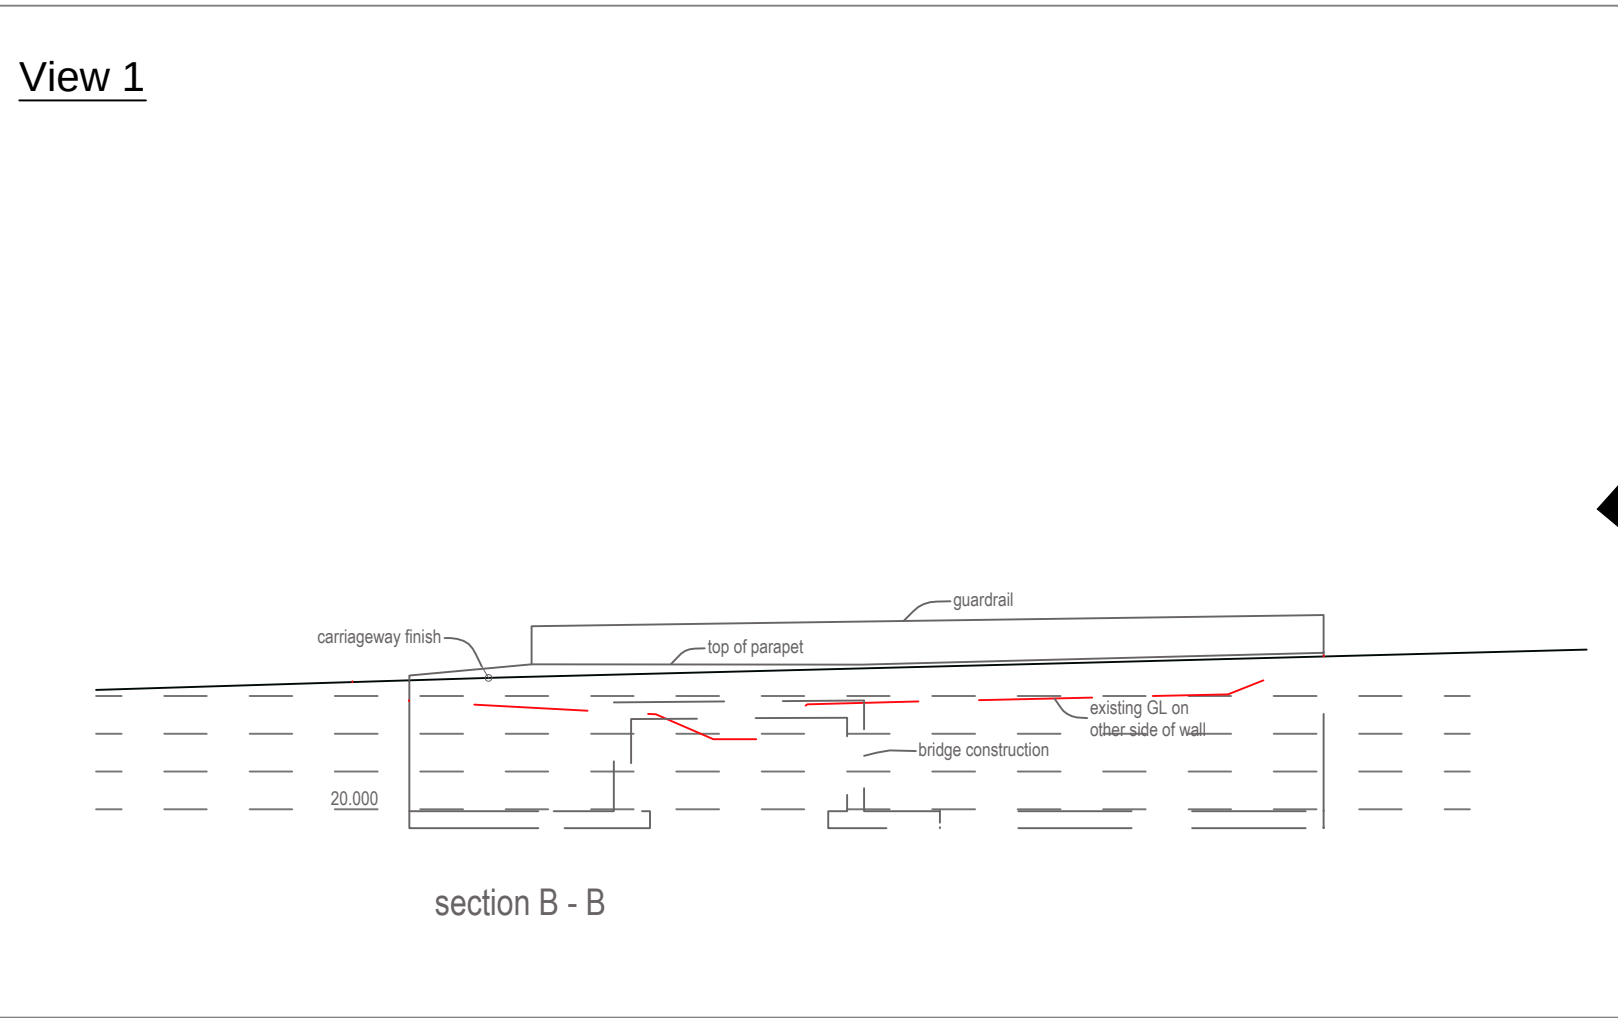
View 1

Areas where special precautions are required when installing the new bridge and raising soil levels. All operations close to the trees must be in accordance with the working details provided in the arboricultural watching brief and method statement by Barrell Treecare. Where necessary these operations will be supervised by the arboricultural consultant.

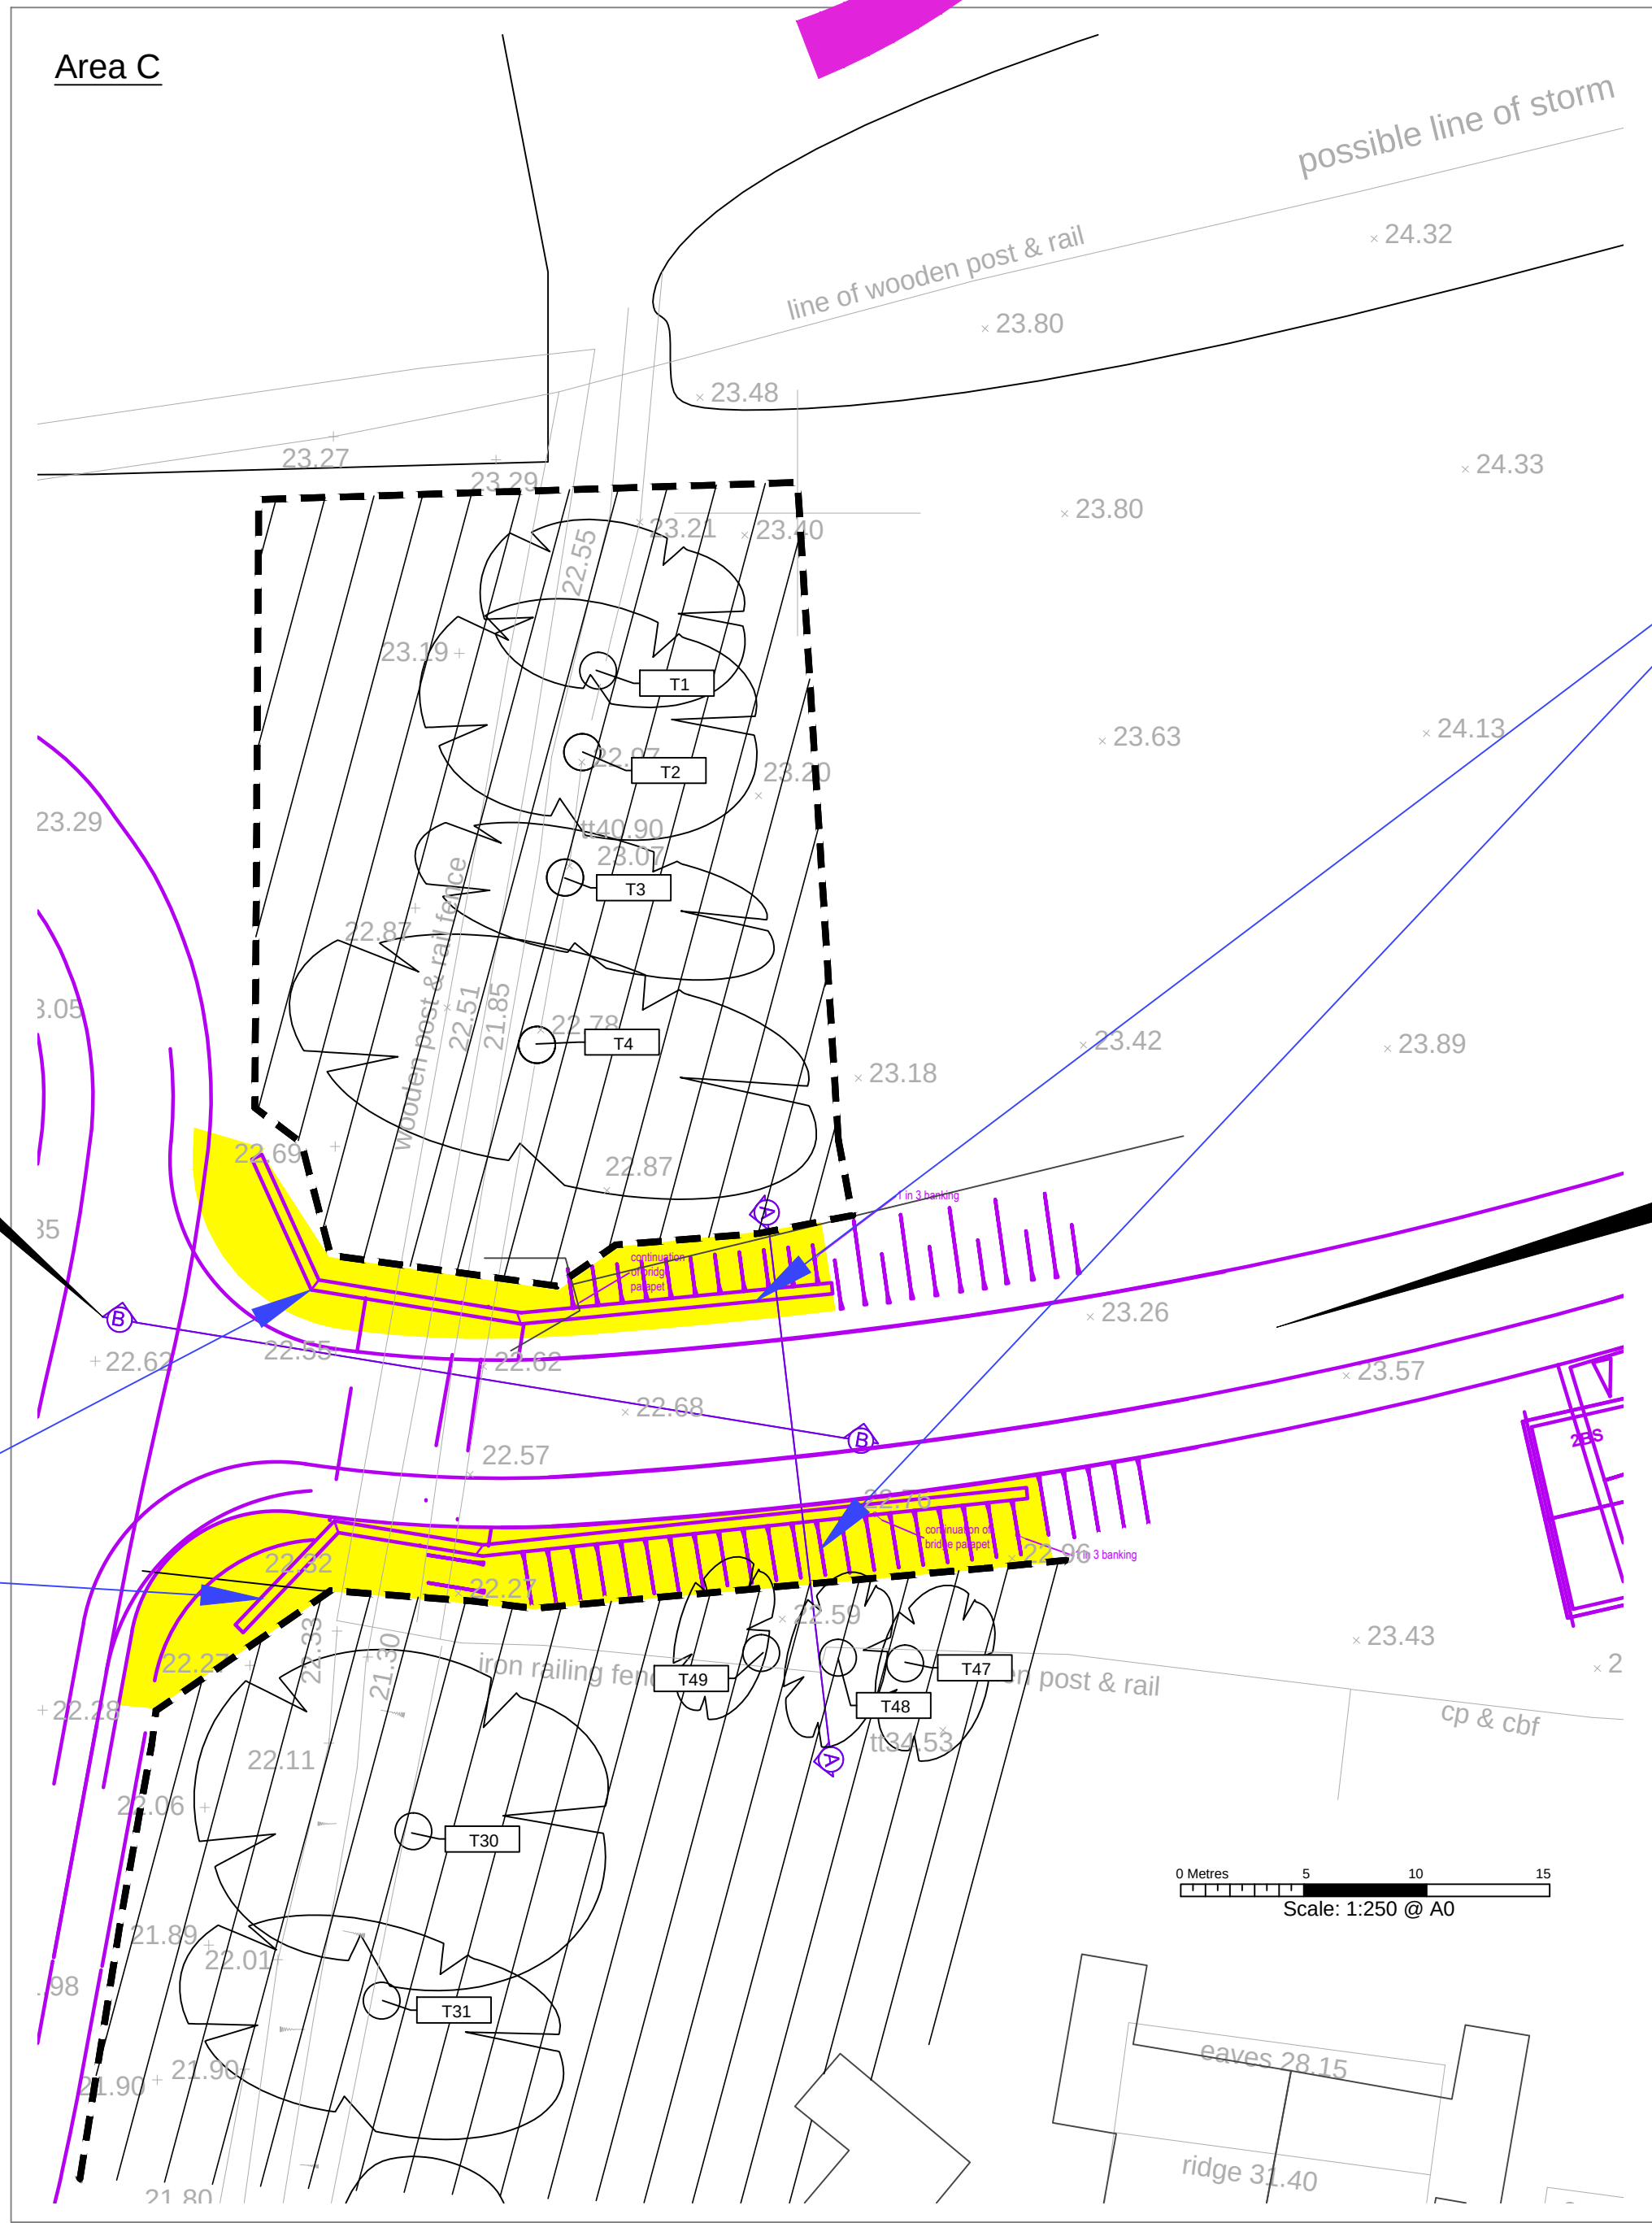
View 2

Areas where special precautions are required when installing the new bridge and raising soil levels. All operations close to the trees must be in accordance with the working details provided in the arboricultural watching brief and method statement by Barrell Treecare. Where necessary these operations will be supervised by the arboricultural consultant.
