## **ARBORICULTURAL IMPACT ASSESSMENT**

**Land at 109 & 111 London Road, Cowplain**

Bernie Harverson M.Arb.

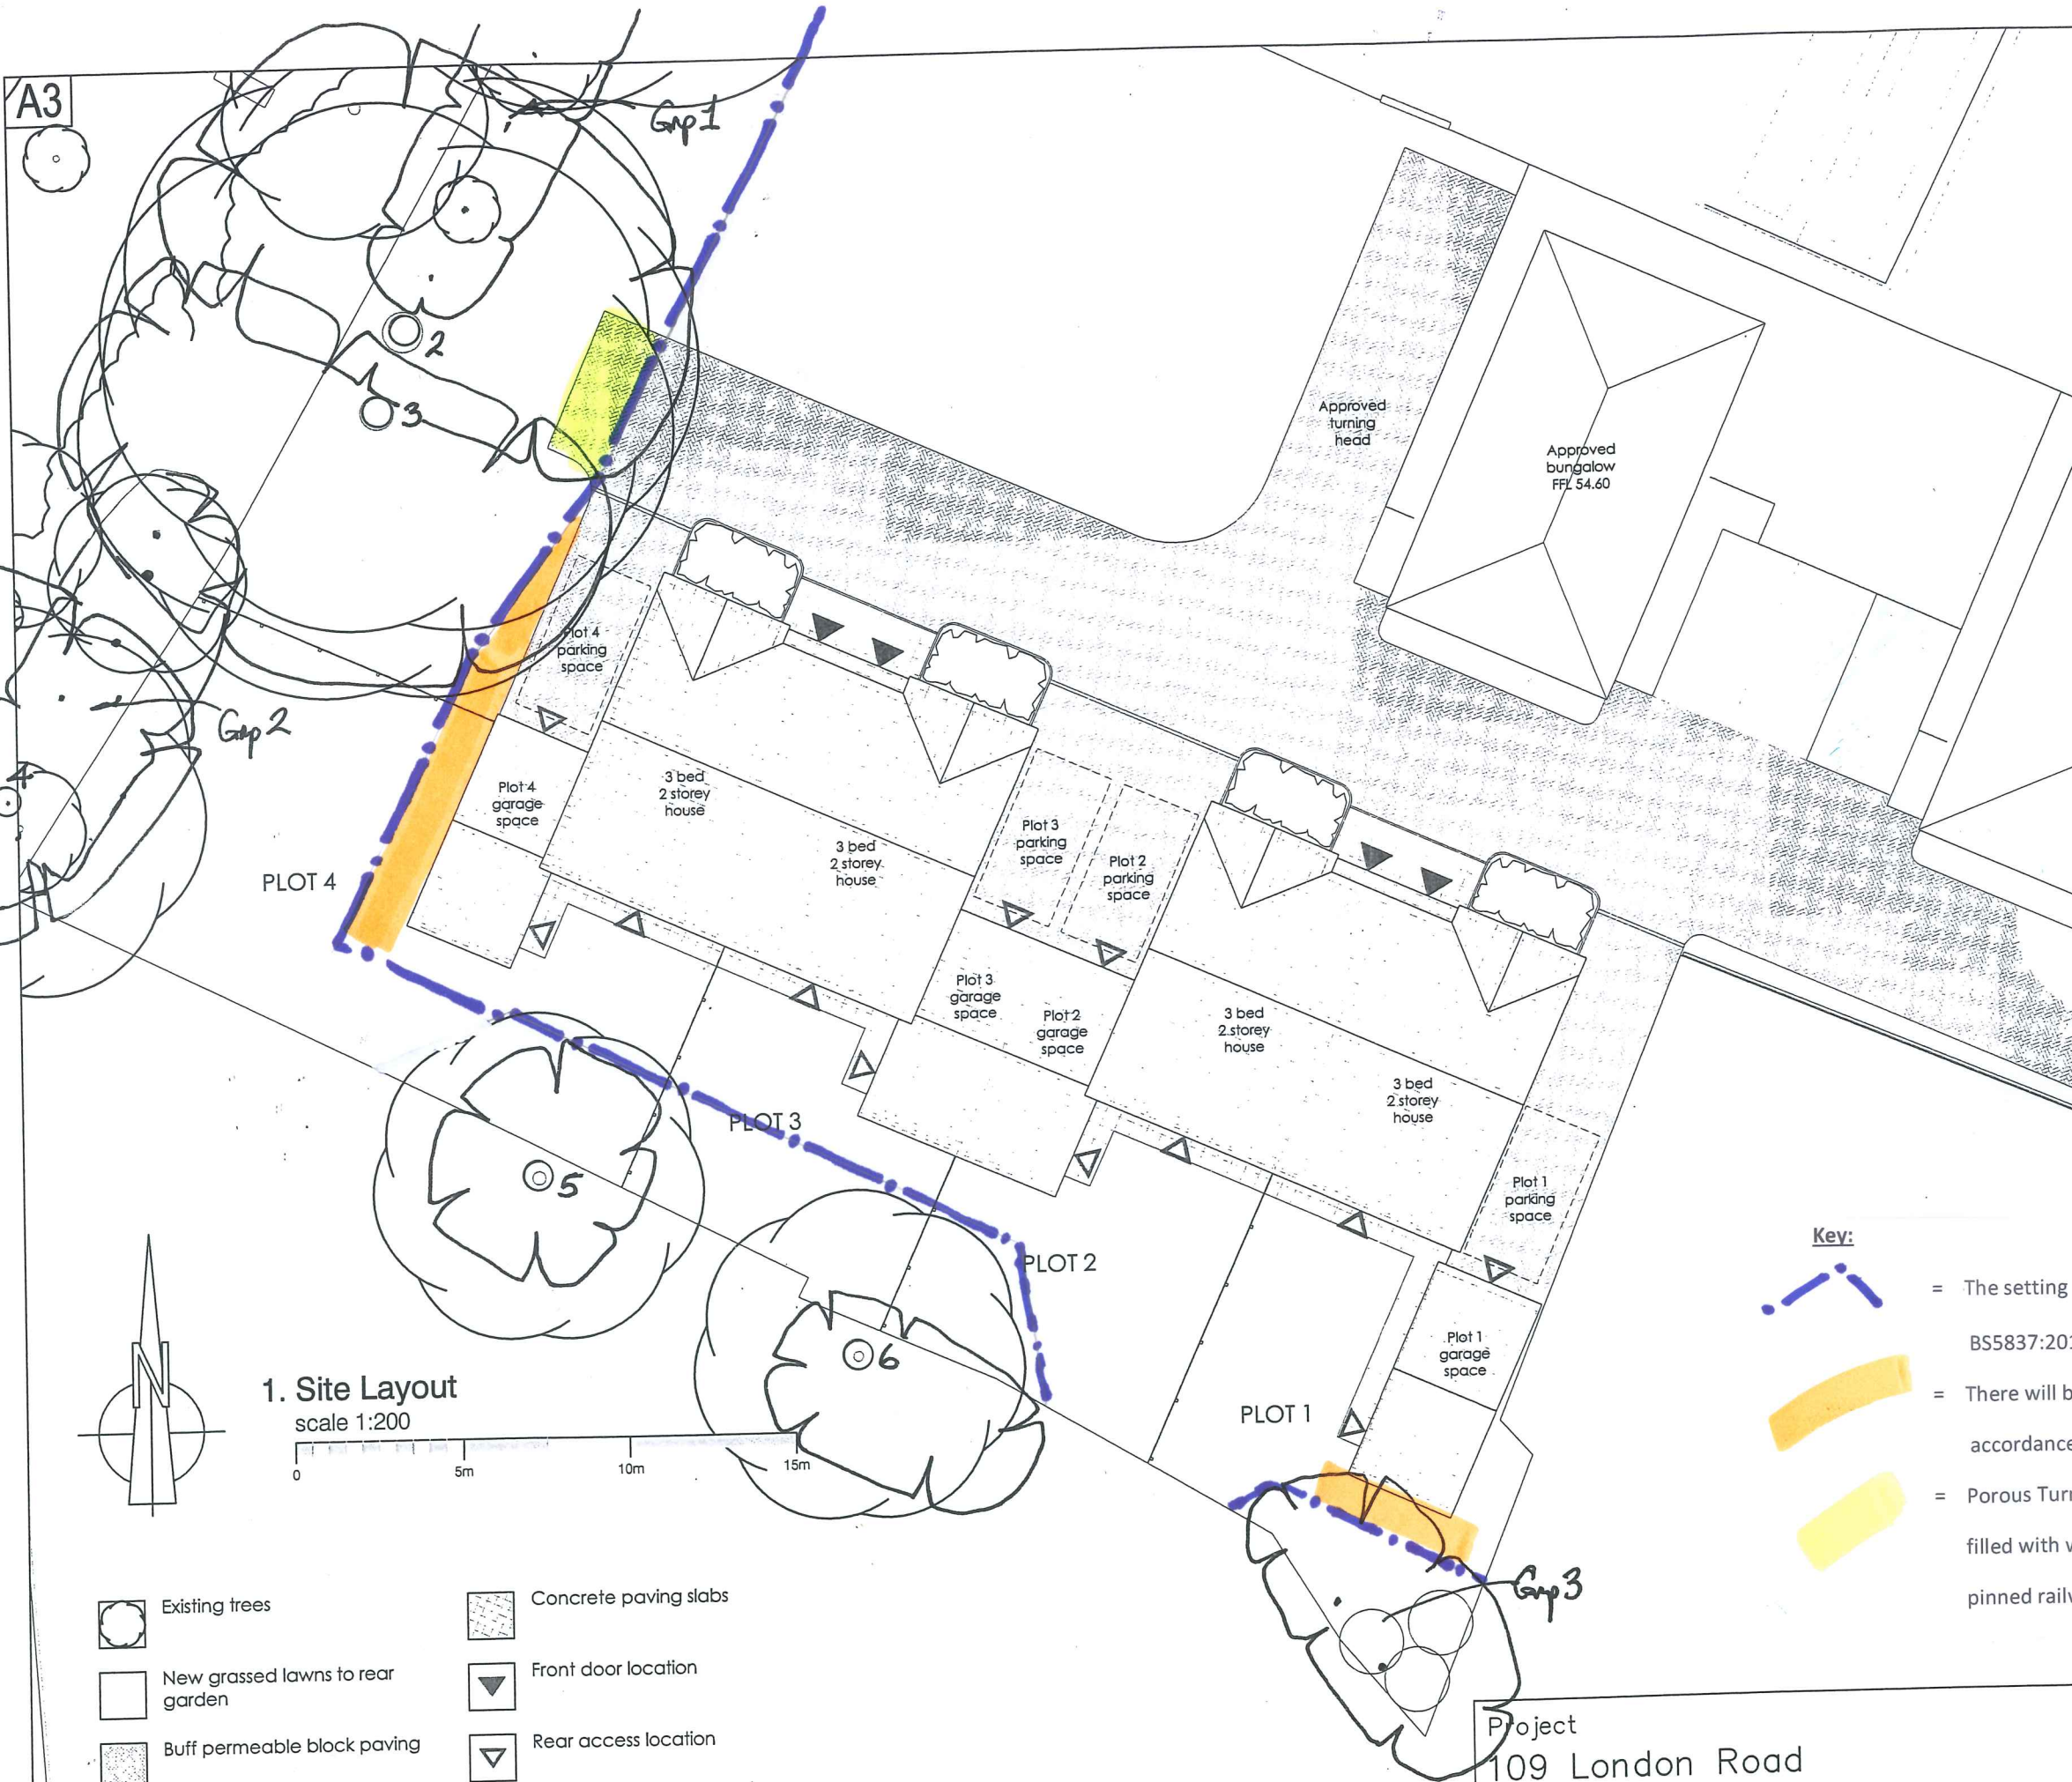
1. Site Layout  
scale 1:200

- = The setting out positions for the Protective Fencing in accordance with BS5837:2012 recommendations – Section 6.2 and Figures 2
- = There will be a need to apply Ground Protection measures in this area in accordance with BS5837:2012 recommendations – Section 6.2.3.3 a)
- = Porous Turning Head of 'No Dig' construction form – suggested 'Cellweb' filled with washed aggregate with a treated and pegged board edging or pinned railway sleepers

There are **4** trees and **2** groups in this category on this project which can be retained and fully protected in accordance with BS5837 recommendations (see **Tree Protection Plan BJH.04** at [appendix BH4](#) and full listing in schedule at 6.1 above).
