Date: 08 April 2013

Ref: 13124-AIA-CA

This report contains the supporting tree information relating to the development proposal to construct new dwellings on land severed from existing gardens at 22 Frogmore Lane, Cowplain.

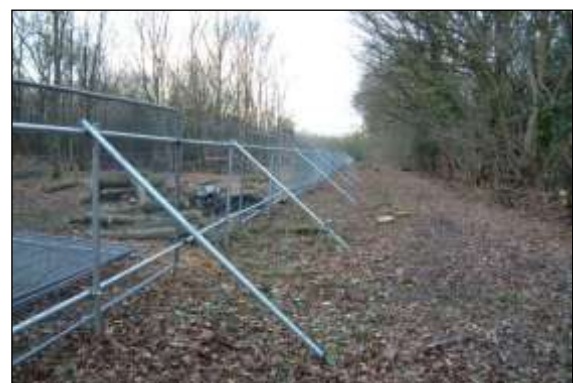
Photo 2: Heras fencing wired to scaffold braced posts is a robust and effective interpretation of the BS specification.

Various fencing options are illustrated in figure 1 and photos 2–4 below. The minimum specification for the fencing must be as described in figure 2 of BS 5837 (figure 1 below) or an equivalent design that effectively restricts access to the RPA it protects.

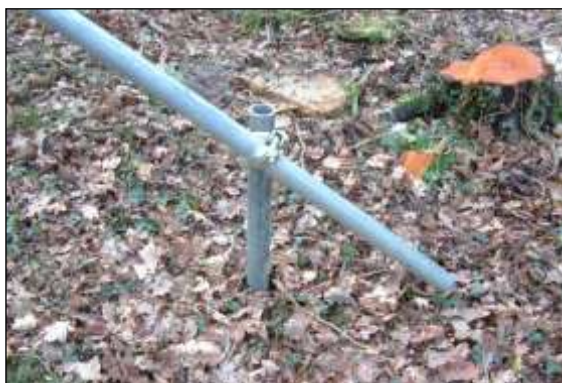
**Photo 3:** Close up of bracing detail, essential for increasing the stability of the vertical framework.

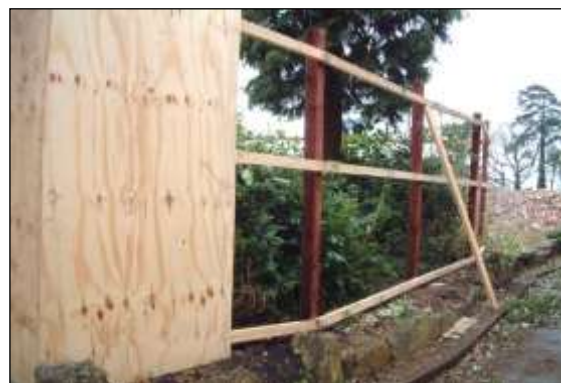
**Photo 4:** Board specification on secure wooden posts is a suitable alternative to the standard braced scaffold design.

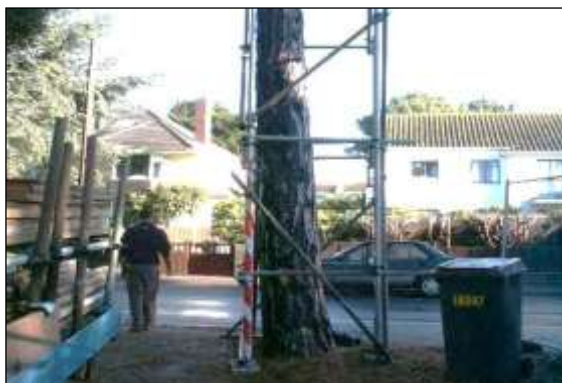
**Photo 5:** A scaffold braced framework surrounding the trunk reduces the risk of accidental impact.

Where individual trunks or branches are vulnerable to impact damage, a framework of scaffold or wood can be constructed to provide protection (photos 5 and 6).

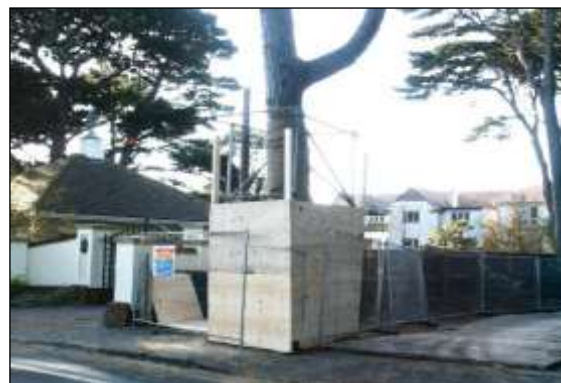
**Photo 6:** Board secured to scaffold framework adds another layer of protection for vulnerable trunks and branches.

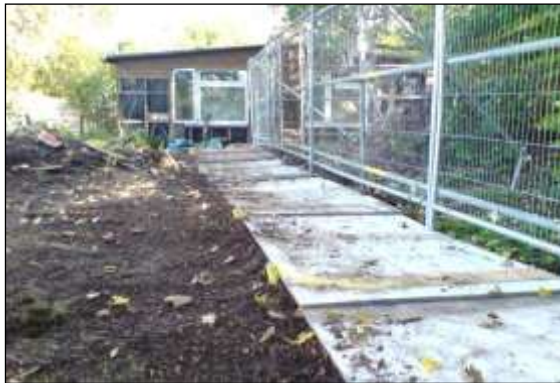
**Photo 7:** Heavy-duty plywood set onto a compressible woodchip layer and pinned into position is suitable to spread the loading from pedestrian access.

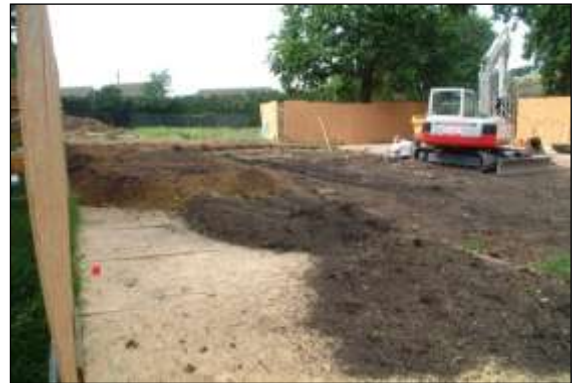
**Photo 8:** Spreading soil excavated from footings is an effective way of buffering the plywood surface from the wear of light vehicles.

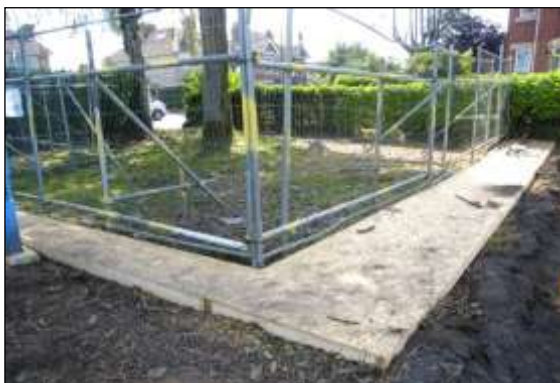
**Photo 9:** Plywood fixed to a wood frame is another effective method of protecting soil from pedestrian compaction.

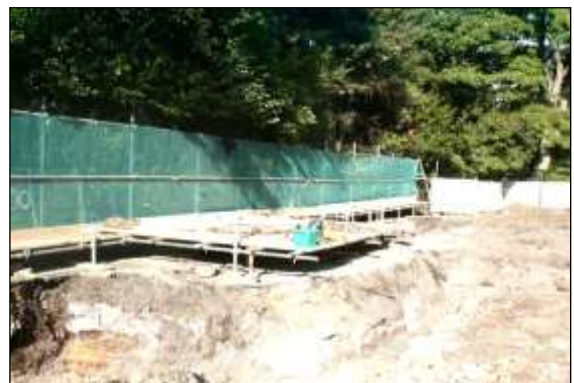
**Photo 10:** A scaffold framework attached to the main scaffold fencing can be used to support either scaffold planks or plywood to create an elevated platform with a gap beneath.

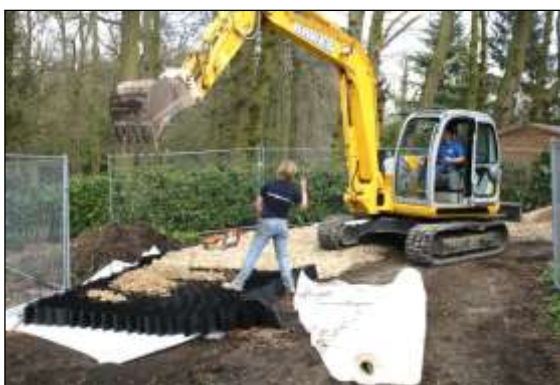
**Photo 11:** Cellular products are a very effective means of providing ground protection where heavy vehicle use is expected. Here, it is being used to temporarily widen an existing road, to be removed once the construction is finished.

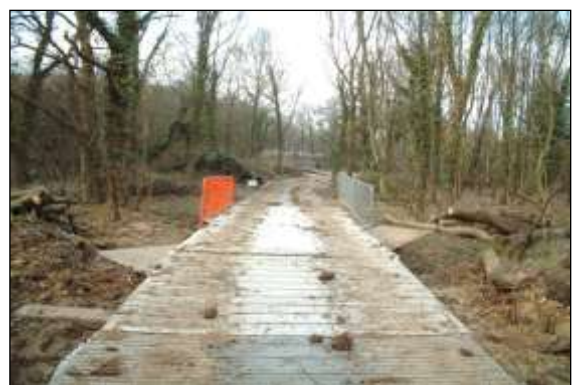
**Photo 12:** Custom designed sectional tracks can be joined to support very heavy traffic use through sensitive areas.

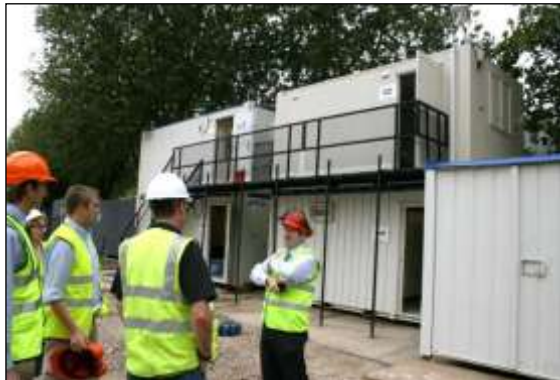
**Photo 13:** A combination of retaining existing surfacing and using temporary construction cabin accommodation can be a very effective means of preventing damage to sensitive areas.

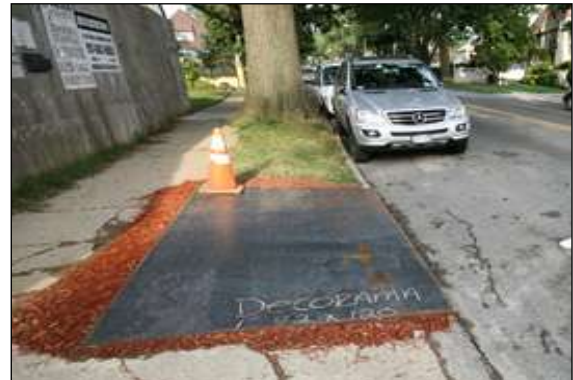
**Photo 14:** Steel plates can be an effective way of temporarily reinforcing weak surfacing over a construction access during the development activity.

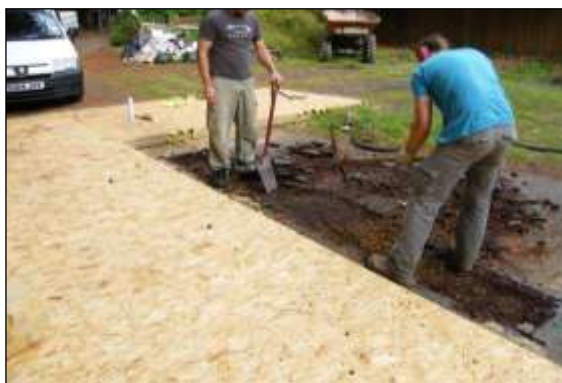
**Photo 15:** Careful hand-digging using conventional tools is acceptable for exposing roots in RPAs.

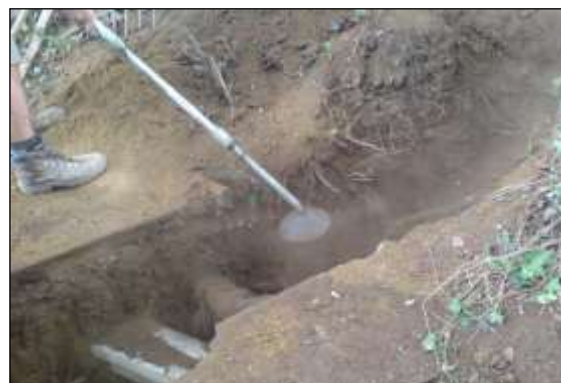
**Photo 16:** Air spades are very effective at exposing roots and services with minimal damage.

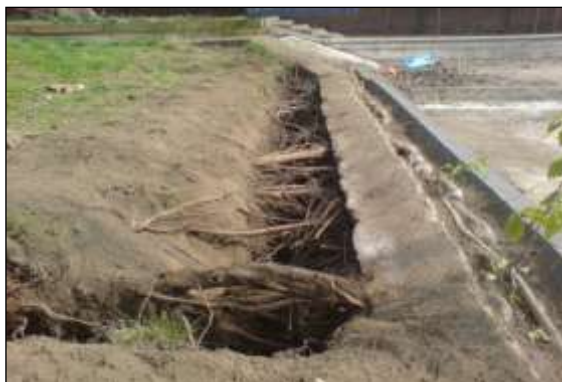
**Photo 17:** Air spades are particularly useful where roots are very dense.

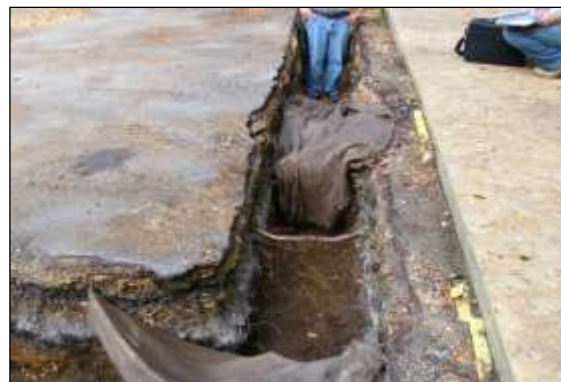
**Photo 18:** Exposed roots must be protected from light, drying out and extremes of temperature by covering with hessian sacking and boards until they can be covered back with soil.

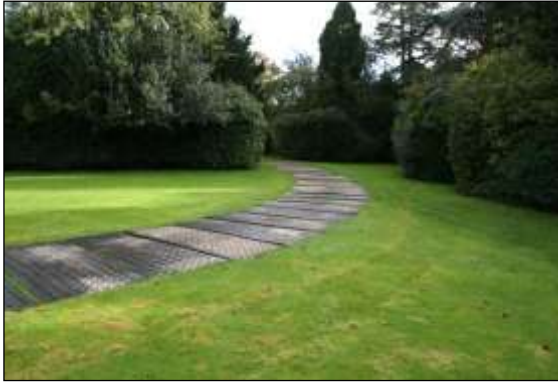
**Photo 19:** Ground protection must be used where repeated foot or vehicle traffic could cause compaction in sensitive RPAs. It can be as simple as plywood for pedestrians, but must be more robust for vehicles.

In summary, there should be no vehicular or repeated pedestrian access unless existing ground protection is retained or new protective measures are installed (photo 19). All exposed RPAs must be protected until there is no risk of damage from the development activity.

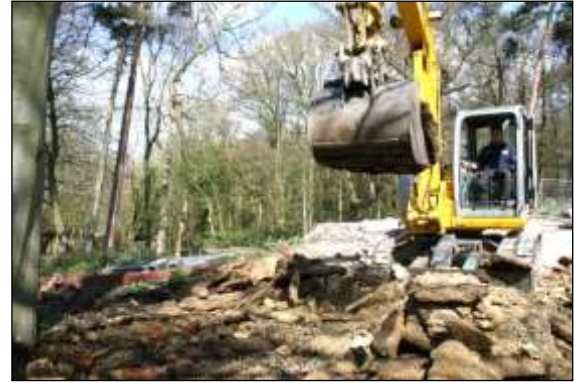
**Photo 20:** Machines with a long reach can be used to lift out heavy surfacing and structures as long as the machine sits outside the RPA and the exposed surface is protected before there is any further access.

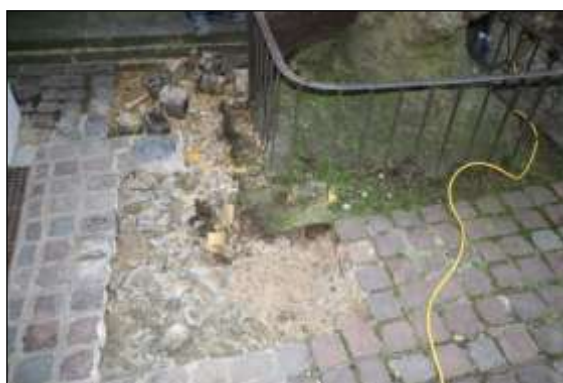
**Photo 21:** Careful lifting of cemented-in sets round this tree allowed them to be re-laid on a permeable sand base, improving the water input into the soil around the trunk.

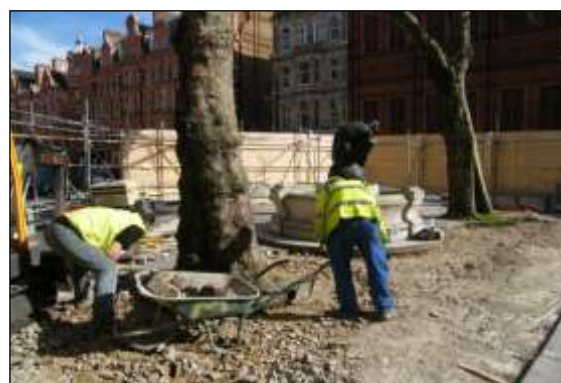
**Photo 22:** These trees had impermeable surfacing right up to their trunks, which had to be removed by hand before installing new structures.

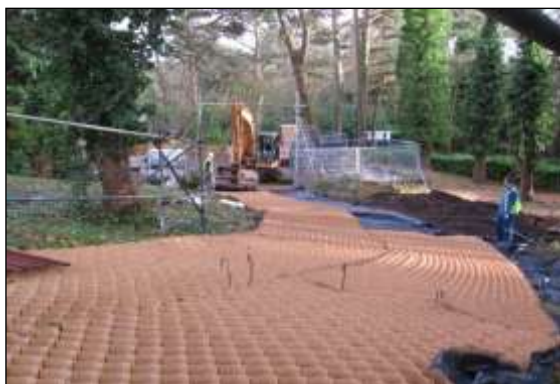
**Photo 24:** The three-dimensional cells are opened up, spread across the area to be surfaced and pinned in place ready for the stone filling.

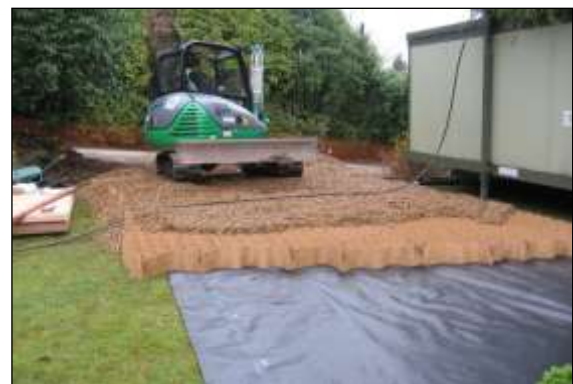
**Photo 25:** The stone-filled cells spread the load of traffic and the geotextile membrane on the ground prevents migration of the stone into the soil profile.

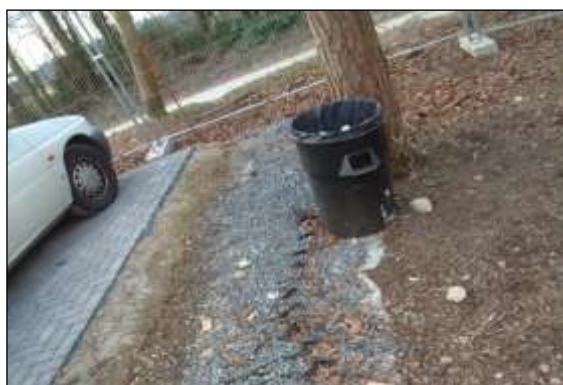
**Photo 26:** A conventional concrete haunching can be used to retain new surfacing as long as it is not dug into a trench - here is it placed on top of the CellWeb layer.

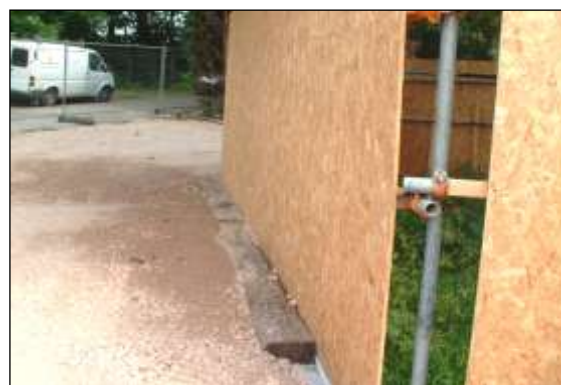
**Photo 27:** Although this is only a temporary surface, railway sleepers pinned into the ground can be used to retain the edges of new surfacing.

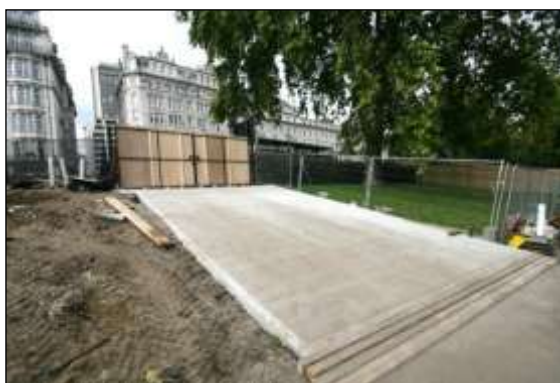
**Photo 30:** This temporary access for heavy construction traffic on the outer edge of a RPA is a concrete slab cast above ground level and will be removed when the project is completed.

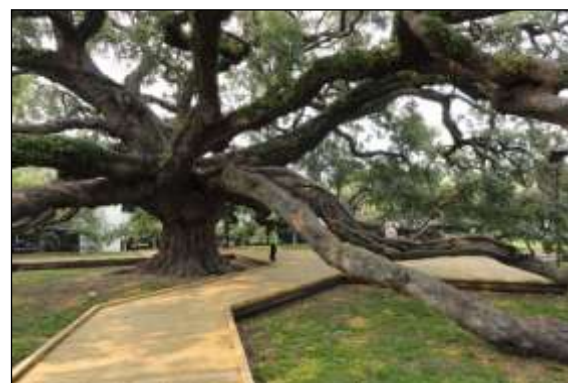
**Photo 31:** Board walks supported on posts or a light frame are another way of providing pedestrian access across sensitive RPAs.

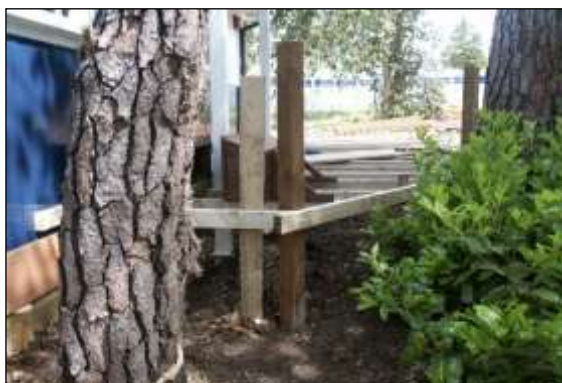
**Photo 32:** New surfacing can be supported above the ground on posts leaving the soil surface beneath undisturbed.

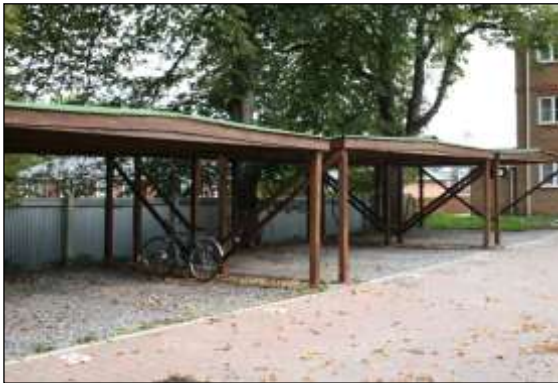
**Photo 34:** These carports are formed by wooden posts above a three dimensional cellular no-dig and load-spreading surface of permeable crushed stone.

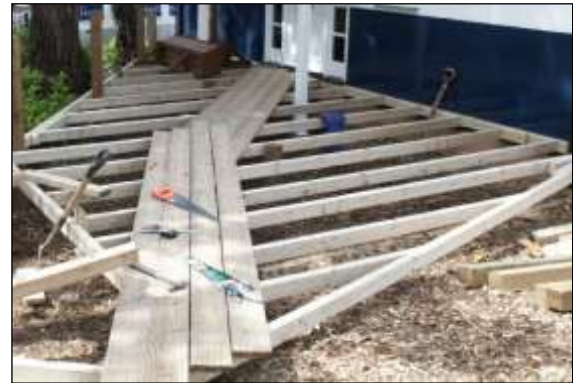
**Photo 35:** This deck supported above the ground on small posts provides a low-impact alternative to conventional stone patio surfacing in RPAs.

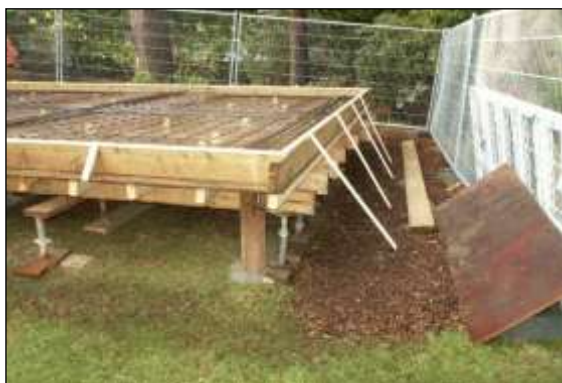
**Photo 36:** Small diameter piles (less than 150mm) are an effective means of supporting structures in RPAs with minimal disturbance.

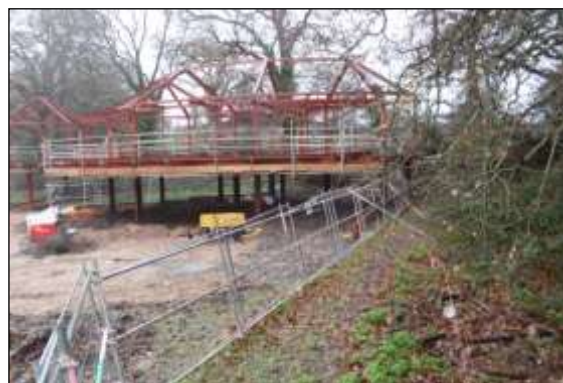
**Photo 37:** It is possible to support very large structures on piles within sensitive RPAs without any significant adverse impact on tree roots.

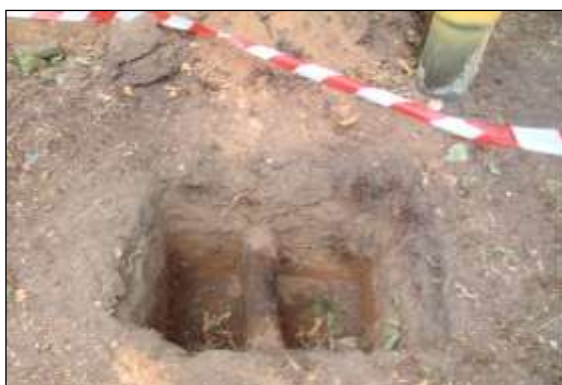
**Photo 38:** Where piles are proposed close to trunks, it is essential to excavate 50–75cm deep to see if there are any significant roots in the way, with provision to move the pile location if roots are found (note the pile was finally installed to avoid this root).

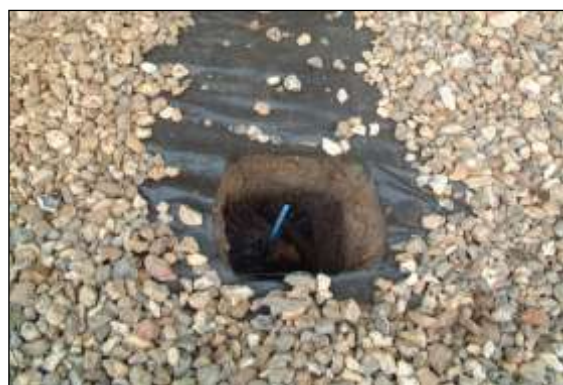
**Photo 39:** Ground protection must be used to spread the load of the piling rig once excavation has confirmed that no substantial roots are in the preferred pile location.

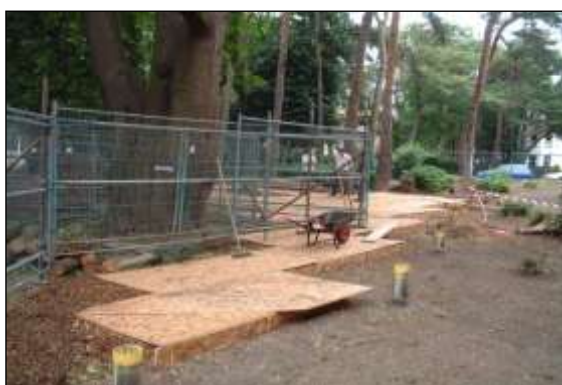
**Photo 40:** Once the piles have been installed (yellow tops), the ground protection to support the piling rig is removed ready to fix the void-former onto the bare soil, in advance of pouring the building slab.

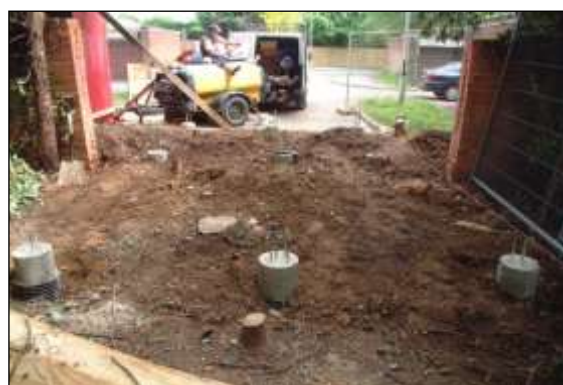
**Photo 41:** Piles can also be used to support bridges across sensitive RPAs, but the temporary ground protection has to be removed before the main structure is either imported in or cast on site.

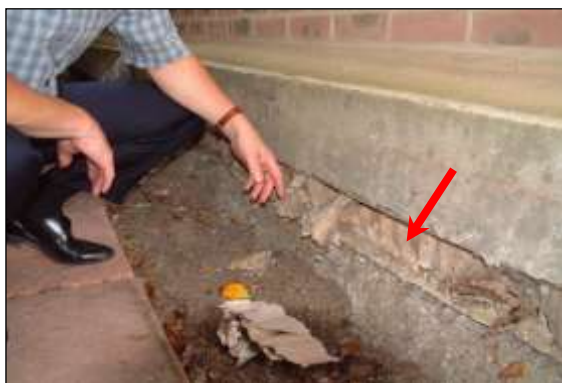
**Photo 42:** Where a slab is cast on site, a biodegradable void-former (red arrow) temporarily supports the weight of the liquid concrete until it sets. The void-former can then be wetted and washed away to leave a void or left to degrade naturally, both of which allow movement of air beneath the slab.

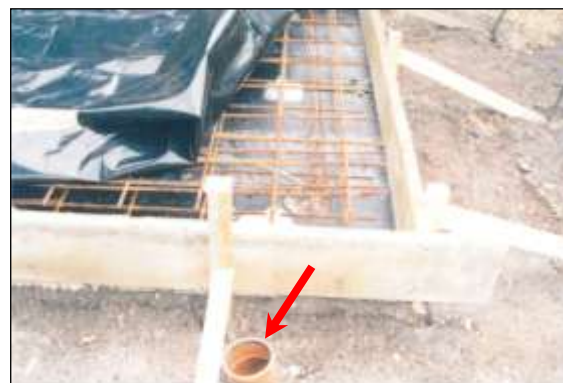
**Photo 43:** This reinforced base slab for a double garage has drainage provision (red arrow) beneath the structure to redirect roof runoff to supply roots with water.

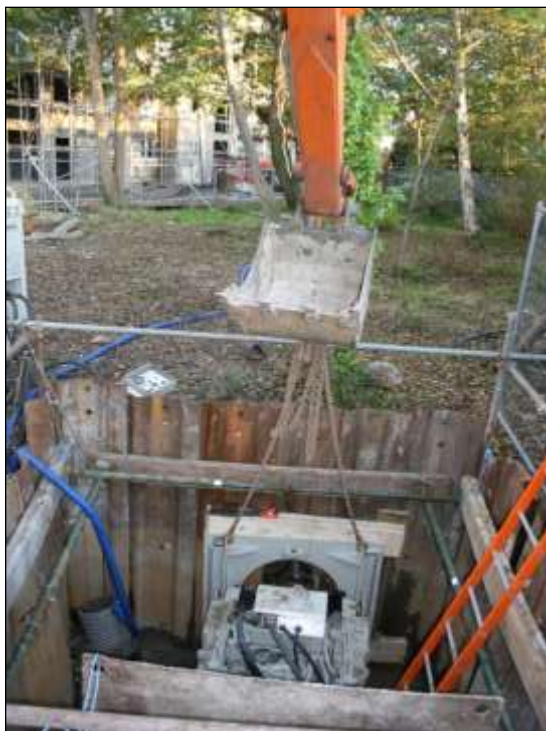
**Photo 44:** If possible, thrust boring is the preferred option for installing service routes through the RPAs of important trees, but there has to be space at the start and finish to dig substantial working pits.

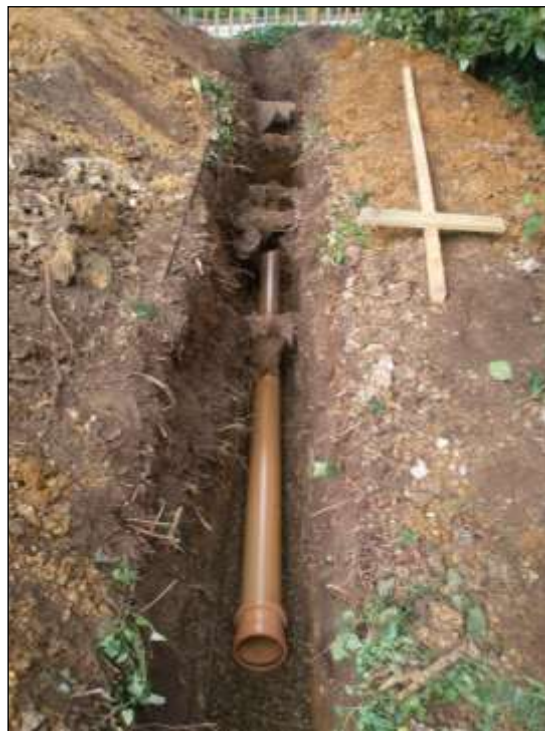
**Photo 45:** Continuous trenches dug by hand so that important roots can be retained (with the service ducting threaded beneath) is an effective means of minimising damage (note the ground protection boards with soil piled on top on the left).

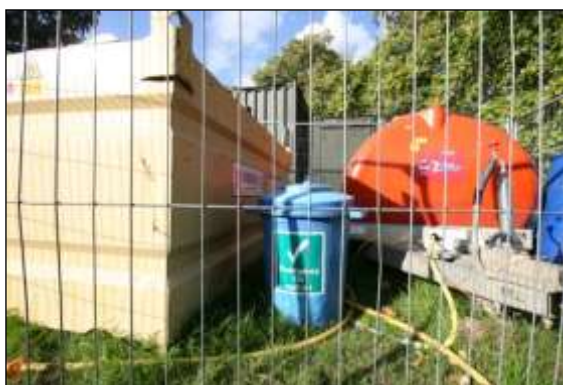
**Photo 46:** Where fuel or other chemical are stored on site, it is now standard practice to have emergency spillage kits available to restrict the environmental impact of accidents.

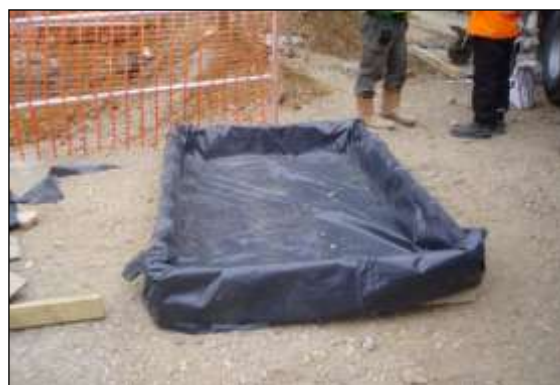
**Photo 47:** Soil bunding or a supporting framework covered in heavy-duty plastic sheeting is essential where there is a risk of spillages contaminating RPAs. This specifically applies to cement mixing areas and vehicle washing facilities.

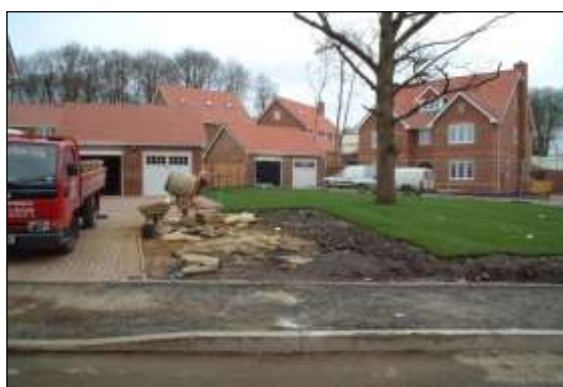
**Photo 48:** The RPA of this tree was not effectively protected during construction and excessive compaction of the soil meant it died soon after this turf covered up the damage.

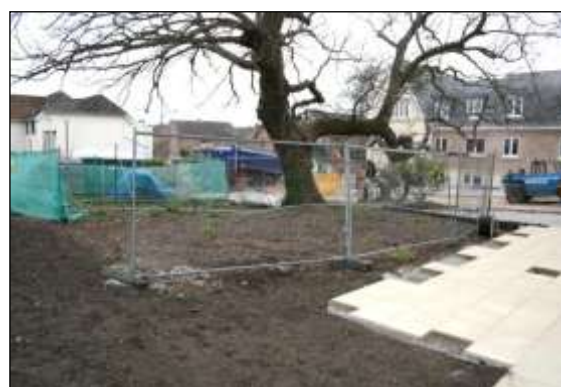
**Photo 49:** This tree had tarmac parking within its RPA that was removed and replaced with an organic mulch near the trunk and limited no-dig surfacing on the outer edges of its RPA.

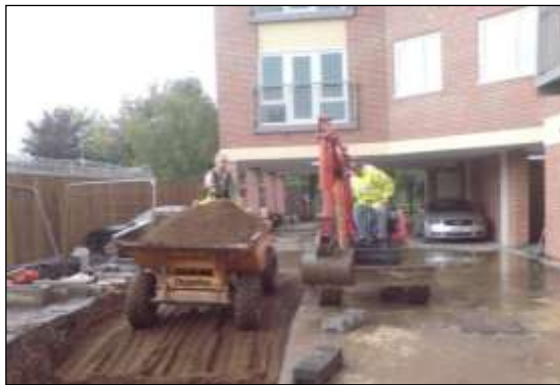
**Photo 53:** Structural tree soil retains sufficient structure for tree roots to grow, even when compacted.

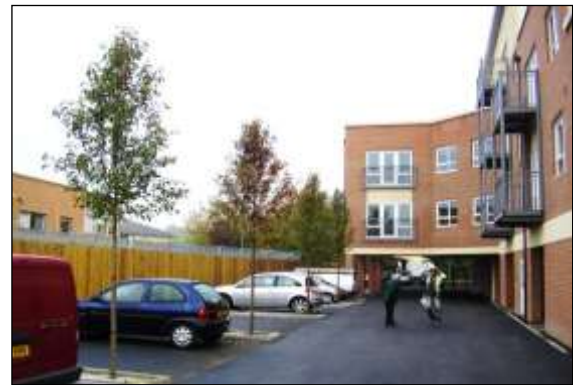
**Photo 54:** It allows trees to be successfully established in areas of extensive hard surfacing, with very little, if any, loss of parking space

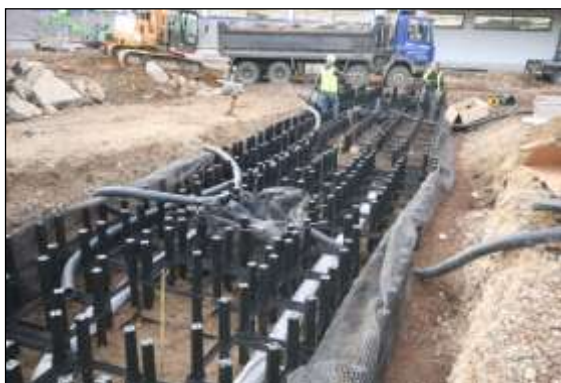
**Photo 55:** The individual Silva Cells can be assembled in layers and service ducting threaded through before filling with soil and fitting the reinforced tops.

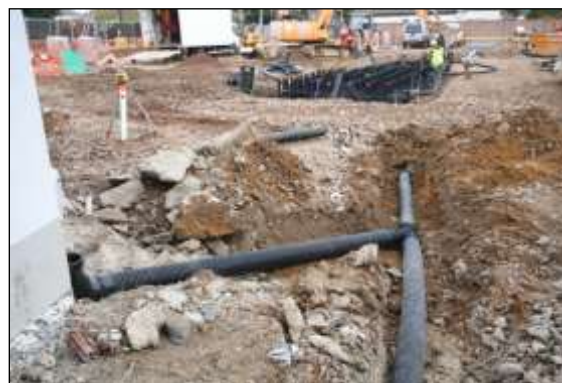
**Photo 56:** Drainage from adjacent buildings can be directed into Silva Cells, significantly buffering rainwater runoff from urbanised areas.

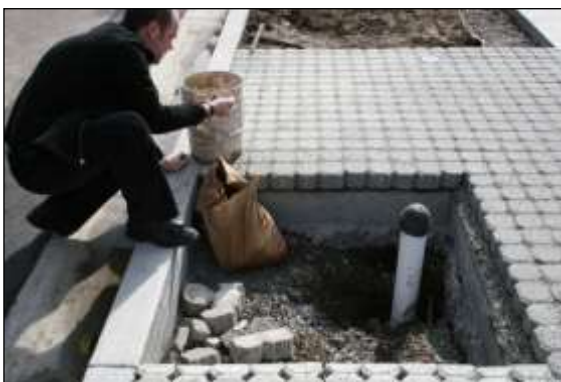
**Photo 57:** The finished surfacing is profiled to leave the tree pit open, ready to be filled with good quality topsoil and the new tree.

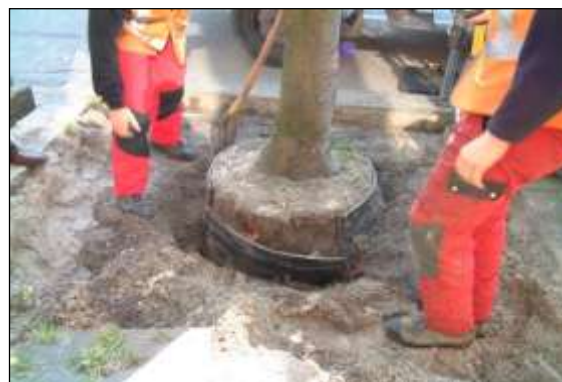
**Photo 58:** This excavated tree shows the root deflectors that were installed when it was planted seven years previously. The product has deflected roots downwards and prevented damage to the adjacent surfacing. Note that this is a permeable sandy soil and the roots were able to grow beneath the bottom of the deflectors.
