# Heritage Statement

To accompany planning application

for two new dwellings

86 and 86A West Street,

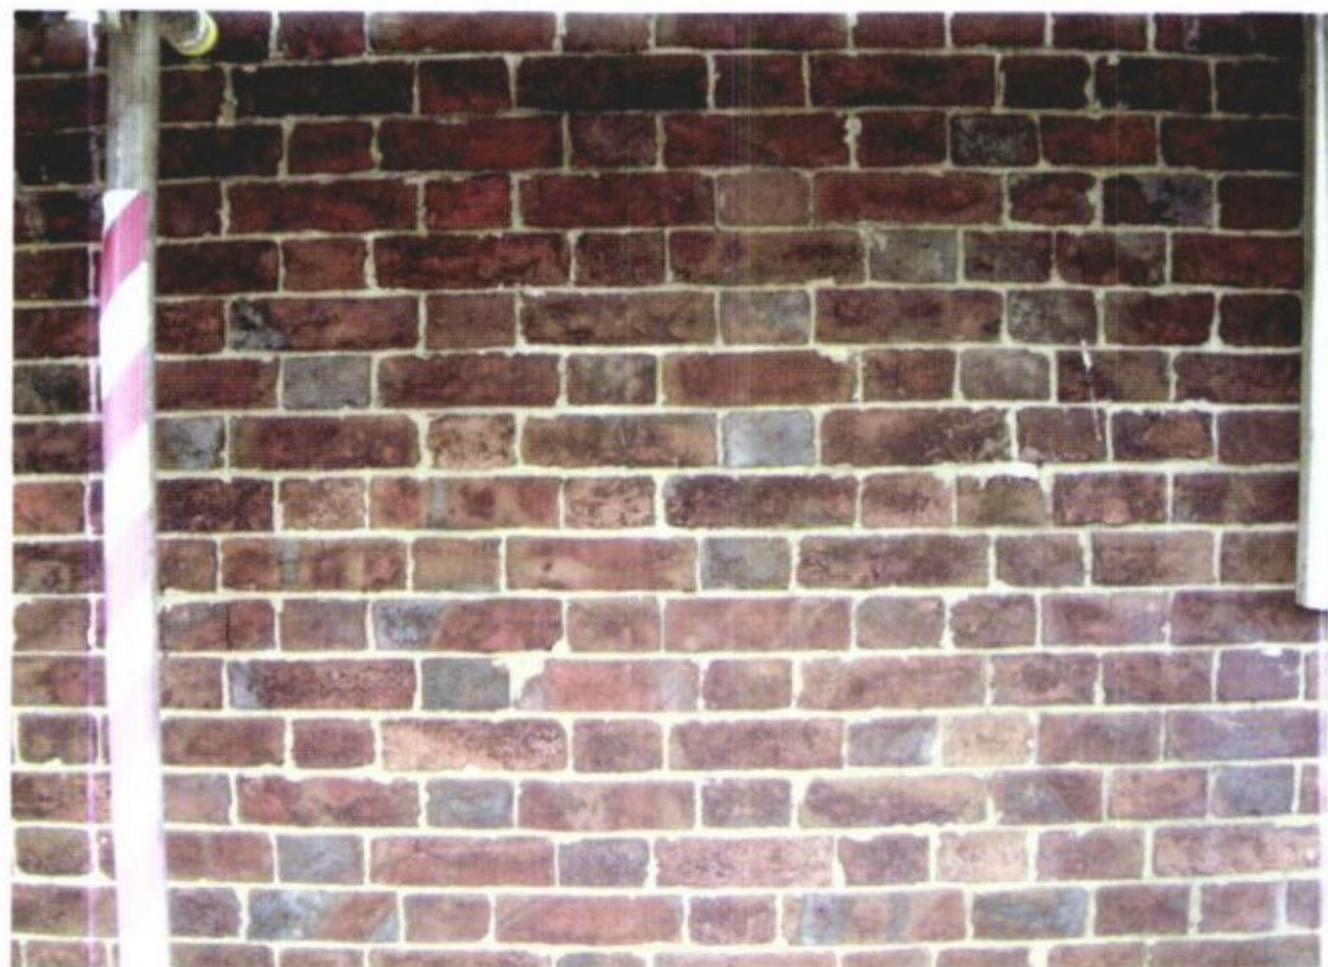
Front wall of new properties to be rebuilt using existing reclaimed and cleaned bricks, in the same bond and with lime mortar as the existing front wall. (See attached photograph).

Remnants of the original two terraces can be seen in for example the framework of the second abandoned staircase. There were ad hoc improvements to the house over the years. However the structural weaknesses of the property were not addressed and the front wall is now seriously bowed and the roof very weak.
