Prepared by  
David Cashman DipA (RFS) CUEW FARBorA MICFor

Date: September 2012  
Ref: 12080-1A-DC

This report contains the supporting tree information relating to the development proposal to construct four new dwellings on land currently used as a paddock at Redlands Lane, Westbourne.

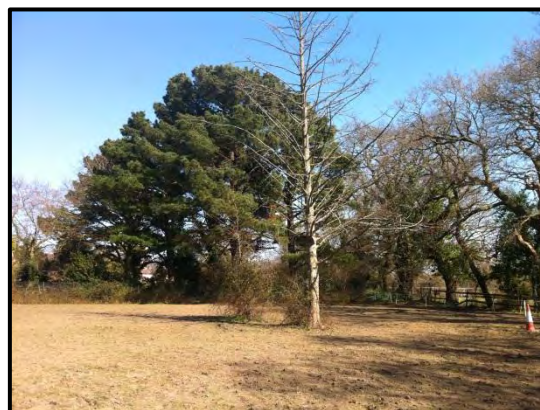
**Image 3:** Tree 33, a dead cedar is shown in the foreground with trees 27, 28 and 29 in the background.

Trees 12, 18 and 33 are in such poor condition, it has been advised for removal in the interest of good management. This work is advisory and is not a direct result of this proposal, so it should not be attributed to it. These trees are not listed in Table 1 for that reason.

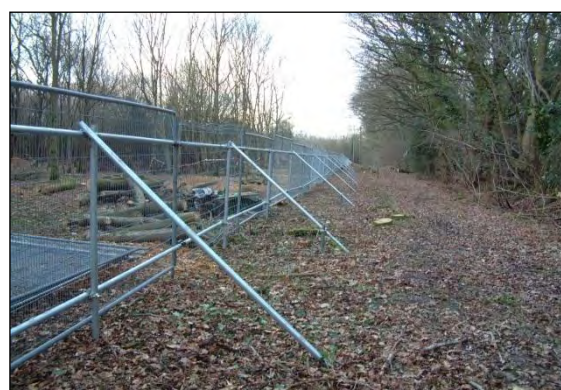
Photo 2: Heras fencing wired to scaffold braced posts is a robust and effective interpretation of the BS specification.

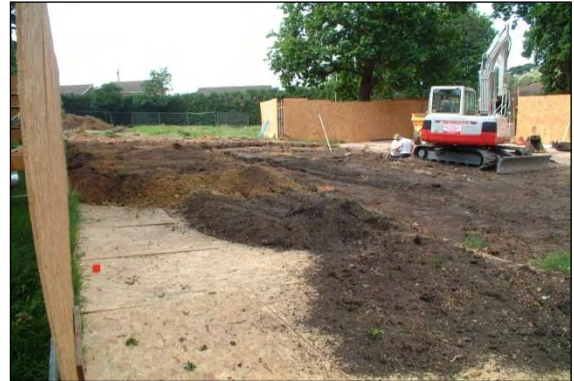
**Photo 8:** Spreading soil excavated from footings is an effective way of buffering the plywood surface from the wear of light vehicles.

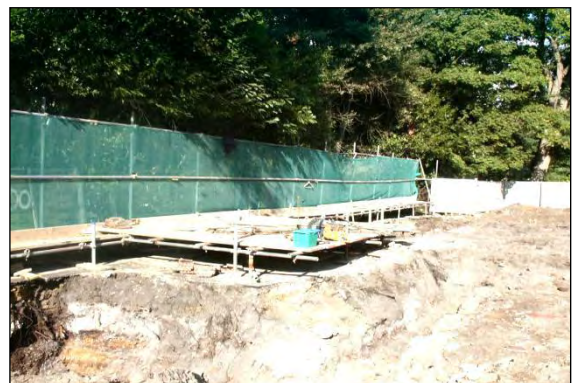
**Photo 10:** A scaffold framework attached to the main scaffold fencing can be used to support either scaffold planks or plywood to create an elevated platform with a gap beneath.

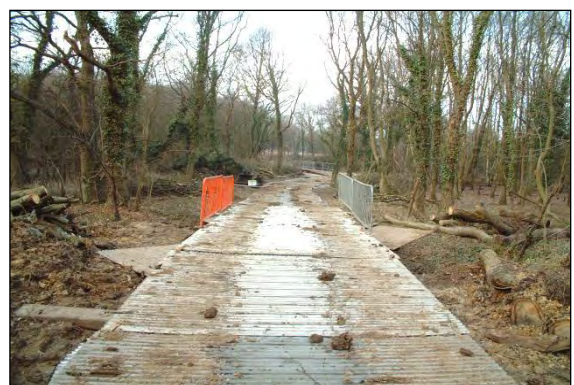
**Photo 12:** Custom designed sectional tracks can be joined to support very heavy traffic use through sensitive areas.

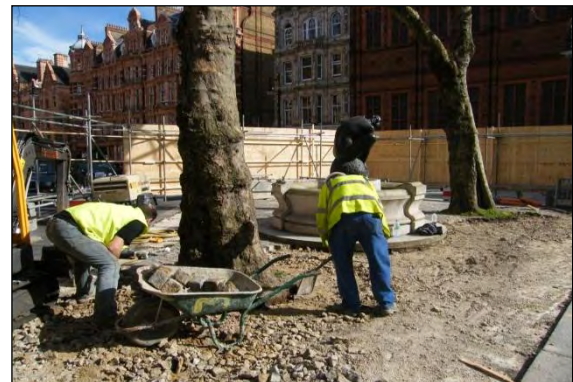
**Photo 22:** These trees had impermeable surfacing right up to their trunks, which had to be removed by hand before installing new structures.

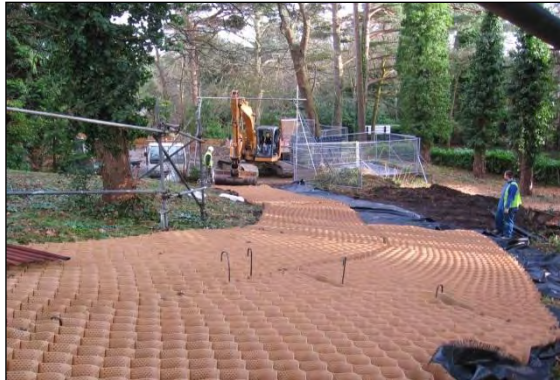
**Photo 24:** The three-dimensional cells are opened up, spread across the area to be surfaced and pinned in place ready for the stone filling.

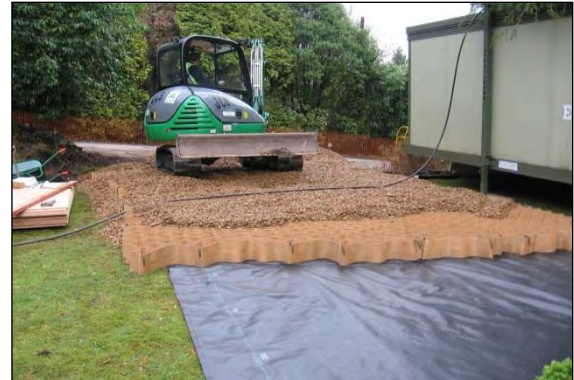
**Photo 25:** The stone-filled cells spread the load of traffic and the geotextile membrane on the ground prevents migration of the stone into the soil profile.

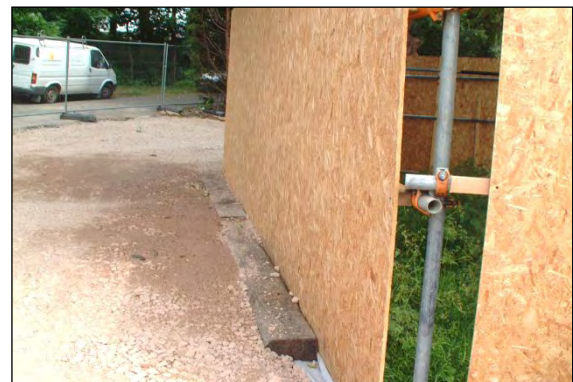
**Photo 27:** Although this is only a temporary surface, railway sleepers pinned into the ground can be used to retain the edges of new surfacing.

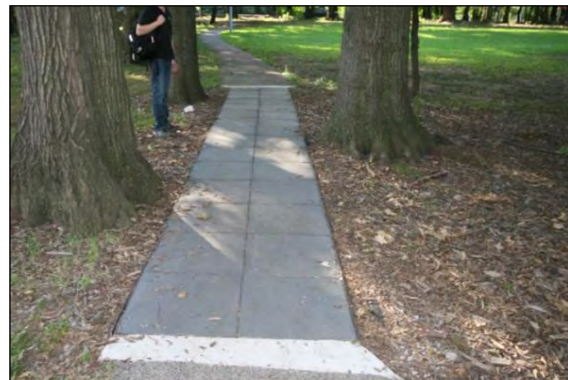
**Photo 33:** Where surfacing is needed close to rapidly growing buttress roots, a light metal frame with rubberised surfacing will allow the path to distort without cracking as the roots grow.

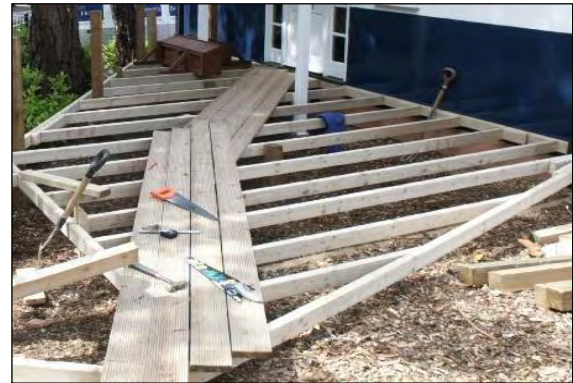
**Photo 35:** This deck supported above the ground on small posts provides a low-impact alternative to conventional stone patio surfacing in RPAs.

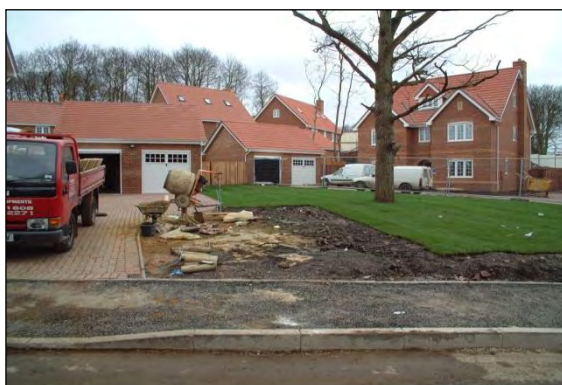
**Photo 48:** The RPA of this tree was not effectively protected during construction and excessive compaction of the soil meant it died soon after this turf covered up the damage.

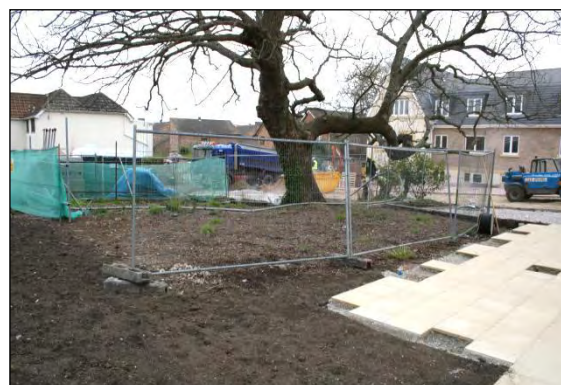
**Photo 49:** This tree had tarmac parking within its RPA that was removed and replaced with an organic mulch near the trunk and limited no-dig surfacing on the outer edges of its RPA.

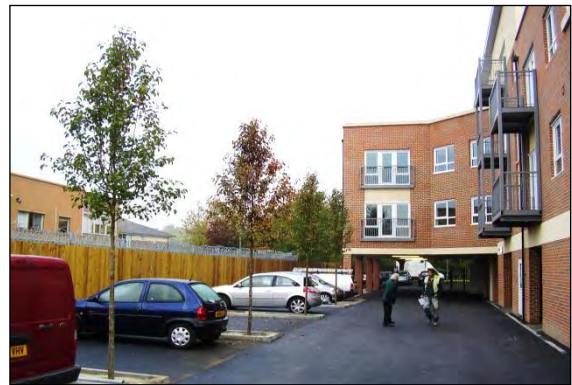
**Photo 54:** It allows trees to be successfully established in areas of extensive hard surfacing, with very little, if any, loss of parking space
