**11 Wallis Gardens, Waterlooville,  
Hampshire, PO7 7SA.**

**ARBORICULTURAL IMPLICATIONS  
ASSESSMENT**

OCA UK Ltd Ref: 52837

To provide information to inform designers and developers of arboricultural constraints on design and construction methodology. Specifically, this report relates to the retention of trees within the context of the proposals as shown on Drawing No. 52837\_01.

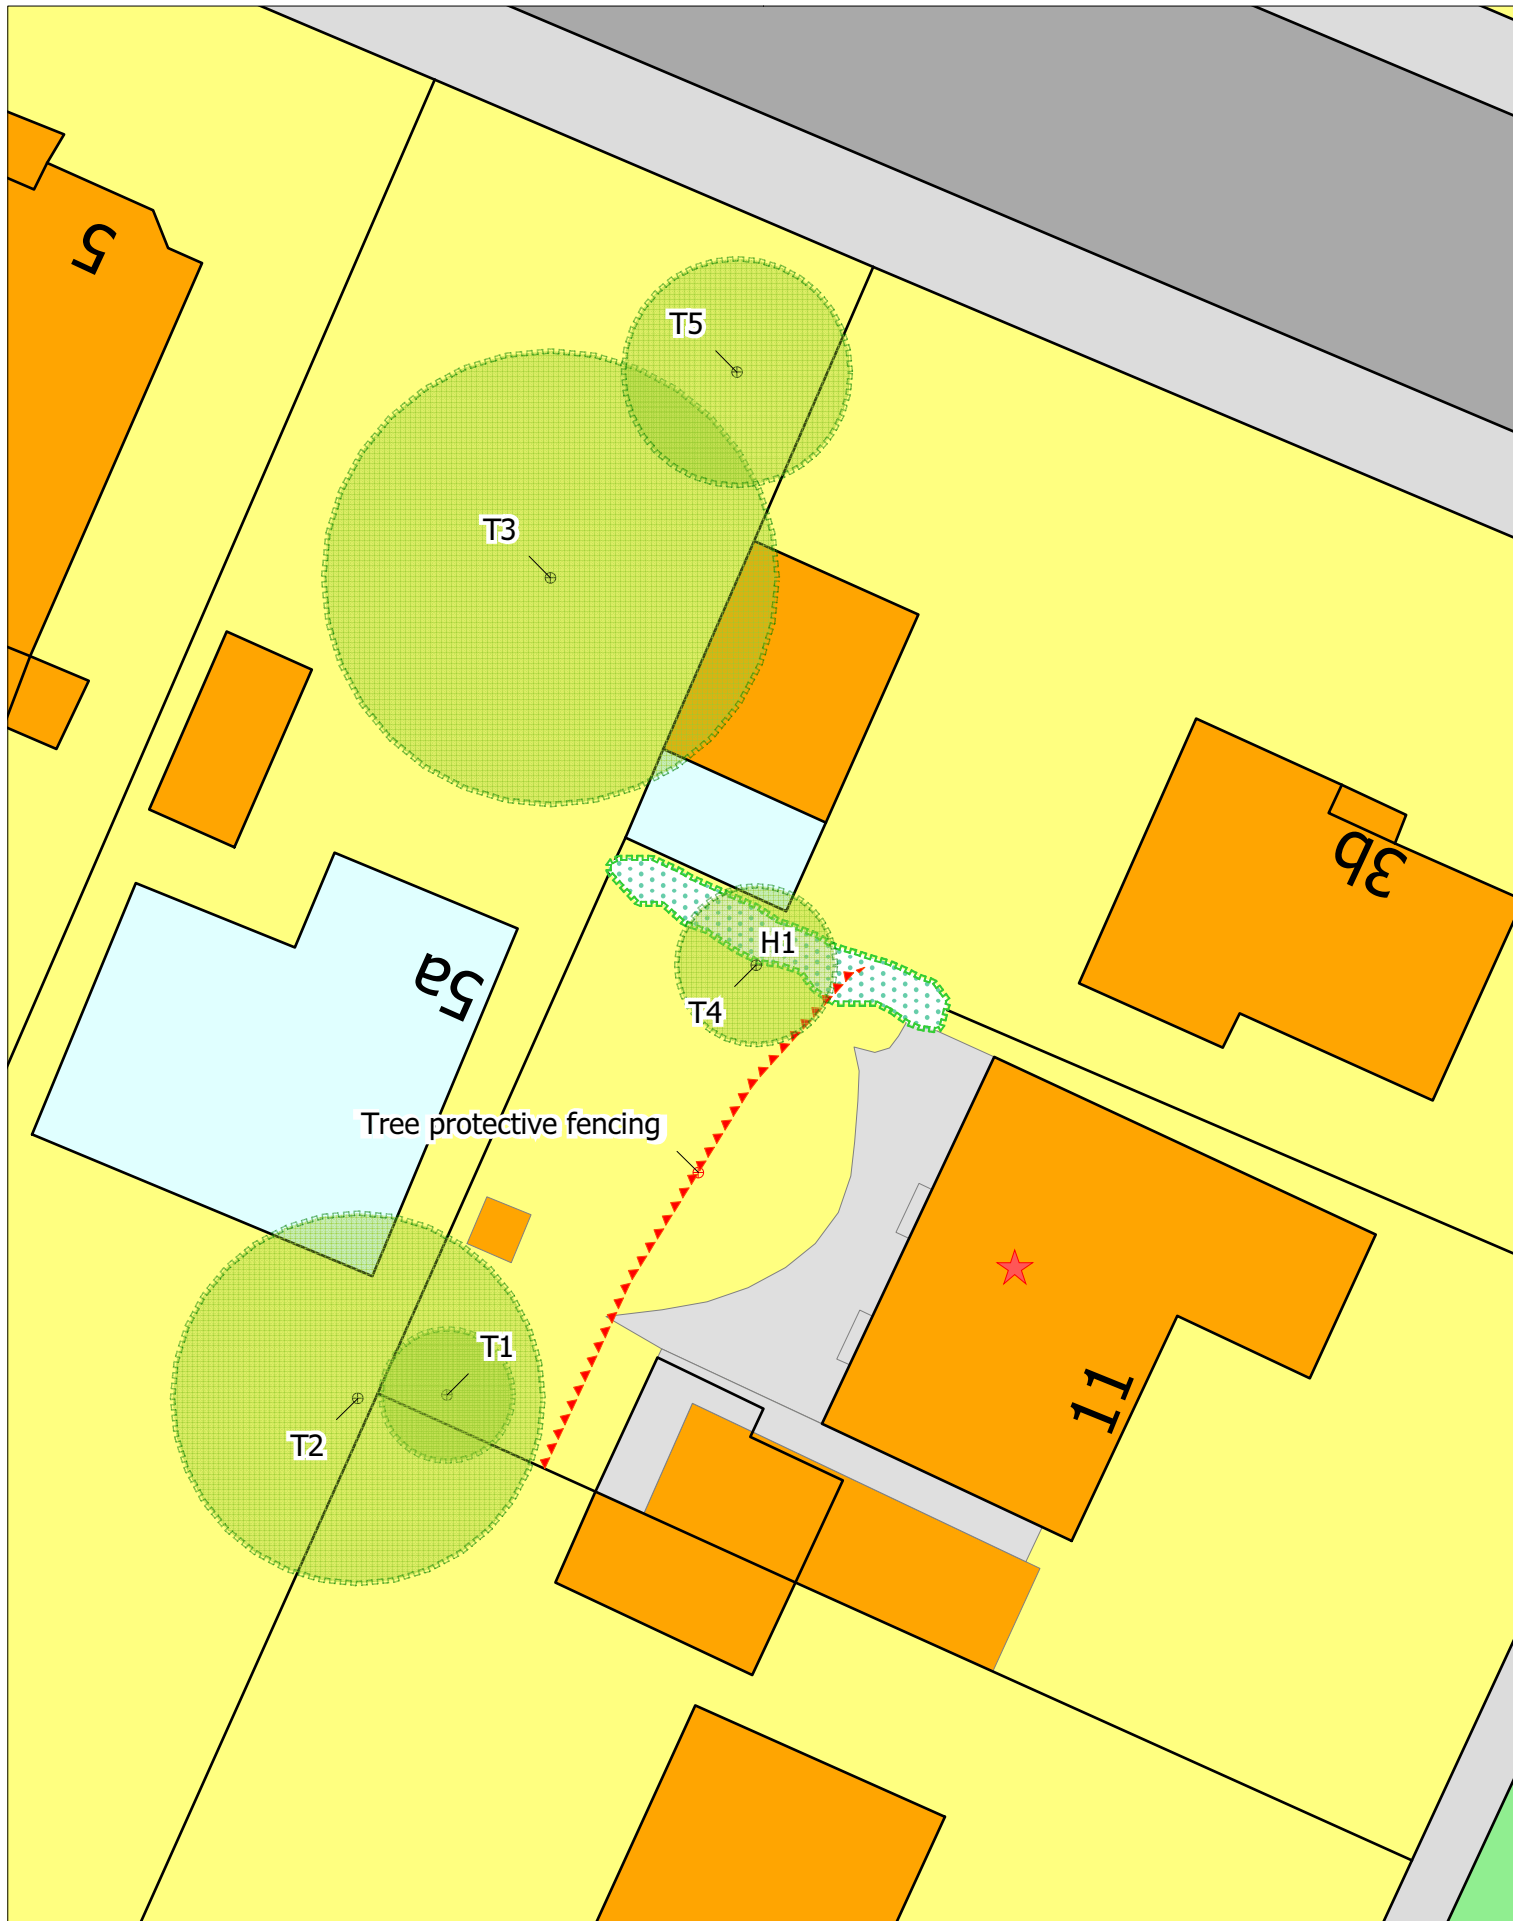
Location: 11 Wallis Gardens, Waterlooville, PO7 7SA  
 Job Ref.: 52837  
 Survey Date: 30/08/2012  
 Scale: 1:200 @ A4

Plan demonstrating the tree protective fencing area.

Given the proximity of the above vegetation and existing boundary fencing, it is considered that the English Oak T3, which is subject to a Tree Preservation Order is at very low risk from the proposed underpinning works. Equally with Horse Chestnut T2 and T5 and Corkscrew Willow T1 and Apple T4 and Pittosporum H1 following the installation of Tree Protective Fencing in accordance with OCA Plan 52837\_01.

The erection of protective fencing as indicated on OCA UK Ltd plan 52837\_01 dated September 2012 shall be undertaken prior to commencing any other works.

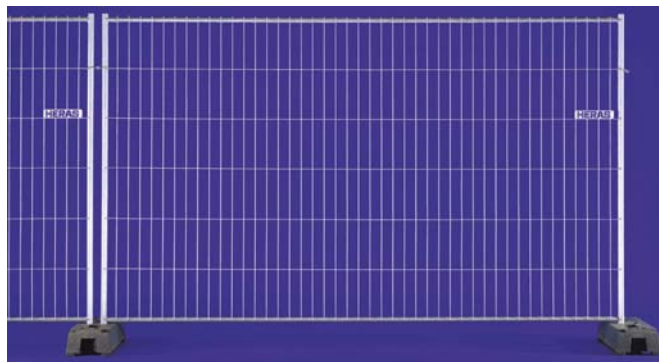
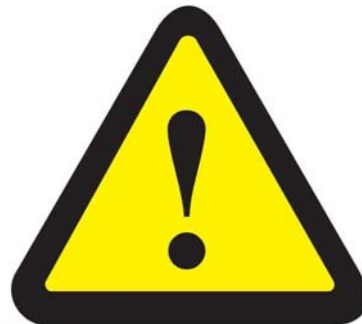
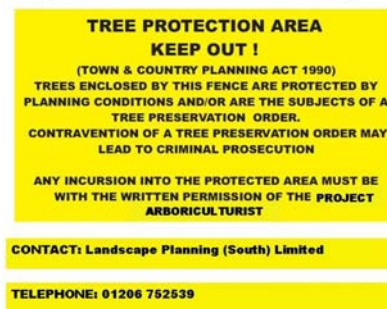
## Design of Weld mesh Type Tree Protection Fence

Tree Protective Fencing shall be 2m high x 3m in length. (see photograph below)

As 'Heras' type fencing can be easily moved, it must therefore be staked into the ground and tied in order to provide semi-permanent protection using 1.8m driven tanalised softwood stakes, or driven scaffold poles, and secured by tying wire or using 'U' bolts / clamps.
