**HAVANT ACADEMY**  
Design and Access Statement

DOCUMENT TITLE: Design and Access Statement  
DATE: 25/07/2025  
AUTHOR: CM  
CHECKER: AP  
STATUS: A3 - For Planning  
REVISION: C01

SUMMARY:  
This document has been prepared in support of a planning application for the demolition of part of a building. Demolition includes the changing rooms, as well as the music and drama hall. Planning permission is sought as the demolition area proposed is greater than 250m².

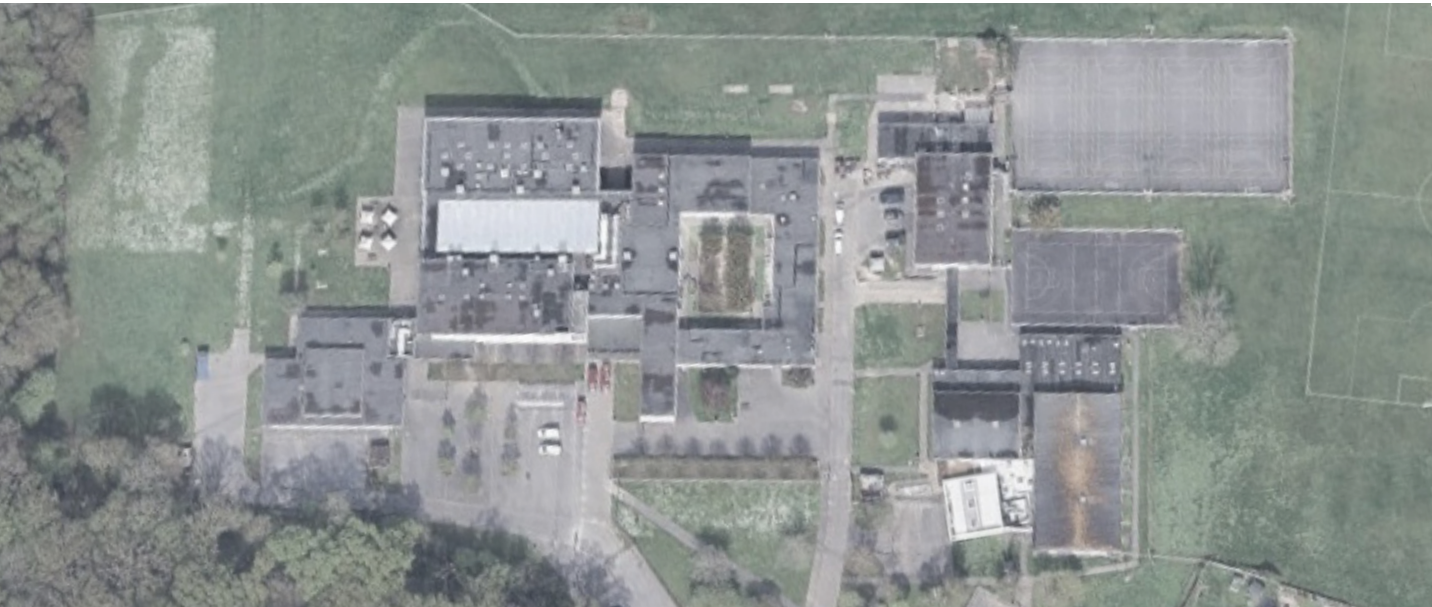
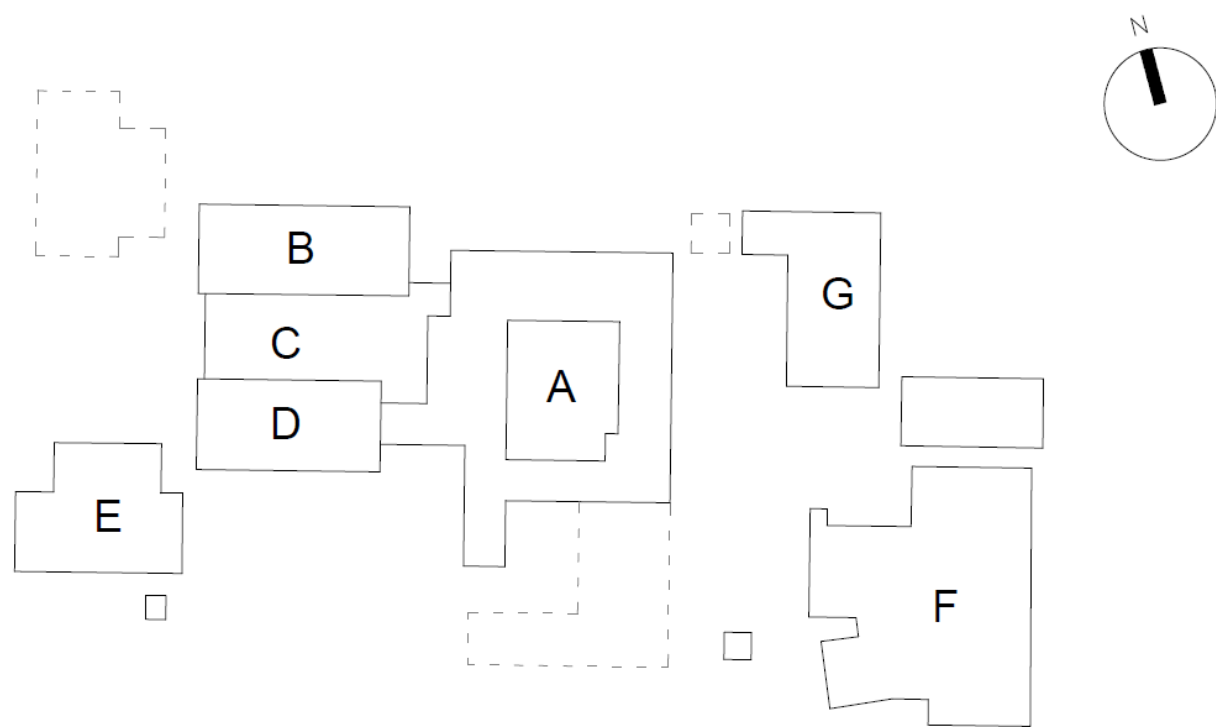
key plan

Havant Academy is located in Leigh Park area of Havant in the English county of Hampshire. It is a mixed secondary school which is situated at the edge of Staunton County Park. The existing Havant Academy consists of several blocks, this application relates to “Block F”.

The application seeks permission to demolish part of Block F due to the presence of RAAC in the building fabric. Excessive degradation of the RAAC could result in sudden failure or collapse of the building, making these spaces unsafe to use. In addition, a part of the external walkway canopy that links the sports hall to the building will be taken down as well.

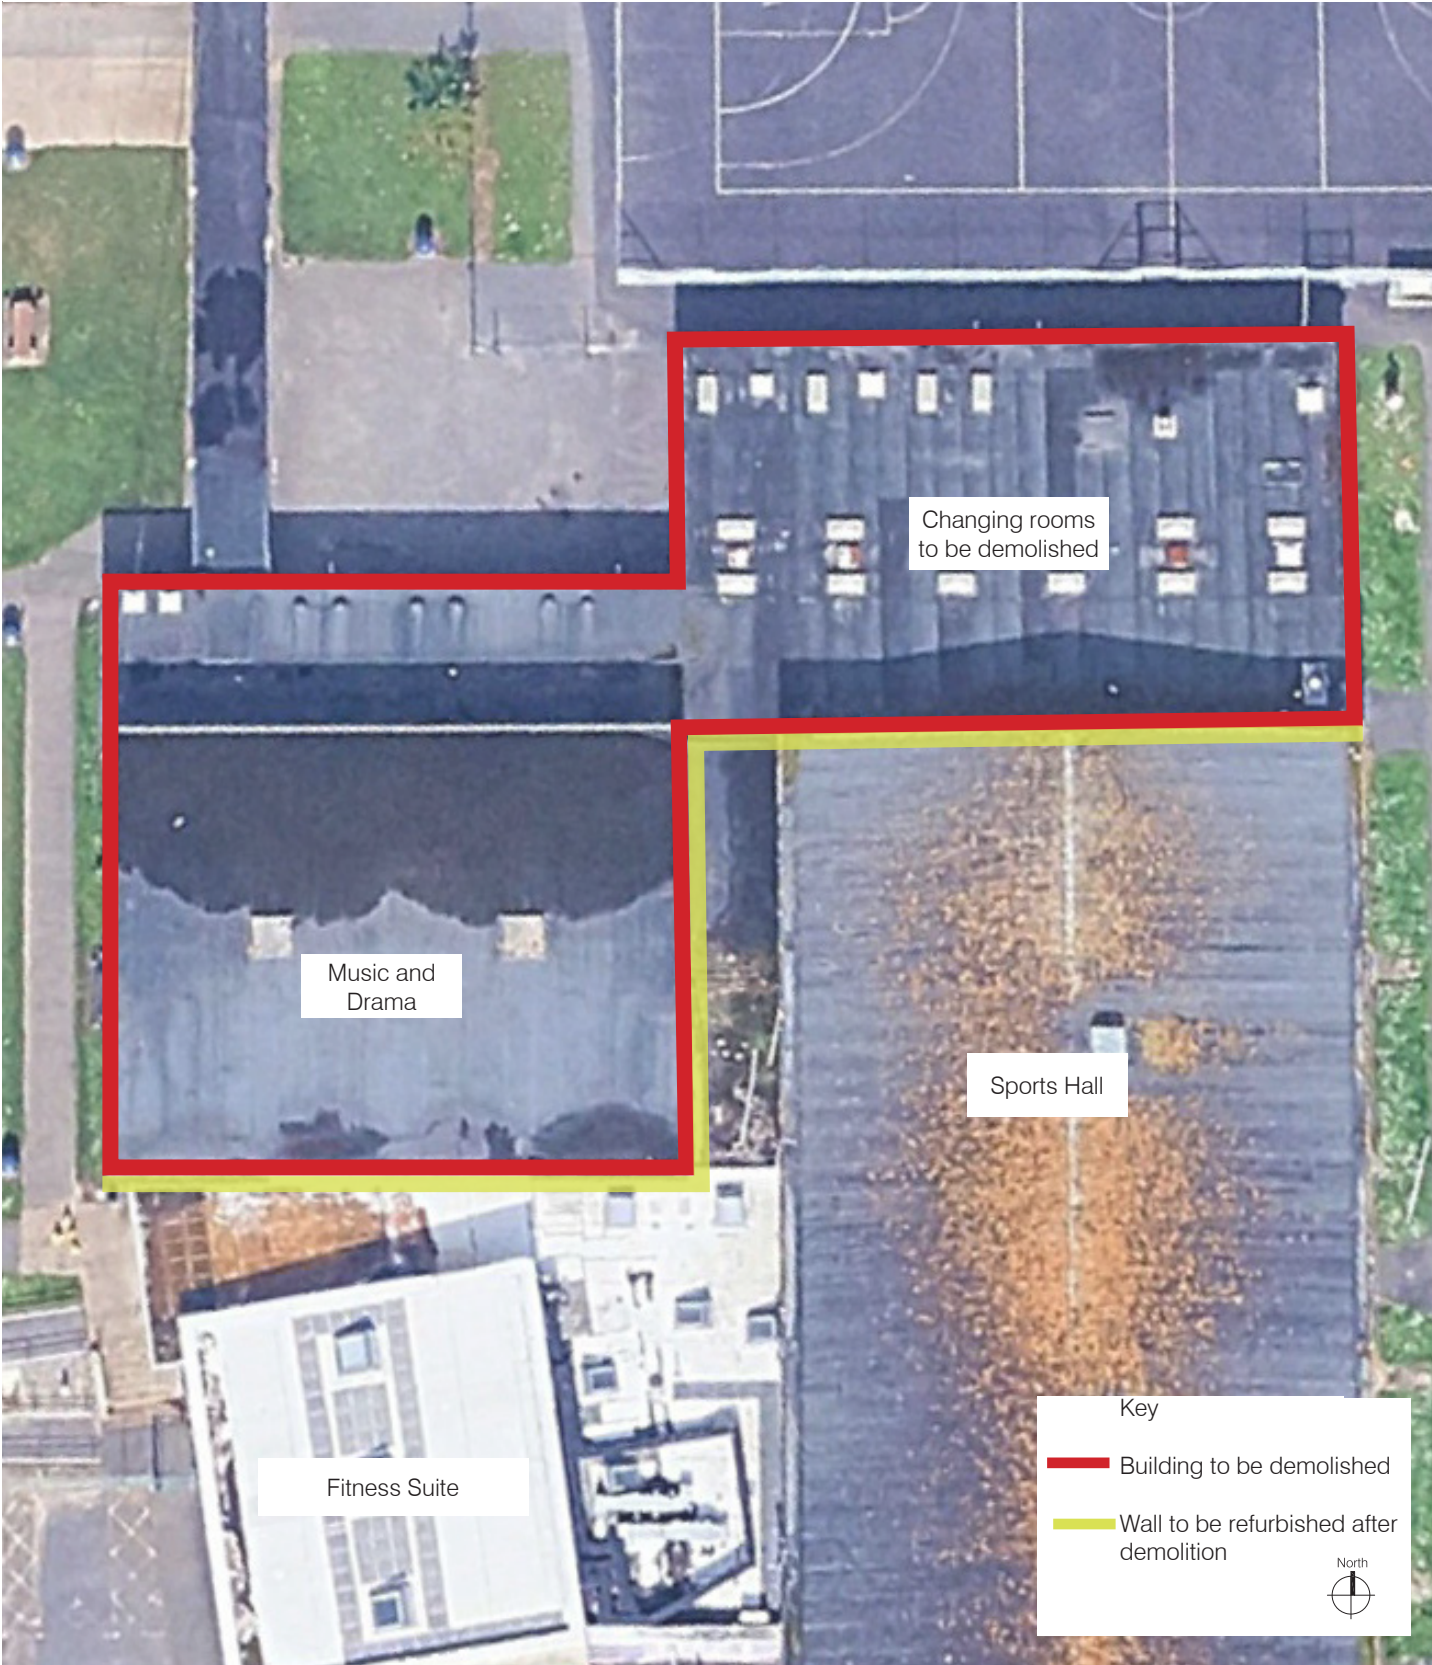
Block F contains a Fitness Suite and Sports Hall, which are to be retained, along with ancillary offices, plant spaces and corridors.

It also contains a Music and Drama hall, as well as changing rooms which are the areas containing RAAC and are to be demolished.

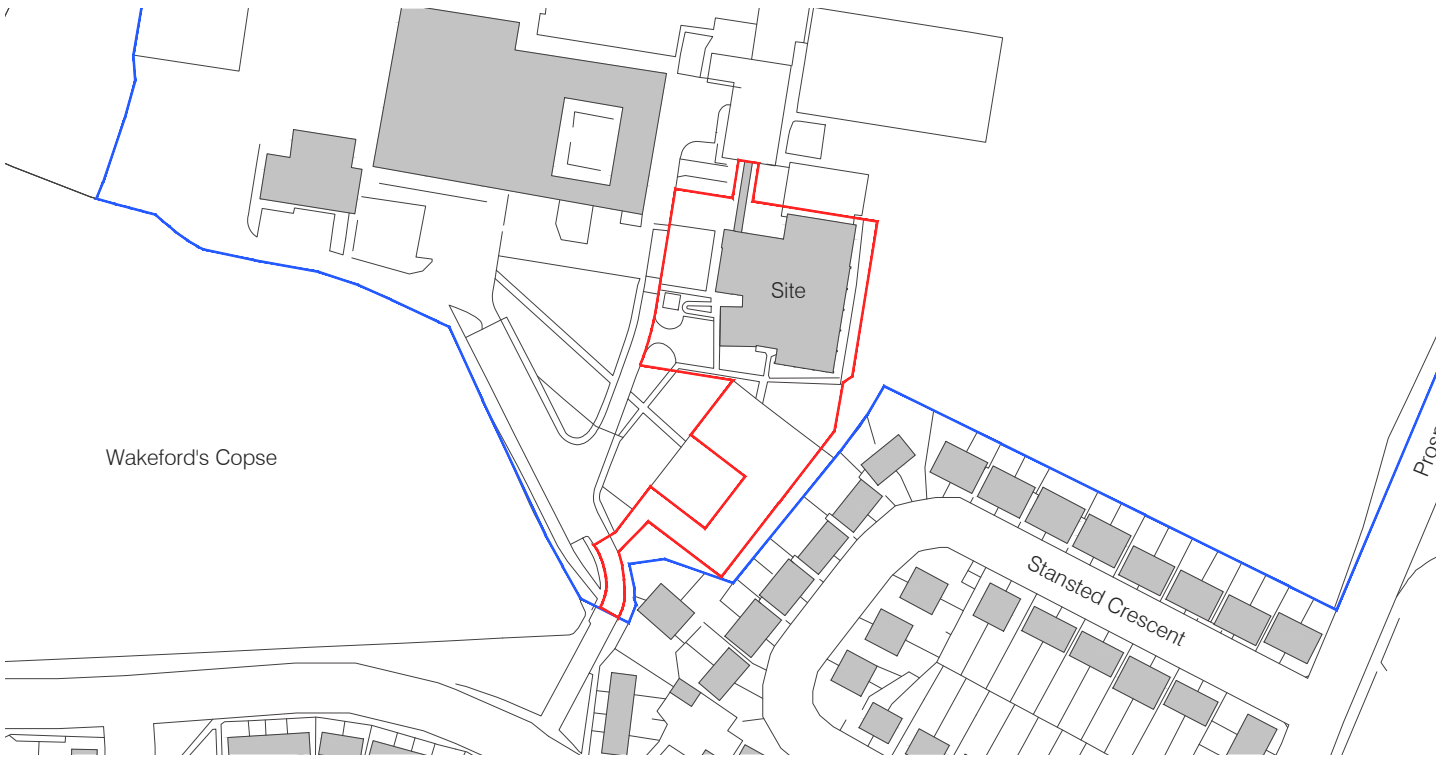
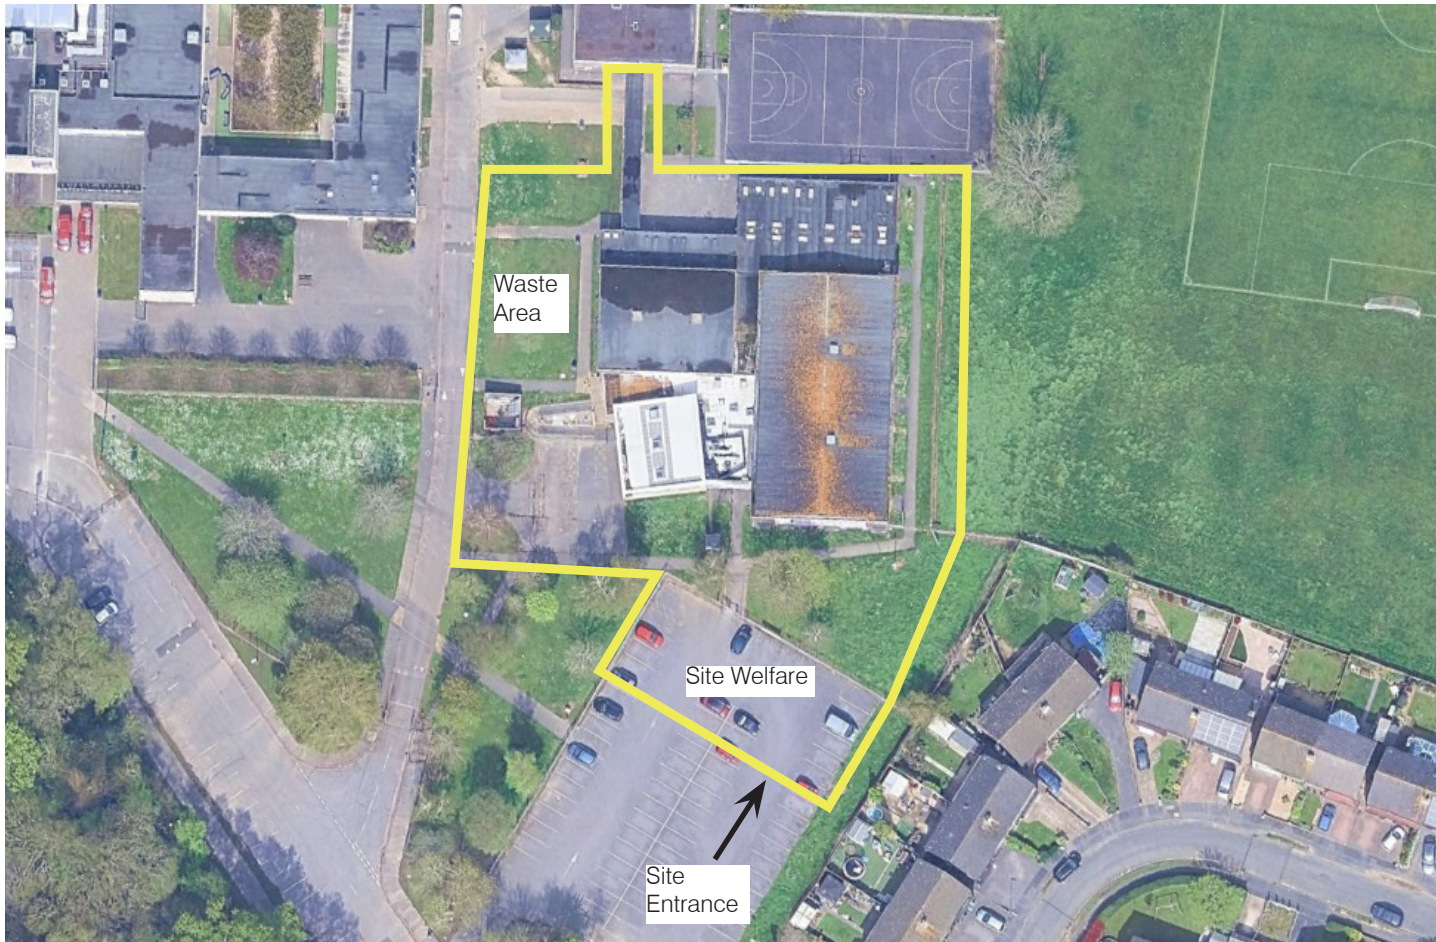
The red line area to allow the demolition to take place is 5762m²

The total area to be hoarded off is 4936m²

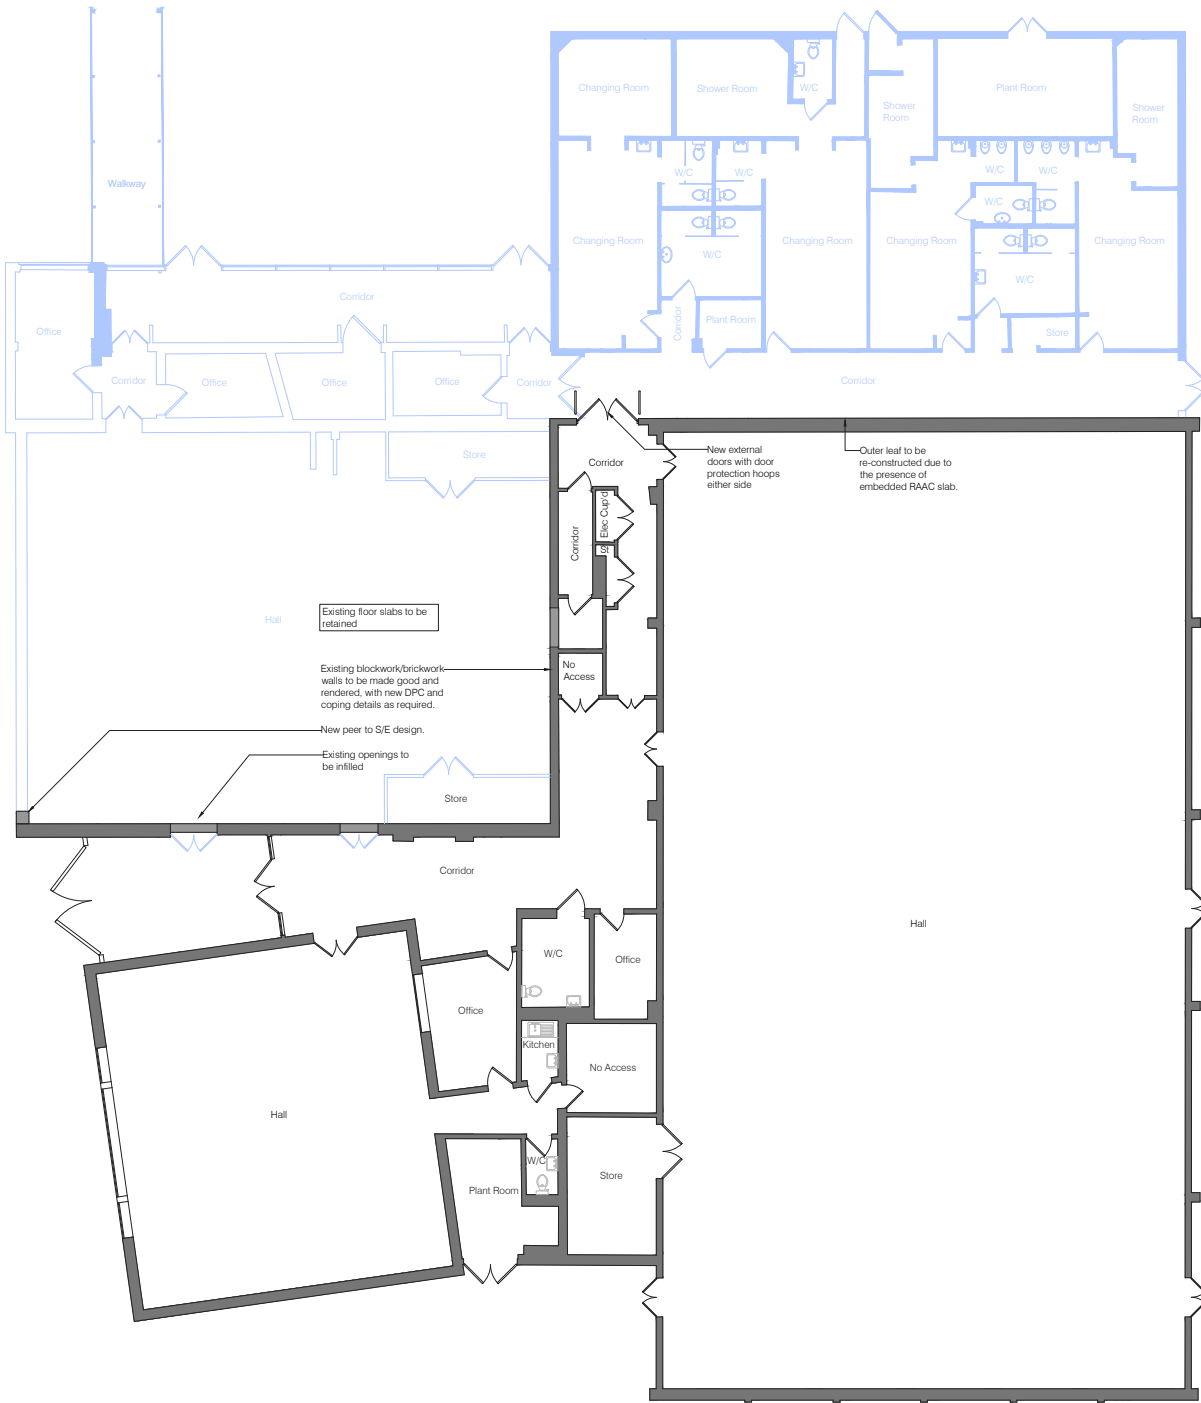
1:100

# 4.0 Layout - Ground Floor Plan

The following have been proposed following the demolition to make good the remaining space:

- New external fire escape door with glazed panels
- New DPC's, flashings and coping details as required.
- Existing floor slabs to be retained to the demolished area with 1.8m high fence to prevent access.
- Blocked up existing openings and existing block-work walls to be made good and rendered.
- A New structural peer to the south west wall of the music hall.
- New hard landscaping and gravel strip (See next page).
- Elements of re-roofing to the corridor spaces to make good the roof finish.

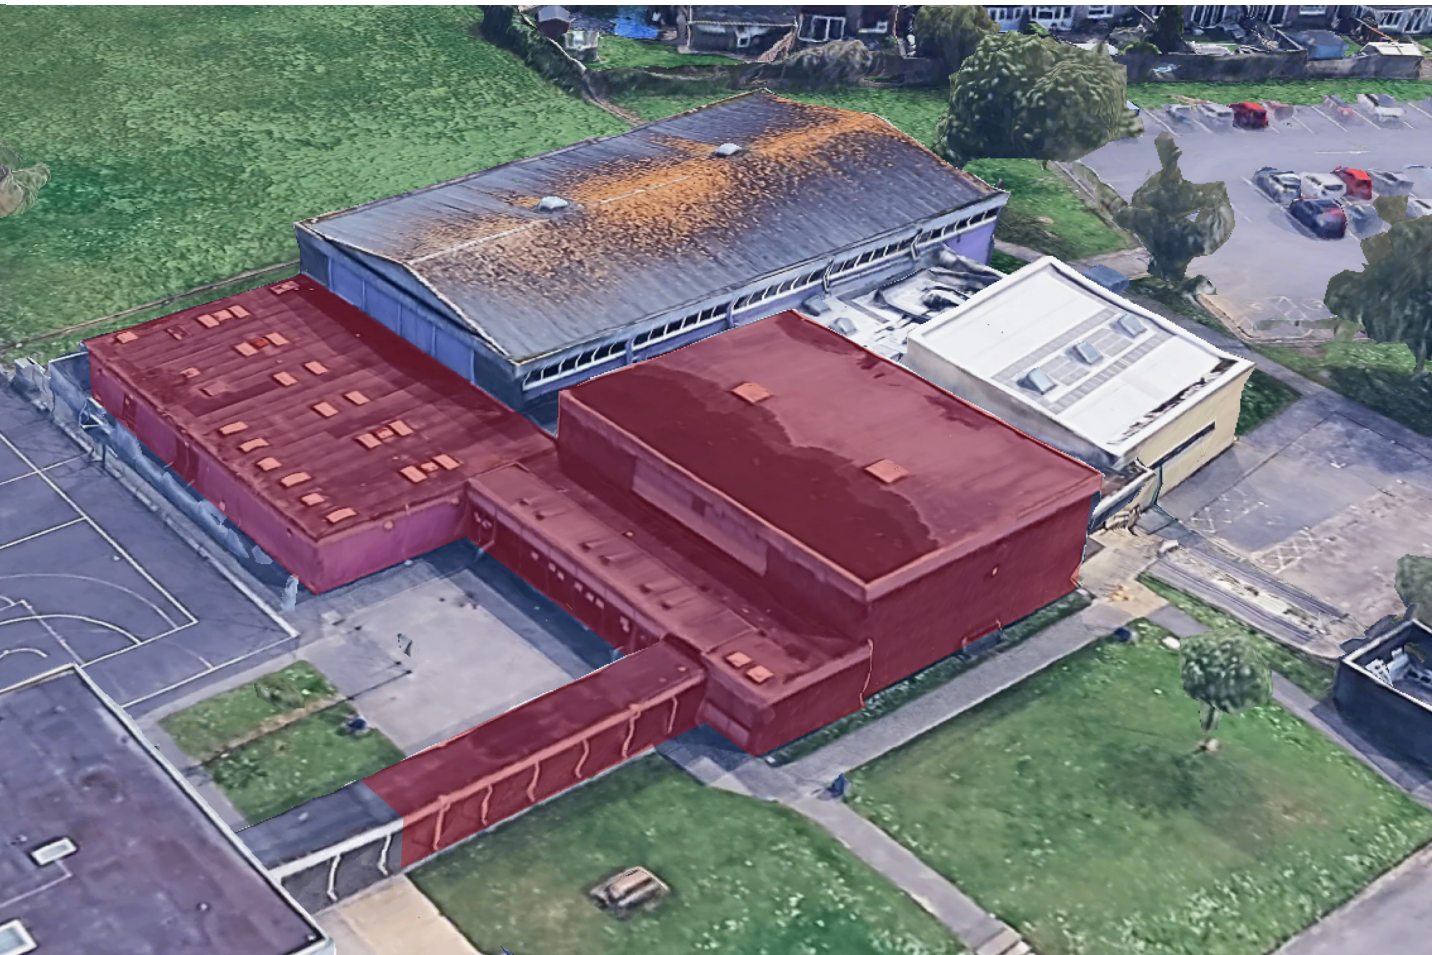
The music and drama hall, the changing rooms as well as part of the walkway canopy joining the sports hall to the building will be demolished.

The area of the building to be demolished excluding the external canopy is 670m<sup>2</sup>.

The area of the building to be demolished including the external canopy is 718m<sup>2</sup>.

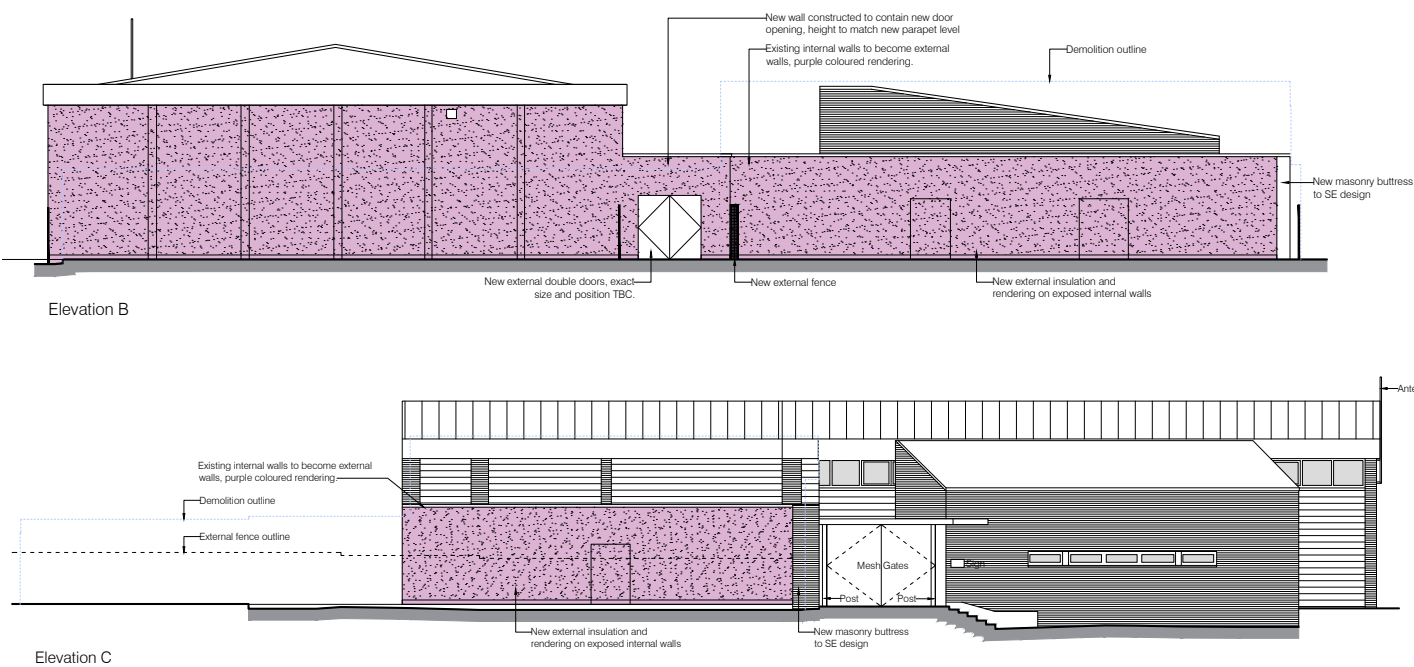
The refurbishments involve the internal walls to become external walls. These are masonry cavity walls, some of which were previously external walls, such as the north elevation of the sports hall. These will be painted purple to match the existing walls. New external aluminium framed doors as well as a new masonry buttress will be added, along with metal copings and flashings as needed.

The newly exposed walls will be made good and rendered to match the colour of the existing blockwork of the current building.

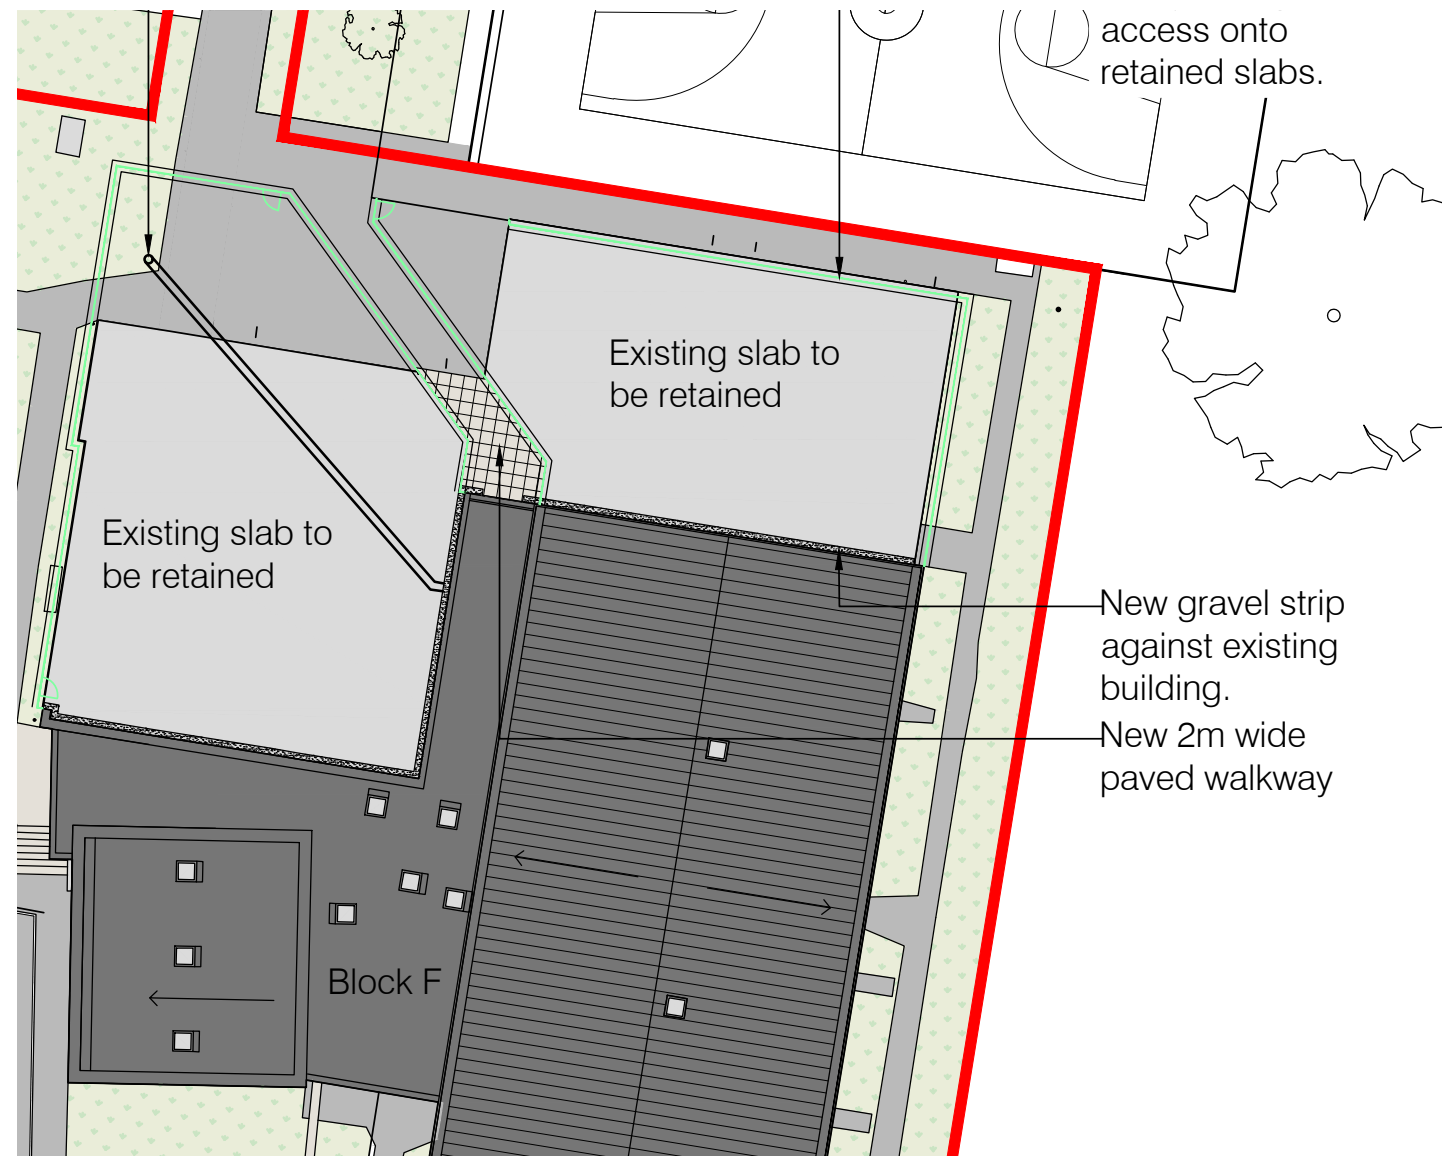
After demolishing the building, the slab will be left exposed. A new gravel strip will be formed around the building to allow suitable waterproofing to be formed. A new paved walkway will connect the building entrance to the main open space. New 1.8m high fences will prevent access to the slabs. New services will be mounted along the top of the western slab, to retain services connections which are currently provided in the walkway roof.
