LANGSTONE PARK, HAVANT

Section 278 Highway Works

Stage 2 Road Safety Audit

Overseeing Organisation: Hampshire County Council

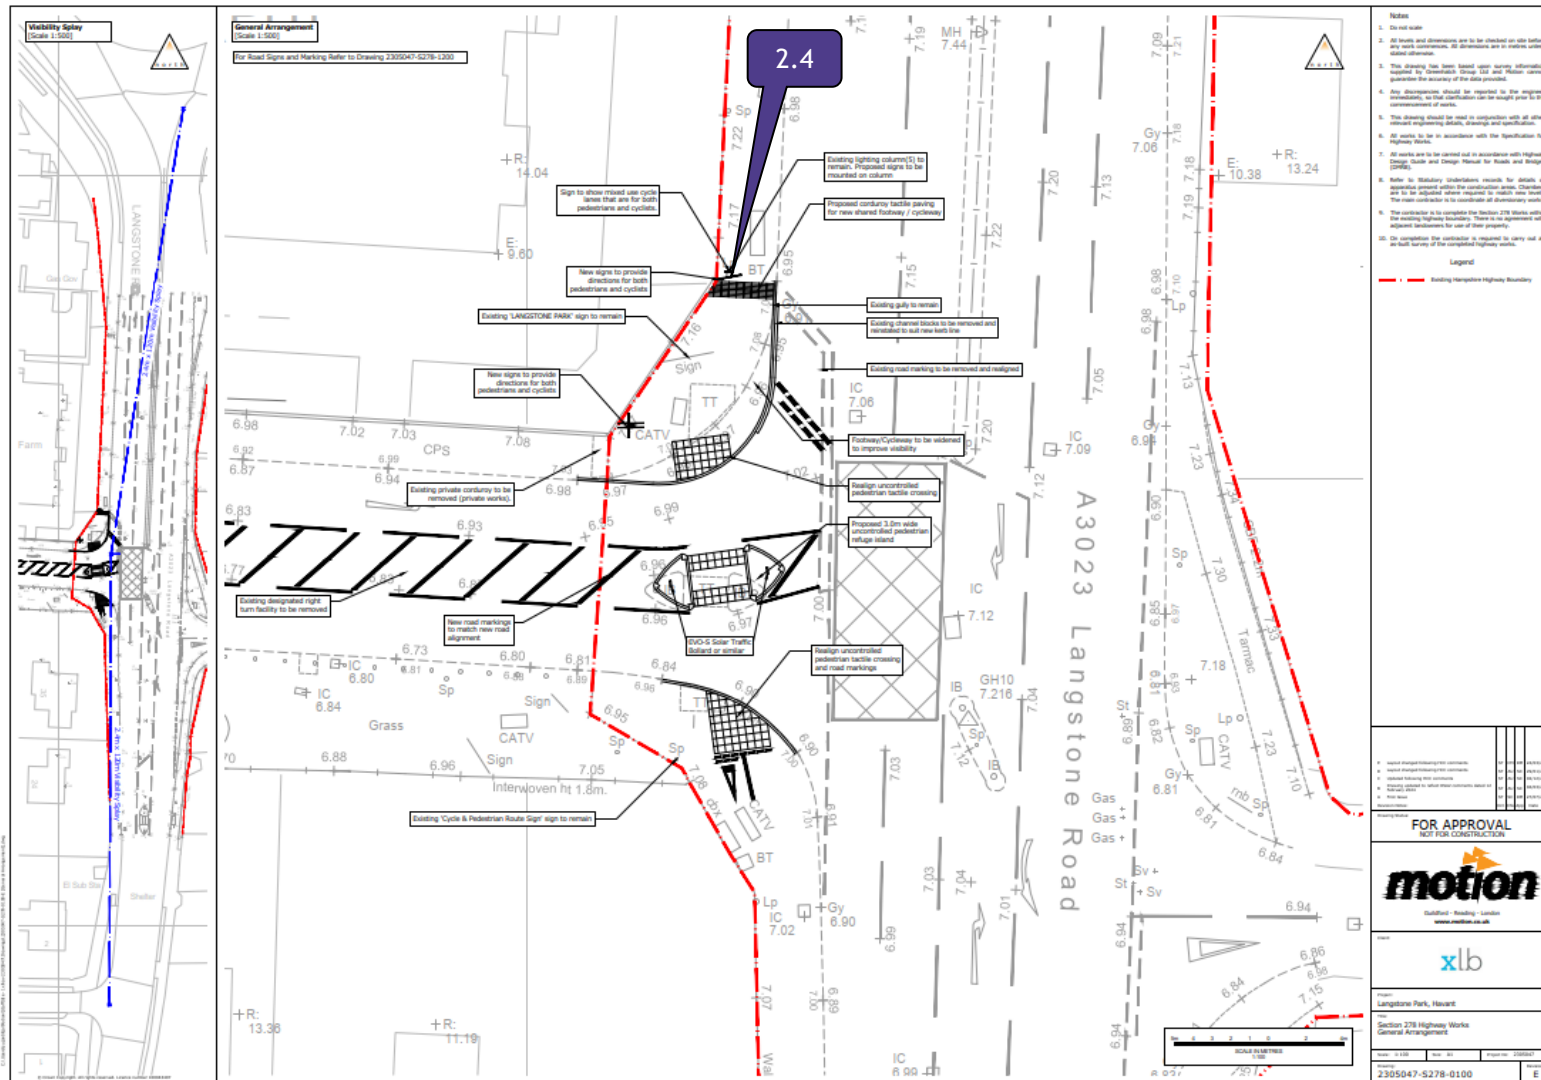
### Location Plan(s)

*Location: Shared footway on north side of Langstone Park access road*

The new corduroy paving north of the access road indicates the end of the shared use footway, but the onward route for northbound cyclists is unclear. Cyclists may continue along the Langstone Road footway, which becomes narrow, leading to collisions between cyclists and pedestrians.

Ensure that direction signage for cyclists is clear and does not indicate an onward route for northbound cyclists along the Langstone Road footway, north of Langstone Park access road.
