Project **TGP Portsmouth**

Enabling  
Elevations

**15 Hemsley Walk PO8  
8JW**

7084 -CTS- 01 - 15 -D-A-4409

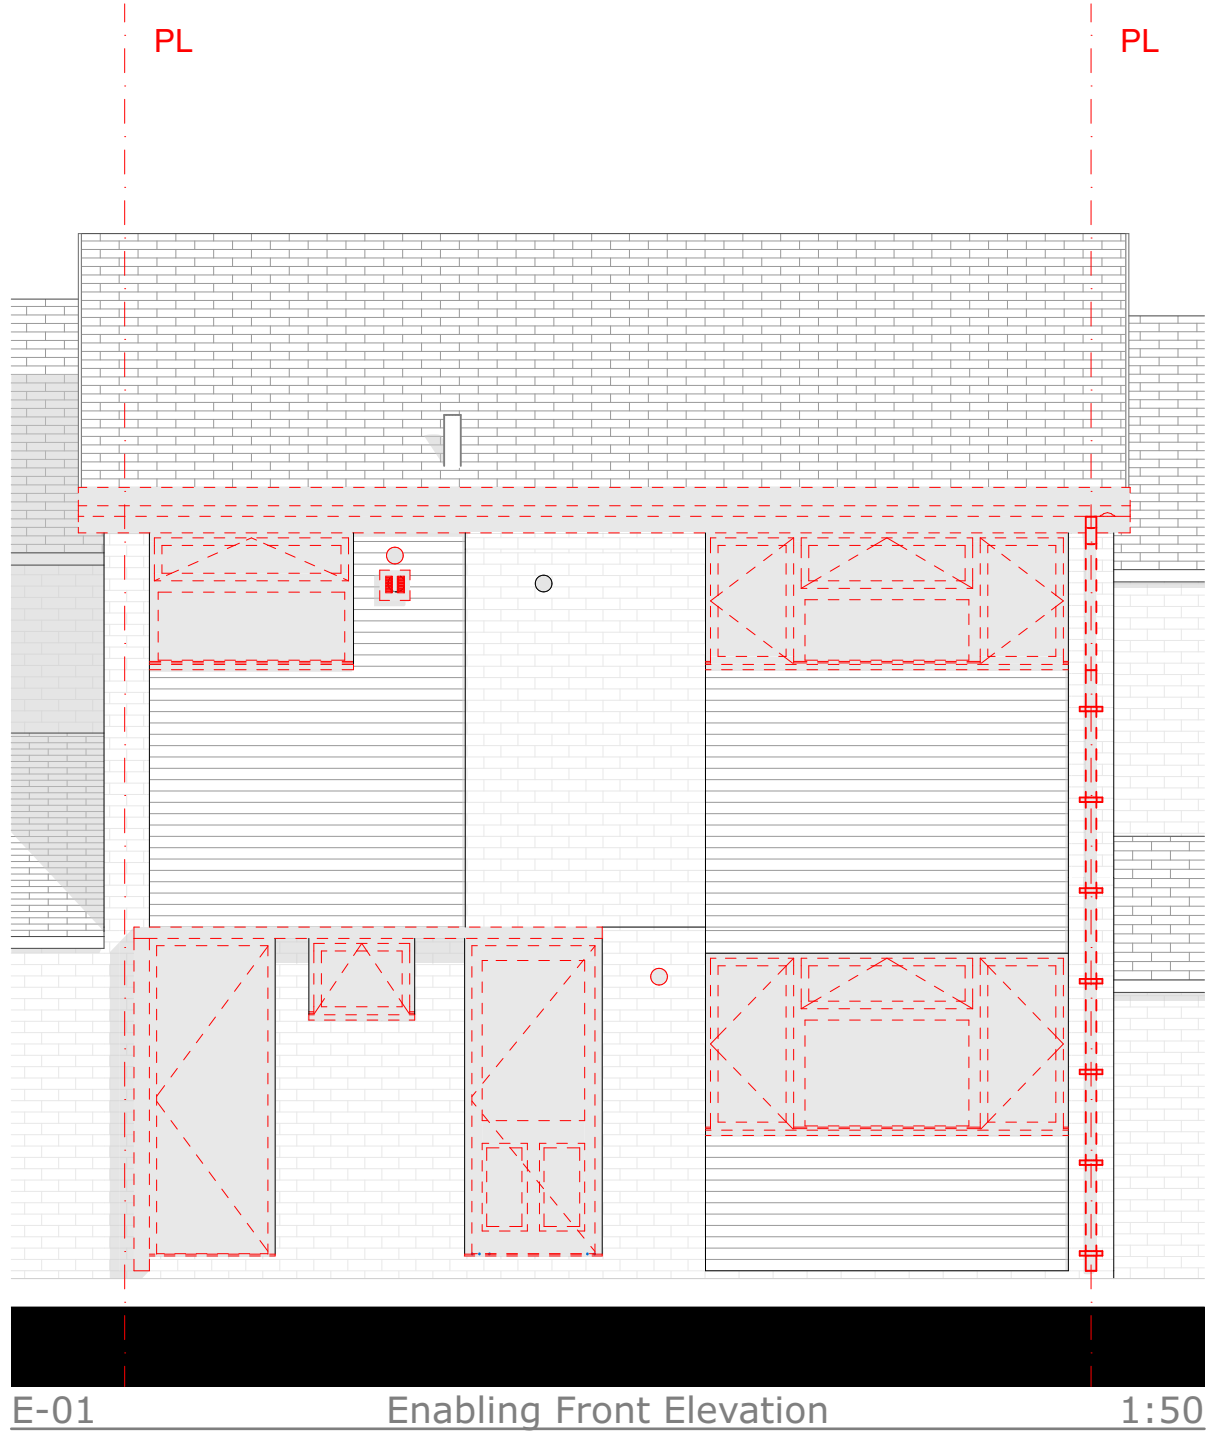
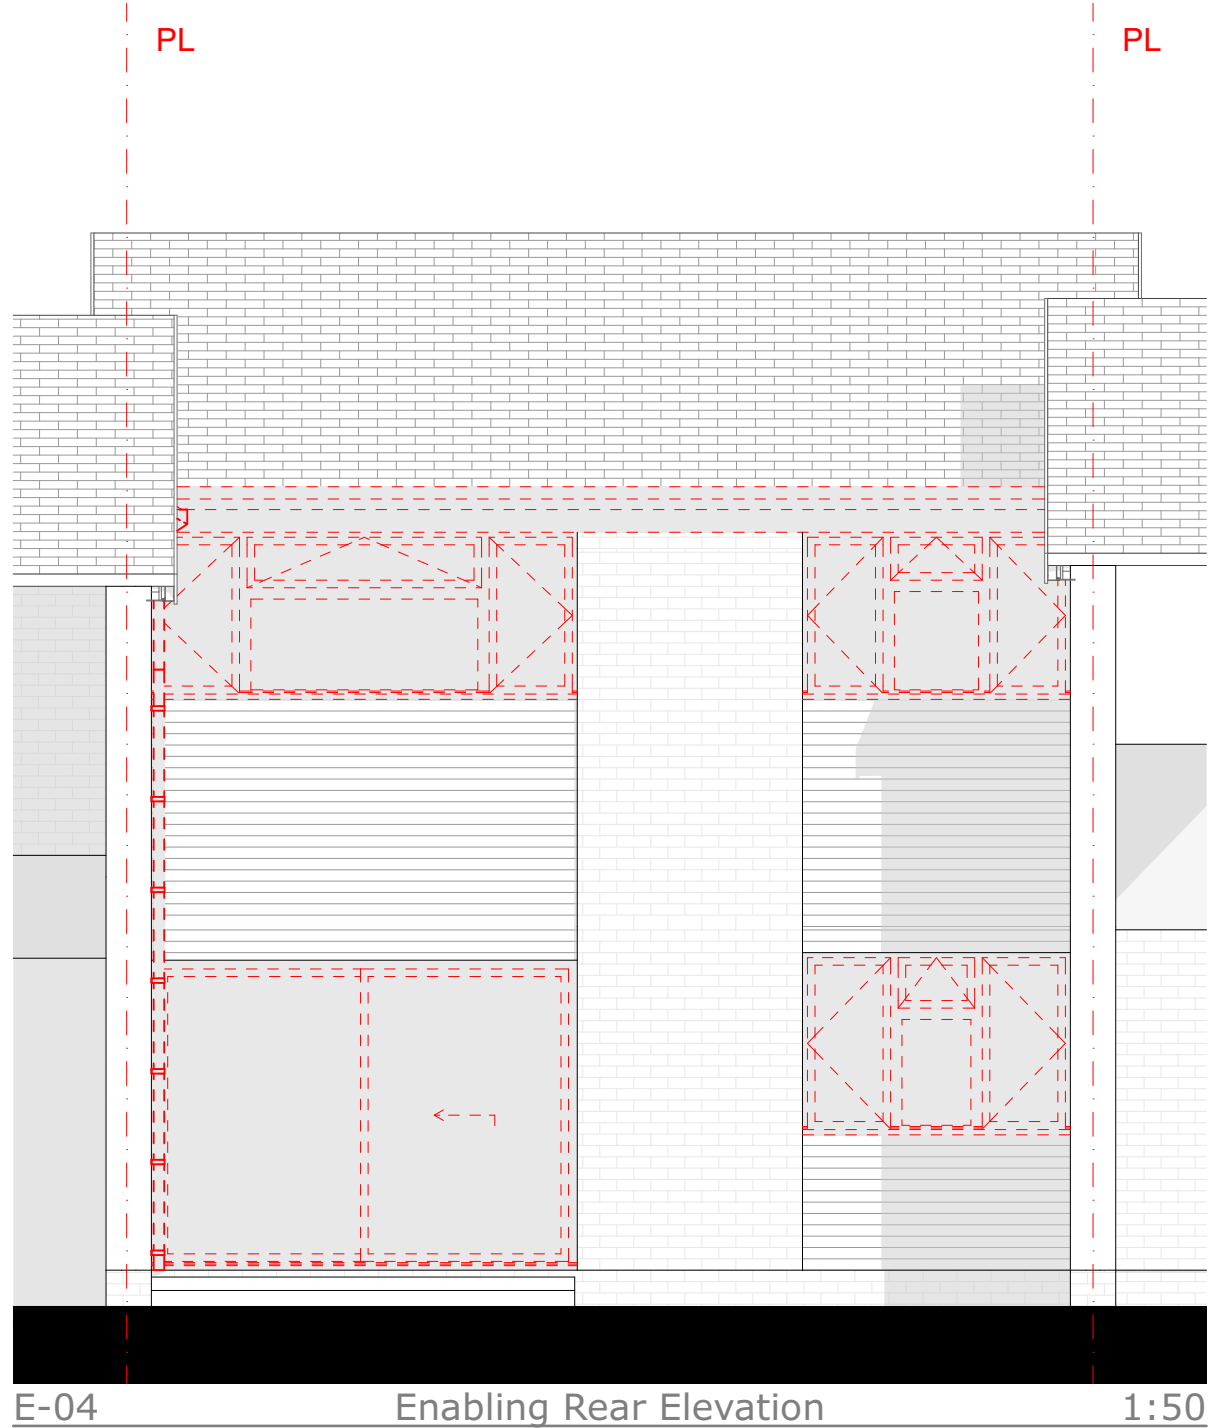
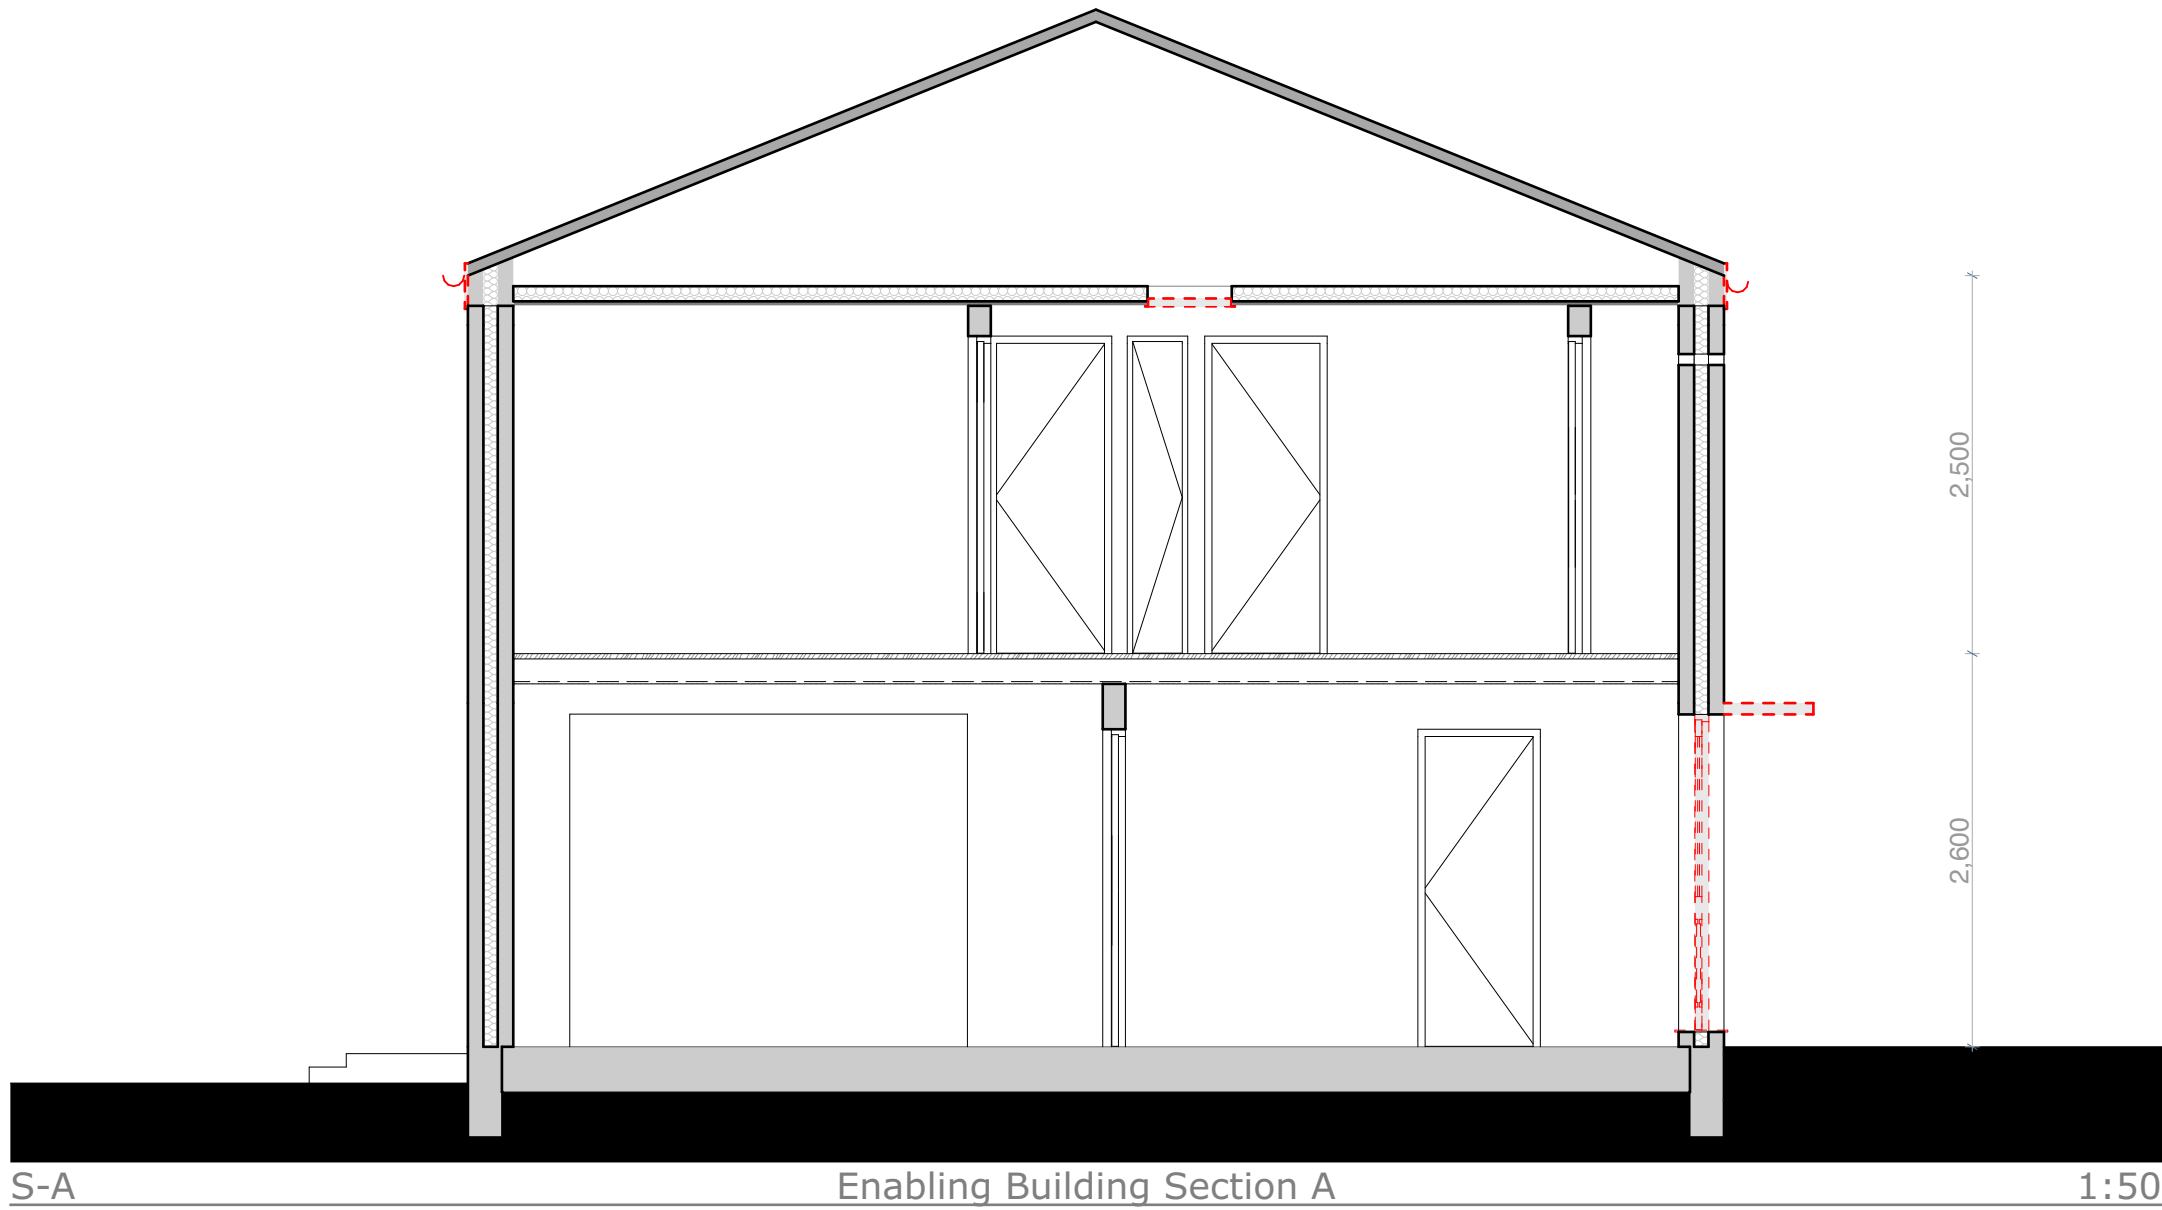
Drawings: Enabling Right Side Elevation, Enabling Left Side Elevation, Enabling Building Section B, Elevations Legend, Enabling Front Elevation, Enabling Building Section A, Enabling Rear Elevation

- Ventilation Strategy Preparation**
  - Remove existing kitchen and bathroom extract fans: ensure 110mm clear core drill aperture and existing fuse spur is adequate for new dMEV fan

- Ventilation of kitchen appliances and open flue items where agreed to be retained and insulated
  - New rigid ducting/sleeve to be installed for dMEV, mitigating deformation

- All air bricks above DPC and below roof insulation to be filled.
  - Trickle vents to be removed from existing kitchen/bathroom window
- Roof and Loft Preparation**

- Existing gutters, soffits and fascia's to be assessed for degradation, replace where required
  - Remove personal items and debris from the loft space

- Loose cabling to be secured underneath loft insulation/ to the back face of the ceiling board
  - Remove existing loft hatch
- Wall Preparation for CWI Areas**

- Remove all trellis or greenery on external walls
  - Remove outside lights and associated fixtures, install new lights upon completion
  - Remove any satellite dishes or aerials, work to be carried out in conjunction with service providers, replace upon completion

- Remove existing porch canopy
  - Remove, retain, and replace handrail to step, replace upon completion
  - Remove RWP's; ensuring 200mm offset from wall, swan neck connection where pipes terminates below ground, adhering to EW1 manufacturer's and CTS Detail Pack

- Extend 40mm wastewater pipes and overflows
  - Remove garden tap, extend copper pipe, replace upon completion or install new outside tap where one is not present

- Remove kitchen and bathroom extract fans: ensure 110m clear core drill aperture and existing fuse spur is adequate for new dMEV fan
  - If gas meter box is present retain, refer to EW1 manufacturers details

- All Airbricks above DPC to be filled, ventilation of kitchen appliances to be retained and insulated
- Wall Preparation for CWI Areas**
  - Remove kitchen and bathroom extract fans: ensure 110m clear core drill aperture and existing fuse spur is adequate for new dMEV fan

- New rigid ducting/sleeve to be installed for dMEV, mitigating deformation during CWI install
  - Missing/spalled brickwork to be replaced and redundant penetrations to be blocked up with brick and mortar, prior to cavity install. If not possible area to be filled with fire rated expanding foam

- All Airbricks above DPC to be filled, ventilation of kitchen appliances to be retained and insulated
  - Replace wetroom windows where trickle vents are currently present

- Internal Remedial Works**
  - Areas damaged or affected by mould growth or damp need to be repaired and cleaned prior to insulation works
  - Areas to consider; bathrooms, WC's, bedrooms, kitchens etc. refer to Retrofit Assessment Condition Survey
